TREE ASSESSMENT REPORT

Assessment of *Araucaria columnaris* (Cook Island Pine)

Located at: 62-64 Beachcrest Rd WELLINGTON POINT QLD 4160

27 March 2013

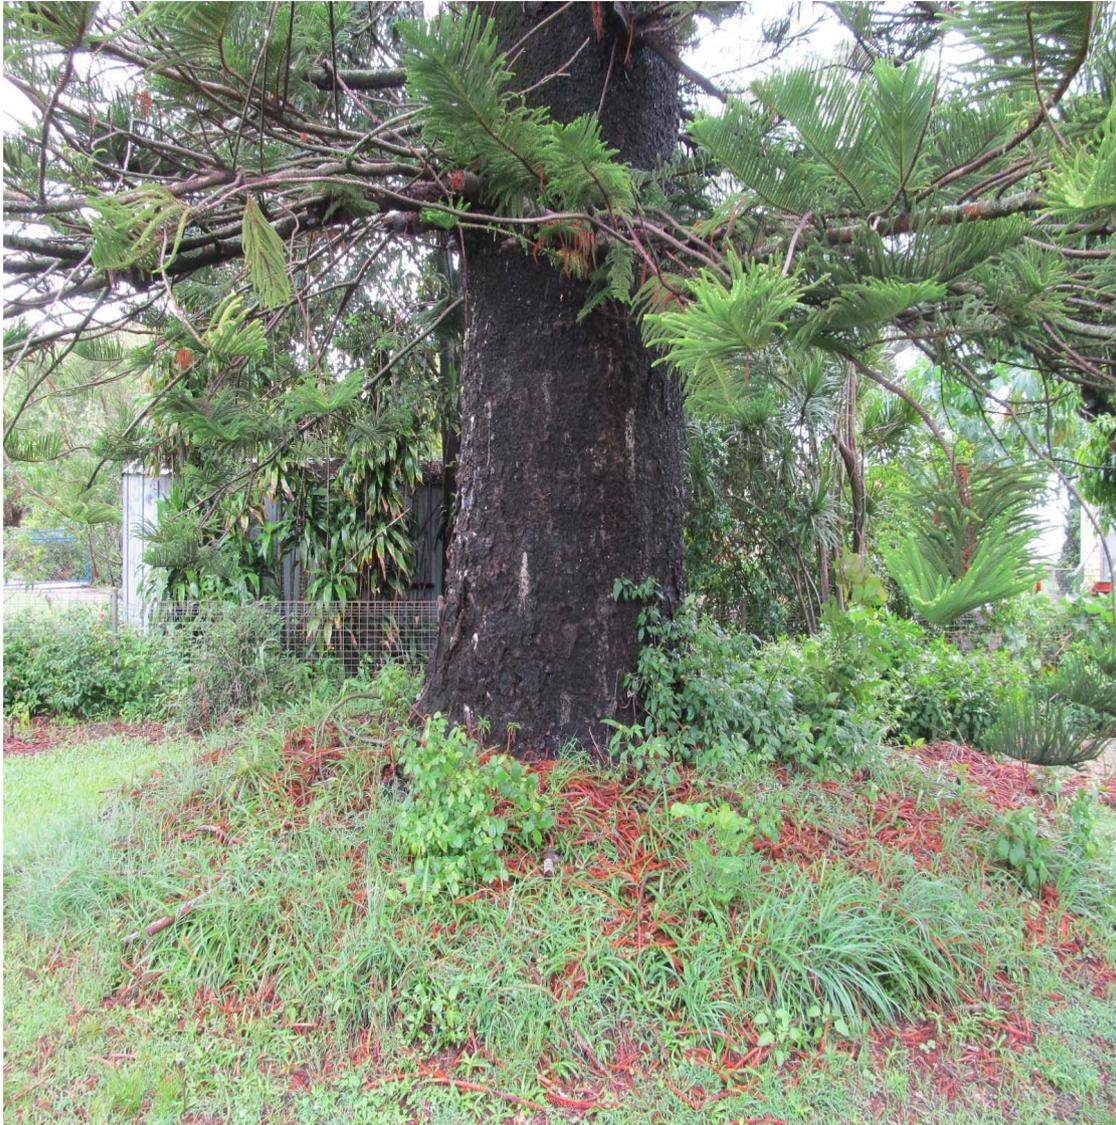
Photograph 1 (showing root flare)

Photographs 1 to 3 show the trees root zone. There are no visual issues with this zone that would warrant a further and more comprehensive assessment. In photograph 3, a root from the tree is visible above ground, located 8 metres from the trunk. Araucaria spp. typically has extensive, shallow root systems, sensitive to disturbance. This specimen has a TPZ (tree protection zone) of around 12 metres. The SRZ (Structural Root Zone) is quite large for these trees due to their great height and shallow root system. They require a larger SRZ than the guidelines outlined in AS4970-2007 Protection of Trees on Development Sites, due to the growth characteristics and root-plate dynamics and strength required by these trees. This particular specimen would require a SRZ of around 6 metres.

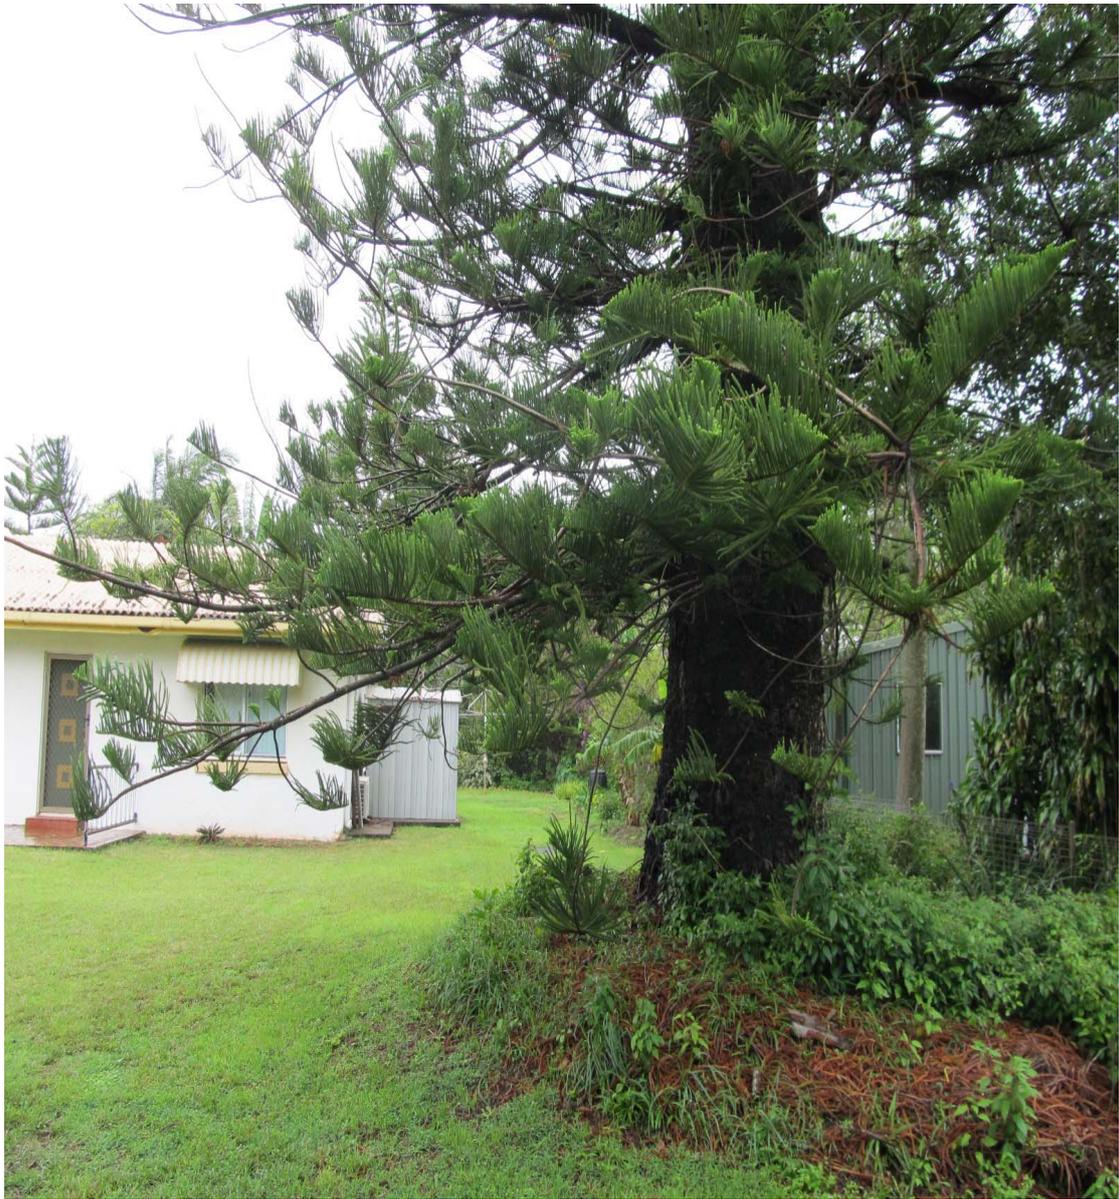
Photograph 2 (looking west towards residence on adjoining property)

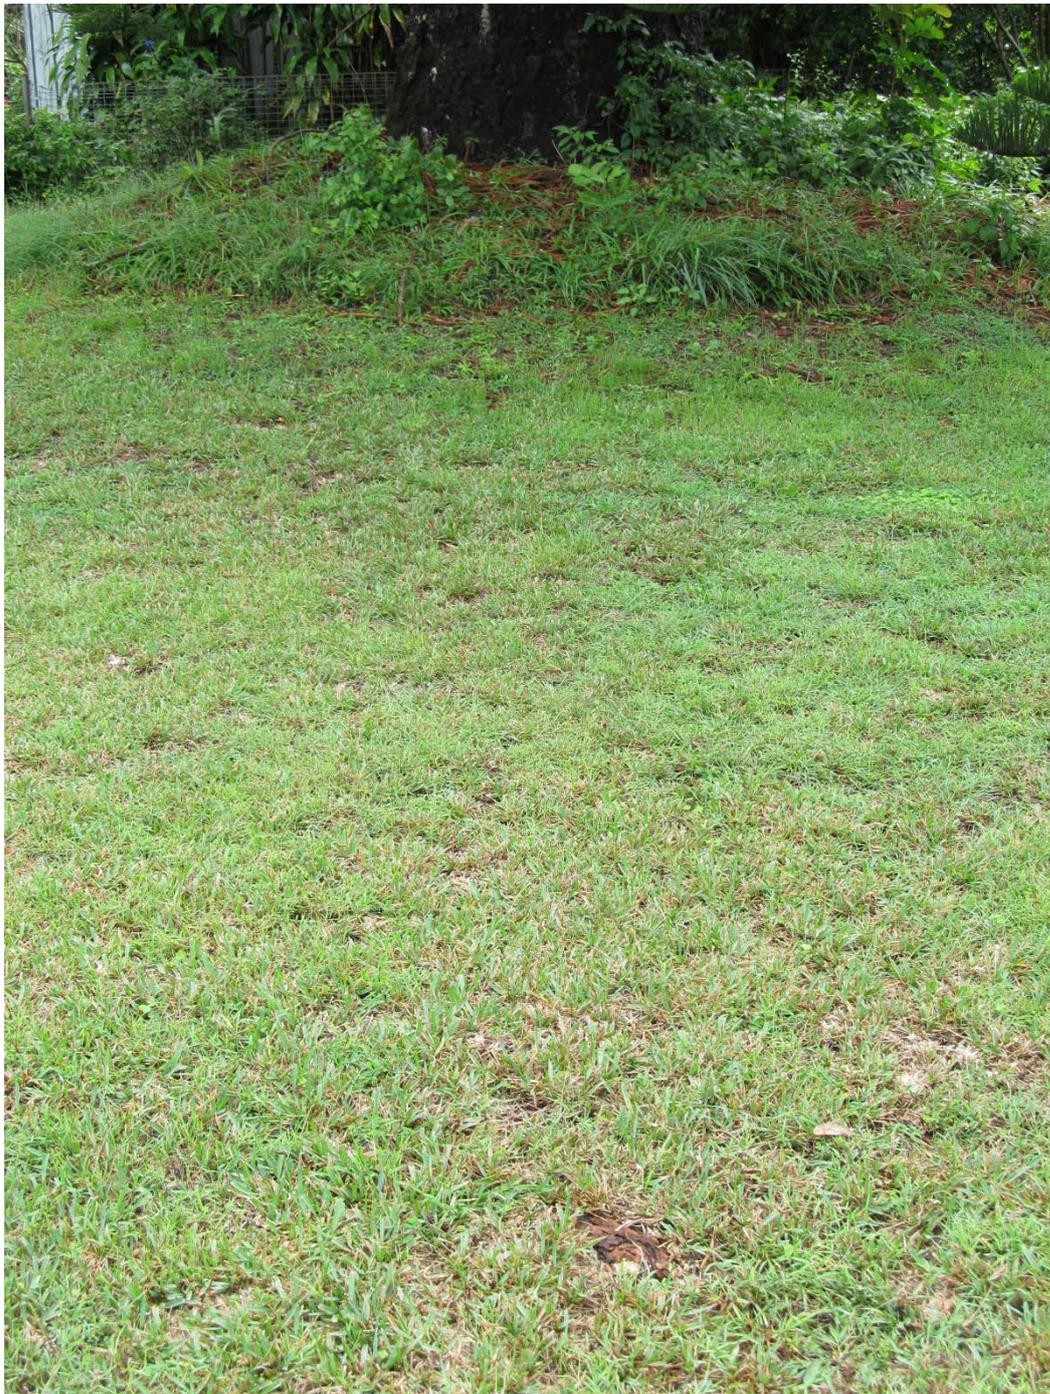
Photograph 3 (exposed surface root 8 metres from trunk)

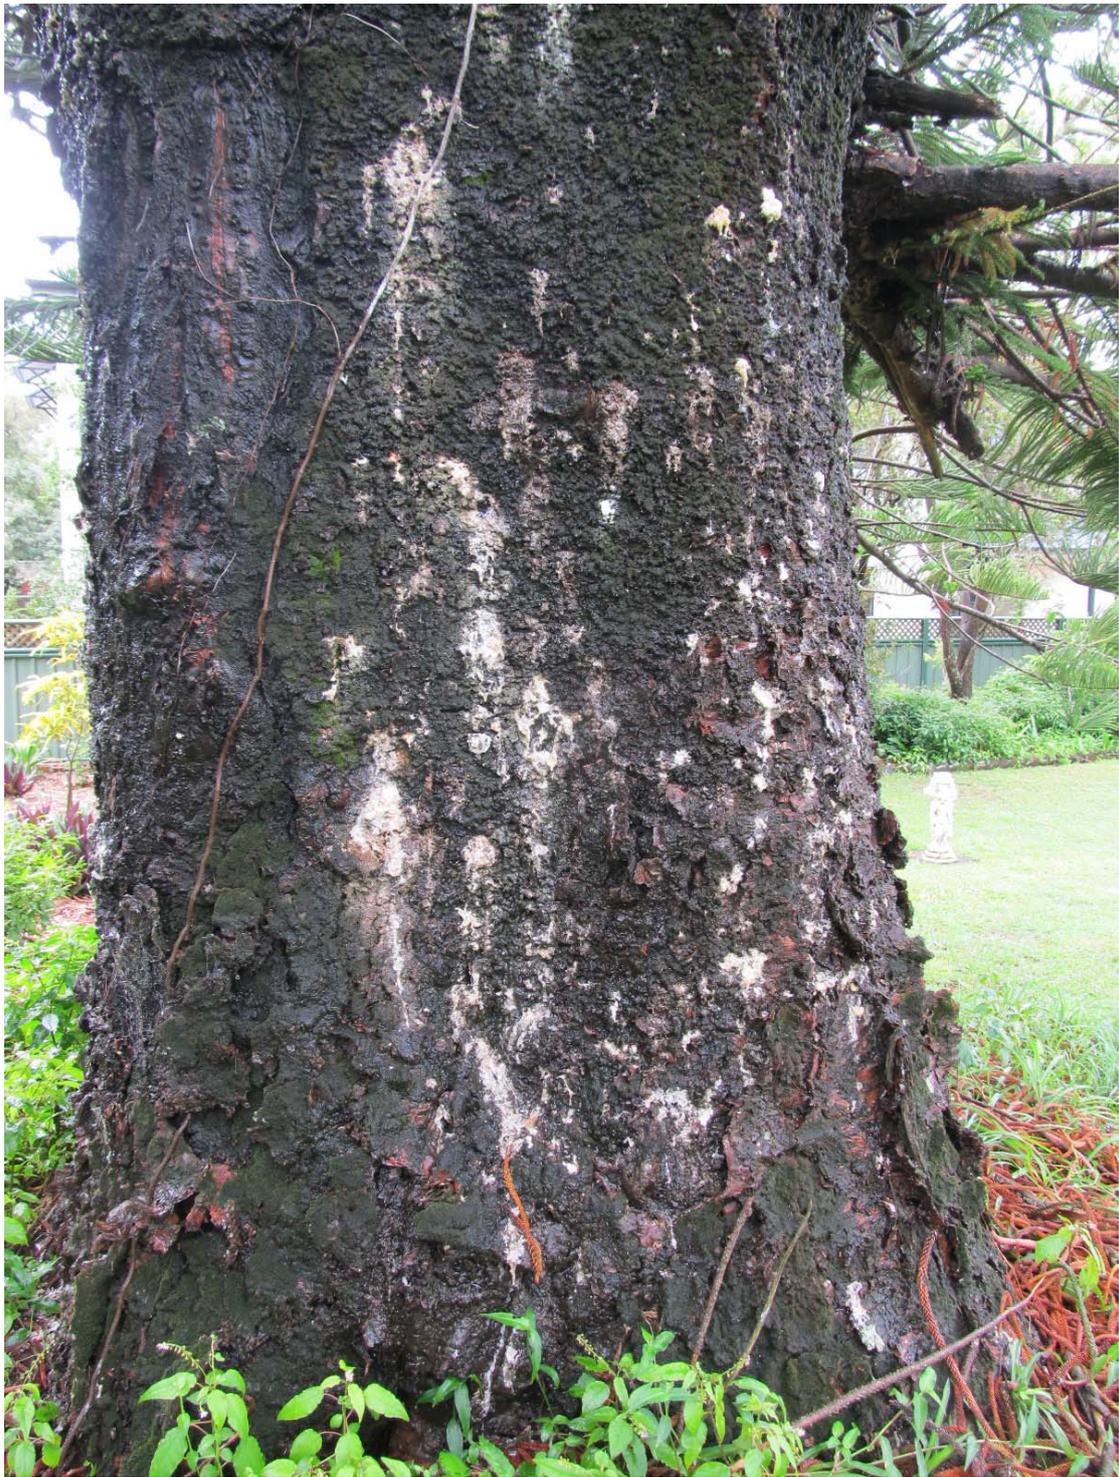
The trunk of this tree presented as sound and acceptable for a Cook Island Pine of this age and form. The trunk is straight, tall and of normal diameter and sequential taper. Exudates present on lower trunk are typical of *Araucaria*, particularly of this vintage and can be caused by fungal or insect pest common to these trees. They are not considered an issue at this stage.

Photograph 4 looking east showing weeping on trunk caused by insect damage, common to *Araucaria* spp.

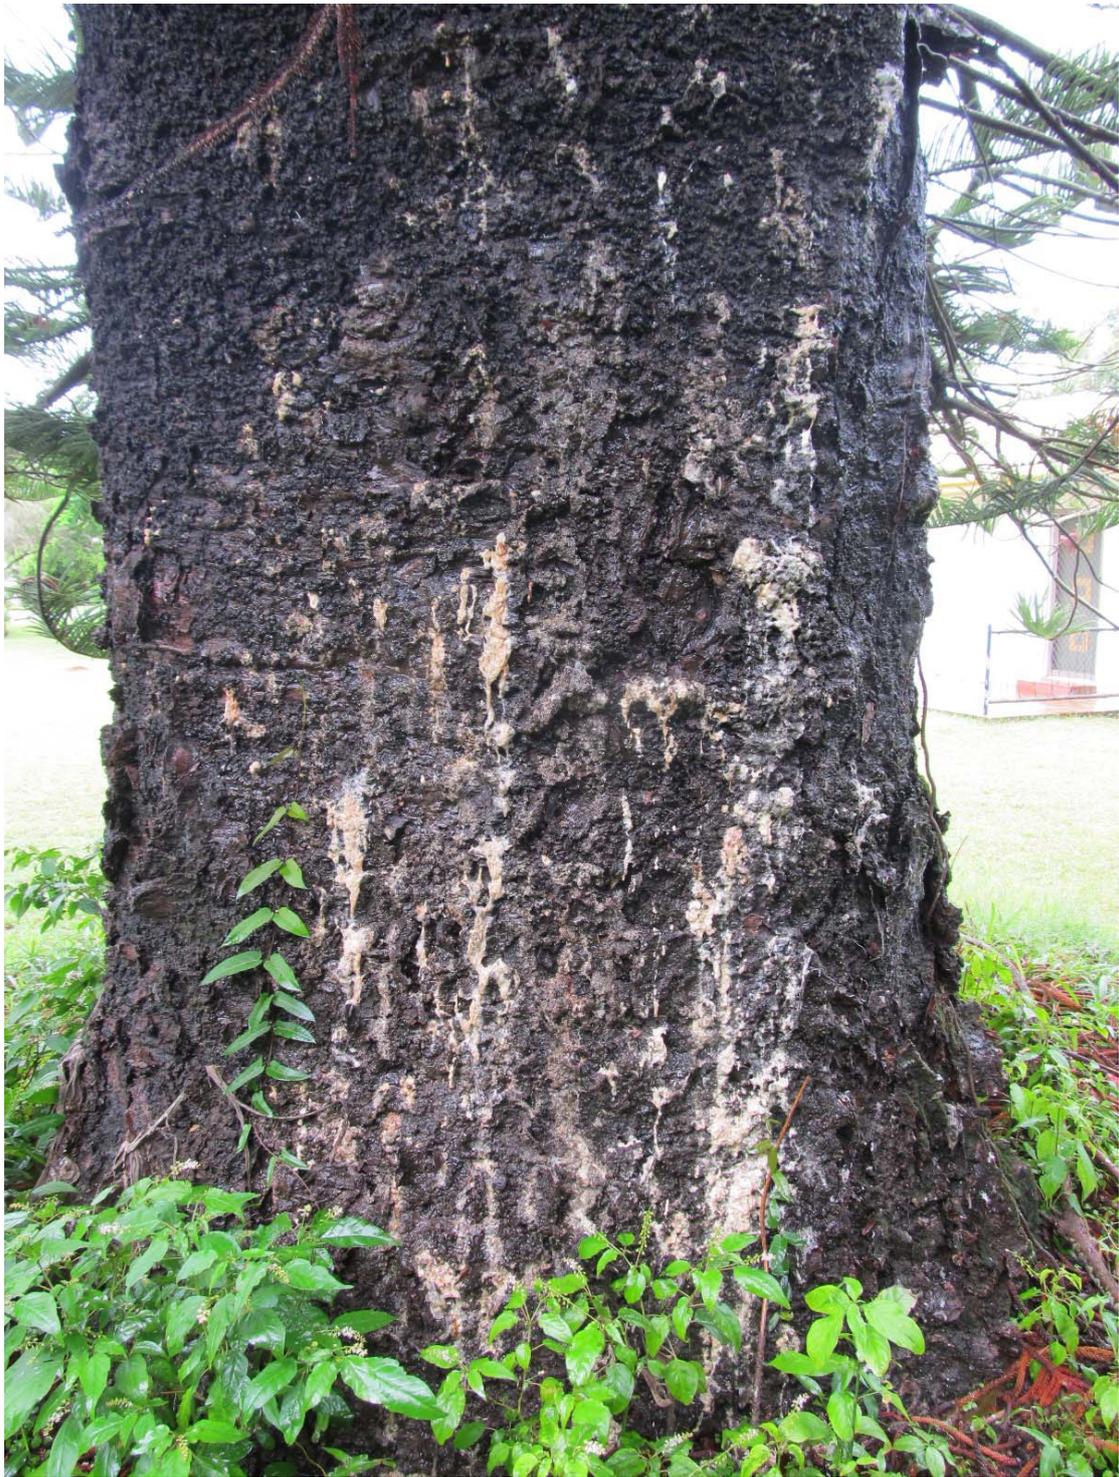
Photograph 5 looking south and showing weeping on trunk caused by insect damage, common to Araucaria spp.

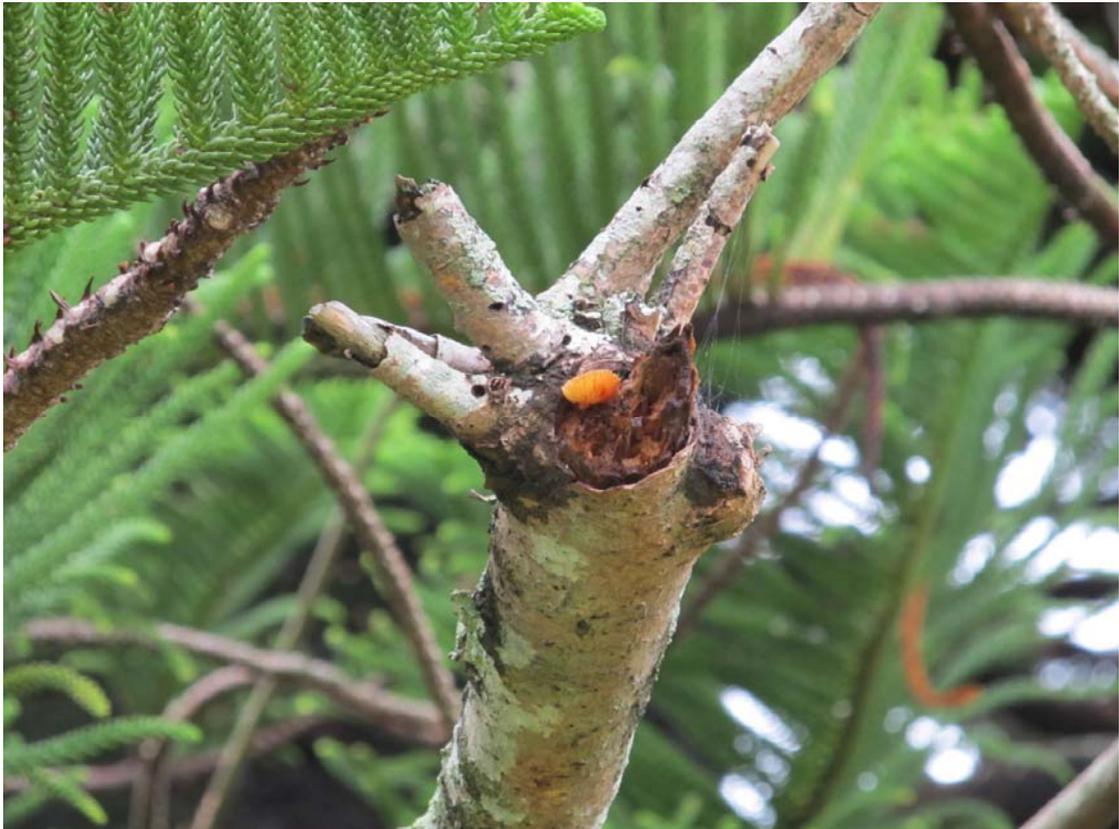
Photograph 9

Jews Ear Fungi is common to Araucaria spp. and does not constitute a 'decayed tree'. This fungus consumes deadwood as can be seen in this photograph.
