28 March 2013

Redland City Council  
Cnr Bloomfield & Middle Streets  
Cleveland  
Qld 4163

## **Peer Review of Raby Bay Geotechnical Study**

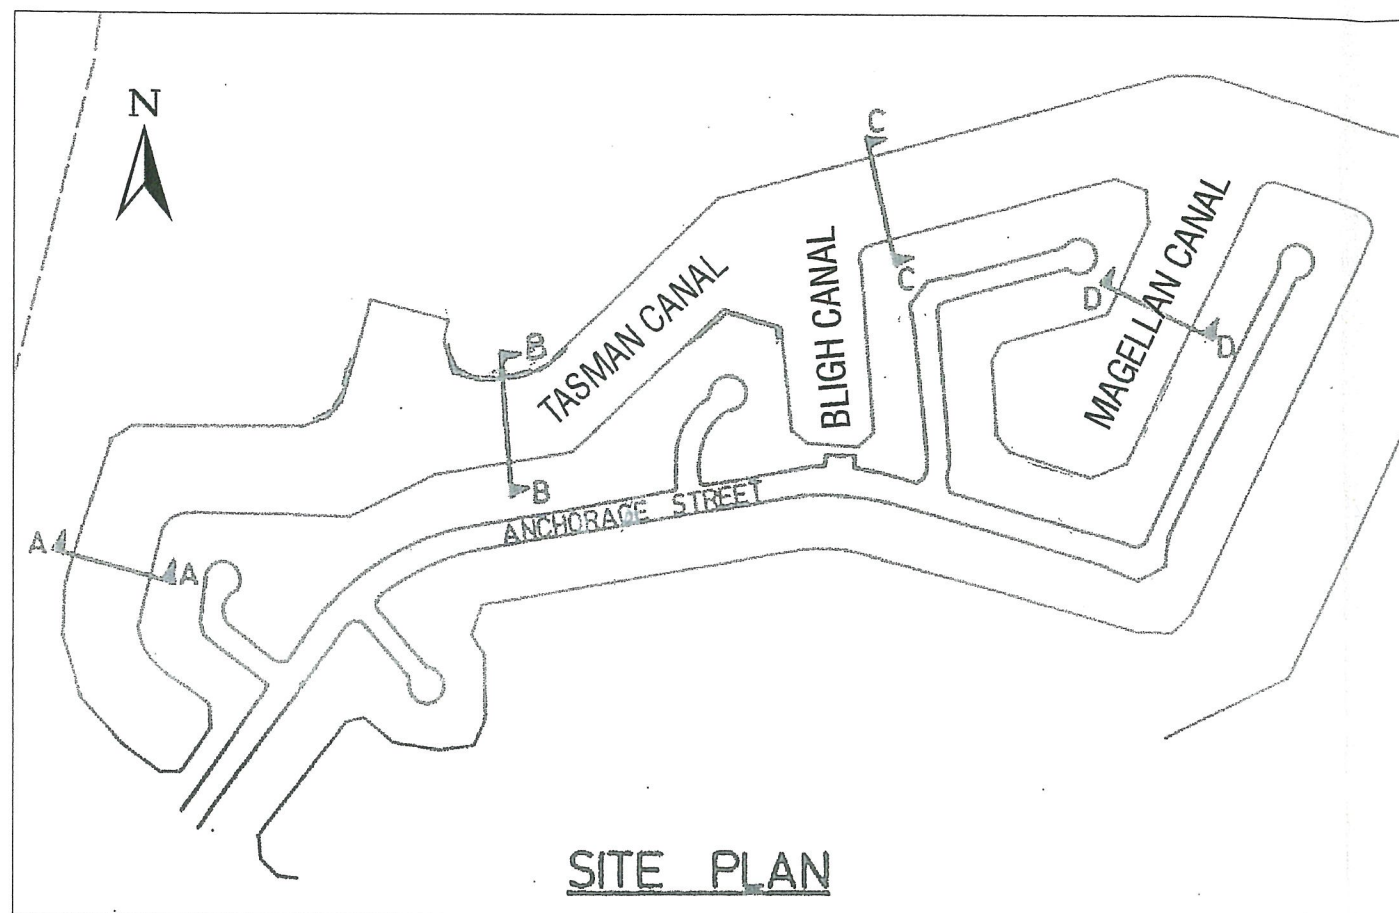
Figure 1 attached presents a simple and practical depiction of the broad subsurface profile at the development and is a useful contextual reference when considering further comments relating to ground conditions. Of course, variability (both natural and man-made) cannot be depicted in such a simplified model, and it has been noted in the literature reviewed that variability can be extreme and over very short distances.

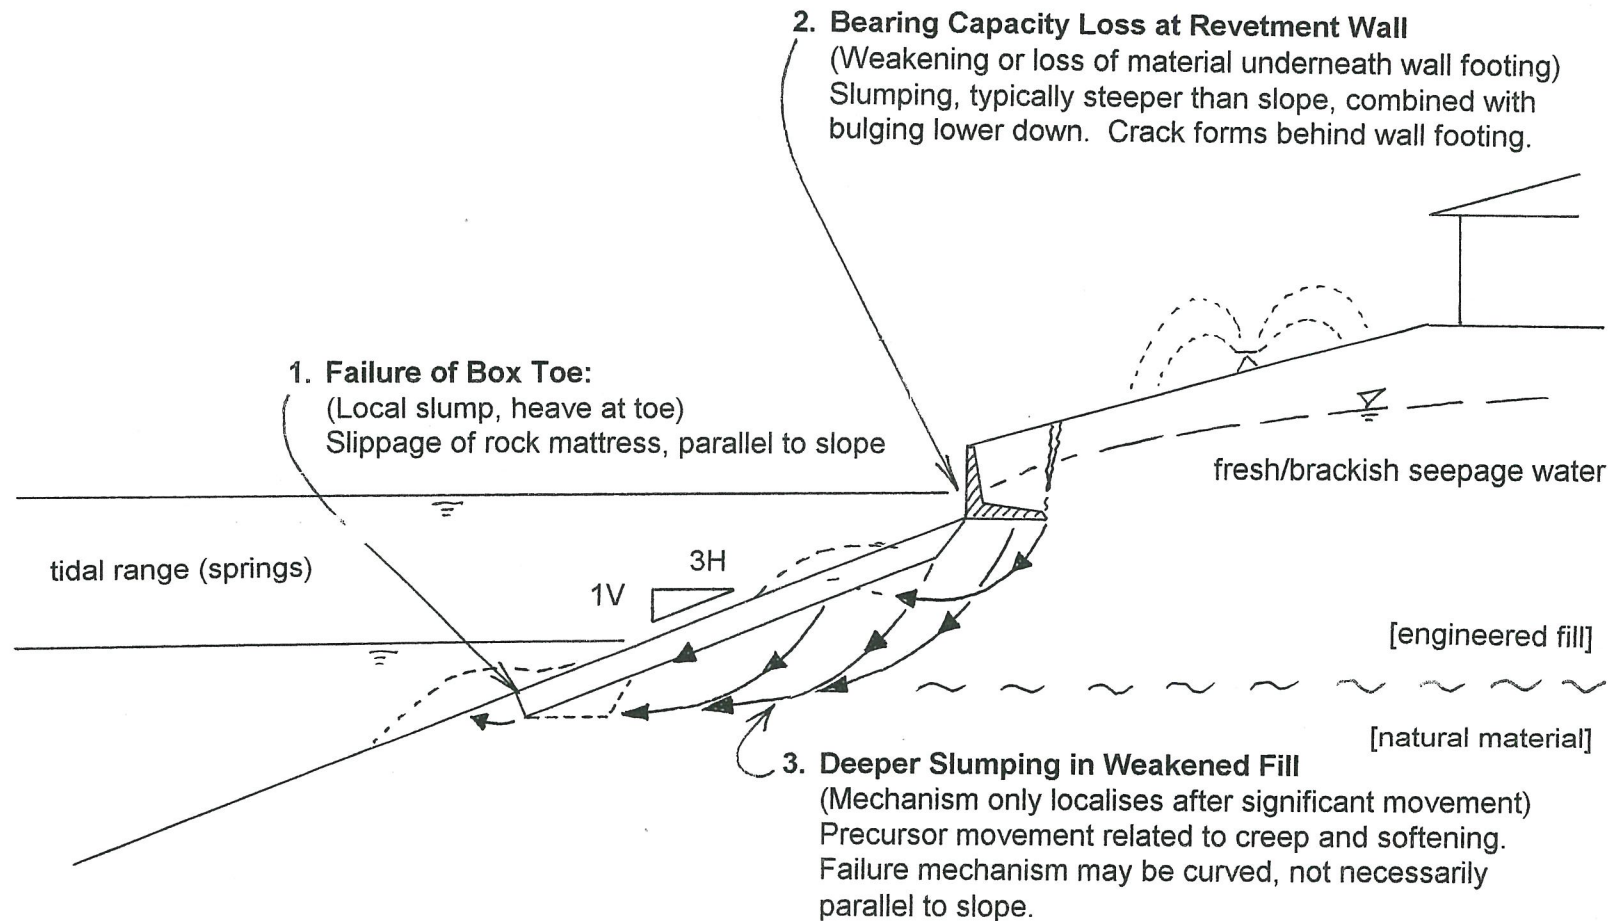
Figure 2 Explanation for Slip-Related Movement Directions

- In 1998/99 SGRS were engaged for several tasks and advised that fissured clay had only been a cause of short term failure during construction, areas where there may still have been some remnant insitu fissured clay were not considered to be at risk of future instability, all fissured clay and immediate wetting-related lot fill failures had occurred and what remained was the time uncertainty of time-dependent fill failure in the lot fill ; SGRS presented sketches of types of localised failure involving the fill in the immediate vicinity of the localised splash zone rock armour (see Figure 2 attached).

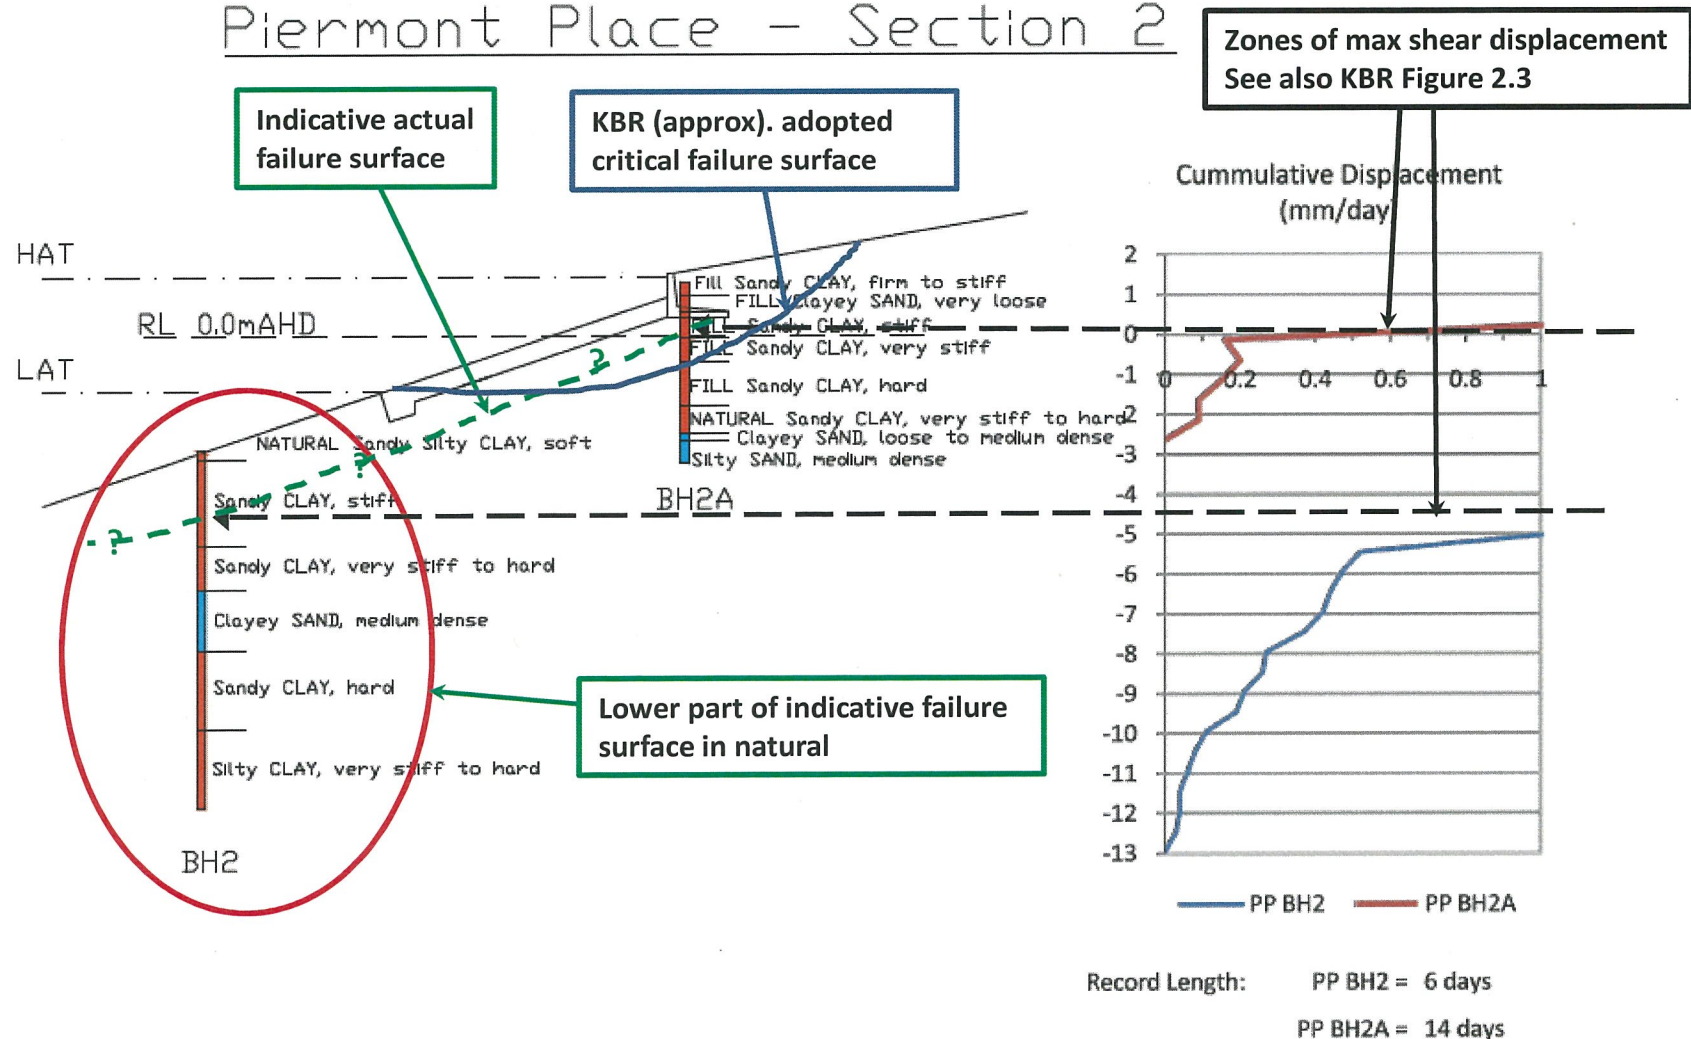
**FIGURE 3**

For the failure at Piermont Place to have occurred, the only reasonable conclusion from the material reviewed is that natural material with a low strength likely caused by fissuring and/or softening existed at some depth and combined with many other factors, was the main contributor to the collapse. Lot # 843 is across the canal from where GHD understand this failure occurred, and from the available information likely suffered a similar fate.
