briefing note

Record of site inspection matters raised by

Macleay Island foreshore east of the barge ramp.

Subject: Inspection results - Foreshore adjacent to 36 Russell Tce, Macleay Island

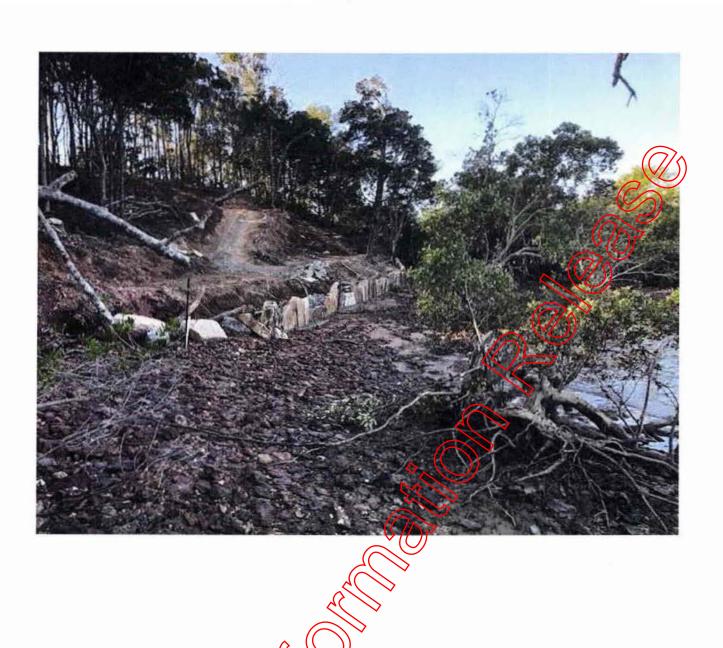
- 1 fence is down
- 2 scour at toe
- 3 undercut causing bank collapse
- 4 evidence of recent collapse
- 5 undercut exposing footings this stairway landing is now unsafe and should be closed
- 6 Seawall construction next door

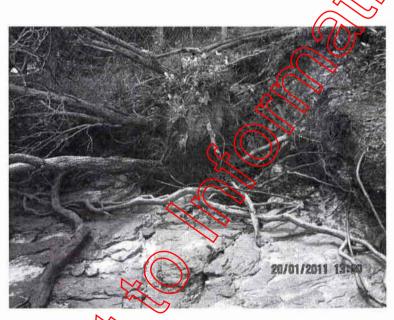
Results: Visual comparison of photos taken at similar locations (Figures 1 and 2 below) indicates apparent progression of foreshore erosion in the period 2011 to 2020, at the foreshore intersection of the 32 and 34 Russell Tce properties.

Figure 1 Tree collapse adjacent to chain-wire fence at 32 Russell Tce

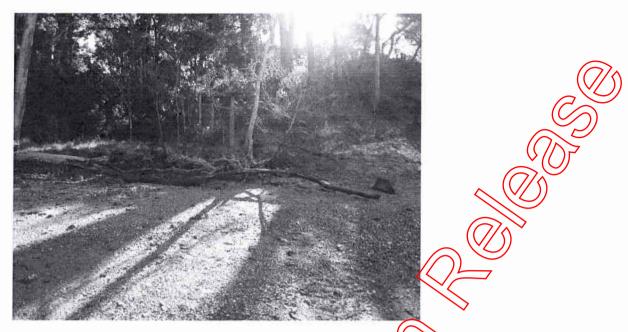
Figure 2 Photo taken in similar location to chain-wire fence at 32 Russell Tce. [Oate: 20/07/2020]

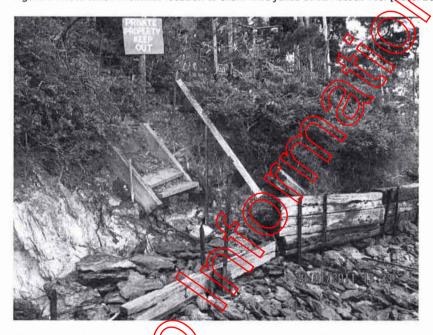
In recent inspections (2020) there is evidence of the remnants of the seawall (Figures 3 and 4) with scouring behind the remaining star-pickets.

Figure 3 Wooden seawall & star-pickets at base of wooden stair

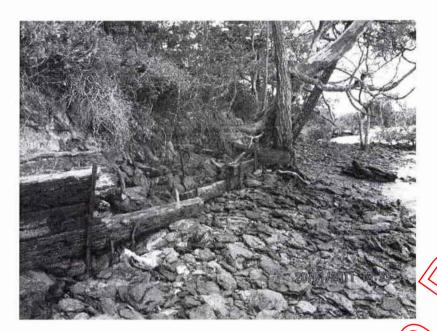
Figure 4 Wooden seawall facing east along the foreshore

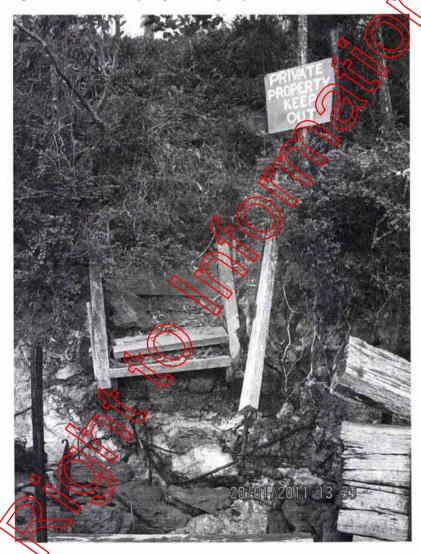
Figure 5 Wooden stair from 36 Russell Tce

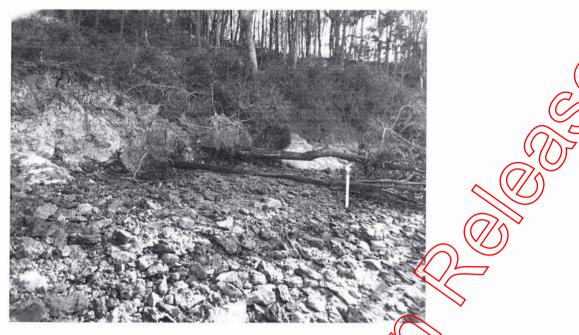
Figures 6 and 7 shows evidence of the progression of erosion in scouring around tree roots, and slumping.

Figure 6 Slumping indicates progression of erosion [Date: 26/06/2020]

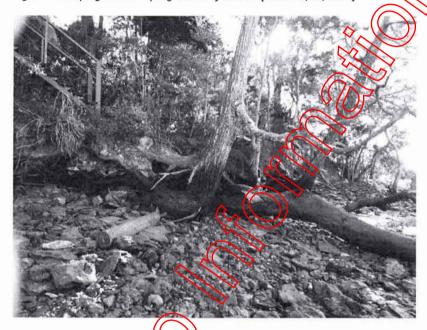
Figure 7 Scouring around tree koots Indicates progression of erosion at base of wooden stair from 36 Russell Tce [Date: 26/06/2020]
