Expert Report in Response to Revocation of Confirmed Order VPO3

Protected Vegetation: ***Araucaria columnaris* (Cook Island Pine)**

Located at: **62-64 Beachcrest Road, Wellington Point, Qld 4160**

25 November 2013

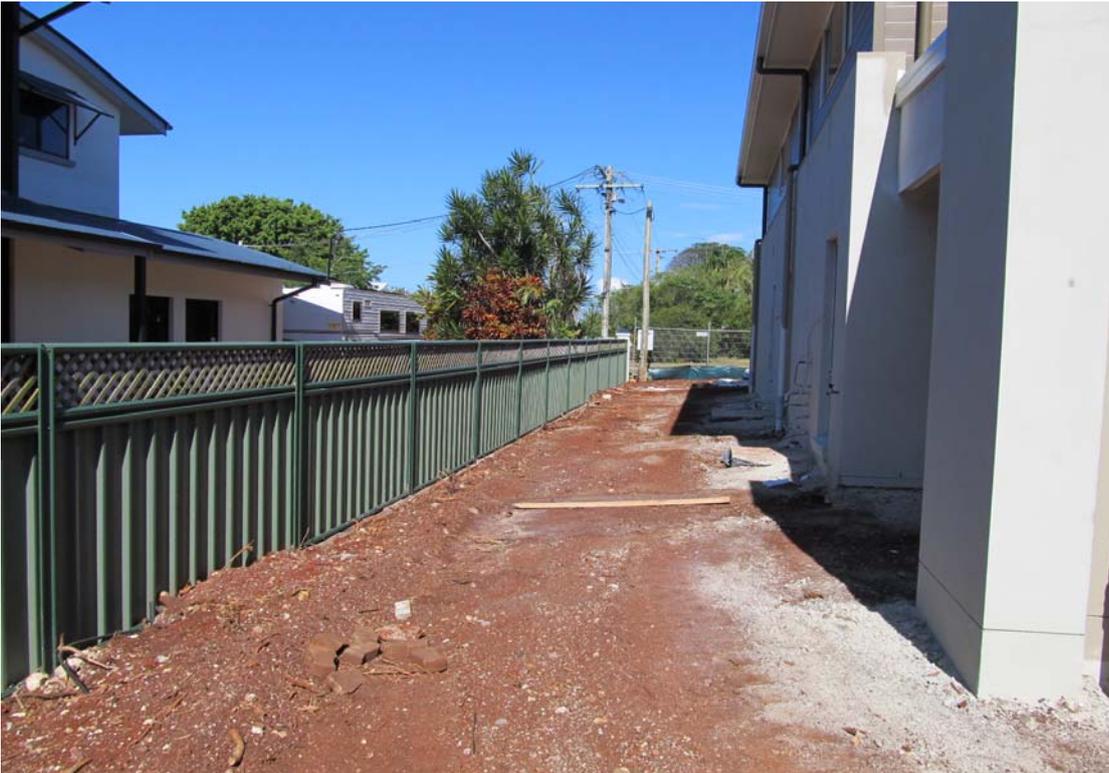
A concrete boat/caravan parking bay is to be constructed down the eastern boundary. The ground level along this boundary has been built up, with all water collected by the adjoining properties paved driveway and diverted to the street (refer to figure 5).

Figure 5: Photograph: A concrete drive/parking bay extends the length and width of the eastern boundary. The ground level has been filled.

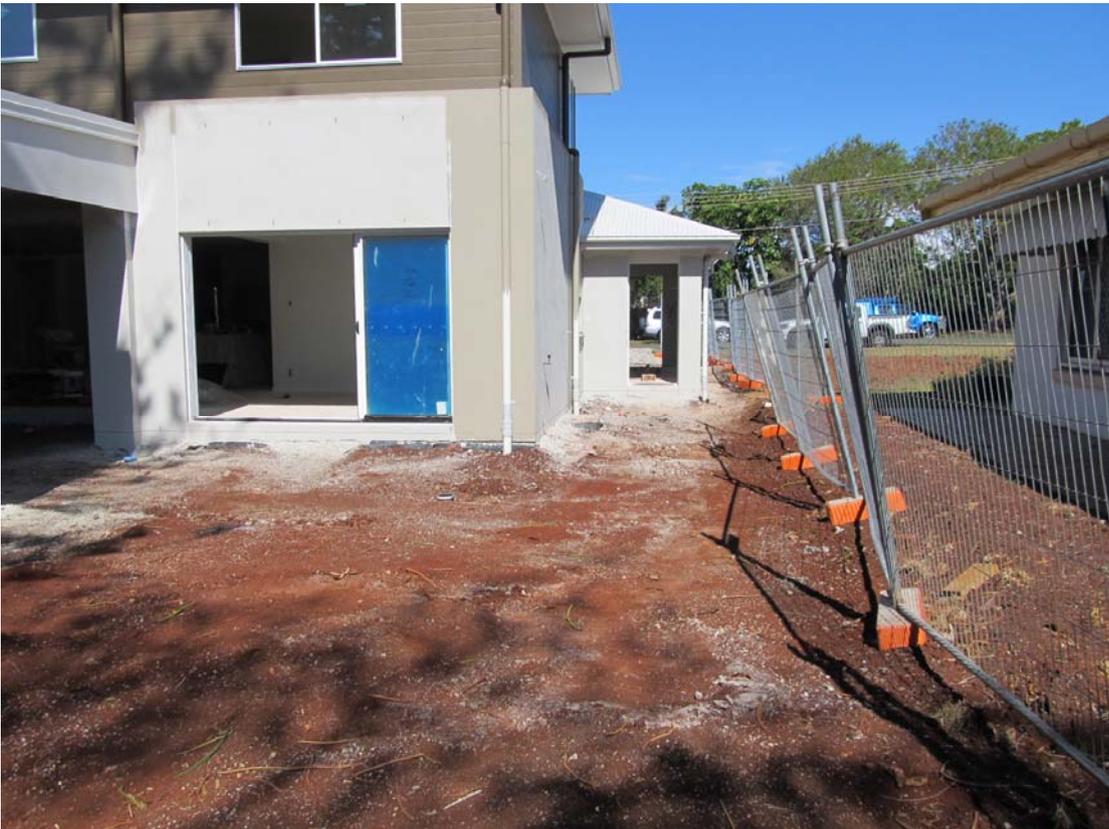
A concrete pathway is to be constructed down the western boundary between the dwelling and the boundary (figure 6). A trench has been excavated along the western boundary for the installation of the sewer pipe. This trench has been filled in with a gravel base, thus further restricting rainwater from reaching the tree roots through natural hydrological processes.

Figure 6: Photograph - A concrete pathway will extend down the western boundary.

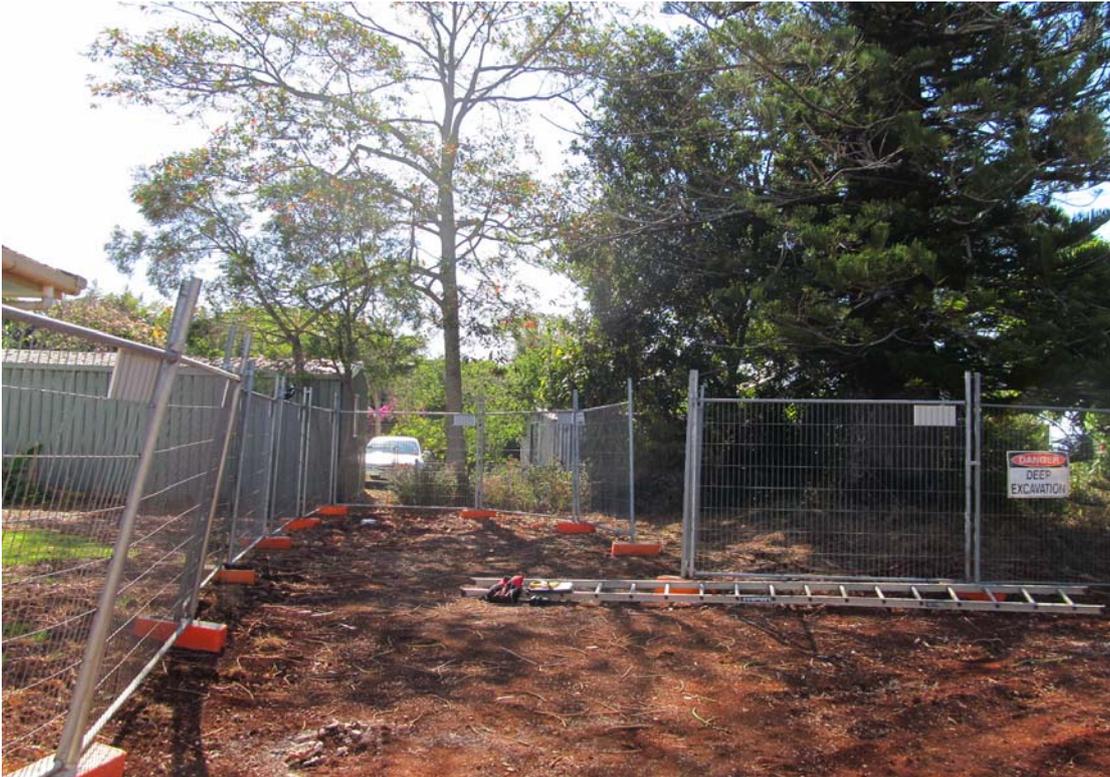
Figure 7: Photograph - Sewer trenching occurred 7 metres from the trees trunk and can be seen in the photo as a white inspection cap near the white car. The exact sewer alignment is unknown but appears to be outside the structural root zone.

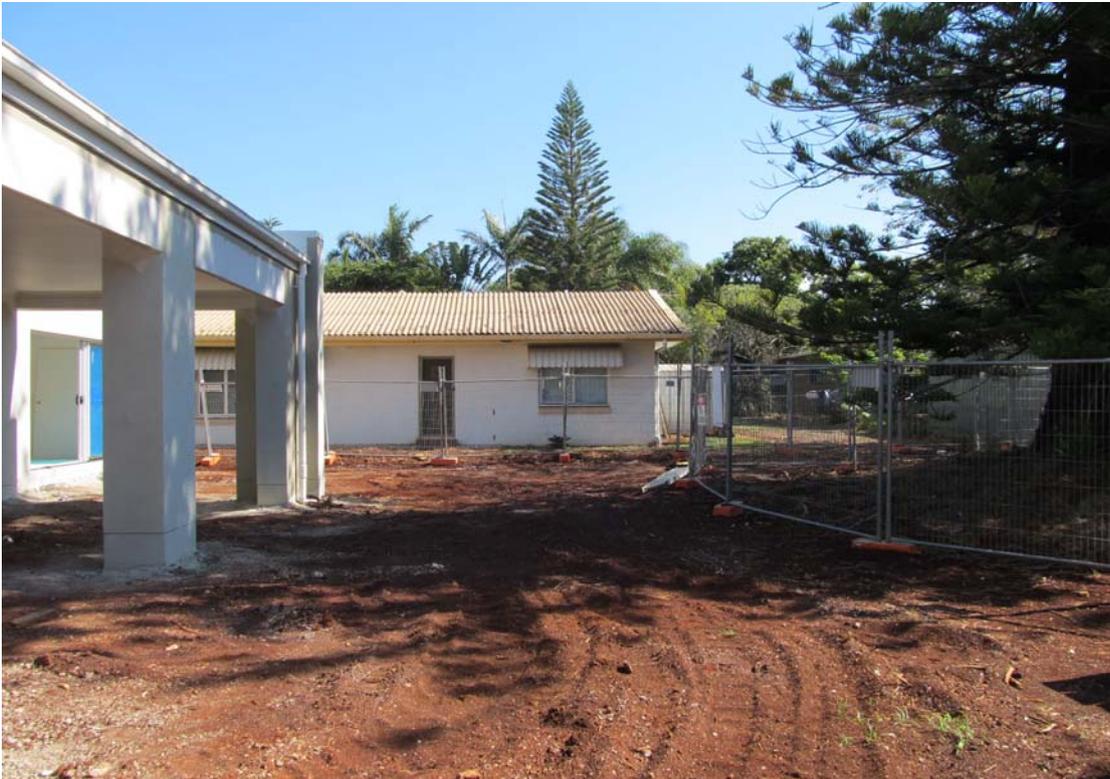
A 3 metre wide concrete slab for paving is to be constructed to the rear of the dwelling, bringing the development encroachment to within 6 metres of the trees trunk (refer figure 8).

Figure 8: Photograph - Looking west. There will be a 3 metre wide concrete pad constructed from the house pillars towards the tree. The distance from the concrete to the tree will be 6 metres.

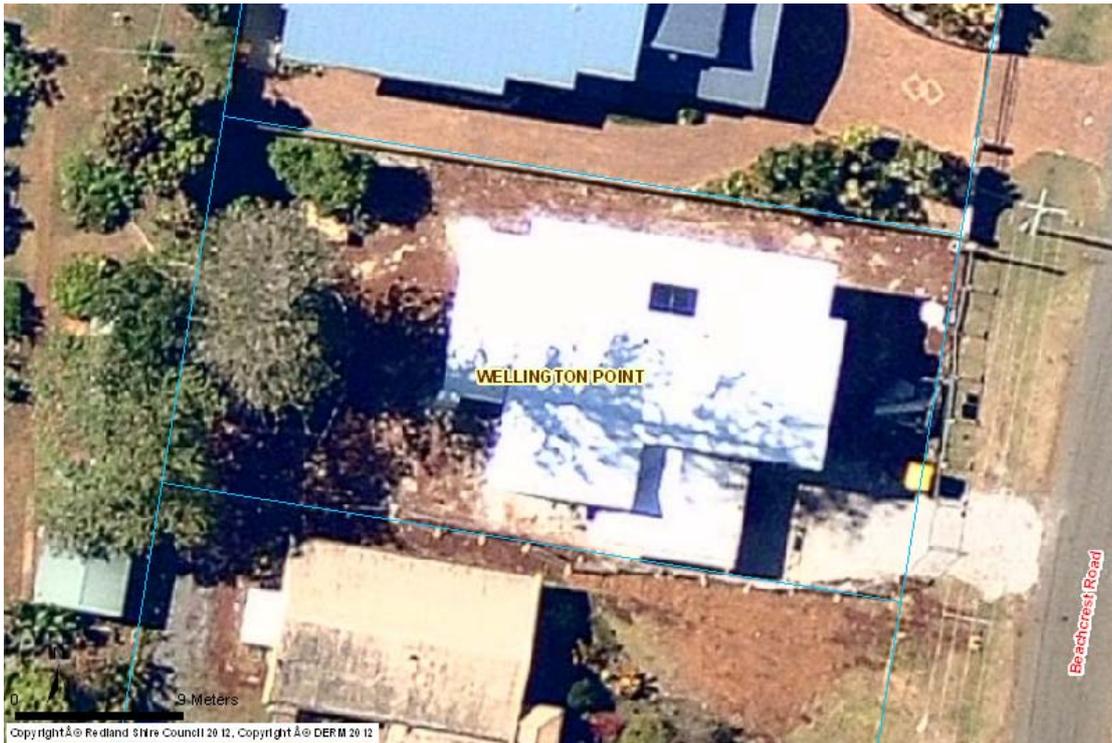
Figure 9: Aerial photograph showing the compact form and canopy of the Cook Island Pine in the rear yard. There is minimal horizontal limb spread.
