### RABY BAY CANAL BATTER STABILITY UPDATE

### Geotechnical Investigation Analysis Report

24 June 2013

BEJ809.002-W-REP-003 Rev. 0

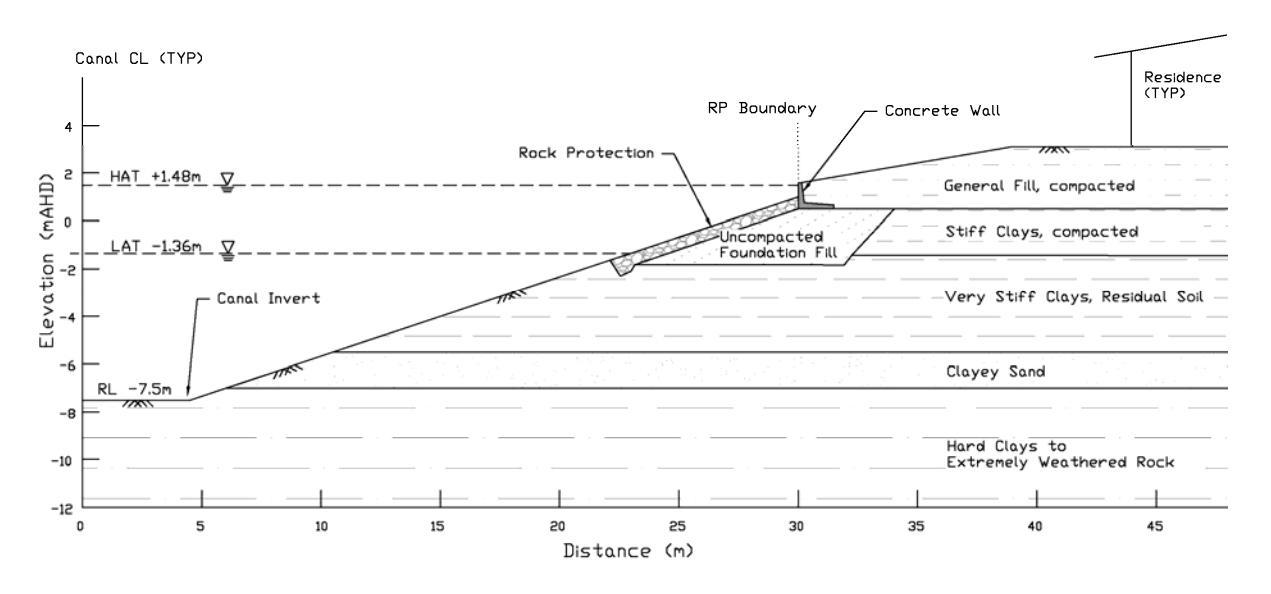
#### Figure 2.1 SIMPLIFIED SOIL PROFILE LAYOUT

Relying mainly on the borehole data and the simplified soil profile of the Piermont Place slope in report 1-14061BR, the soil profile as shown in Figure 2.1 is believed to be typical of Raby Bay. This soil profile layout has been used for the basis of the slope stability calculations in Chapter 3.

- the author's interpretation of the geotechnical data is the observed slope failures are largely confined to this uncompacted 'foundation fill' wedge, thus the slips appear to be shallow and short in length.

Figure 2.1 is based on construction drawings, Soil Surveys report and KBR interpretation. An A3 copy of this diagram is included in Appendix C.

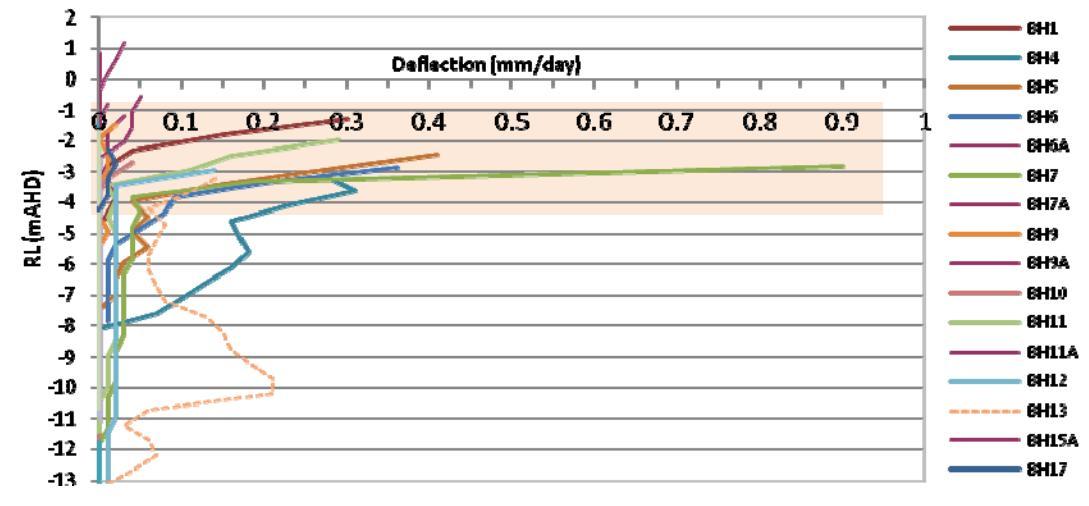
Figure 2.2 BOREHOLE DISPLACEMENT RECORDS

This information suggests that the soil slip is occurring in a shallow zone underneath the rock protection and concrete wall. As the soil begins to move in these higher layers, the movement stresses the lower soil layers which result in the small displacements observed here. Figure 2.2 and 2.3 show the displacement records from the boreholes demonstrating this pattern of soil movement.

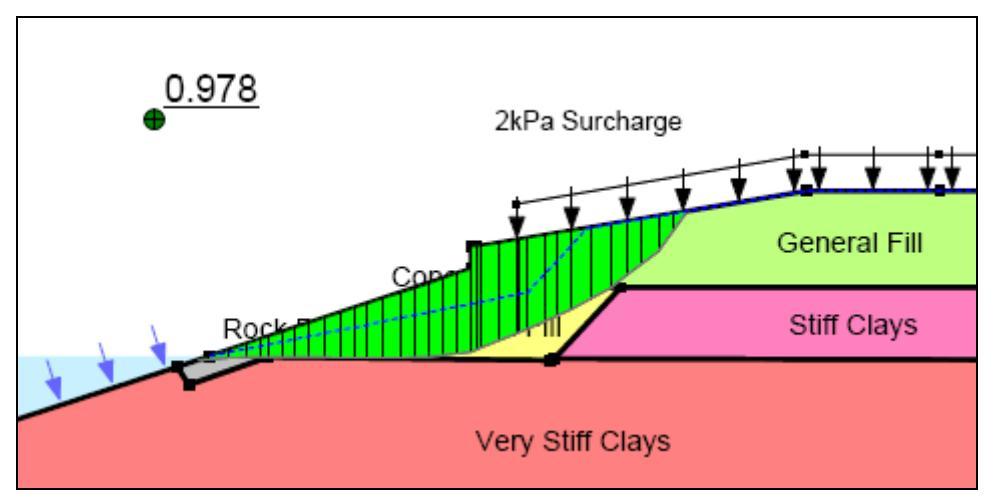
Figure 3.2 CRITICAL SLOPE FAILURE – FOS ≈ 1.0

The critical slip surface is shown in Figure 3.2. The authors believe that the model result is consistent with the surface observation of slope failures in Raby Bay; a shallow slip surface through the weak wedge of uncompacted fill behind the rock protection. Borehole data indicates lower shear strength in this region. A hypothetical deep slip failure mode doesn't appear to be critical, nor has it been observed in the field by the writers.

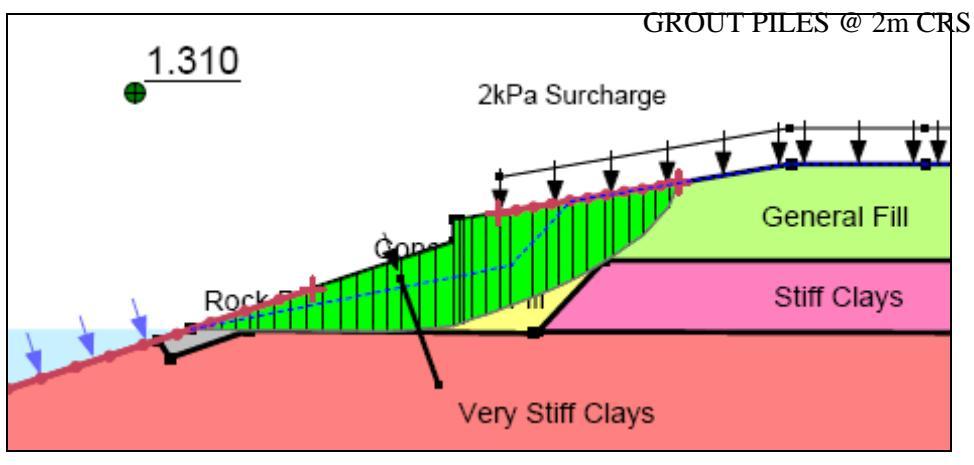
Figure 3.4 GROUTED PILES INCLUDED (A) – FOS < 1.5

A plausible low cost method of stabilizing a shallow slip is the installation of groutinjected piles into the soil behind the rock protection. Figure 3.4, 3.5 and 3.6 show the Slope/W model with the addition of 0.6 m diameter piles at varying spacings, to a depth of 3 m to test the impact to slope stability.

It appears that grout injection could be an effective method of stabilizing the canal slopes based on the assumed soil profile and properties. Grout piling is further discussed in Section 4.2.1.
