CLEVELAND AQUATIC CENTRE UPDATED POOL CONDITION ASSESSMENT

AND MAINTENANCE PLANS

(July 2014)

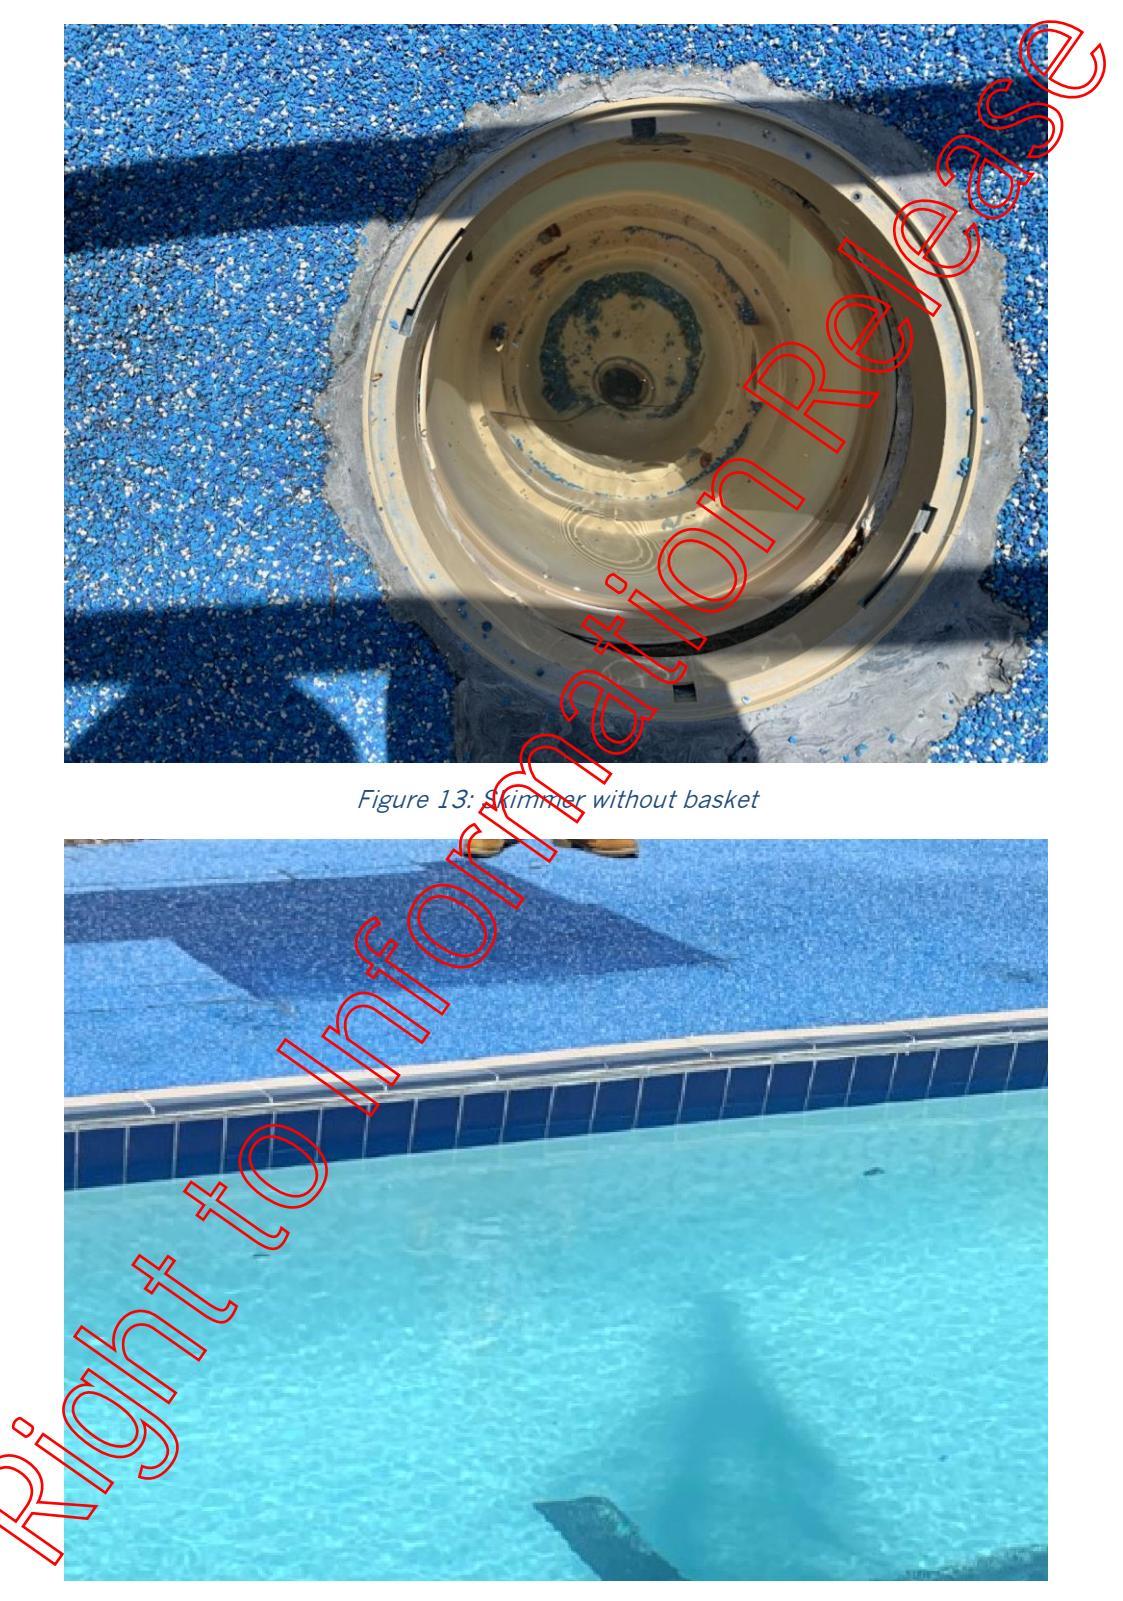
Figure 14: Uncovered filtered water returns

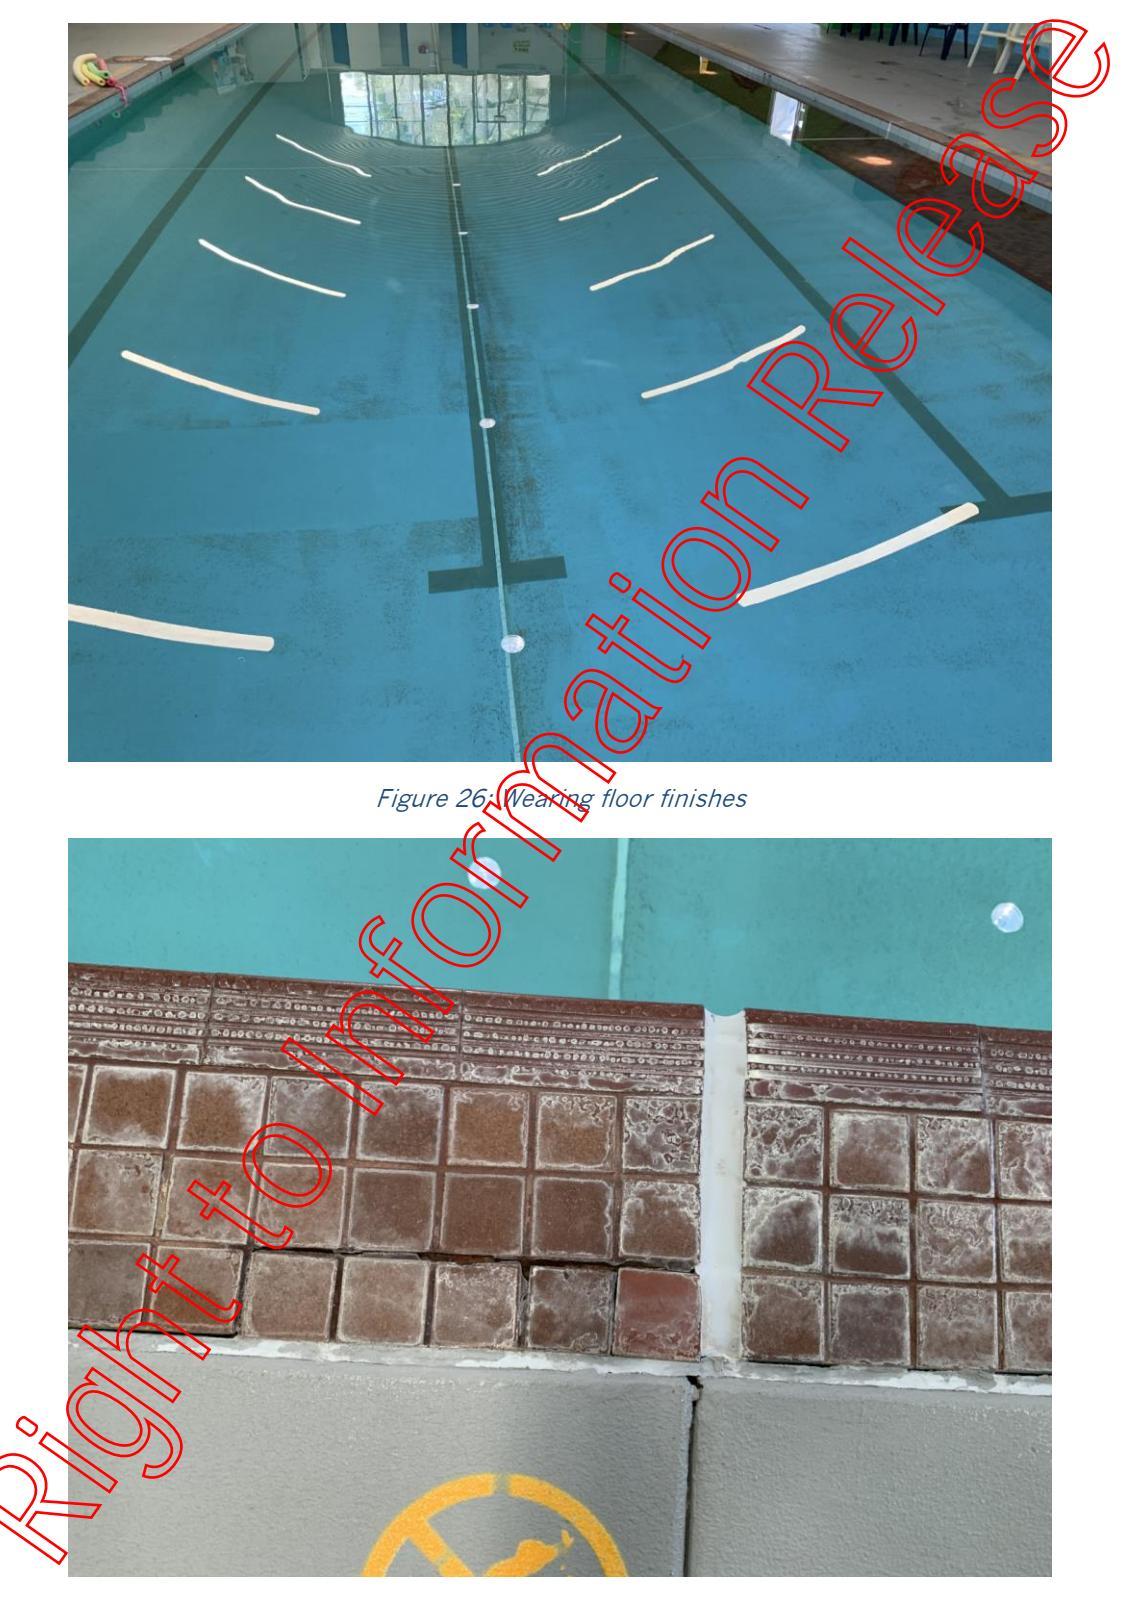
Figure 27: Degraded / damaged finishes

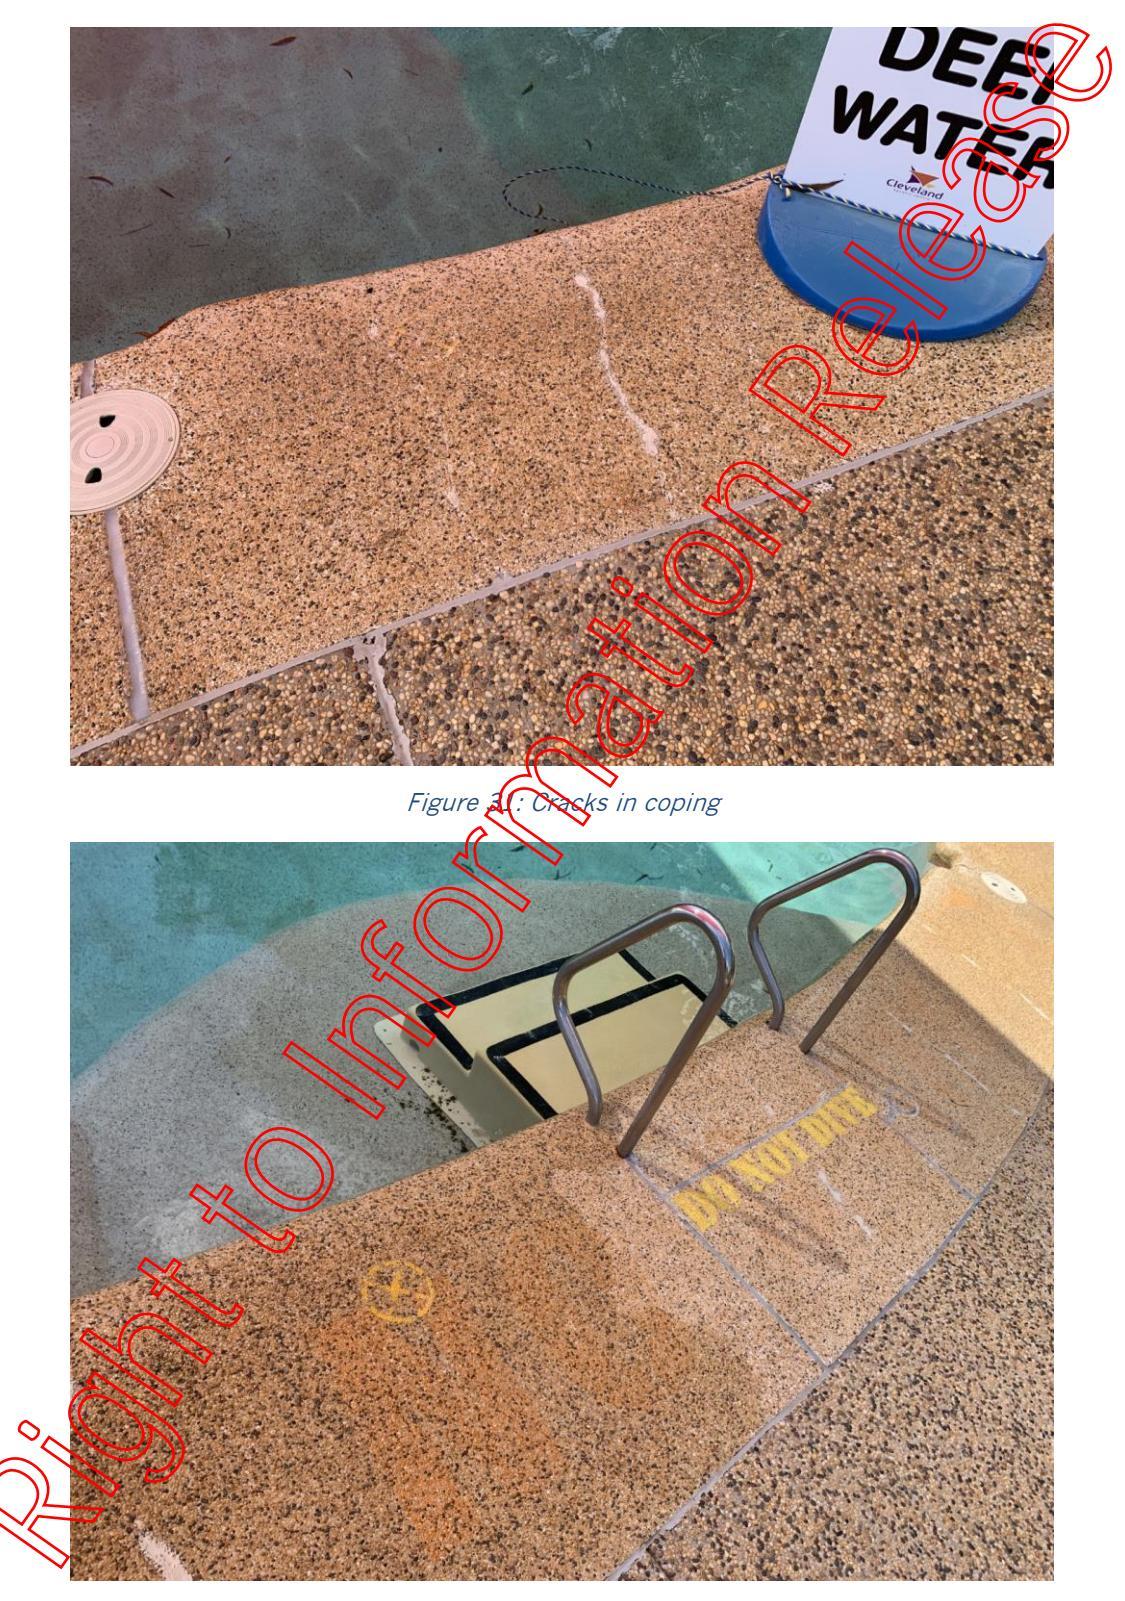
Figure 32: Cracks in coping, fibreglass stairs

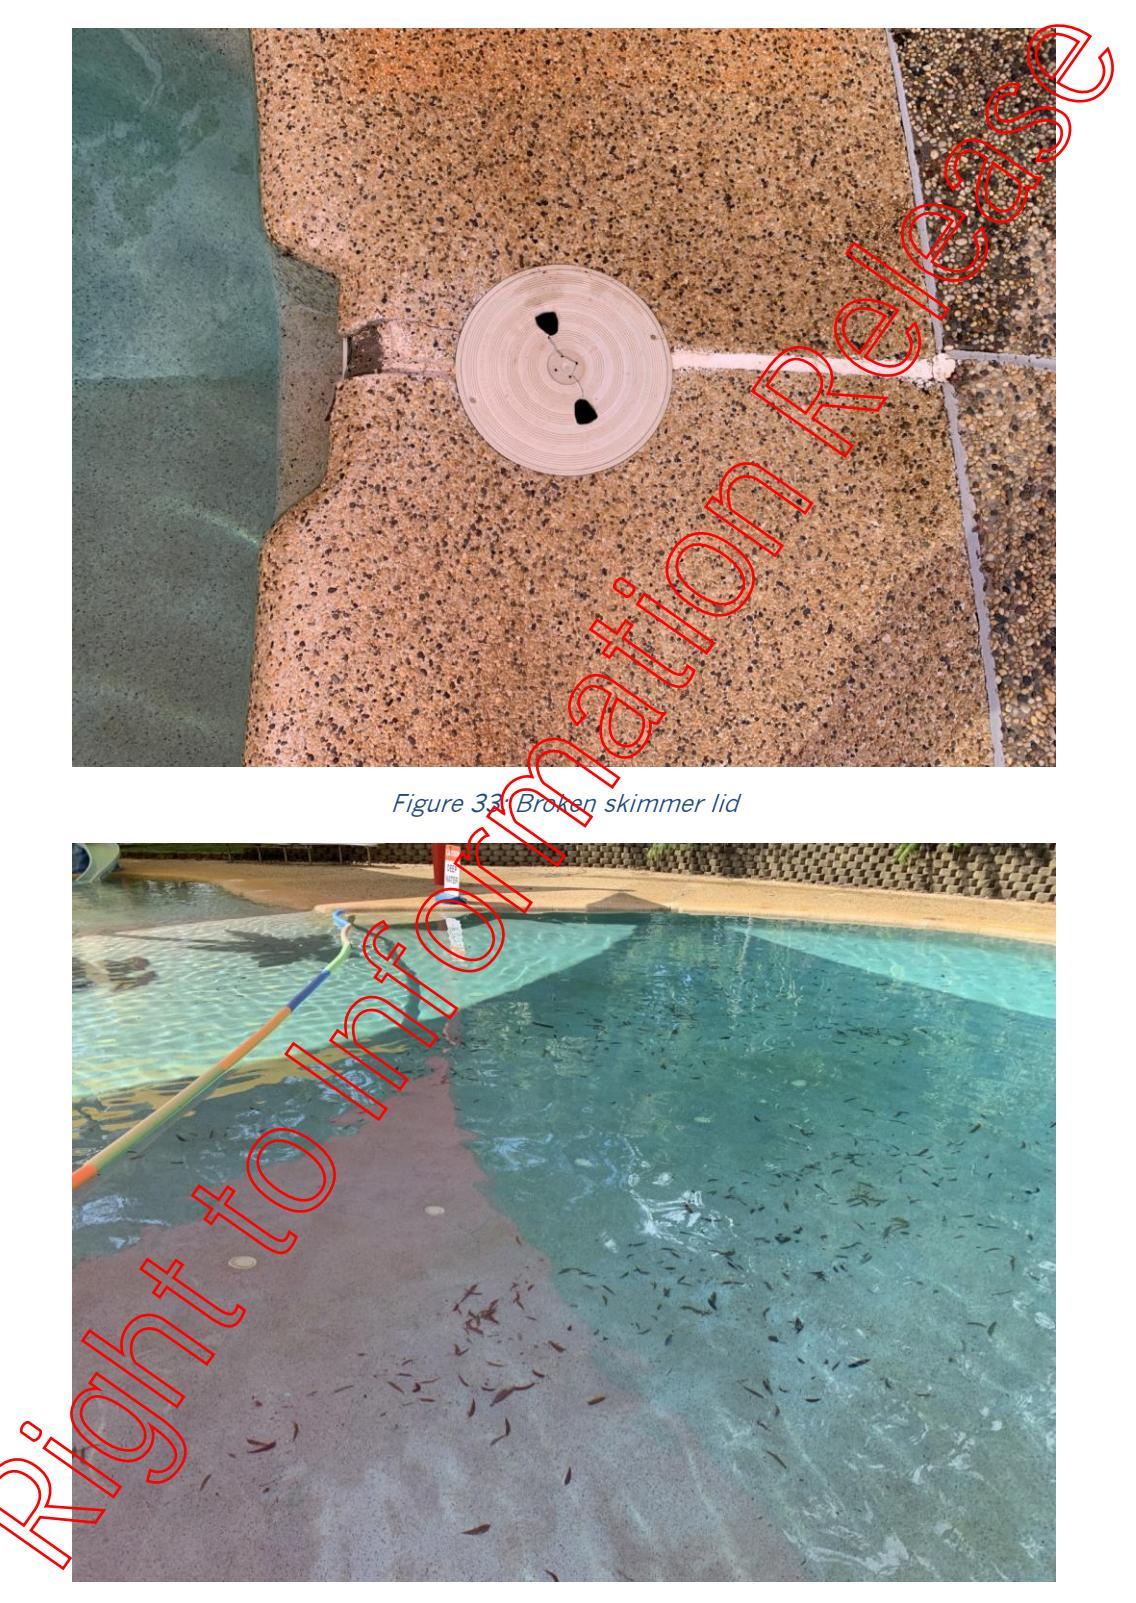
Figure 34: Leaves in deep region blown away from returns

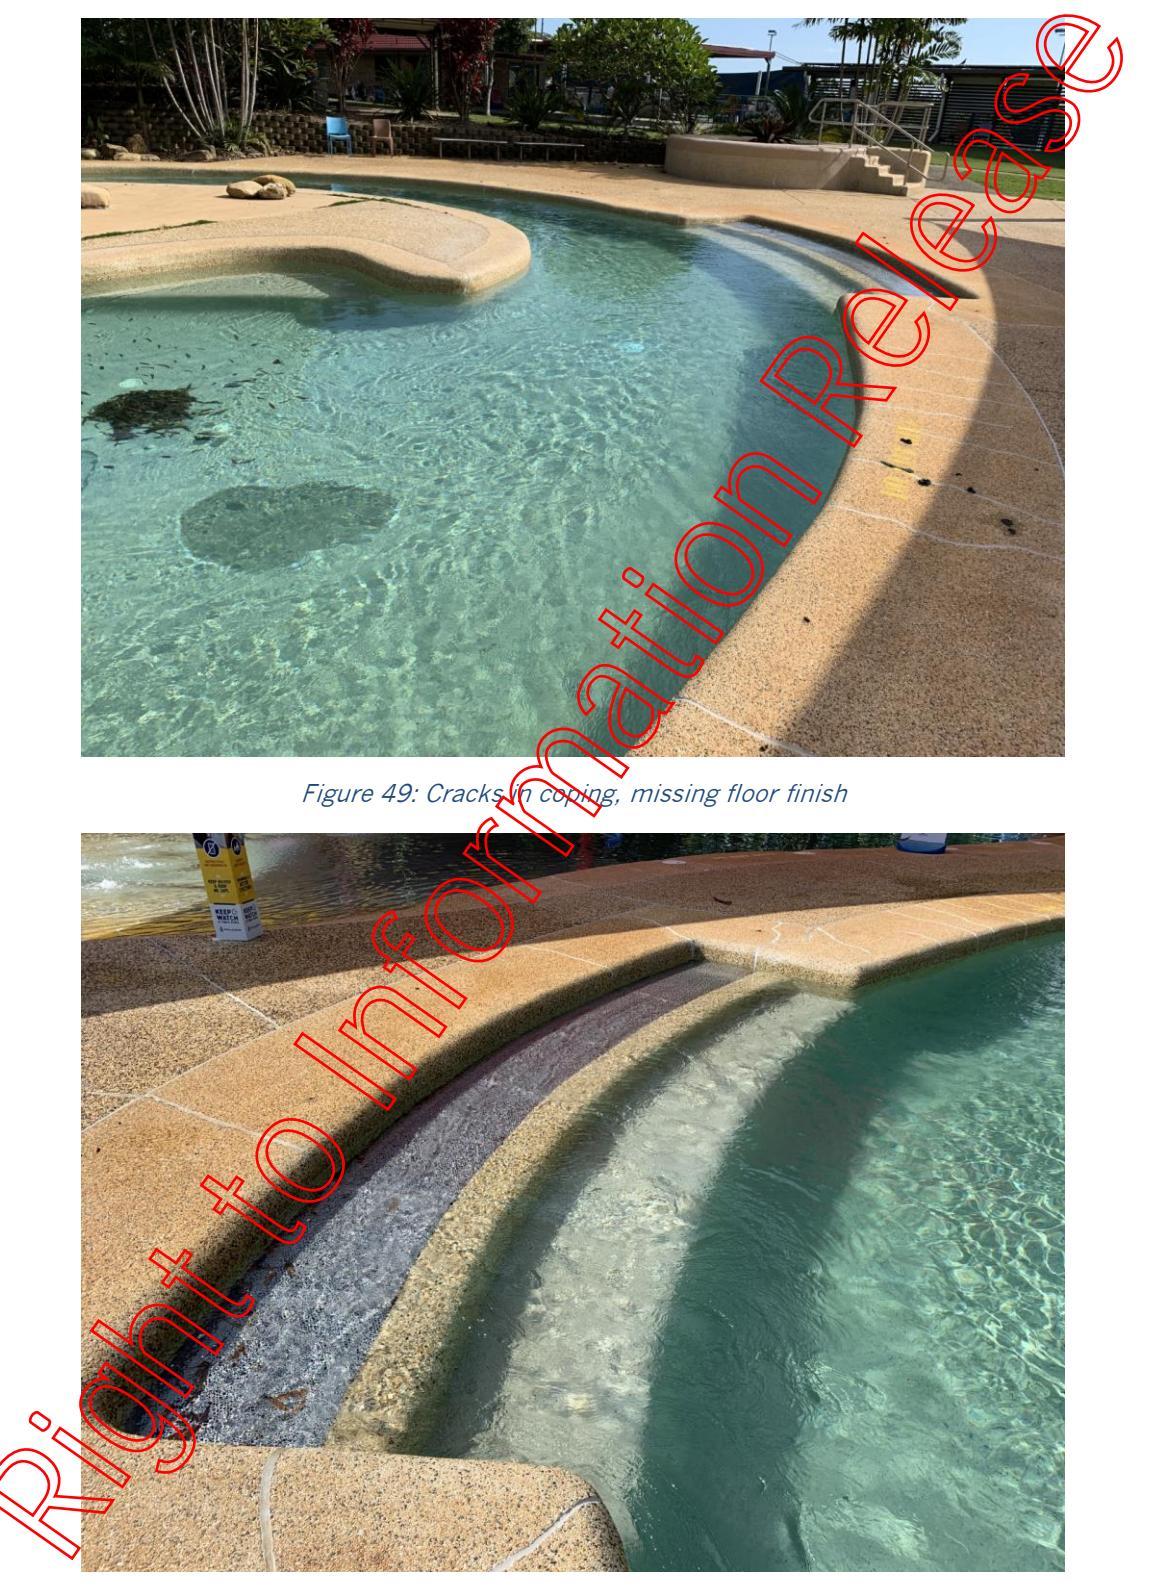
Figure 50: Overflow grate with bench in front

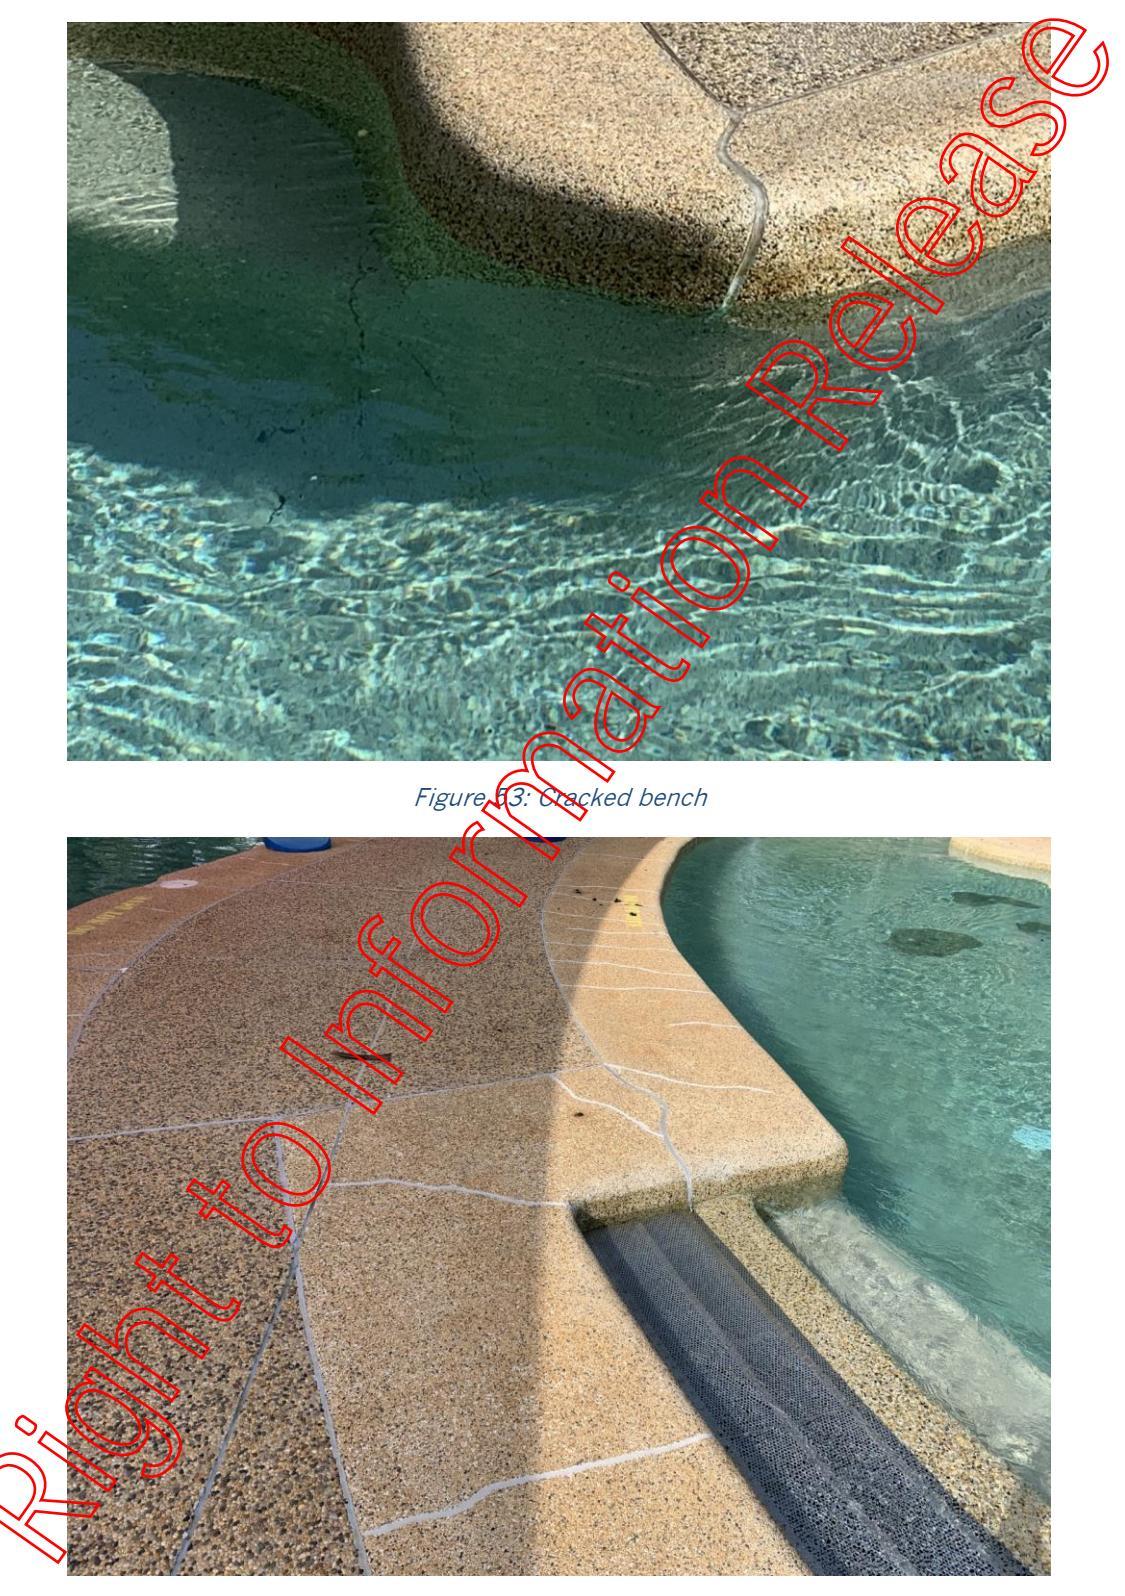
Figure 54: Sealed cracks at overflow chamber

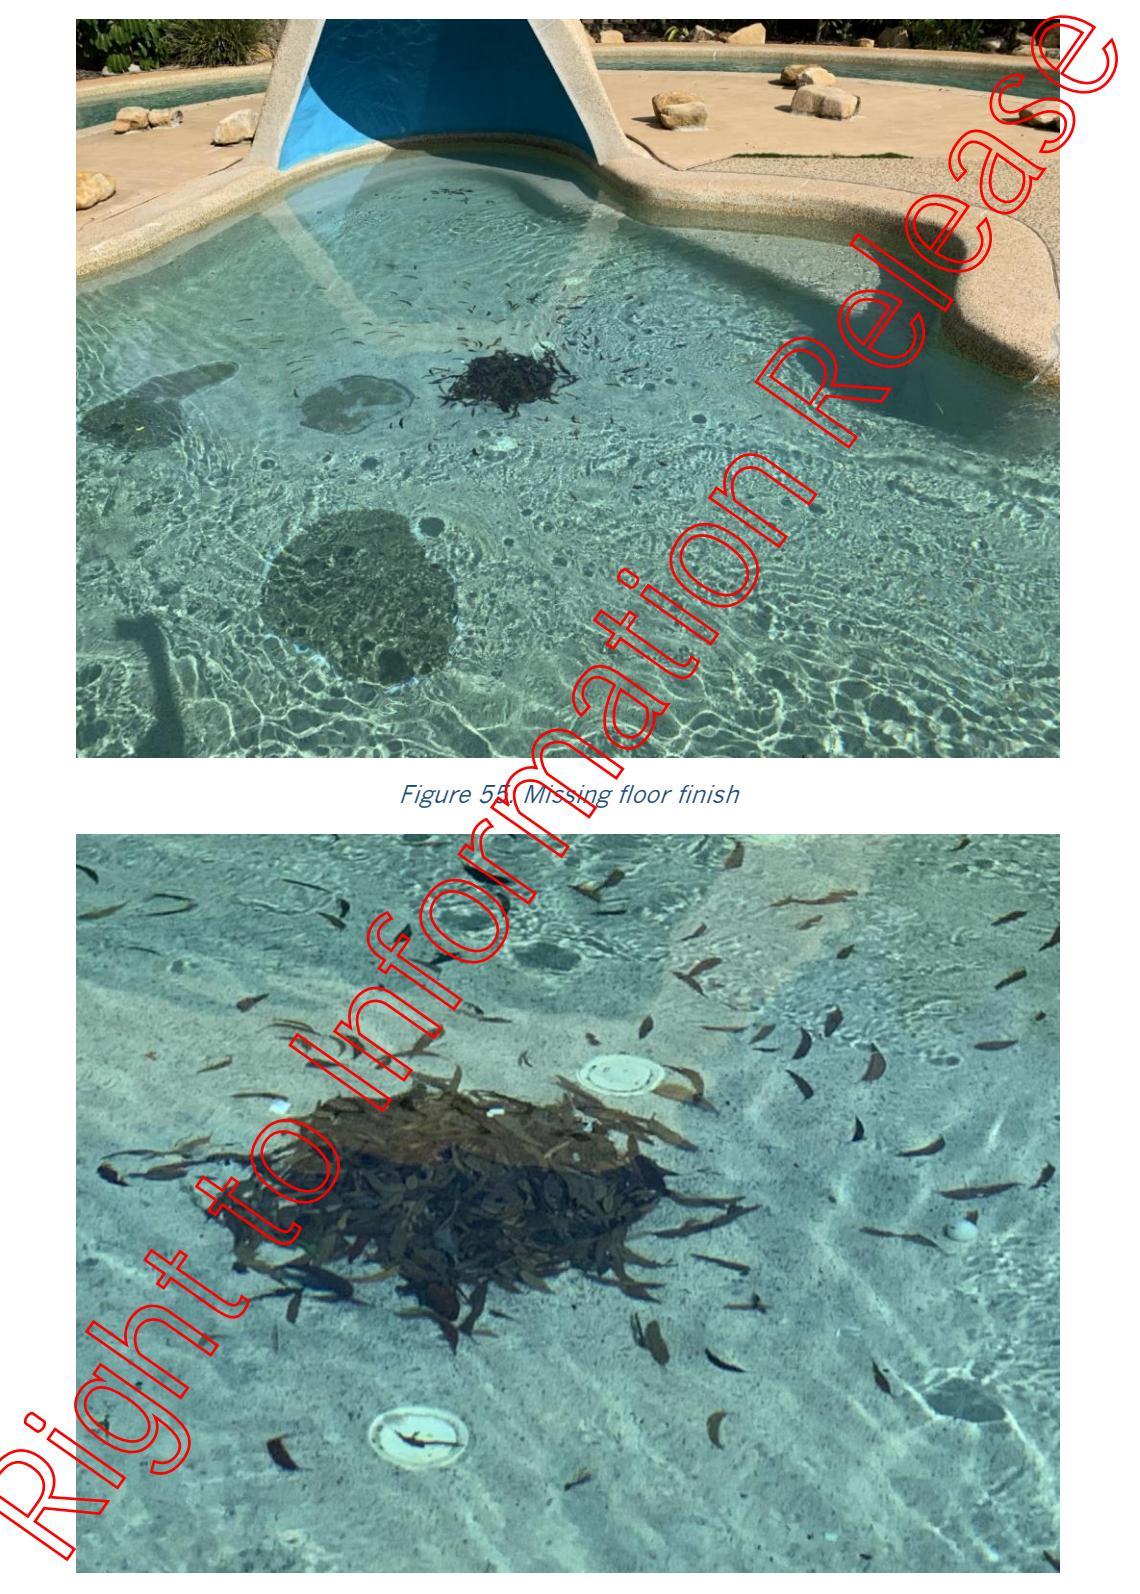
Figure 56: Debris accumulation in pool

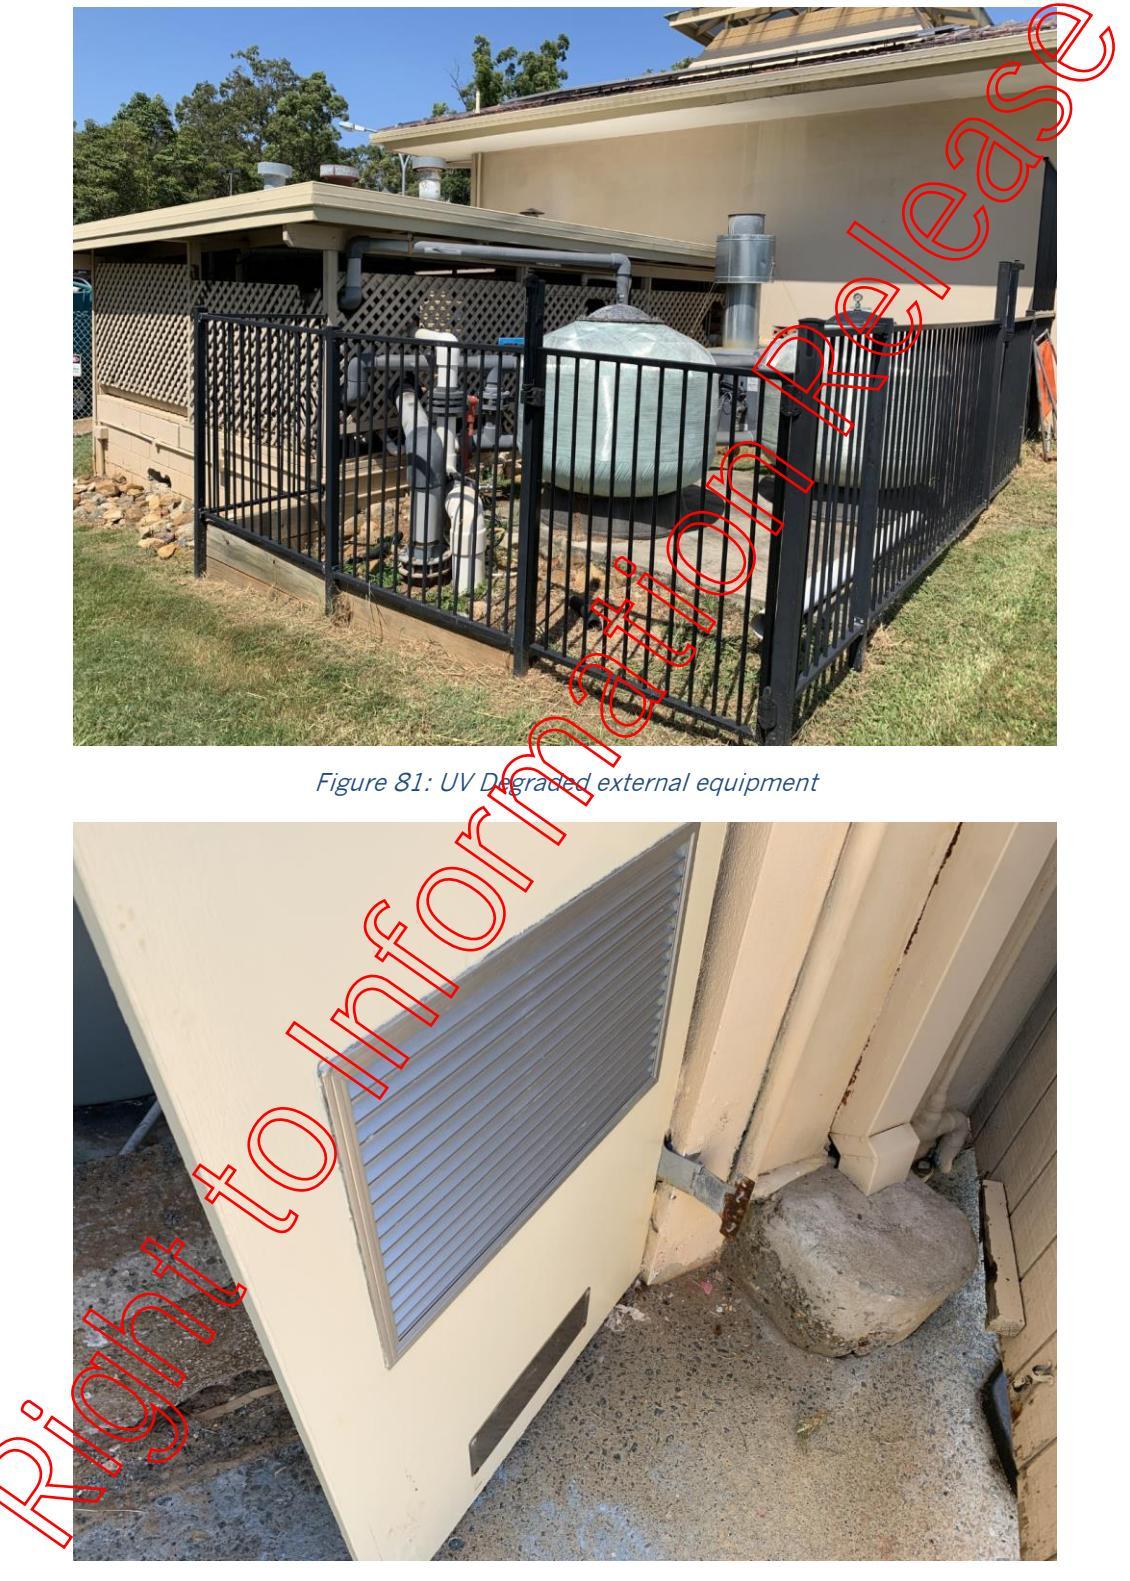
Figure 82: Failed door hinge, poor building condition

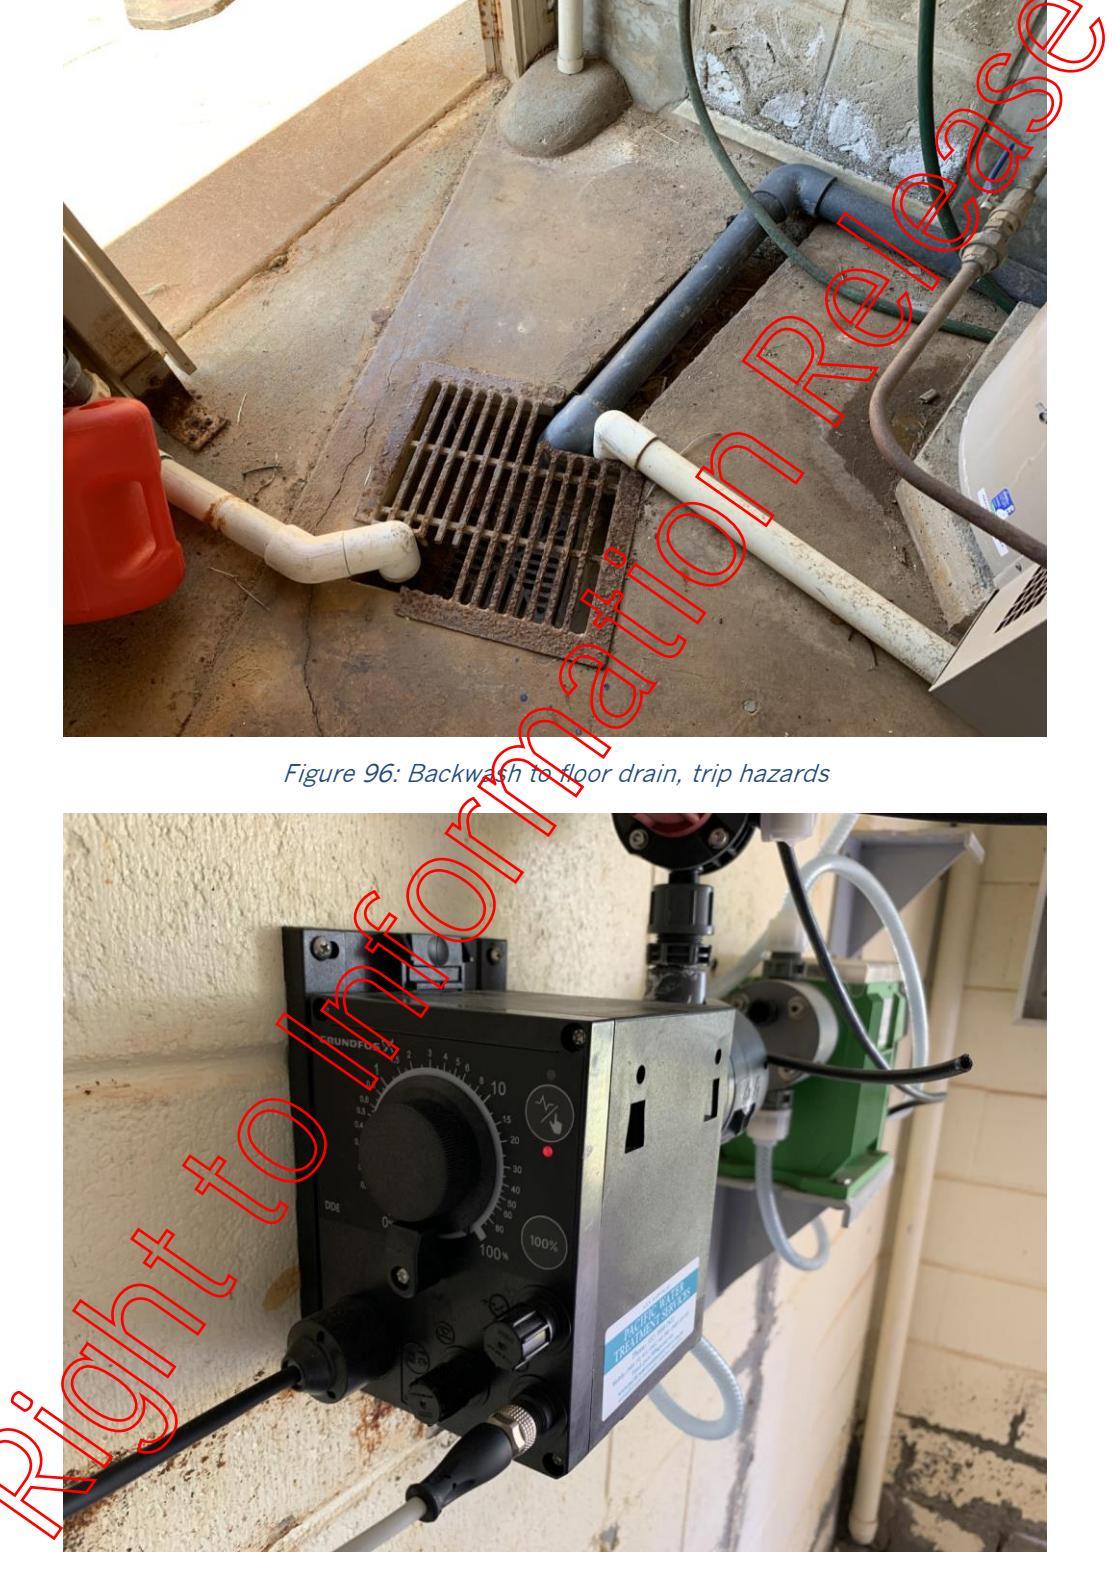
Figure 97: Chlorine dosing pump, overpressure line discharging to room

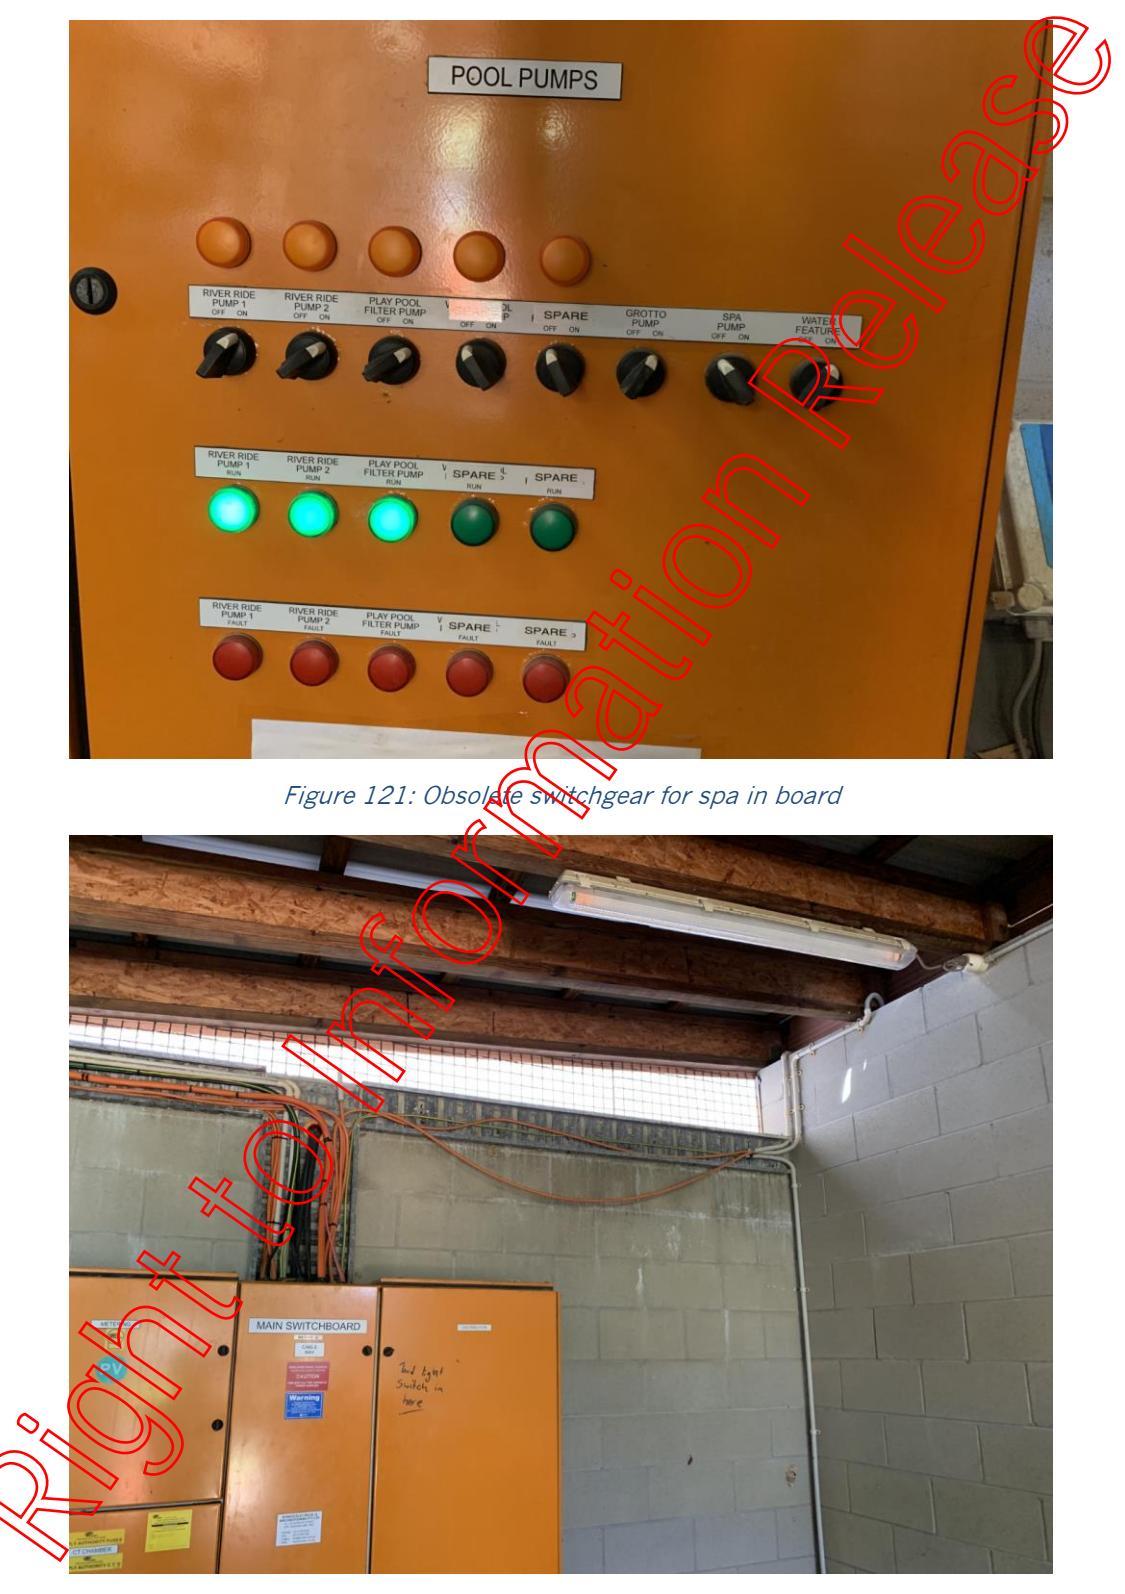
Figure 122: Electrical Cabling

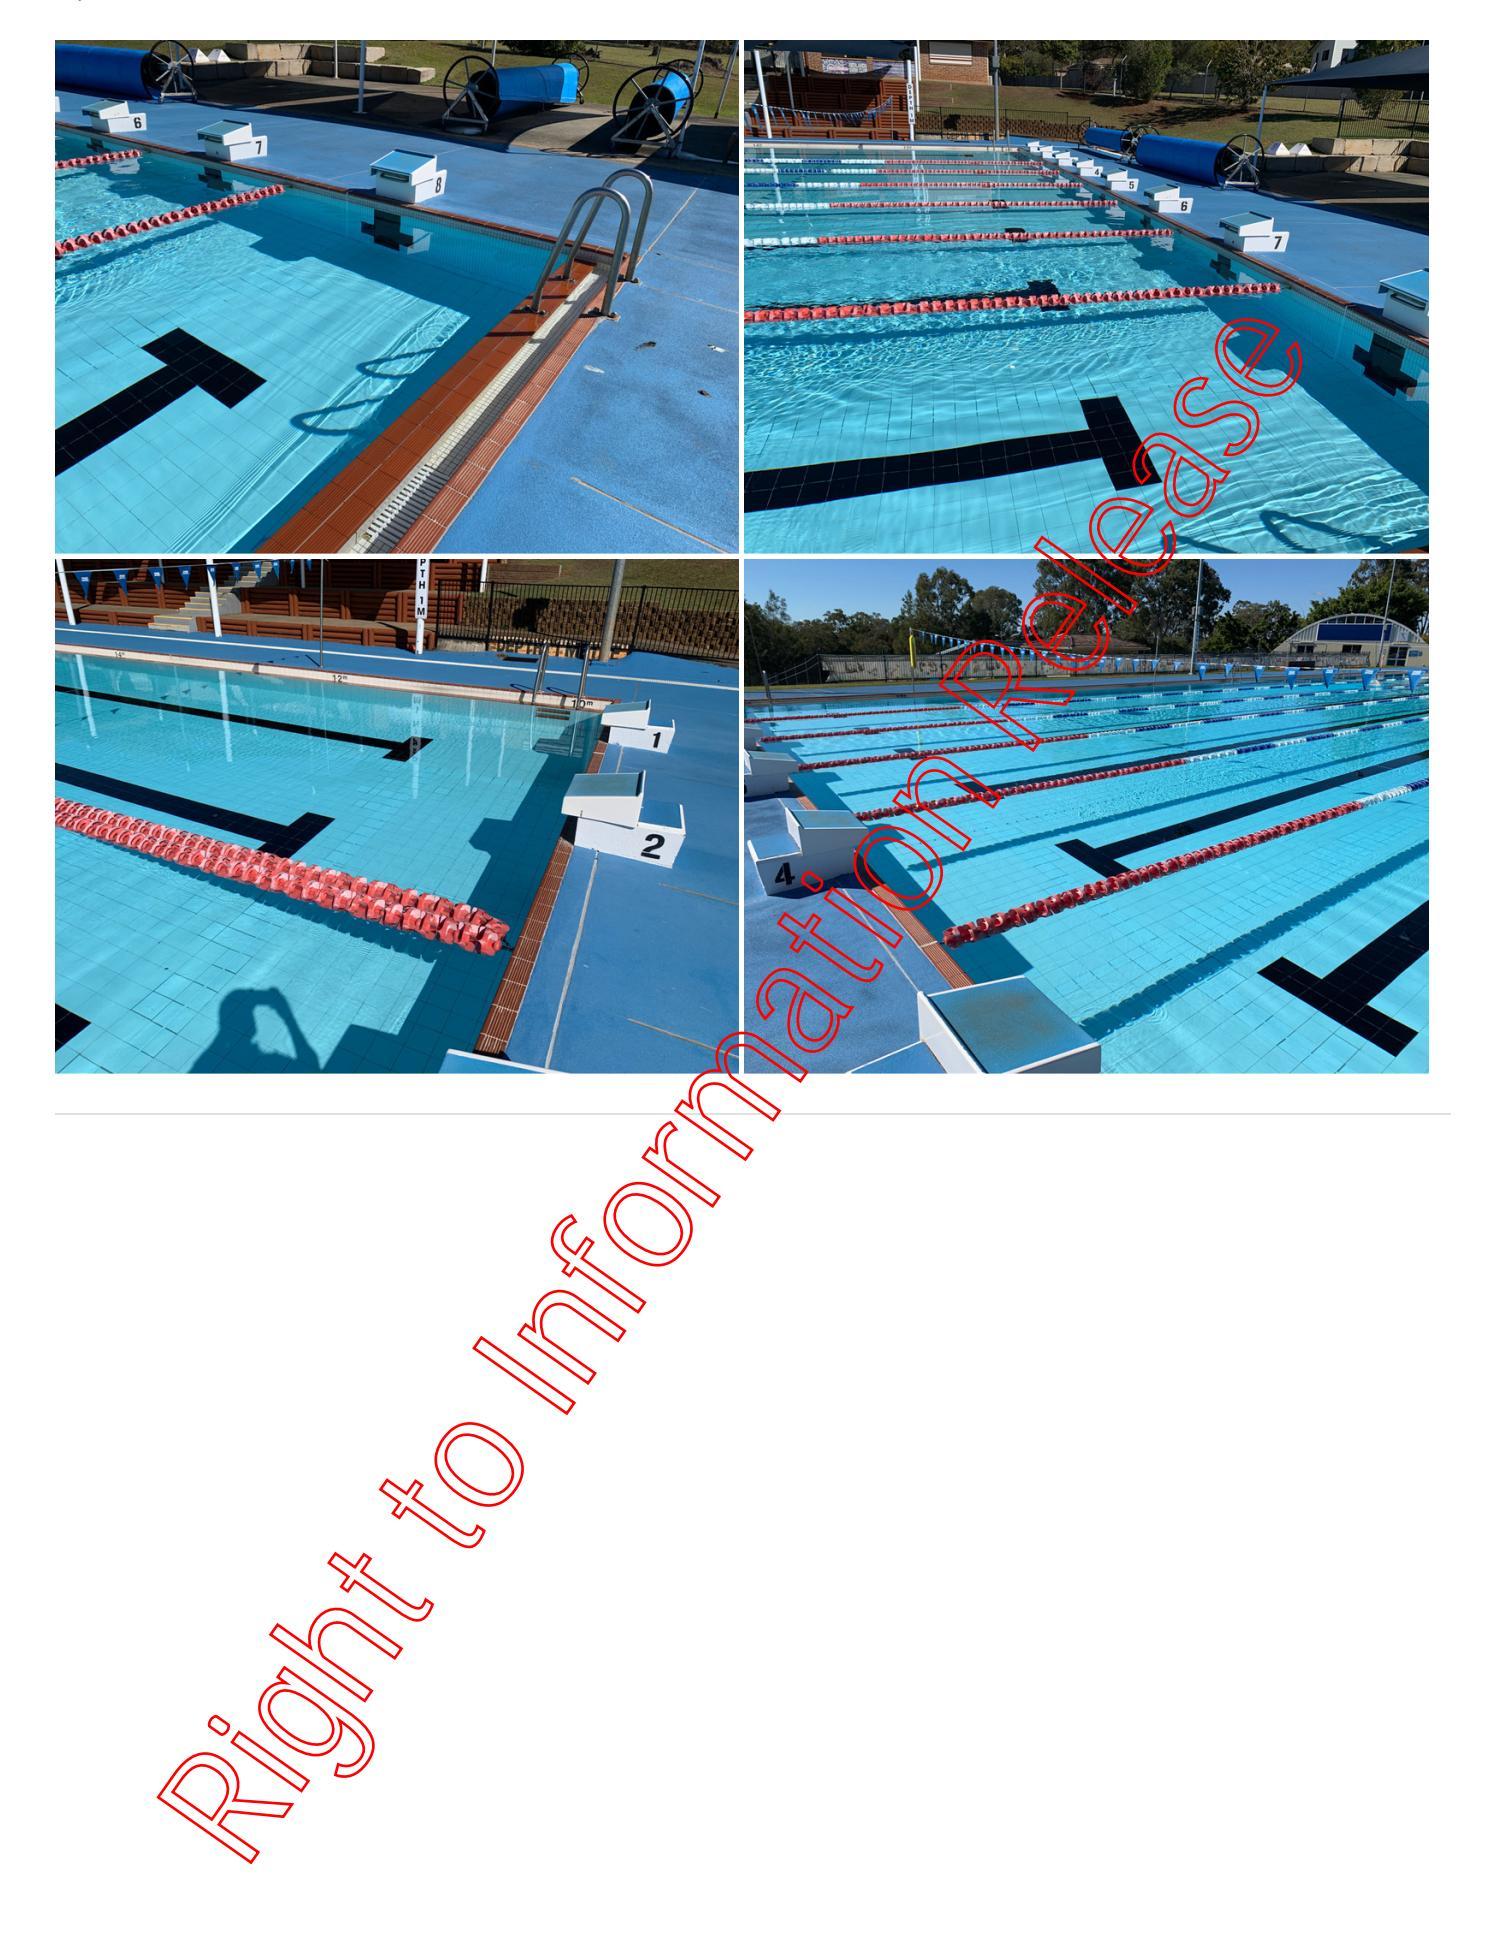
SCUM GUTTER

Observation Description	Scum Gutter	
Observation Details	The scum gutter is of an aged design. The system is running full, indicating the flow is at maximum capacity. Additionally, more water is flowing over the northern wet edge, with this side being out of level along the length indicating structural movement of the pool.	
Recommendations	Consider an upgrade to the 50m pool	
Critical Item?	Νο	
Observation Photos		\bigcirc
