CLEVELAND AQUATIC CENTRE UPDATED POOL CONDITION ASSESSMENT

AND MAINTENANCE PLANS

(July 2014)

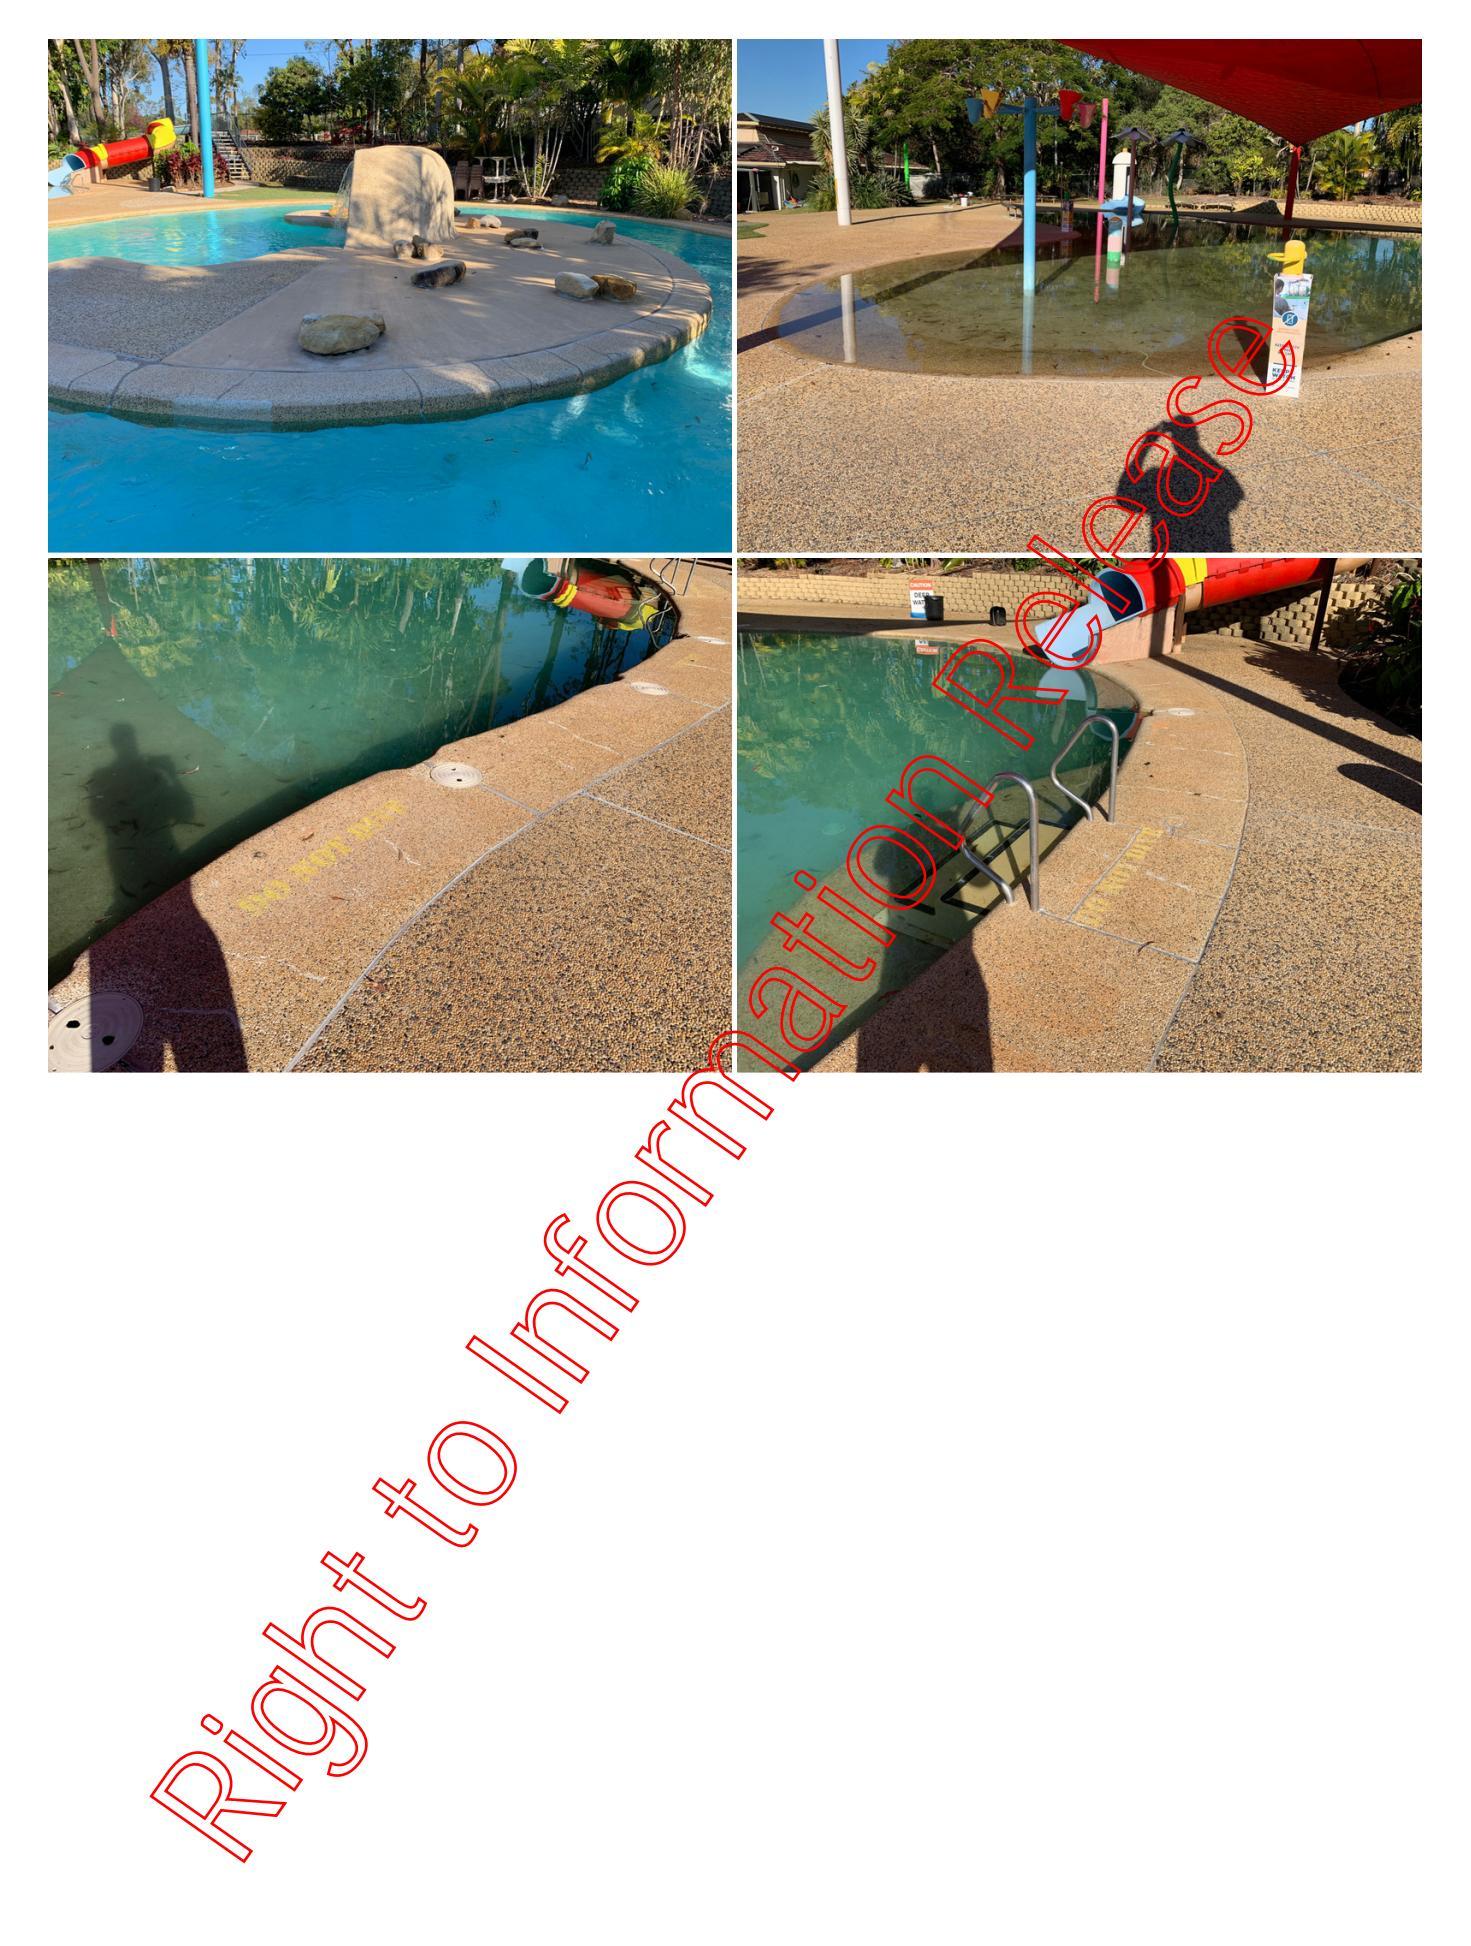
EQUIPOTENTIAL BONDING

Observation Description	Equipotential bonding	
Observation Details	Conductive items are present within arms reach of most pools, requiring equipotential bonding. This extends to all pools.	
Recommendations	If not provided within the past 12 months, engage an electrician to undertake an earth bonding test of all items as required by AS3000	
Critical Item?	Yes

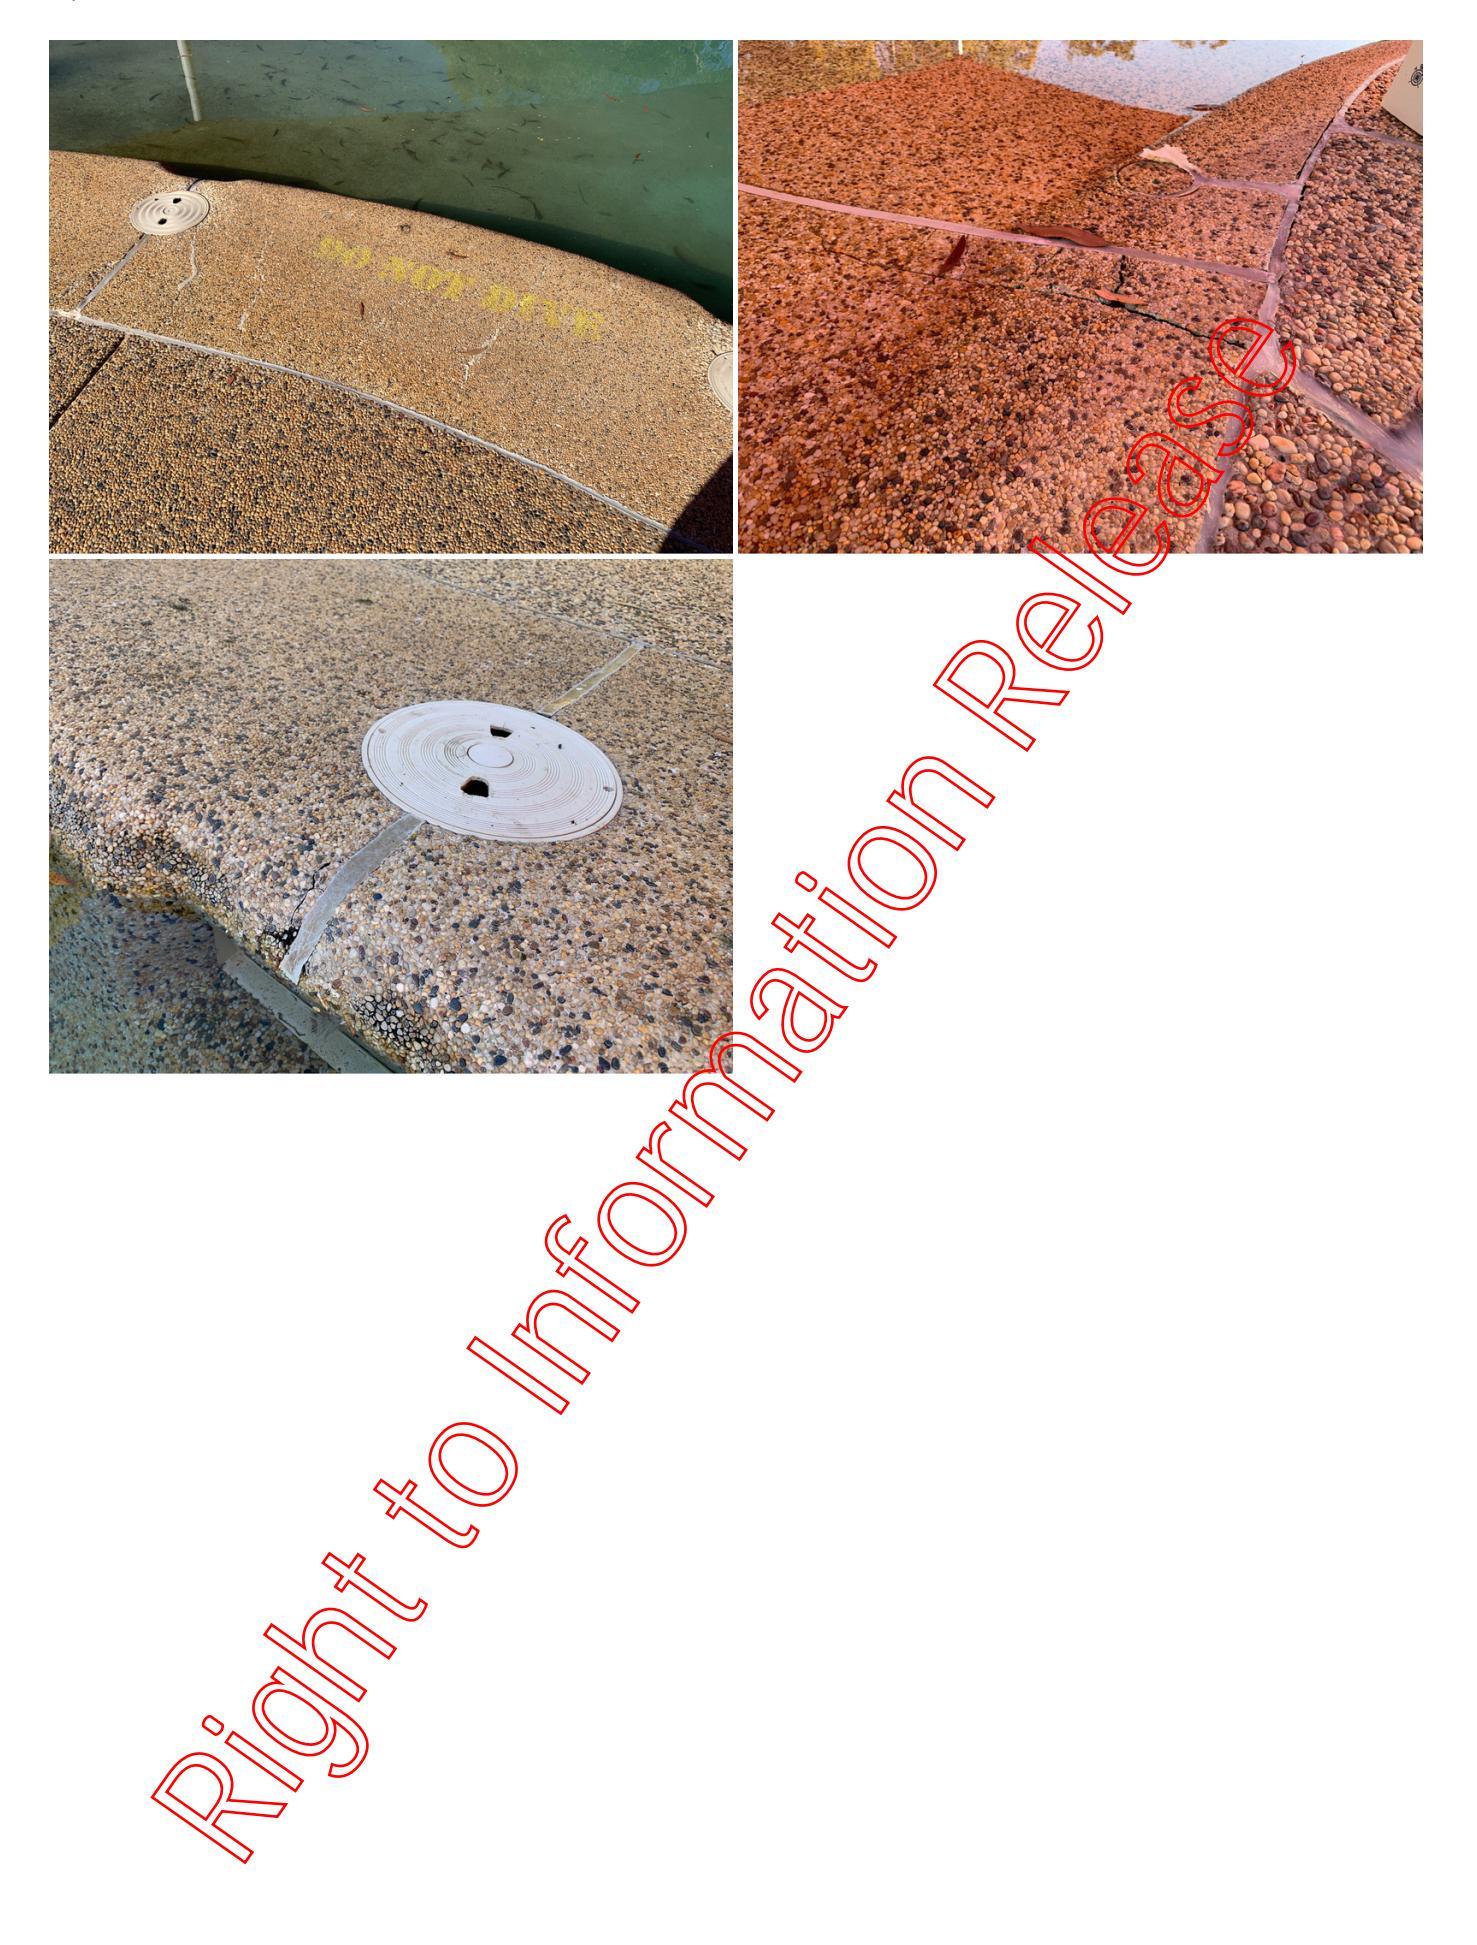
POOL SILICON

Observation Description	Pool Silicon
Observation Details	Pool silicon requires replacement
Recommendations	Leak test and replace.
Critical Item?	No
Observation Photos

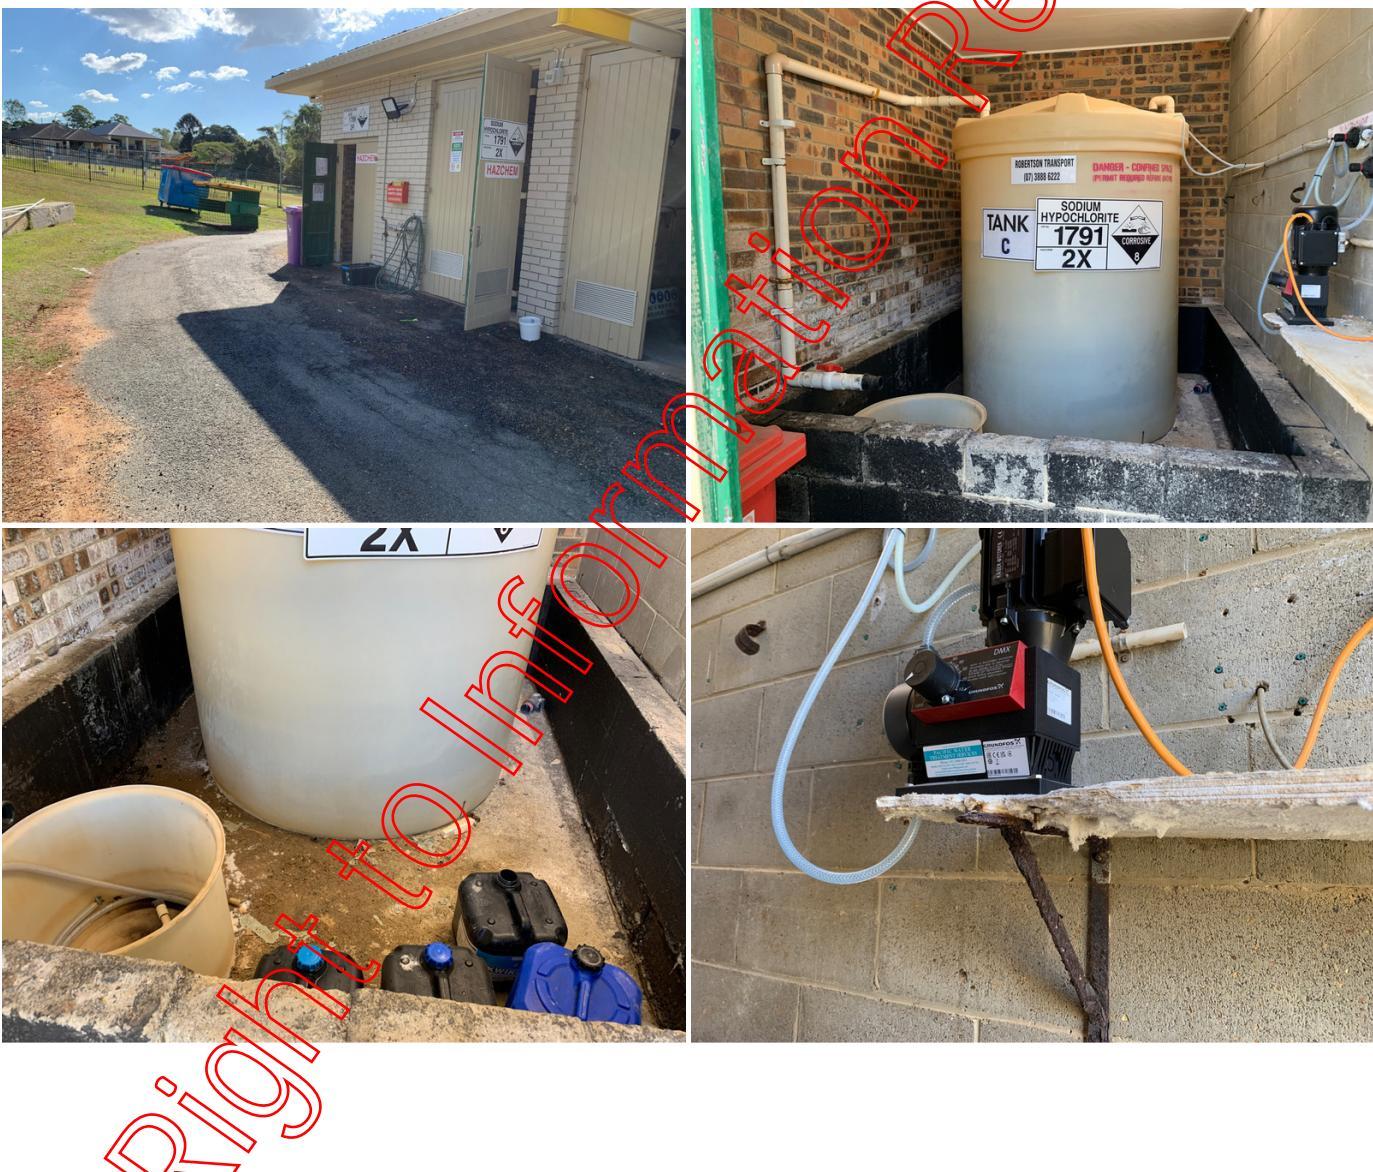
Observation Description	Chlorine Storage
Observation Details	The bulk chlorine storage produces several non-conformances including: o No truck unloading bund o Levels not marked on tank o No tank overflow o Bund in poor condition and unlikely to seal o Tank vents to room o Chlorine pump mounted on degraded shelf
Recommendations	Replace the entire chlorine storage facility
Critical Item?	Yes

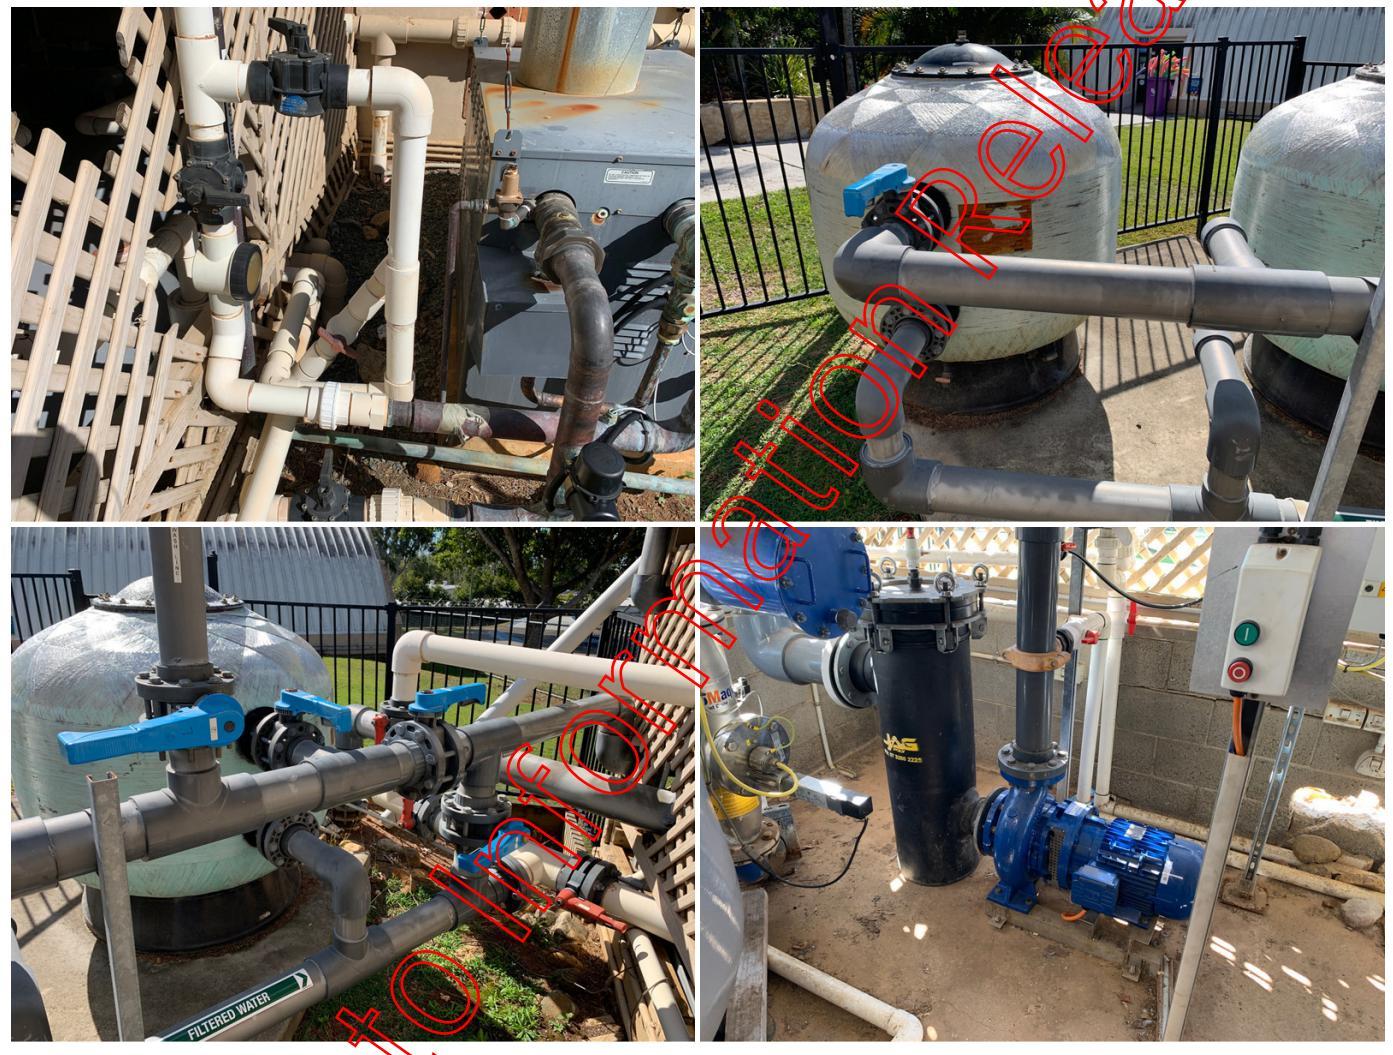
Observation Description	Pipe and equipment labelling	
Observation Details	Labelling is generally poor.	
Recommendations	Provide labelling to each item of equipment and each service	
Critical Item?	No

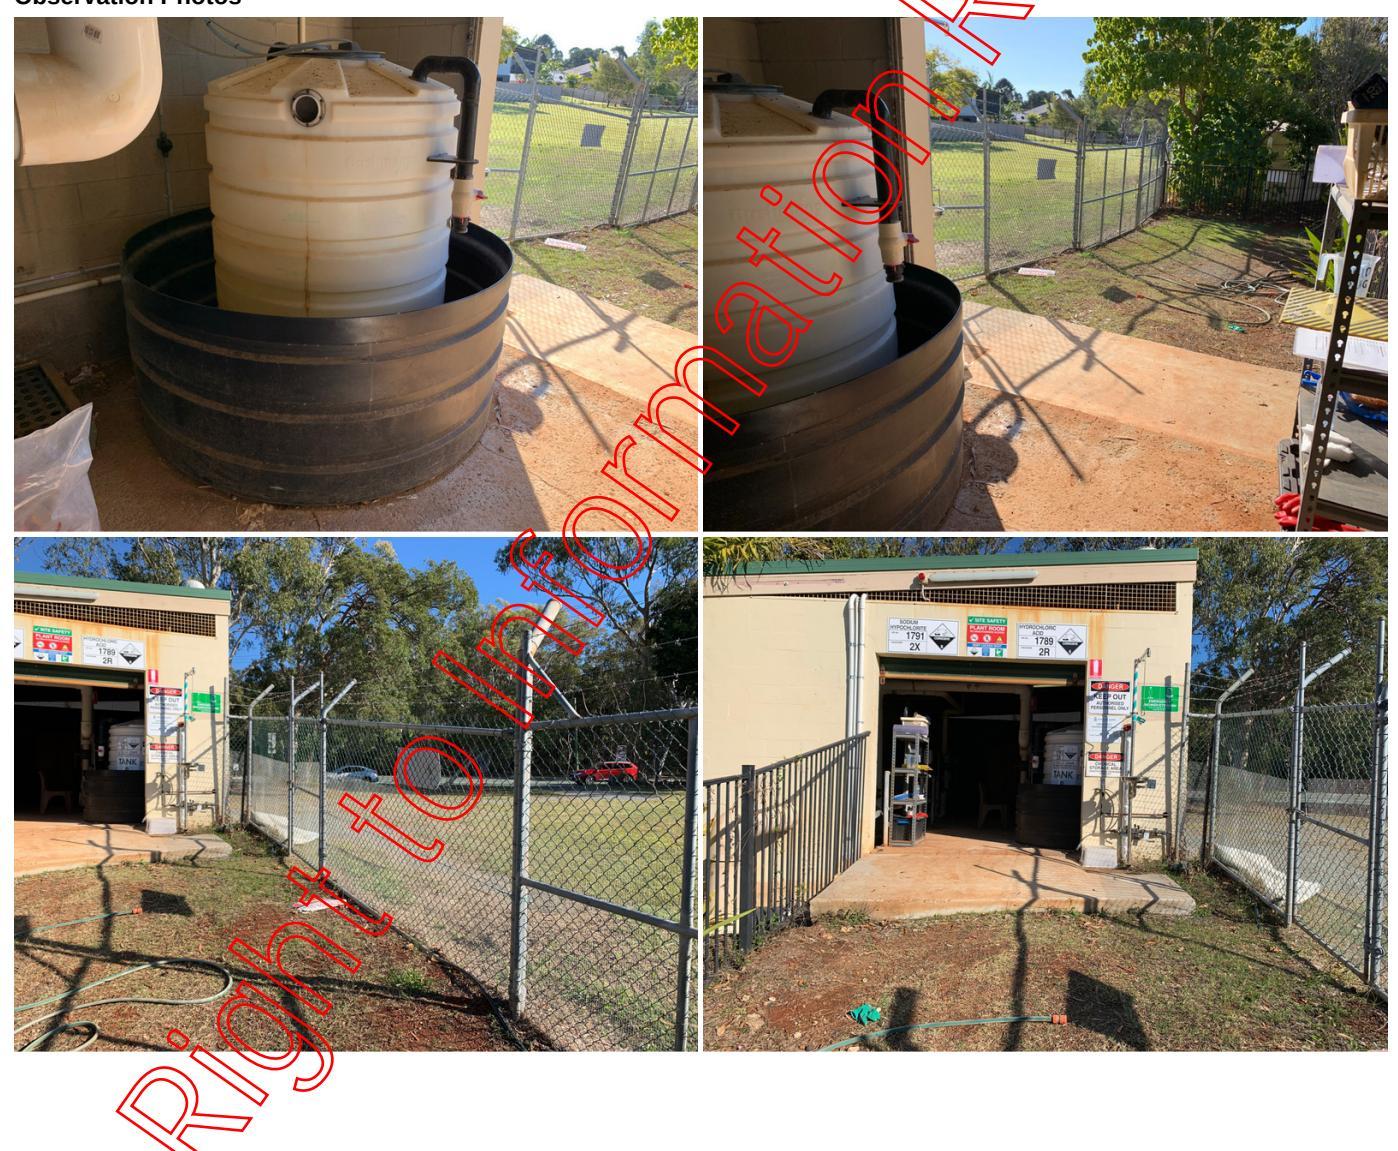
Observation Description	Chlorine Storage	
Observation Details	The chlorine storage system presents several non-conformances: o No truck unloading bund is provided. The truck has to park on grass. o A trip hazard is present between the truck parking area and the transfer point. o No line drain system is provided, resulting in spilled chlorine every fill. o The safety shower is in direct sun but not insulated o The tank volume levels are not marked o The overflow is not plumbed into the bund and may spray beyond the bund o The tank vents into the room o The proximity to the bund is too close	
Recommendations	Replace the entire chlorine storage system	
Critical Item?	Yes

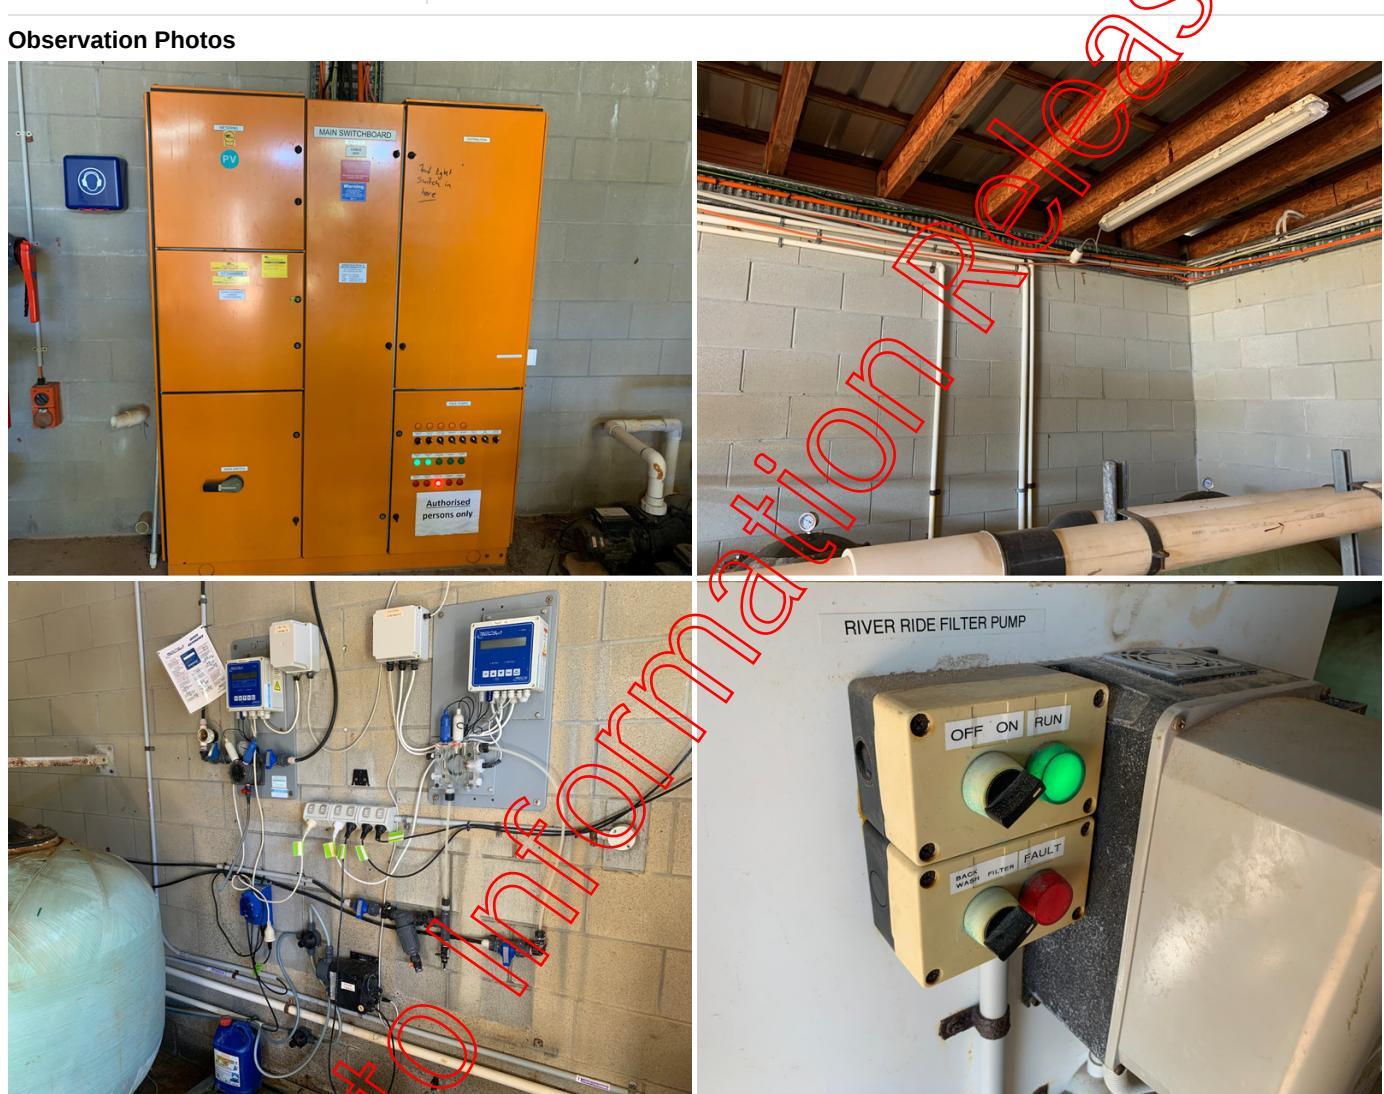
Observation Description	Electrical Installation
Observation Details	The electrical installation is messy in some areas
Recommendations	It is recommended to engage an electrician to provide a condition and compliance audit
Critical Item?	Yes
