onsite meeting at 2 Sanctuary Dr, Mt Cotton

Re, the Ficus Trees at 2 Sanctury Drive, Mount Cotton.

Assetic chronology and notes of WR88126 and following WO226299

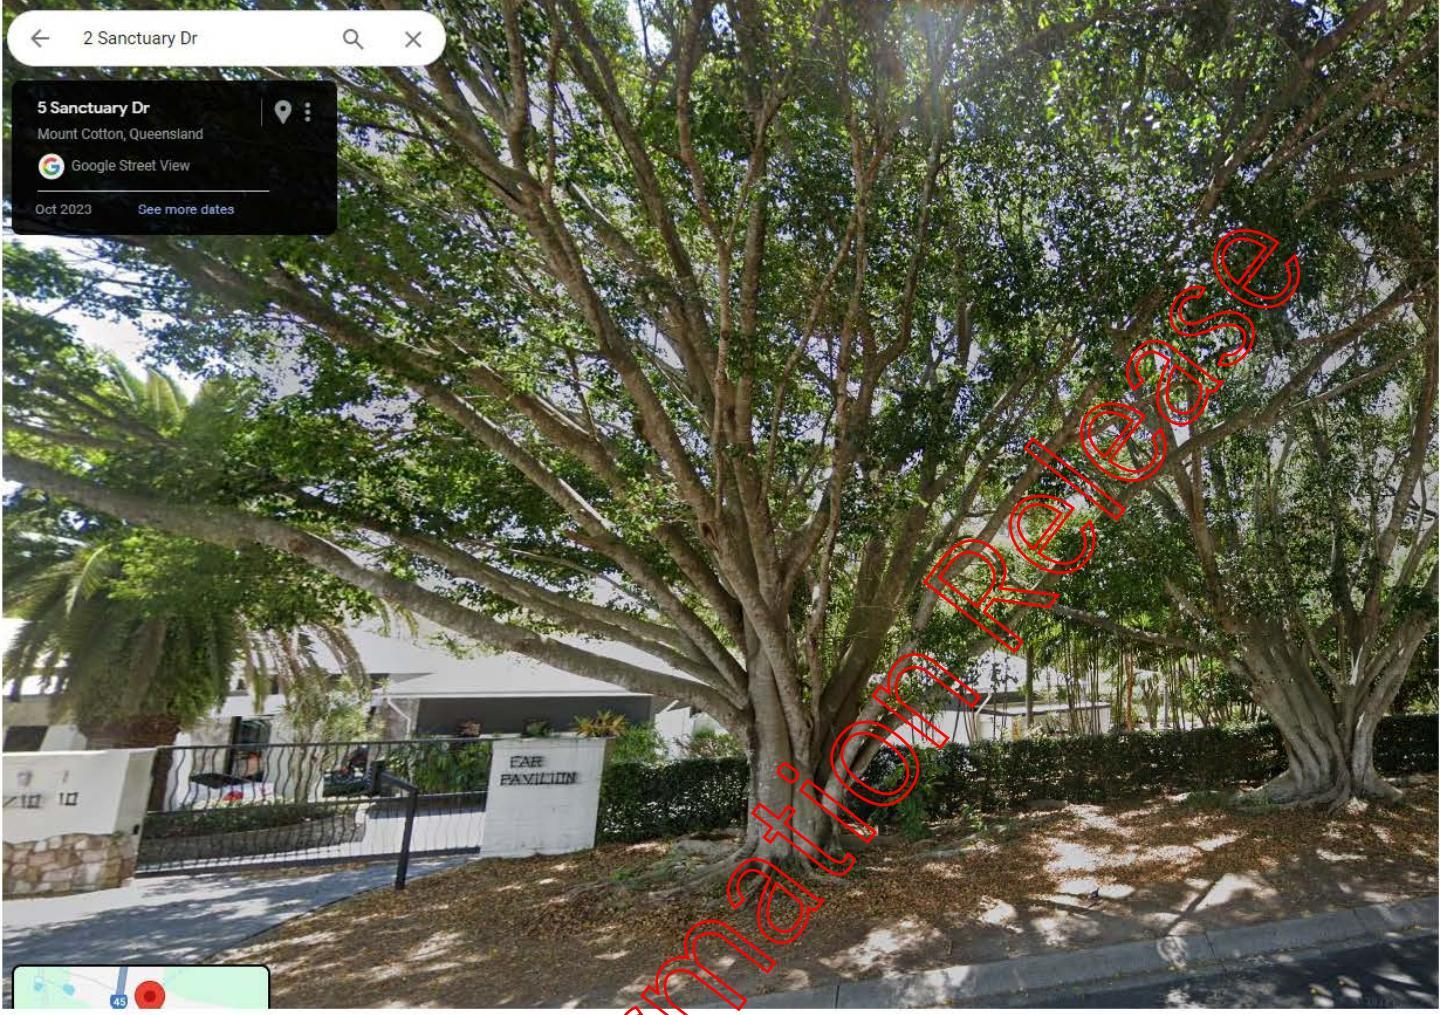
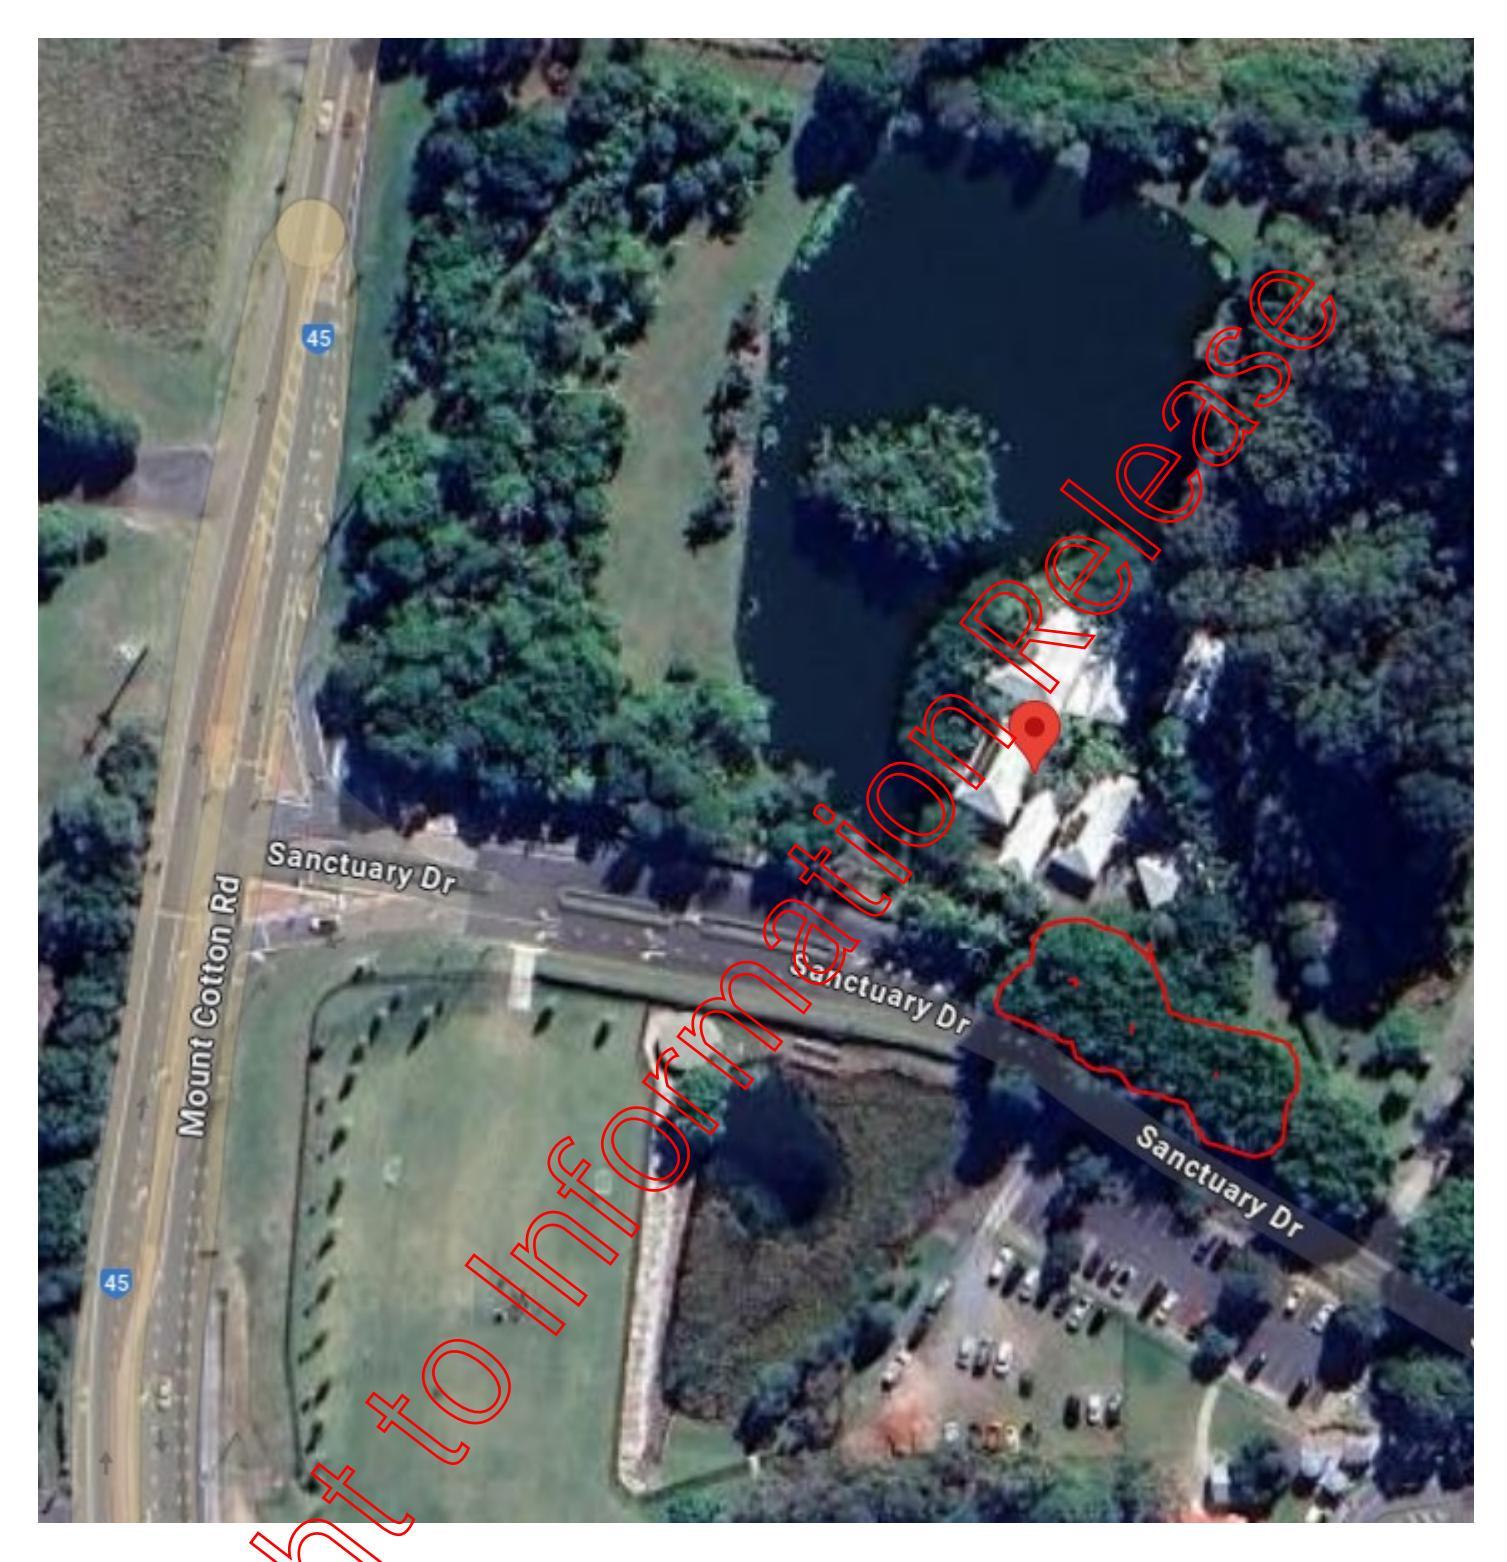
have assessed the site and it is a visibly obvious that large roots are

infrastructure is more than likely being effected. We are proposing the removal of the three (3) Figs as root barriers are feasible whilst maintain tree stability. Given this is part of probably the most significant avenue planting of trees we have on a roadway in the city there is going to be considerable public interest and comment.

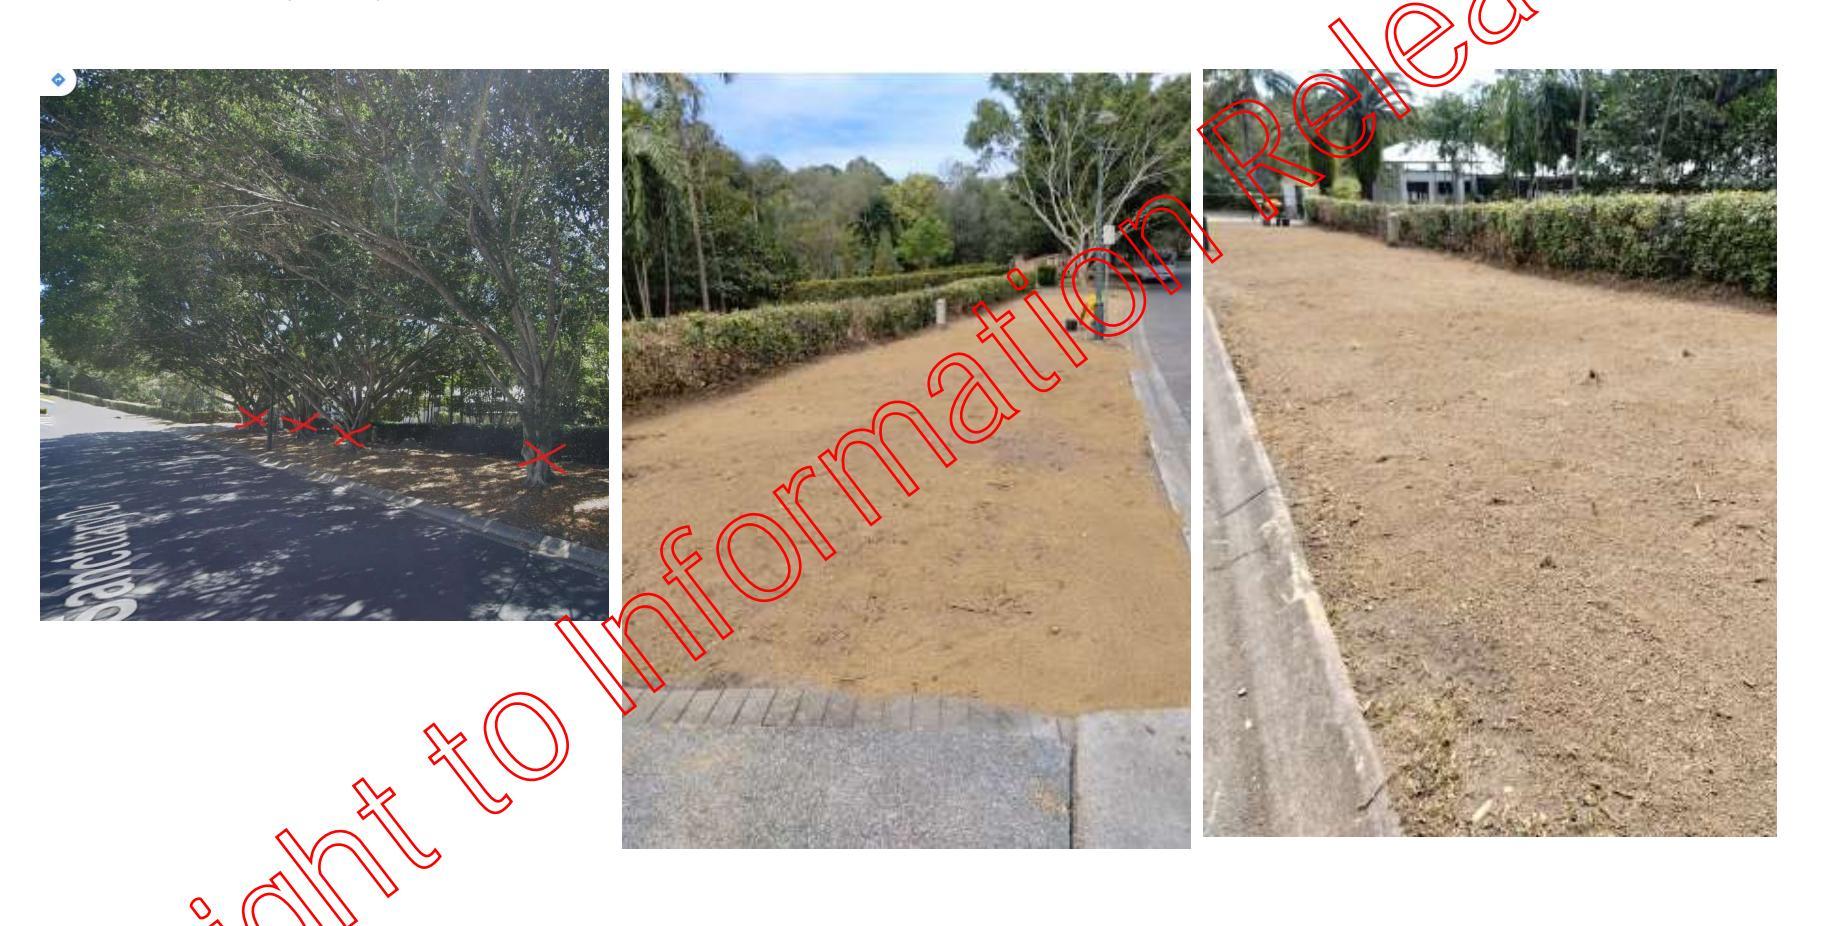
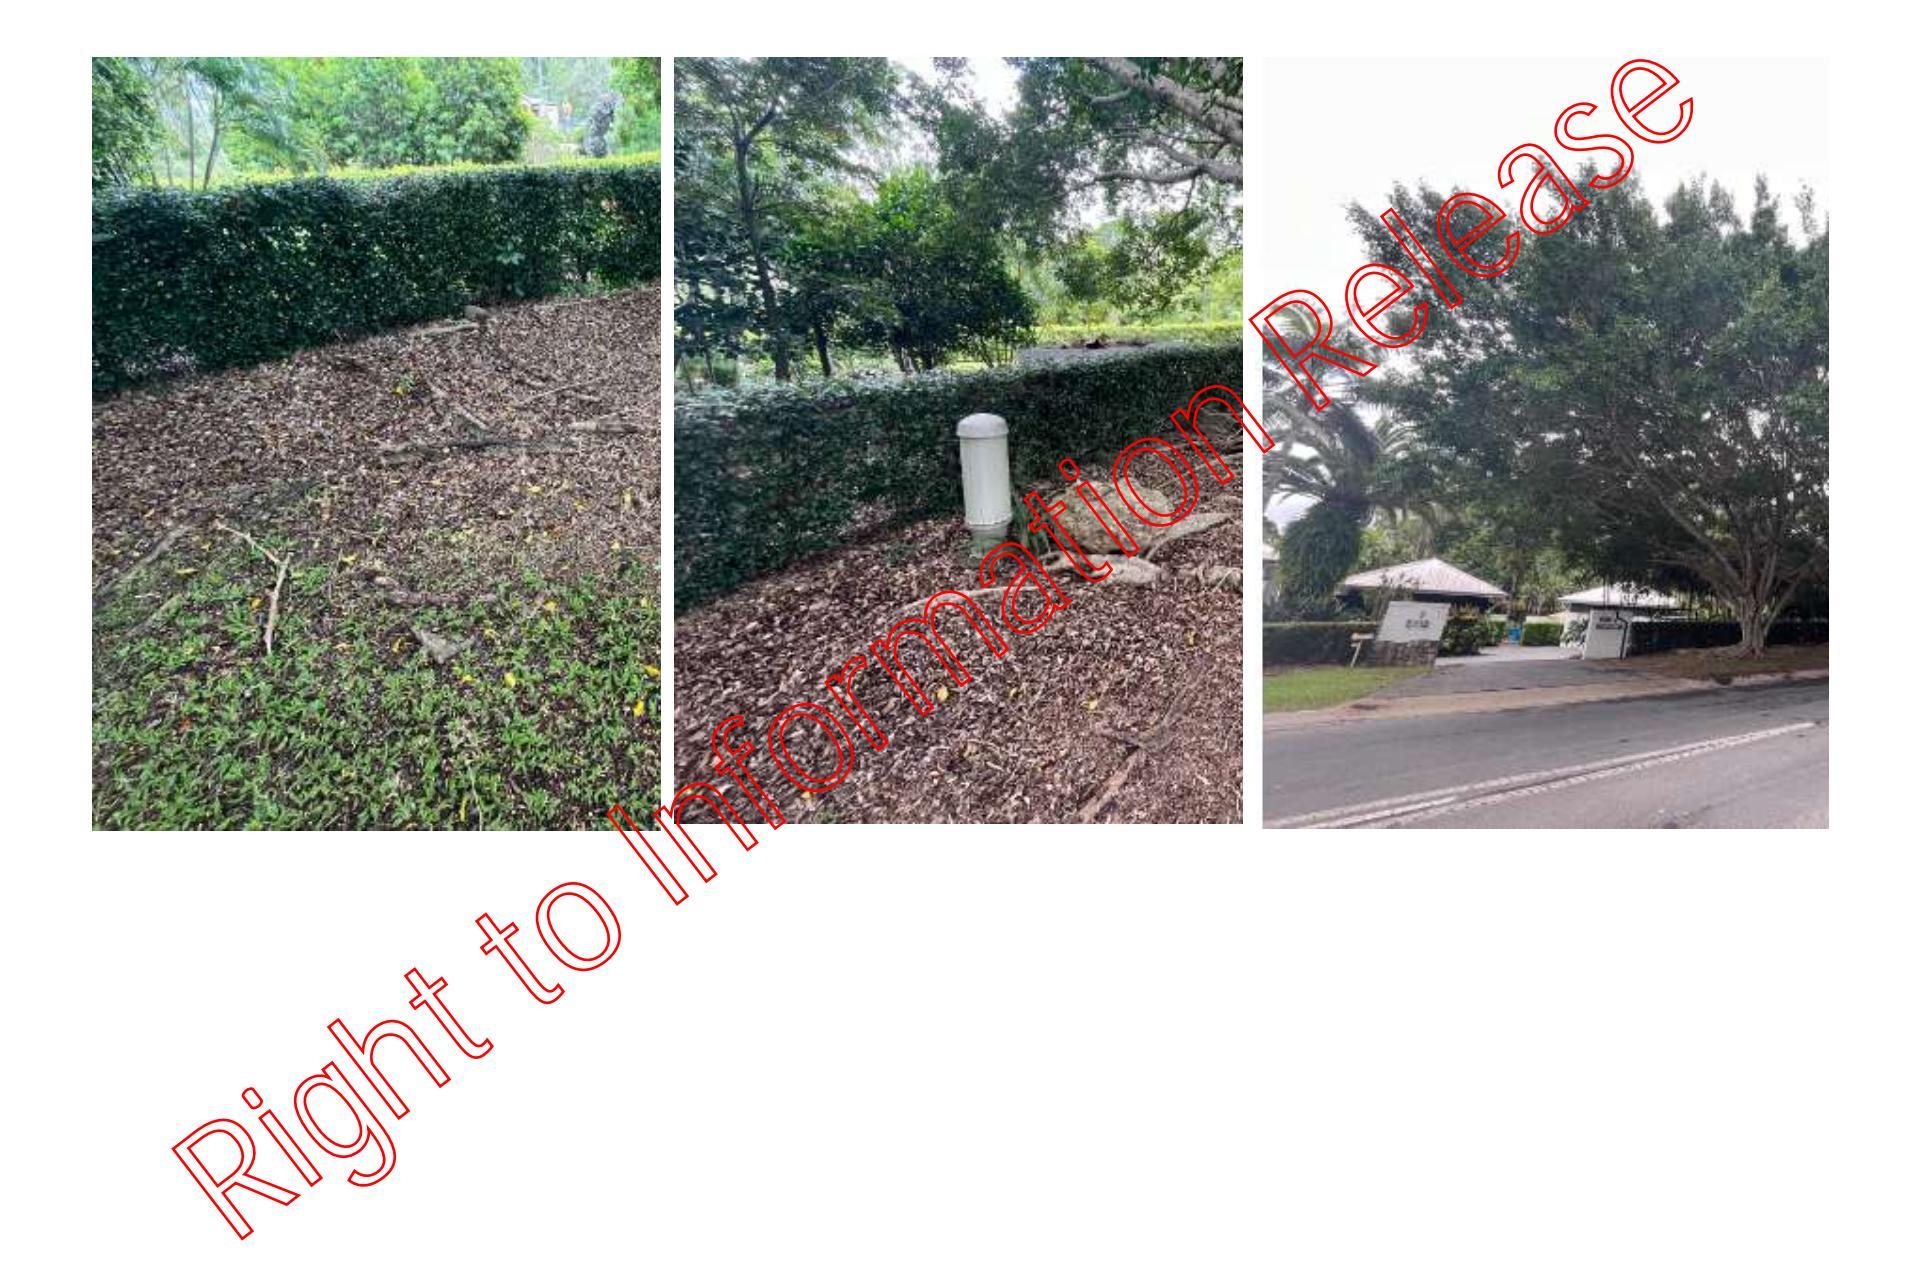
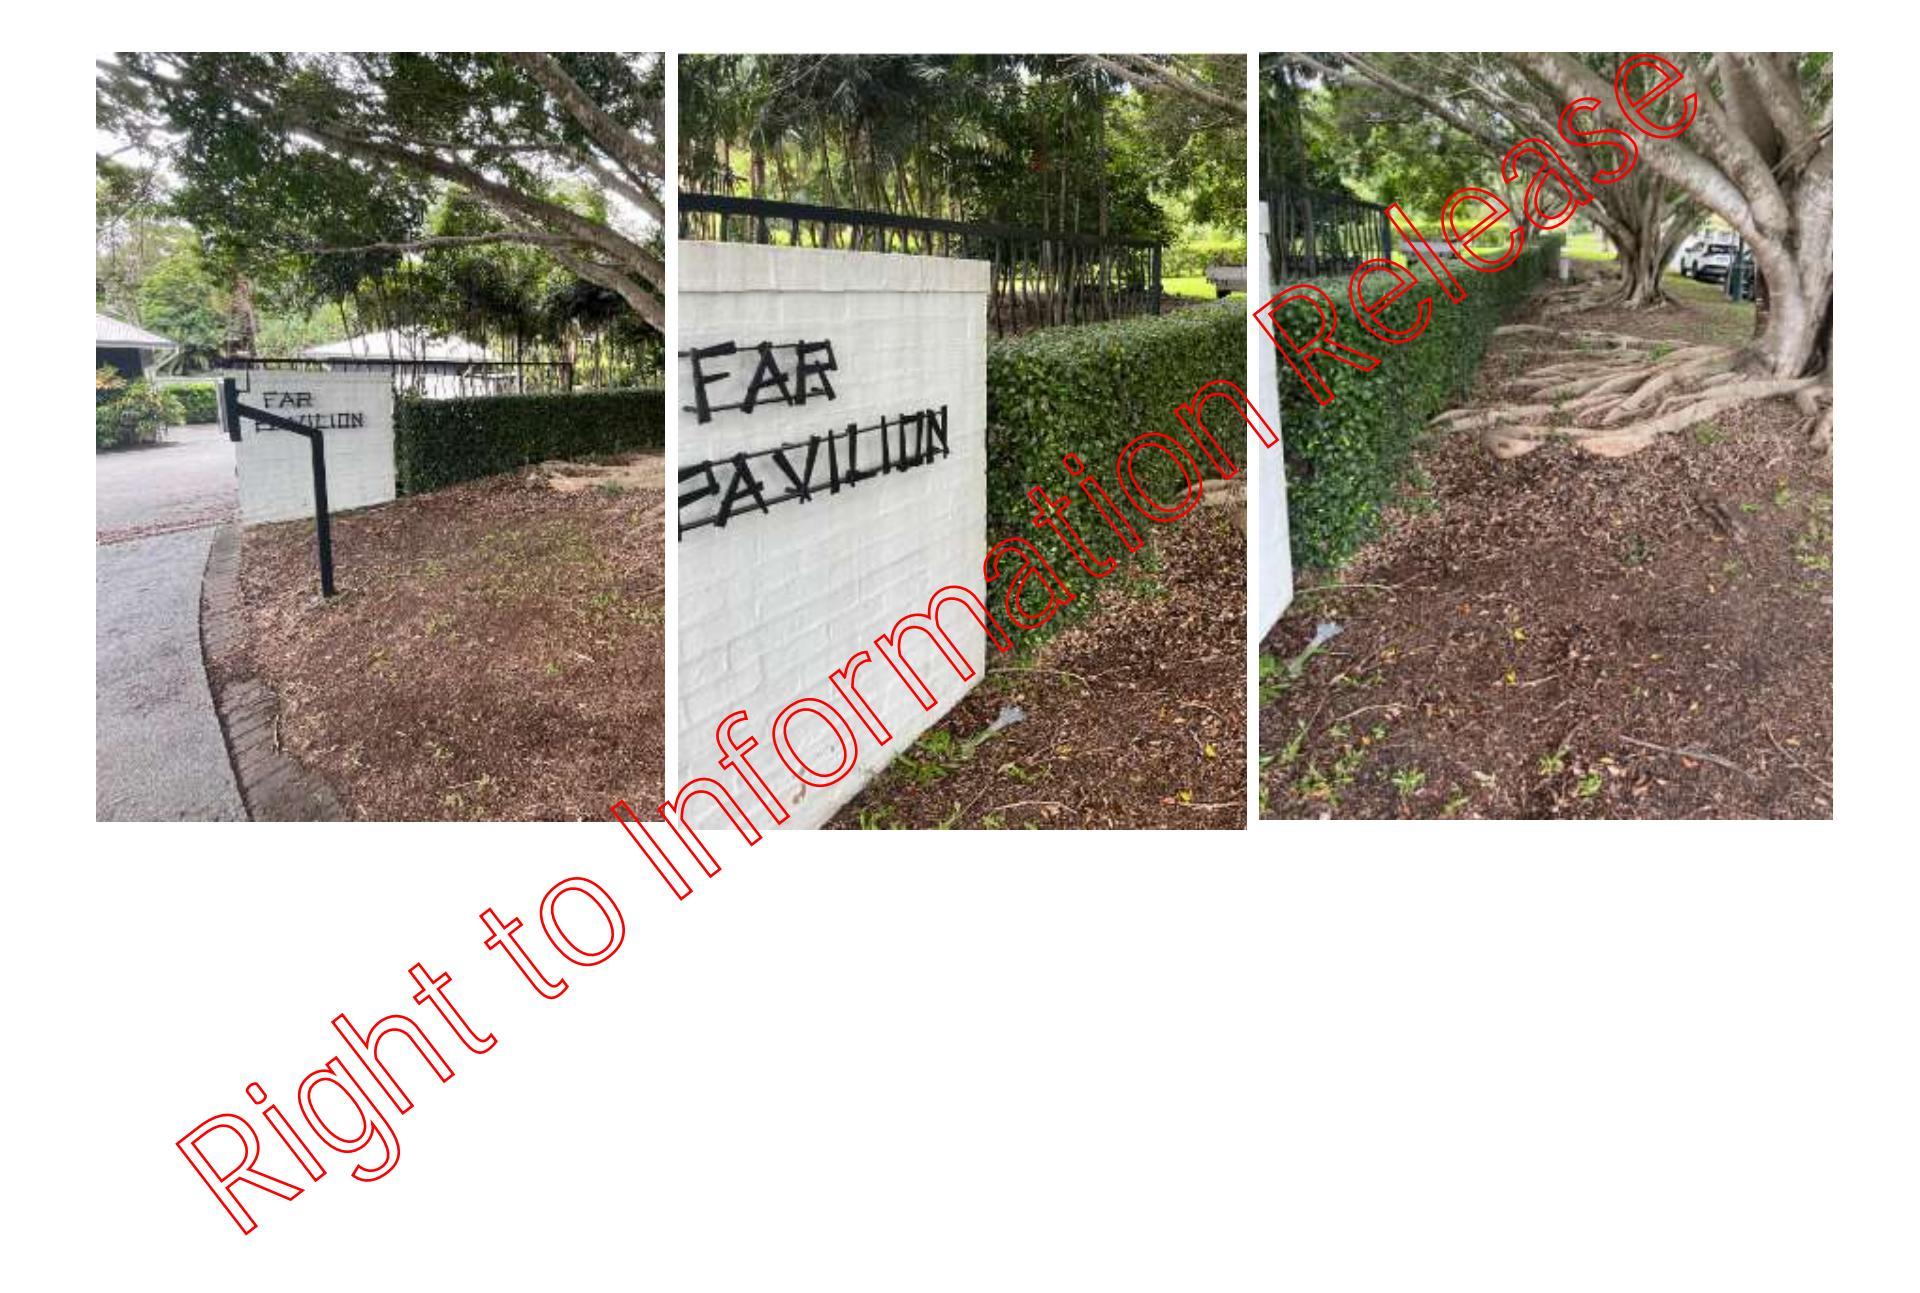
Please see below as requested photos from WR88126 / WO226299

When inspected it was clearly evident that the roots of these Ficus trees were causing and had the potential to cause significant increasing property damage

which had several large exposed roots in close proximity and multiple large exposed roots that can down the slope

Additionally a telecommunications pillar on the road reserve was being uplifted and displaced through root contact.

expected when planted in reserve adjacent a hard surfaced road. The root systems have been hindered in developing southwards under the road due to the non viable growth environment under a road with compacted, dry and nutrient deficient soil. Therefore as would be expected the trees roots systems have predominantly grown northwards and down the slope

(exposed roots in excess of 15m away from the trees were visible, and undoubtedly there is a prolific sub surface root system as well).

From a risk management perspective the retention of these Ficus tree could not be managed arboriculturally without introducing additional and potentially increasing levels of risk, hence the final decision to remove these Ficus trees was made.
