Redland
CITY COUNCIL

Waterway Recovery Report

2011

Welcome to the Redlands Waterway Recovery Report 2011.

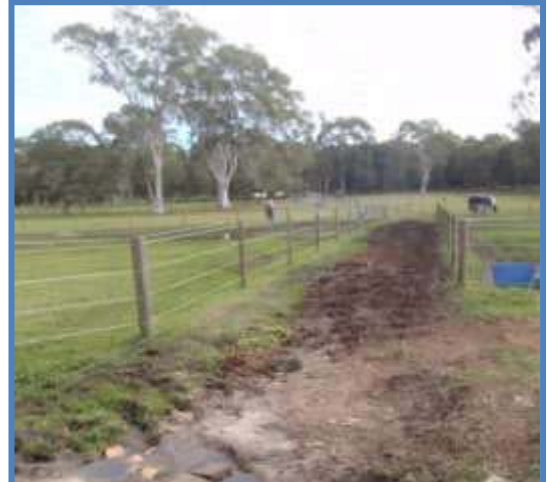
Before: Main passage through the property producing high amounts of sediment and nutrients.

A pasture management plan was developed for the property. The plan outlined methods to cover bare soil and improve pasture. The recommendations included: isolating the feeding area; fencing and resting paddocks to aid pasture regeneration and stopping the use of synthetic fertiliser. Less land is now used for pasture and more land has become available to allow natural regeneration.

Riparian vegetation was planted to help stabilise the banks of creek and the farm dam.

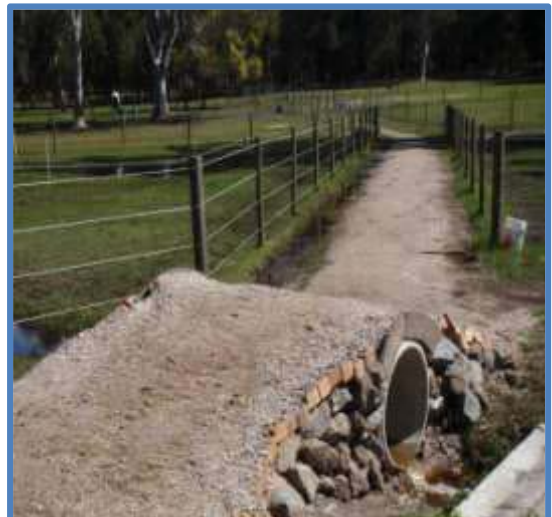
After: Formal causeway to prevent leeching of nutrients and sediment into the creek.

Water quality improvements are obvious in the farm dam. Aquatic weeds are no longer present and the amount of sediment and nutrients entering the dam has reduced. The latest monitoring results show that over a six month period the levels of chlorophyll-*a*, total suspended solids and nutrients are lower. This will have positive flow on effects to downstream water quality in Eprapah Creek.
