**Redland Smart Signs and Smart Messages:
A Driver Behaviour Change Project – Year 2
Final Report (2019-2020)**

Report prepared for Redland City Council

July 2020

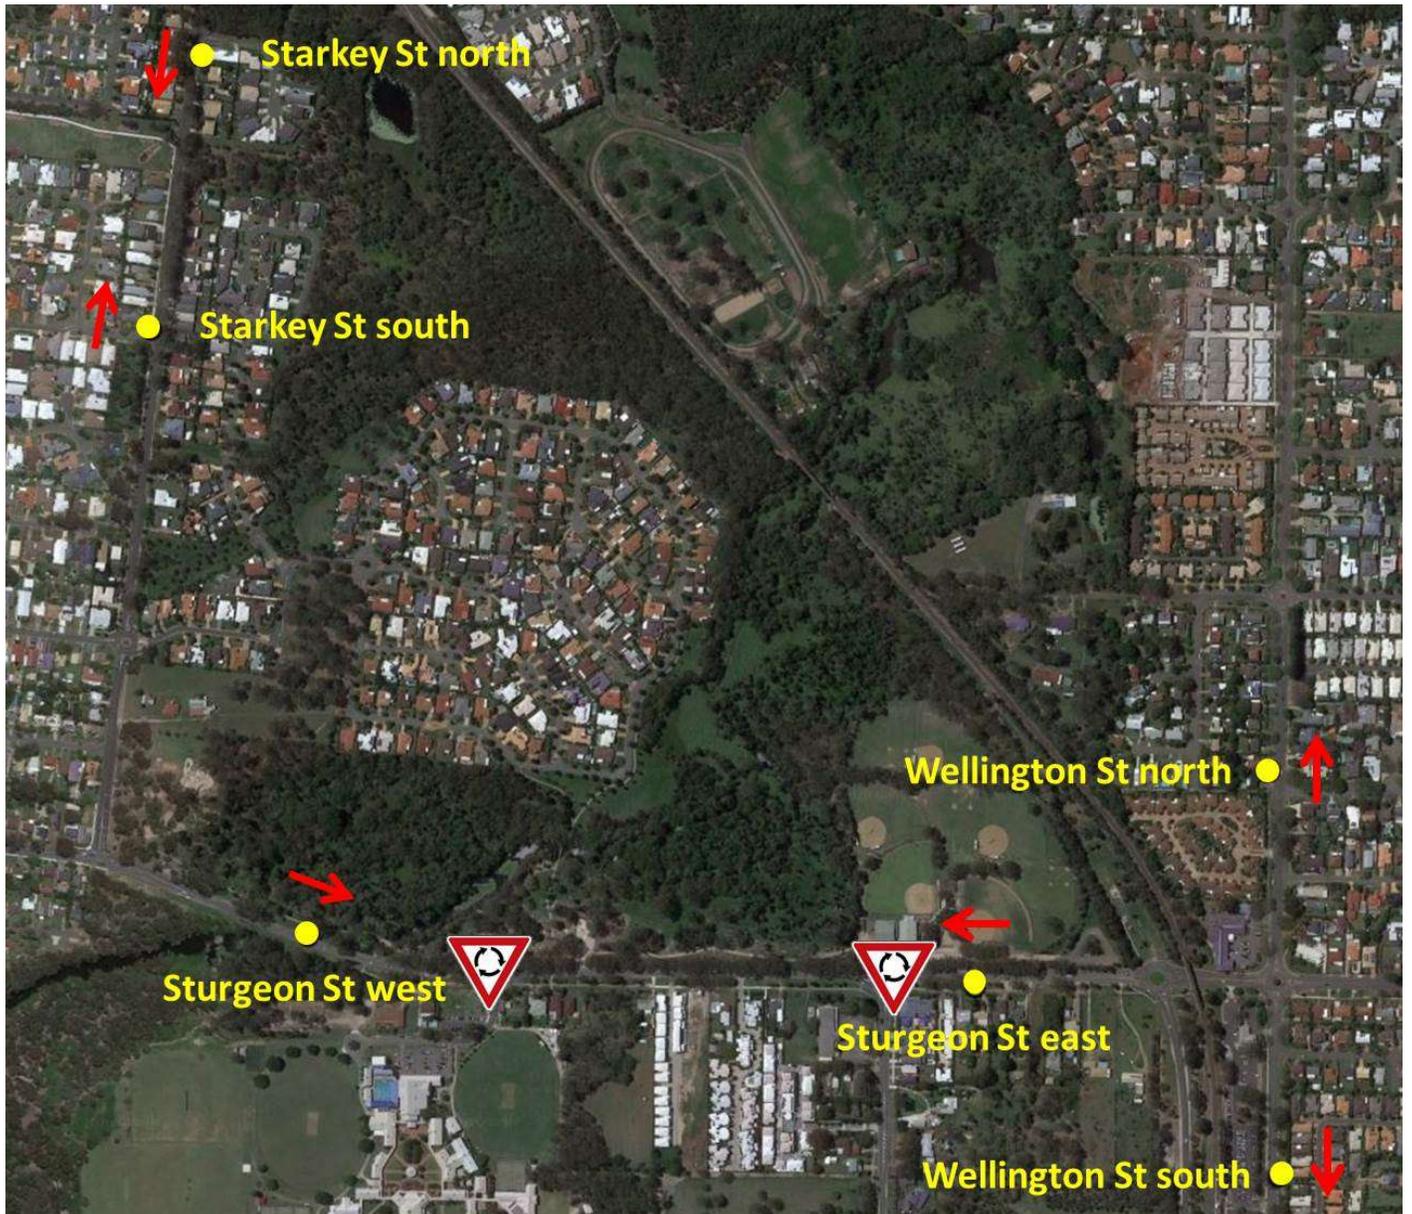
Figure 1. A map showing the locations of signs on three streets in Ormiston, Redlands.

symbols indicate the positions of roundabouts on Sturgeon Street. Red arrows show the direction of vehicle travel for a particular sign/site.

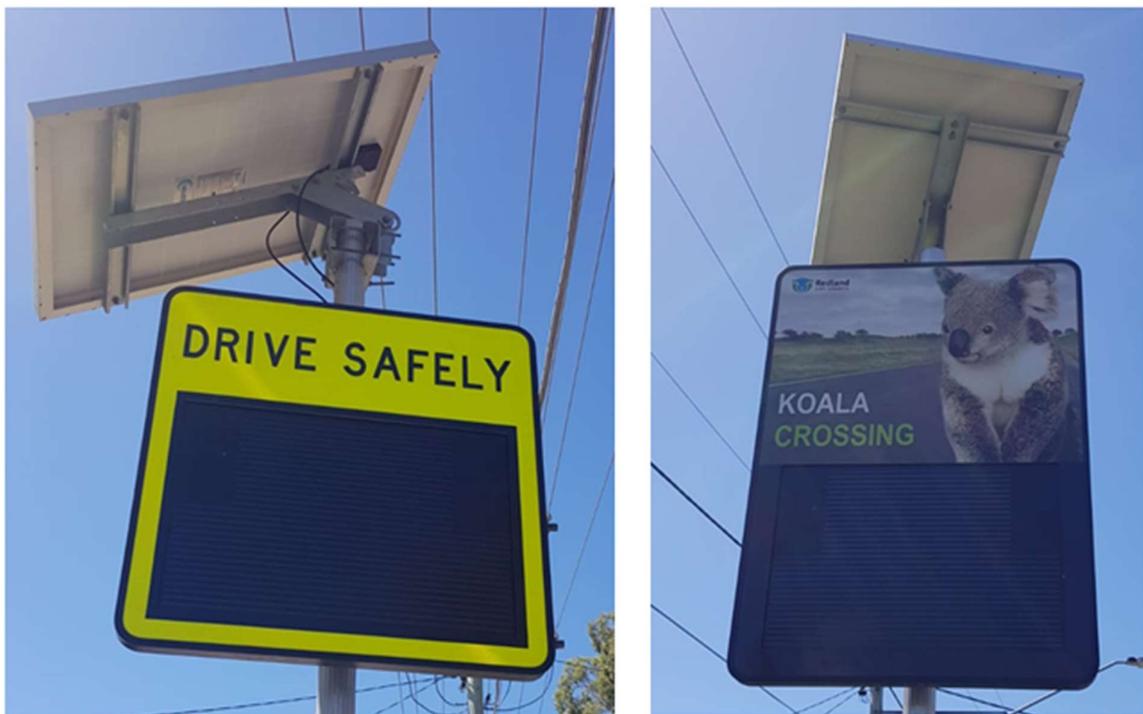
Figure 2. Jenoptik brand named for this project as 'smiley' (left) and 'koala_smiley' (right) models of dynamic (variable) message signage.

Three types of signs were trialled, from two different manufacturers/suppliers. Two were dynamic message signs (Jenoptik) that reported tailorable messages to drivers via an LED display panel. In each case, the display panel was the same, with the primary variation between the two types being the passive messaging displayed on each. A 'generic' version of the sign (named Jenoptik 'smiley') featured a high visibility border and the words: "DRIVE SAFELY", whilst a koala-specific version (named Jenoptik 'koala_smiley') featured the image of a koala with the words: "KOALA CROSSING". Figure 2 shows each version of the Jenoptik signs side-by-side for comparison.

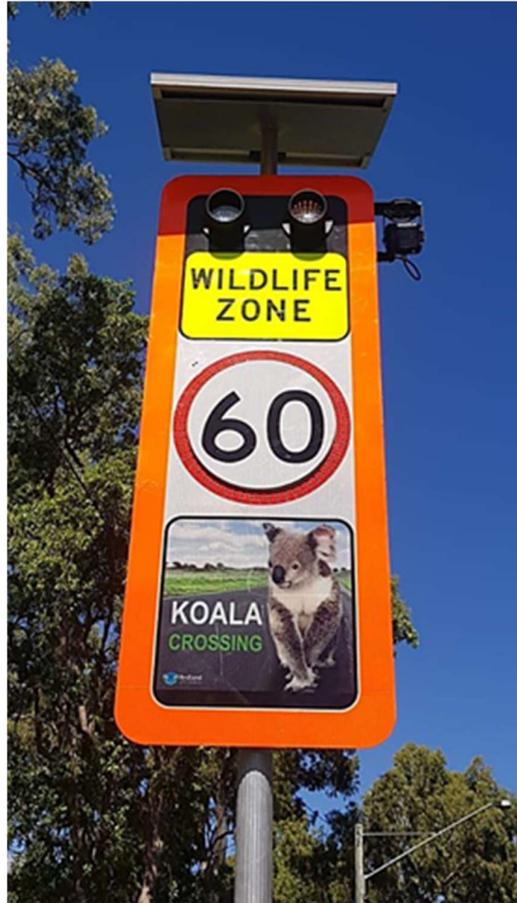
Figure 3. ITS/Artcraft koala sign incorporated into the present study phase

The third sign type (ITS/Artcraft) featured two LED flasher lights that flashed on and off whenever a vehicle was detected exceeding a specifiable speed threshold. The posted speed limit was also displayed (and could be replaced depending on the speed of a given street) along with a smaller version of the same koala image and

message featured in the Jenoptik koala smiley sign and a high visibility banner with the words: “WILDLIFE ZONE” (see Figure 3).

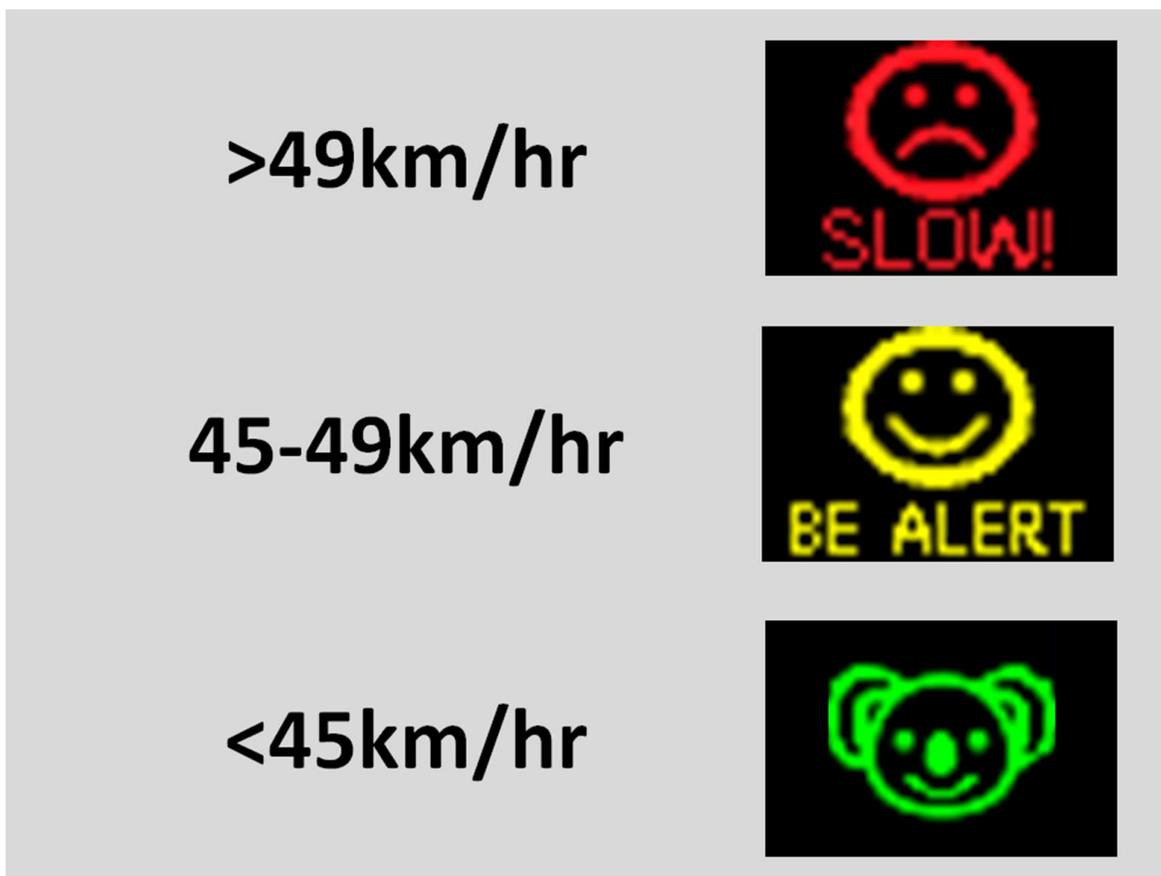
Figure 4. An example of the dynamic, variable sign messaging that greeted drivers given certain, measured vehicle speed thresholds, capable with the Jenoptik models. In this example, messaging was tailored to a 50km/hr posted speed limit zone. For a 60km/hr posted speed limit zone, each threshold was increased by 10km/hr. The green koala symbol which greeted drivers if they were recorded to be driving under 45km/hr (or under 55km/hr in a 60km/hr zone) was unique to the Jenoptik koala_smiley model (i.e. the generic Jenoptik smiley model featured a green, round 'smiley' face as pictured for the other speed thresholds).

Jenoptik signs were capable of dynamically changing (often referred to as: ‘variable’) messaging conveyed to drivers depending on their speed. Figure 4 provides an example of the different messages drivers received at different speeds.

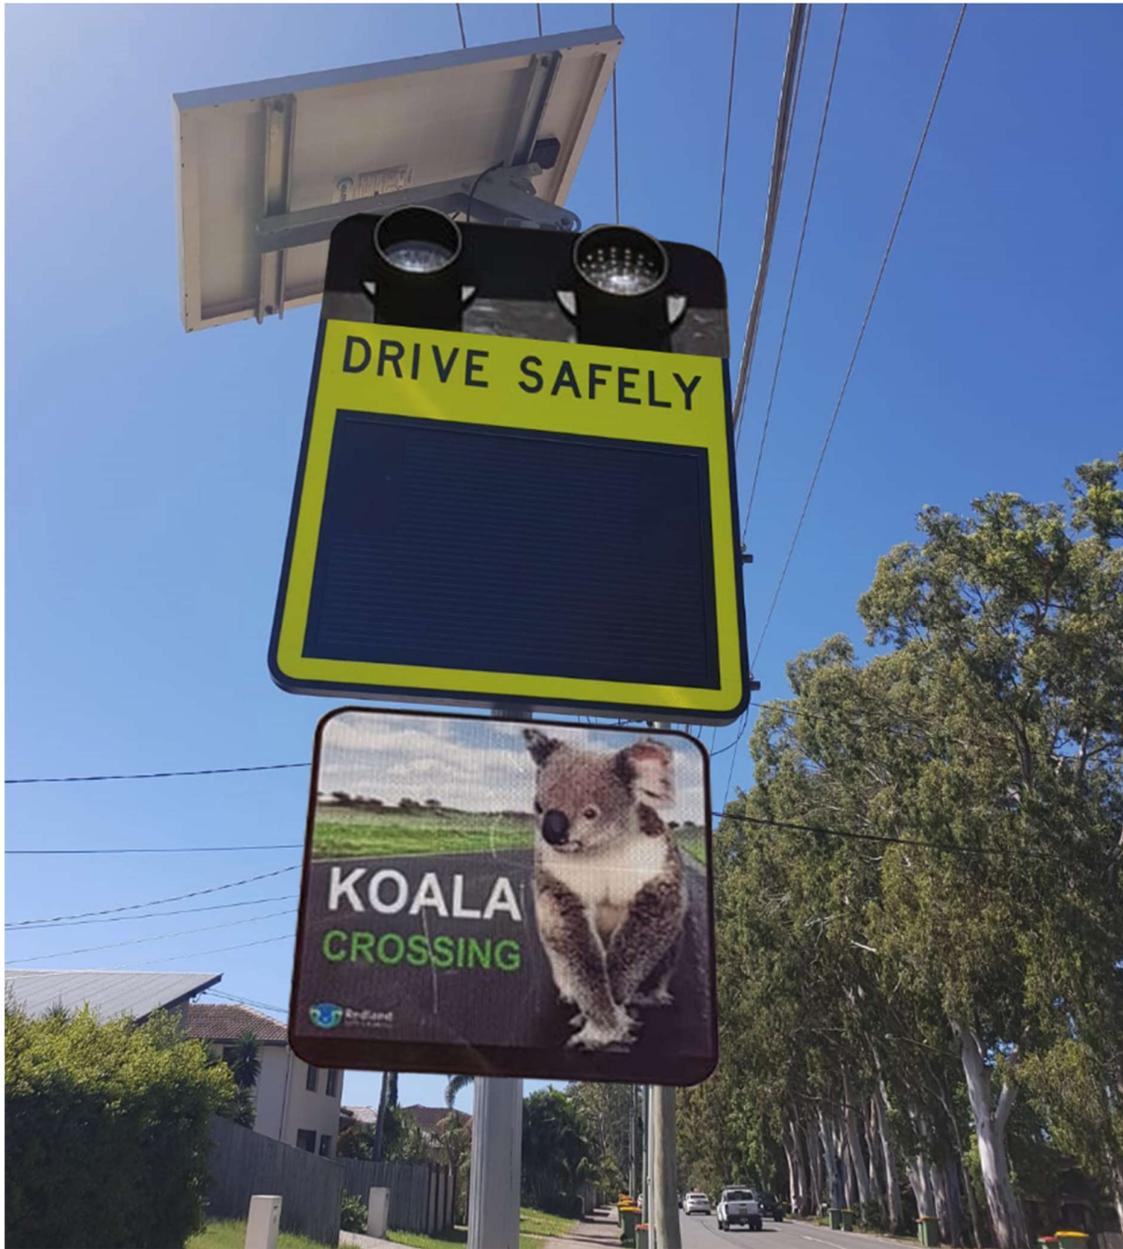
Figure 18. A conceptual image of a koala sign that combines features from all three of the signs trialed during the current study phase.

Figure 18 provides a concept of such a design, taking the flashing lights and koala information panel from an ITS/Artcraft sign, and combining them with the generic Jenoptik smiley sign. Each element is principally 'standalone', such that it could be added or removed as necessary. Additional considerations such as the colouration of text (e.g. which colours do drivers prefer or are more visible) could be explored via surveys or small pilot-level investigations.
