**Redland Smart Signs and Smart Messages:
A Driver Behaviour Change Project – Year 4
Final Report (2021-2022)**

Report prepared for Redland City Council

May 2022

Report published by Griffith University's Applied Road Ecology Group

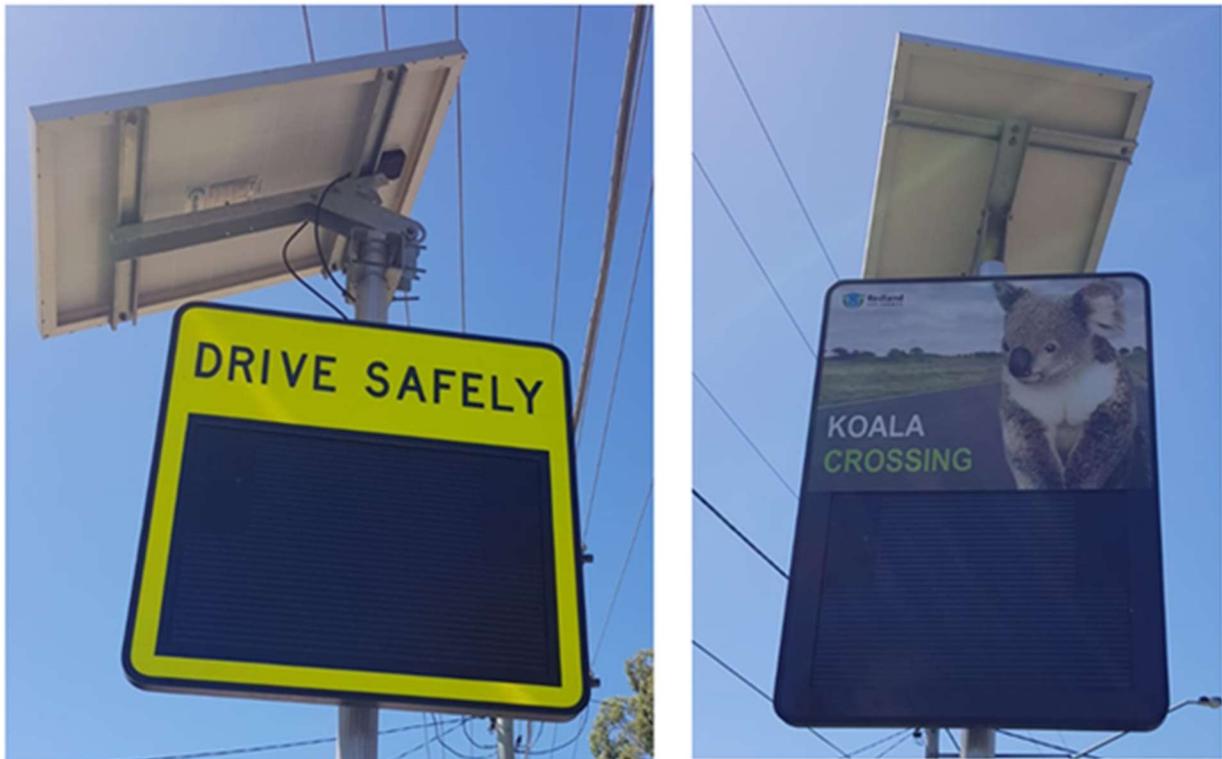
Figure 2. Sierzega brand models of dynamic (variable) message signage, named for this project as Jenoptik ‘smiley’ (left) and ‘koala smiley’ (right).

Three types of signs were trialled, from two different manufacturers/suppliers. Two were Sierzega dynamic message signs (supplied by Jenoptik Traffic Solutions) that reported tailorable messages to drivers via an LED display panel. In each case, the display panel was the same, with the primary variation between the two types being the passive messaging displayed on each. A 'generic' version of the sign (named Jenoptik 'smiley') featured a high visibility border and the words: "DRIVE SAFELY", whilst a koala-specific version (named Jenoptik 'koala smiley') featured the image of a koala with the words: "KOALA CROSSING".

Figure 2 shows each version of the Jenoptik signs side-by-side for comparison.

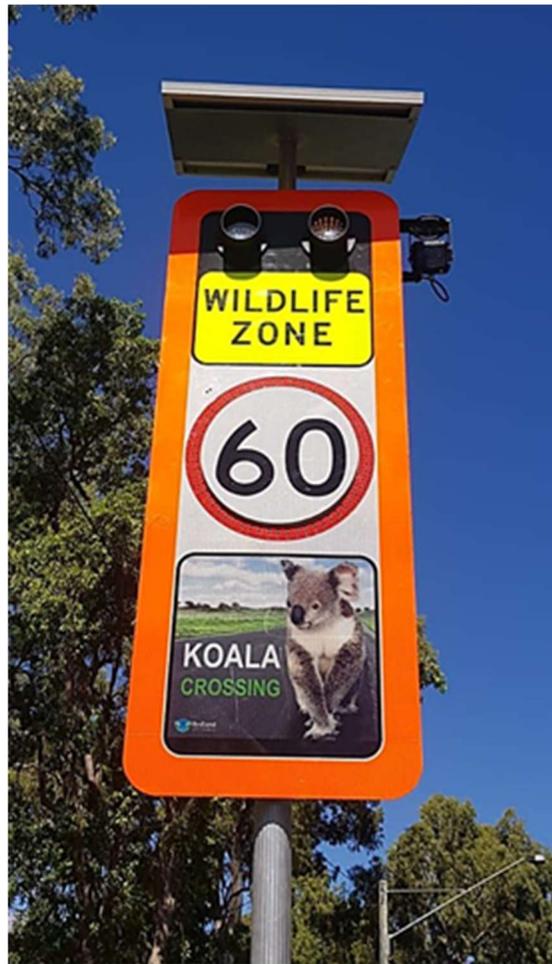
Figure 3. ITS/Artcraft brand koala sign.

The third sign type (ITS/Artcraft) featured two LED lights that flashed on and off whenever a vehicle was detected exceeding a specifiable speed threshold. The posted speed limit was displayed (and could be replaced depending on the speed of a given street) along with a smaller version of the same koala image and message featured in the Jenoptik koala smiley sign and a high visibility banner with the words: “WILDLIFE ZONE” (see Figure 3).

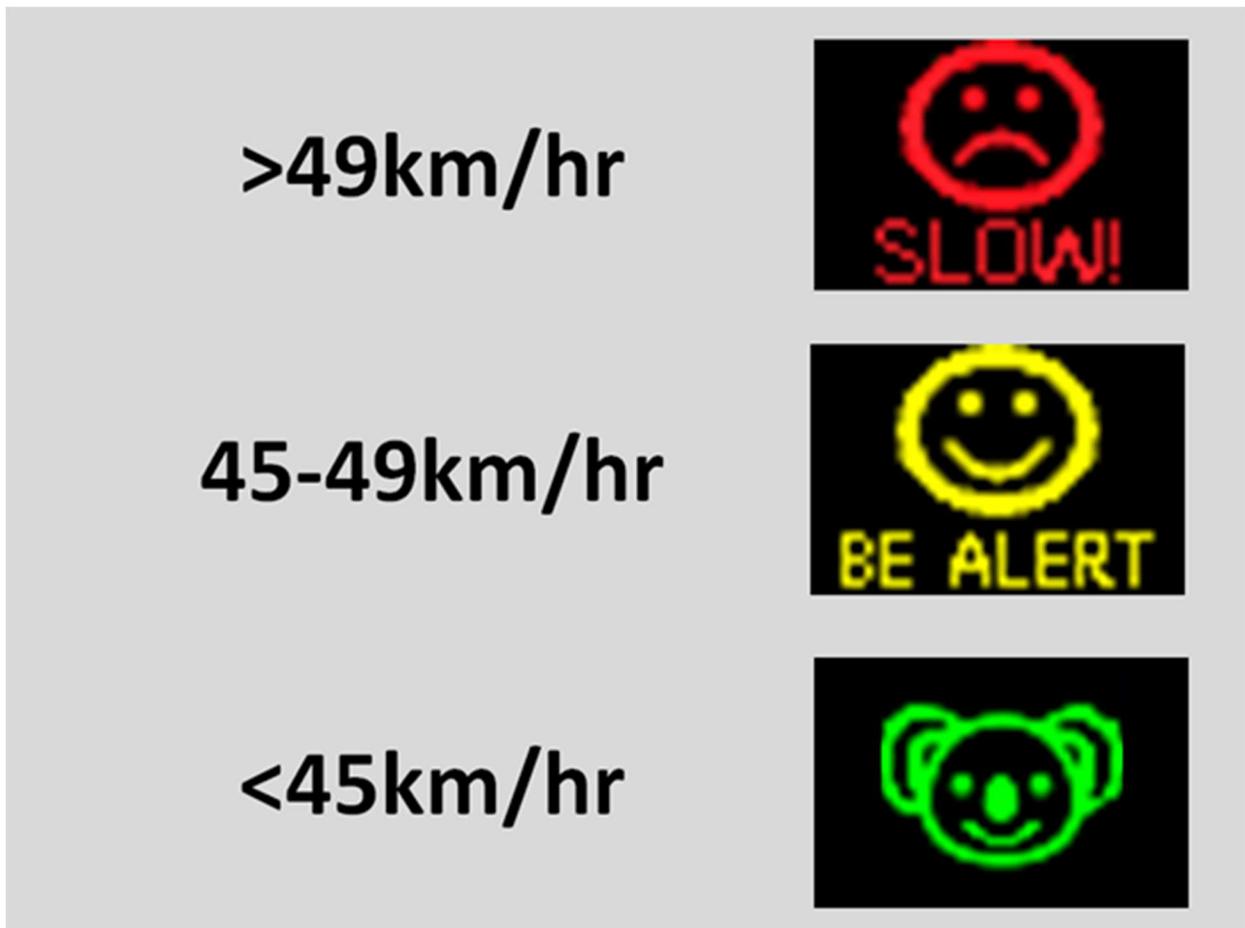
Figure 4. An example of the dynamic, variable sign messaging that greeted drivers given certain measured vehicle speed thresholds, capable with the Jenoptik models. In this example, messaging was tailored to a 50 km/hr posted speed limit zone. For a 60 km/hr posted speed limit zone, each threshold was increased by 10 km/hr. The green koala symbol that greeted drivers if they were recorded to be driving under 45 km/hr (or under 55 km/hr in a 60 km/hr zone) was unique to the Jenoptik koala smiley model (i.e. the generic Jenoptik smiley model featured a green, round 'smiley' face as pictured for the other speed thresholds).

The two Jenoptik sign types were capable of dynamically changing (often referred to as 'variable') messaging conveyed to drivers depending on their speed. Figure 4 provides an example of the different messages drivers received at different speeds.

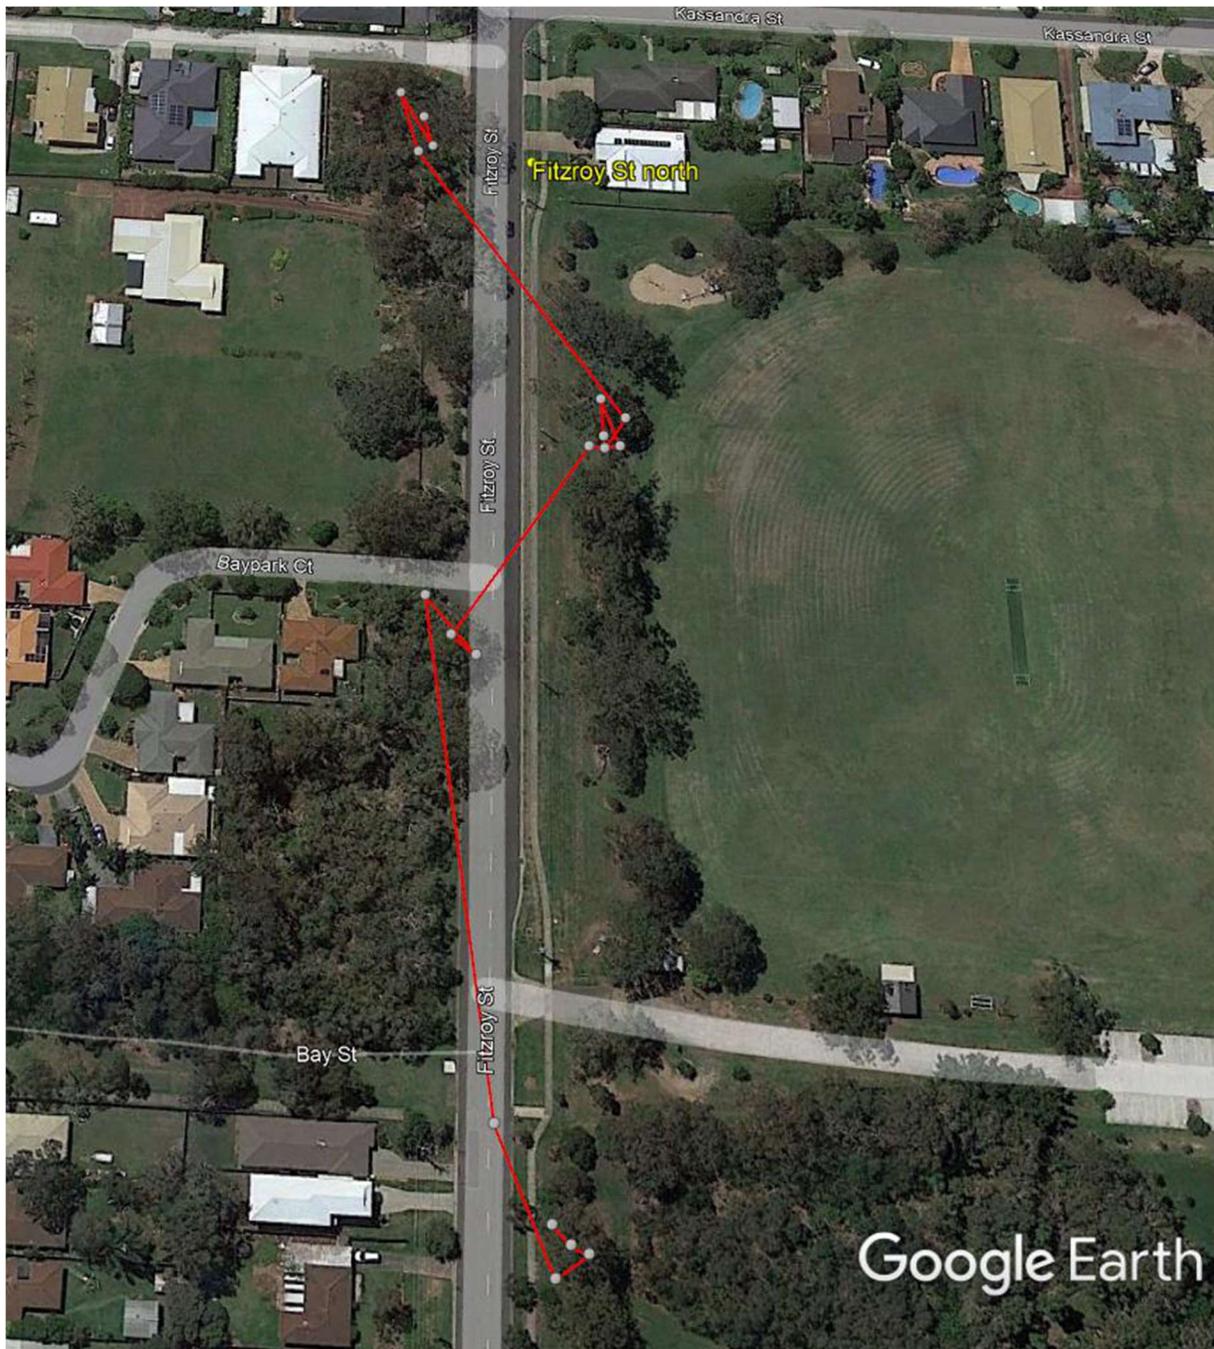
Figure 14. An example of possible crossings of Fitzroy Street by Blake the koala near the Fitzroy Street north sign. The red lines connect locations from 19 to 23 March 2022 (moving north), as indicated by GPS collar data. The GPS locations shown in the figure had errors of 30m or less. Data source: Caio Santos Neto and Dr Romane Cristescu, University of the Sunshine Coast. [Map created in Google Earth, using GPS Visualizer].

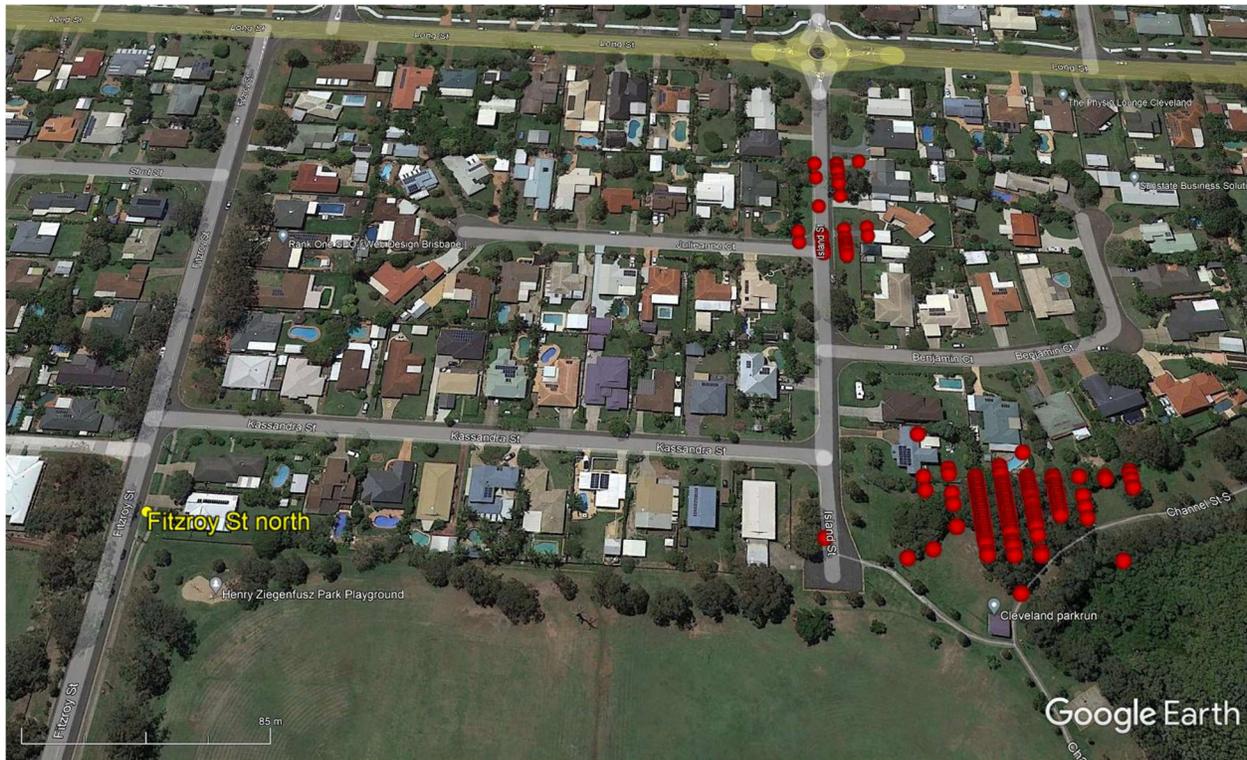
Appendix Figure 1. GPS locations for Grace in parkland and residential areas to the east of Fitzroy Street in Thornlands. Data source: Caio Santos Neto and Dr Romane Cristescu, University of the Sunshine Coast. [Map created in Google Earth]

Appendix Figures 1-3 show koala movement have been recorded in areas nearby current and future study sites, including some road crossings.
