From: Gildas Colleter [redacted]
Sent: Friday, 29 March 2019 12:02 PM
To: Michael Holland
Cc: Daniel Rodger
Subject: Accepted: Initial meeting for 'Marine Foreshore Concept Plan Development' - Amity Point and Rocky Point, Russell Island.

Redland Marine Foreshore
Project - Concept Plan
Development

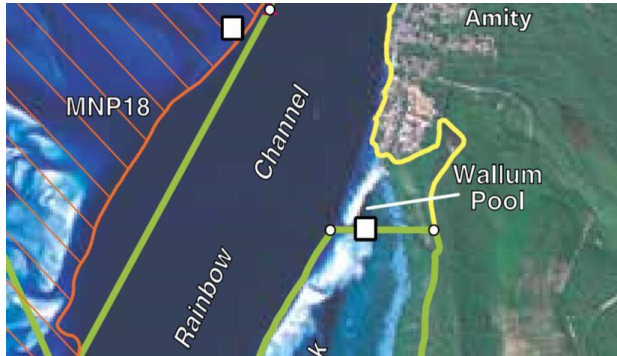
Figure 2-1 Moreton Bay Marine Park - Zone Plan for Southern Amity Point

Figure 2-1 shows that Park Beach is located along the Moreton Bay Marine Park in a Conservation Zone. Further South a Marine National park zone is declared across the Wanga Wallum sand flats. The Wallum Pool indicated on this map has disappeared alongside the Wanga Wallen sandbank.

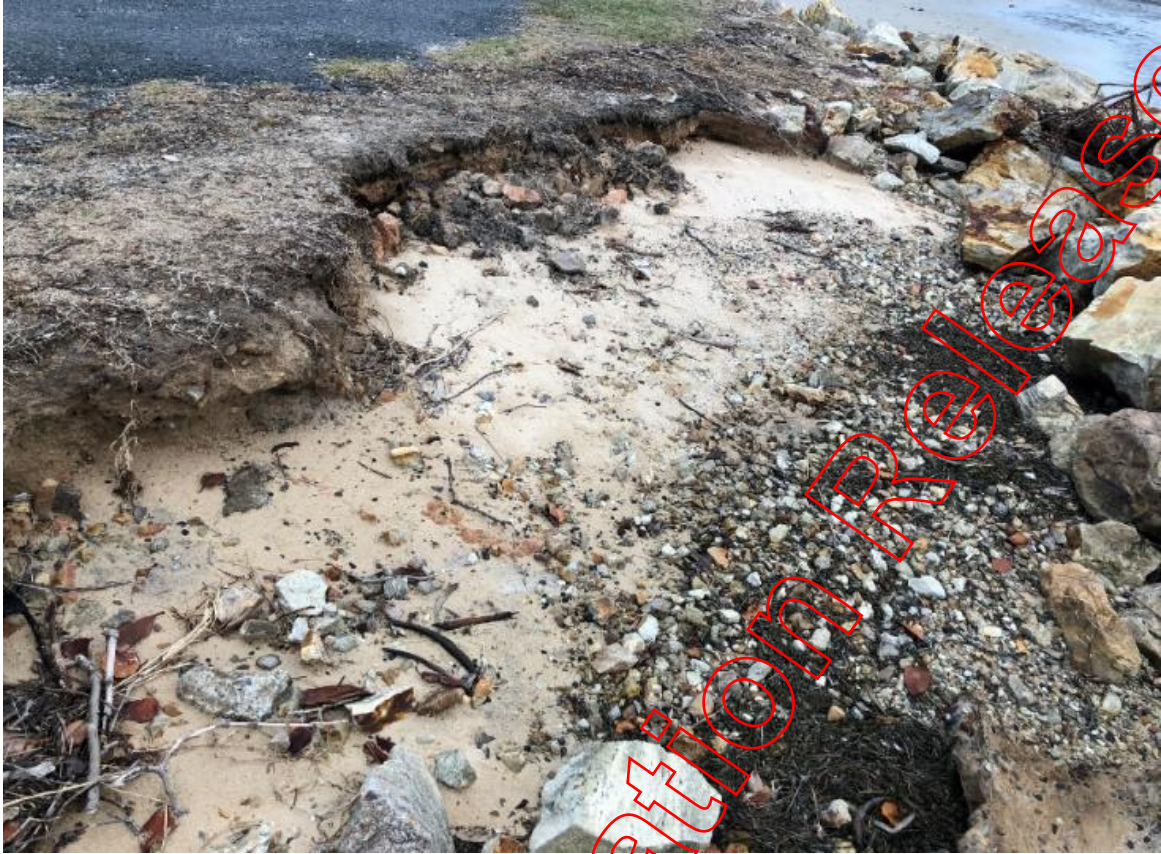
Figure 3-2 Crest of seawall condition

Around the bitumen seal, there is a dip in the pavement with an elevation drop from 1.7m AHD to 1.30m AHD, which then drops further to 1.15m AHD along the crest of the sea wall. This is visually displayed in Figure 3-2. Additional evidence of scour along the crest were noted and displayed in Appendix A.4.

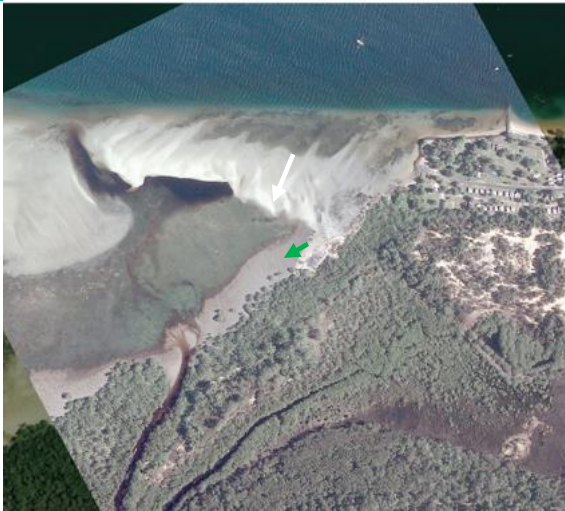
Figure 3-3 Selected aerial pictures

is built around 1975.	Rainbow Channel edge which is controlled by the groyne.

<p>16 July 2009 - the bar has split in several perpendicular to shore tidal bars. These small bars continue to move towards the shore (white arrow) and the estuary (green arrow). Sand accumulation at park beach is moving towards the Wallum Creek estuary.</p>	<p>27 October 2017 - the sandbar is fully welded into the shoreline and mangrove have died along the shore, buried by the sand. The erosion at the Park Beach is pronounced. A seagrass colony has established in front of the seawall. Mangrove died back along the shoreline.</p>

The migration of the Wanga Wallen begins after the construction of a southern groyne along the Amity Point coastline. This groyne was constructed to stabilise erosion along the western side of the caravan park area. The dominant sand longshore transport appears to move southward on the beach and the onshore deposition of the Wanga Wallen sandbar has resulted in mangrove die-back but also in the creation of a wide healthy beach.

Based on aerial photography, the volume of sand in the Wanga Wallen bar is estimated to be around 20,000m³, while the volume of beach loss at Park Beach is around 2,000m³ over the period 2009 to 2019 (i.e. 200m³ per year).

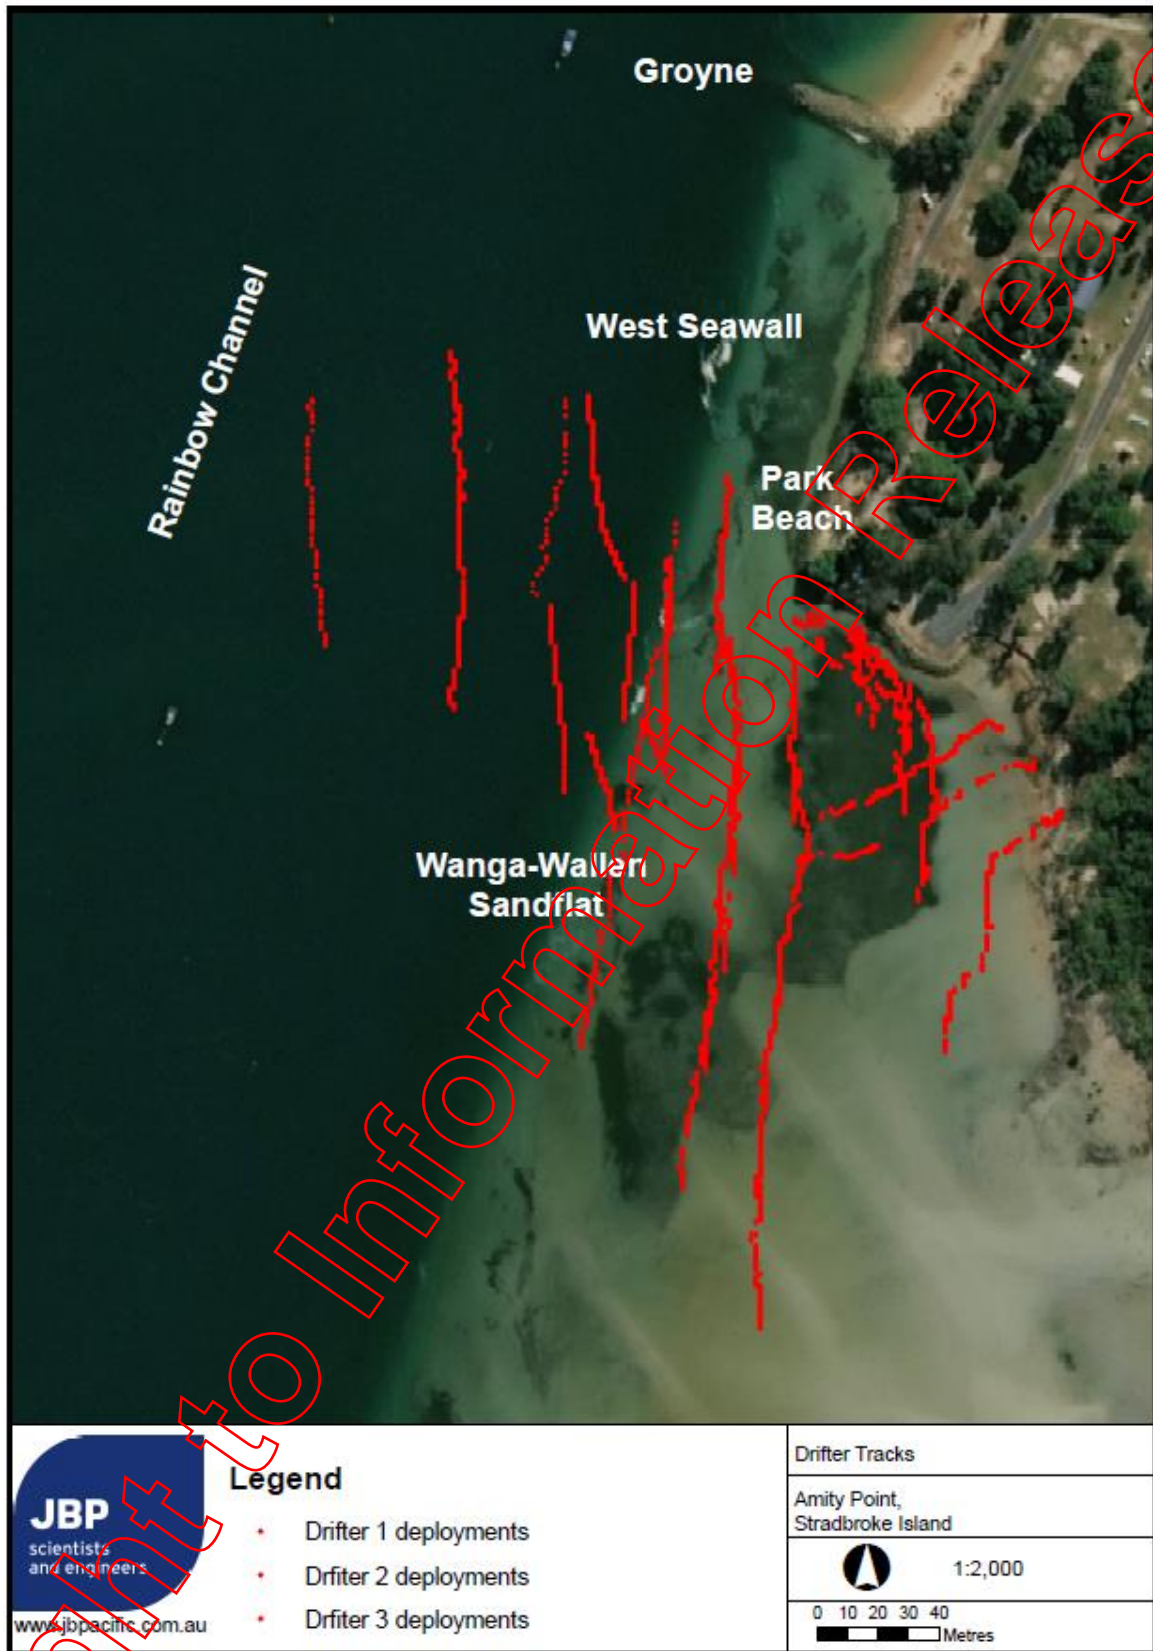
Figure 3-7 Tracks from deployment of drifters

New field data was collected to verify the modelled trends. To understand the nature of the currents in the vicinity of Park Beach, three drifters (A, B, C) were deployed simultaneously and repetitively (25 deployments) over a tide cycle. Figure 3-7 shows the stack of tracks obtained during the period of measurement, indicative of tidal flow patterns around Amity Point.

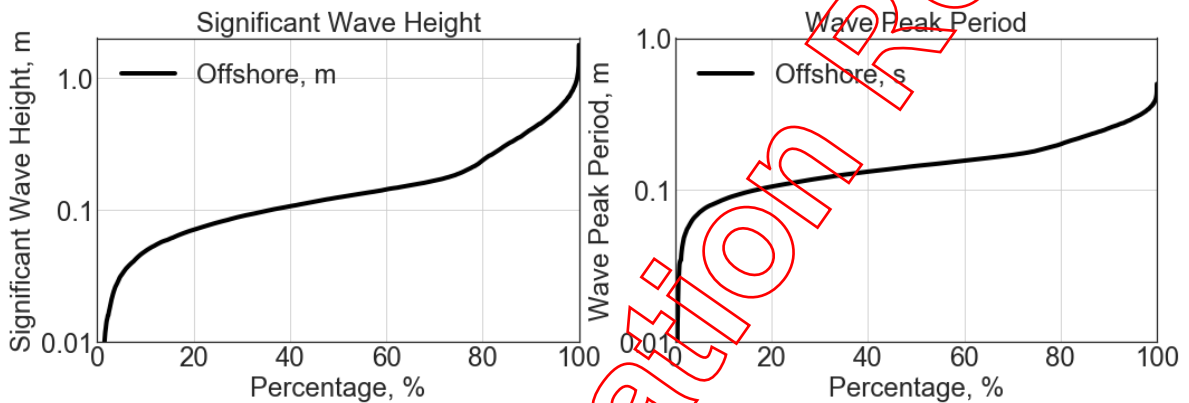
Figure 3-8 Wave parameters distribution at southern Amity Point

Hourly wave significant height and peak period, including tidal interactions and breaking processes, have been modelled for the period 1957 to 2019. The distribution of nearshore significant wave height and period near the toe of Park Beach is shown on Figure 3-8. The trends within the distribution indicate that the median wave height is approximately 0.15m, with occasional storm waves reaching 1.5m. These relatively small waves are due to the combined effect of nearshore tidal water level variations, the Moreton and Rainbow Channel offshore banks, and the relatively protected Moreton Bay.

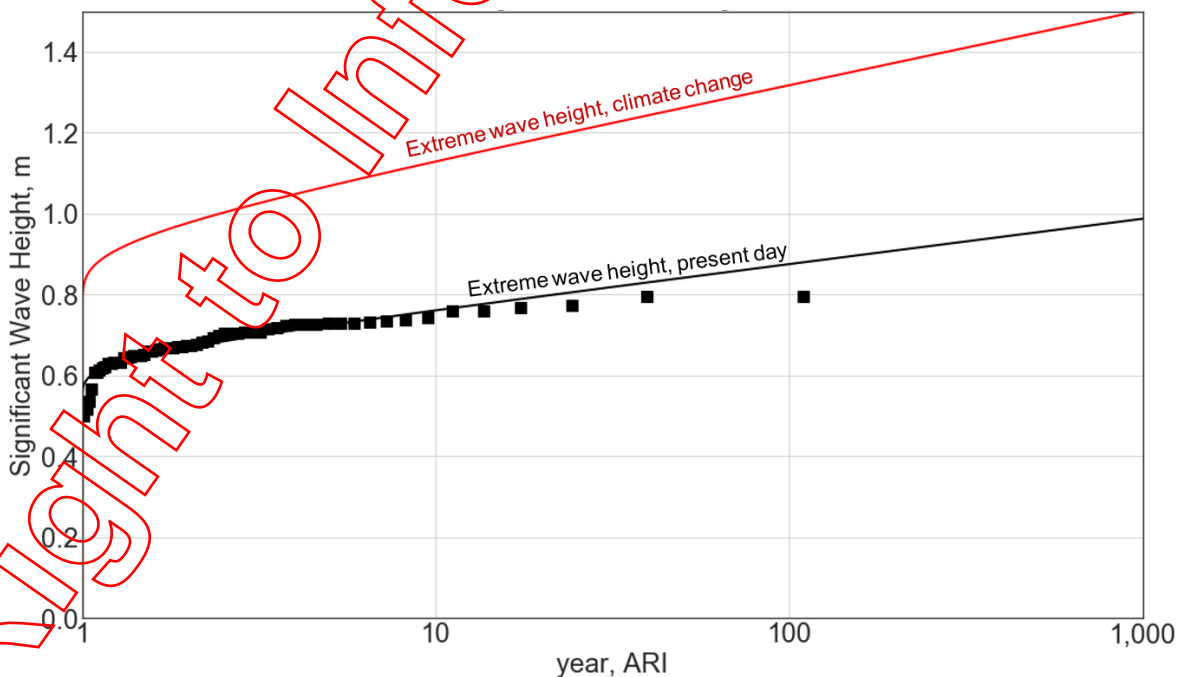
Figure 3-9 Significant wave height exceedance at Southern Amity Point

A further wave hindcast calculation was carried out including a 10% increase in wind speed to provide an estimate of design waves at a 2100 planning horizon. The distribution is presented on Figure 3-9 and summarised in Table 3-3. The findings are compatible with the 2013 Lawson and Treloar Storm Tide Study.

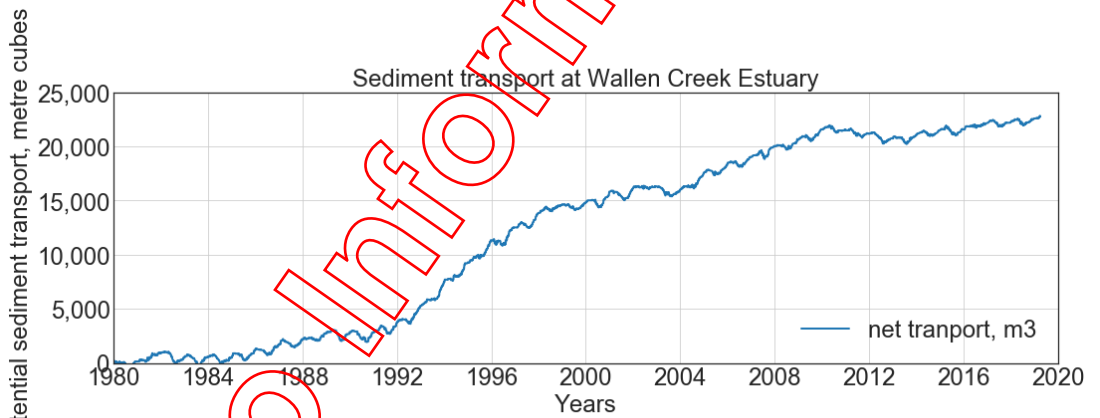
Figure 3-11 Longshore sediment transport in the intertidal area (positive going South)

The general movement on the sandflats, intertidal bars and upper beach is southward. This is opposite to the dominant flow direction in the Rainbow Channel, which runs northward under the dominant ebb tide current. Seasonal variations are observed in the LST direction; northward transport dominates during the summer period and southward the rest of the year. Averaged annual potential LST rates are relatively low, approximately 500m³ per year along the southern seawall and Park Beach, and 550m³ along the Wanga Wallen Beach.

Given these trends, without active management Park Beach will continue to erode landwards into the camping ground, until a morphodynamic equilibrium is found. Further erosion of Park Beach will also lead to a narrowing of the Wanga Wallen beach, due to the decreased 'downdrift' sand supply. Park Beach erosion will therefore increase the risk of a breach of the Wallum Creek estuary north of its current position, in closer vicinity of Park Beach because the dune height typically lower or near extreme storm tide levels and are not protected by seawalls, unlike the camping ground.

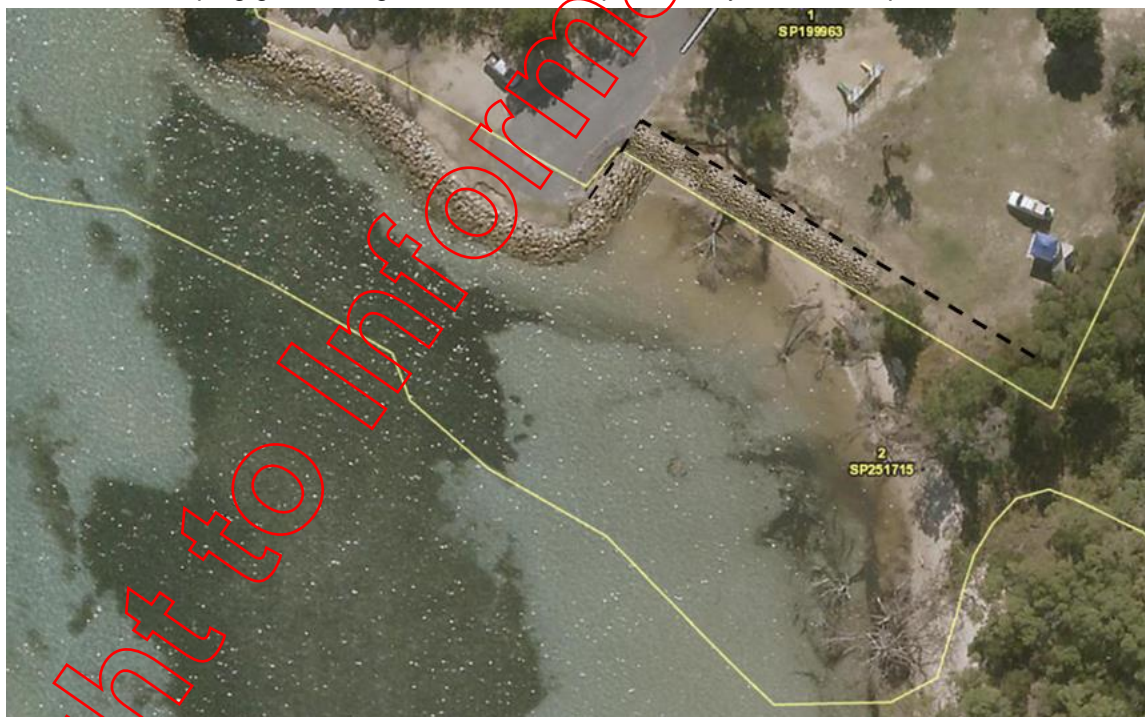
Figure 3-12 Option A - Park Beach Seawall

- **Option A - Seawall** - A seawall extension would reduce the erosion issue along the southern edge of the camping ground. This is likely to be the fastest and effective method to manage erosion in the near future. However, a seawall will not mitigate erosion along the Wanga Wallen Beach and is likely to require further extension around the camping ground. There is a risk for the seawall to trigger an early breakthrough of the Wallum Creek near the camping ground. Figure 3-12 shows a possible layout for this option.

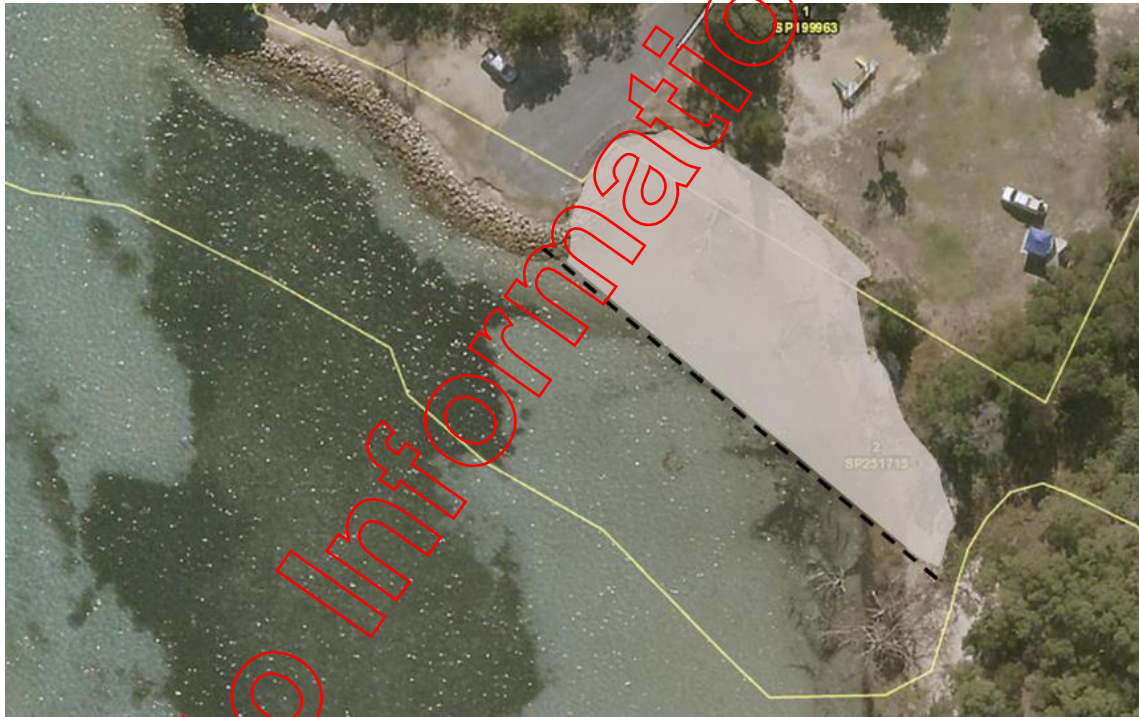
Figure 3-13 Option B: Park Beach Nourishment

- Instead, a smaller beach nourishment of around 2,000m³ is proposed. This would require an on-going investment but will remain economically viable for the short term (10 years) to medium term (40 years or more). Figure 3-13 shows a possible General Arrangement for Option B.

Based on the sand transport mechanisms observed and modelled in Section 3.2.10, a nourishment volume of sand of at least 2,000m³ at Park Beach could provide a 10-years buffer to counter sediment loss. The beach nourishment would consist of forming an artificial dune to nourish the Wanga Wallen Beach.

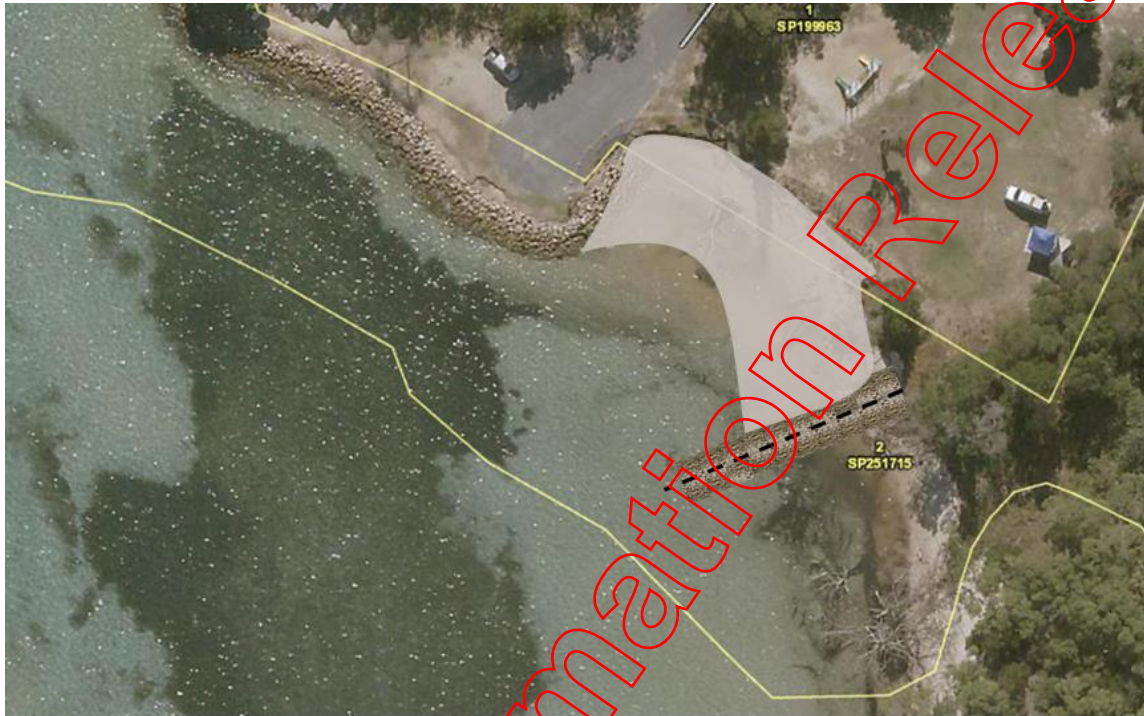
Figure 3-14 Option C: Park Beach Groyne

- **Option C - Groyne** - A groyne could be constructed at the downdrift side of Park Beach to interrupt the southward sediment transport, provide shelter from waves and thereby reduce erosion at Park Beach. However, this option will lead to further sand loss of Wanga Wallen Beach, as the groyne will exacerbate the downdrift longshore sediment transport deficit. The issue of land tenure is also significant since a Groyne would have to be built in the Marine Park to be functional. Figure 3-14 shows a possible General Arrangement for Option C.

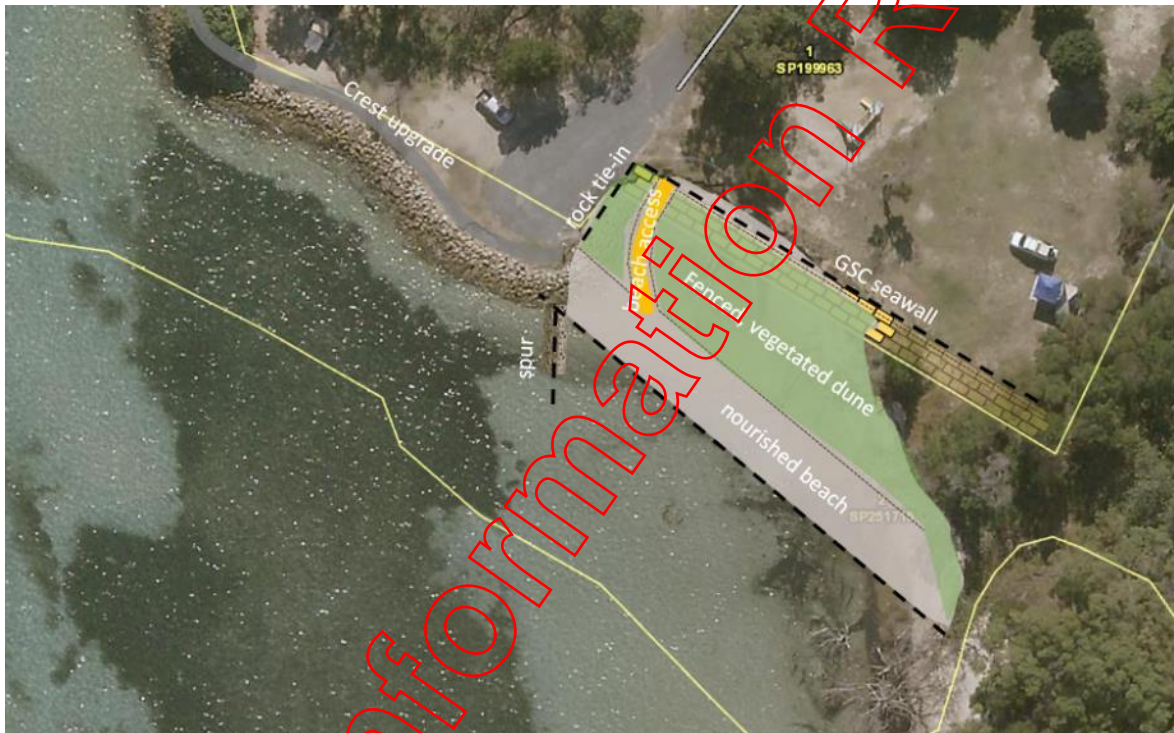
Figure 3-15 Proposed Park Beach coastal management plan

During nominal weather conditions, particularly during south easterlies wind conditions, the spur will maintain the position of the toe of the beach nourishment. This would be particularly notable during the summer months when northern LST dominates, which coincide with the camping ground peak season. The spur would also control the undertow currents along the seawall toe which tend to deflect sand westward. The spur will act as a rock oyster bed in the inter-tidal zone which will have some environmental value. This spur is also reminiscent of indigenous rock fish traps present around the island. This small spur is a measured response locally which may be subject to further evaluation if it is found to be detrimental to Wanga Wallen Beach stability it can be disconnected from shore.

Figure 3-15 shows a possible General Arrangement for the recommended coastal management scheme for Park Beach.

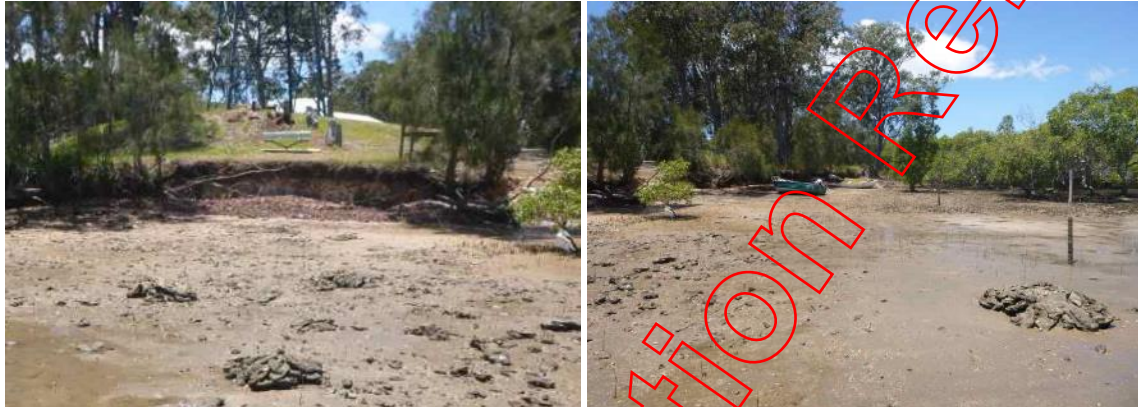
Figure 4-2 Rocky Point Foreshore (left) and Mangrove (right)

Aerial pictures show that the erosion has been progressing slowly at the site, at a rate around 0.1m per year over the last decade which are consecutive to local slip failures created by toe erosion.

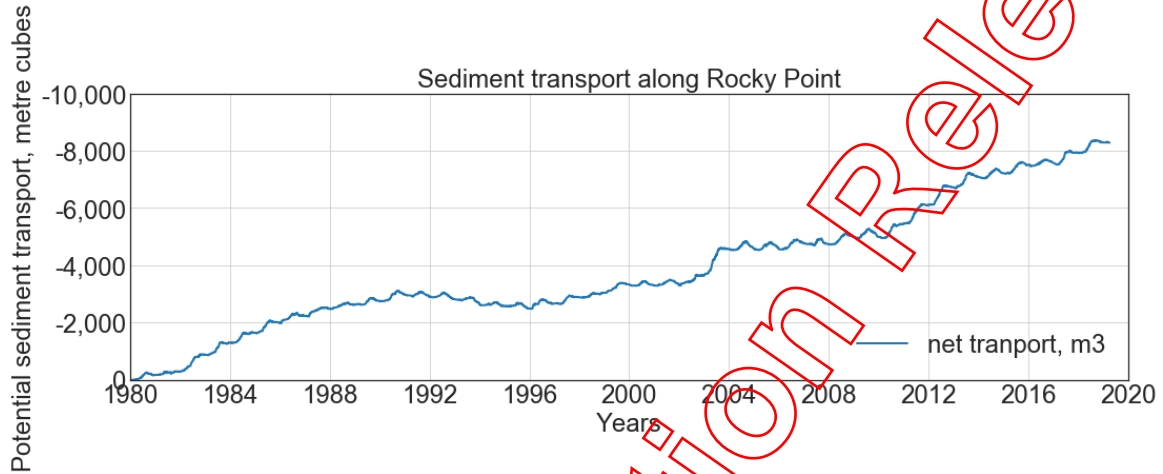
Figure 4-5 Potential sediment transport along Rocky Beach

Generally, the longshore transport is moving northward and is very small, in the order of 200m³ per year. Seasonal variations are observed in the LST direction, with northward transport dominant during summer, with slower sediment transport in the winter months.

There is no significant sandy beach along Rocky Point, therefore the sediment transport potential does not materialise into the movement of sand.

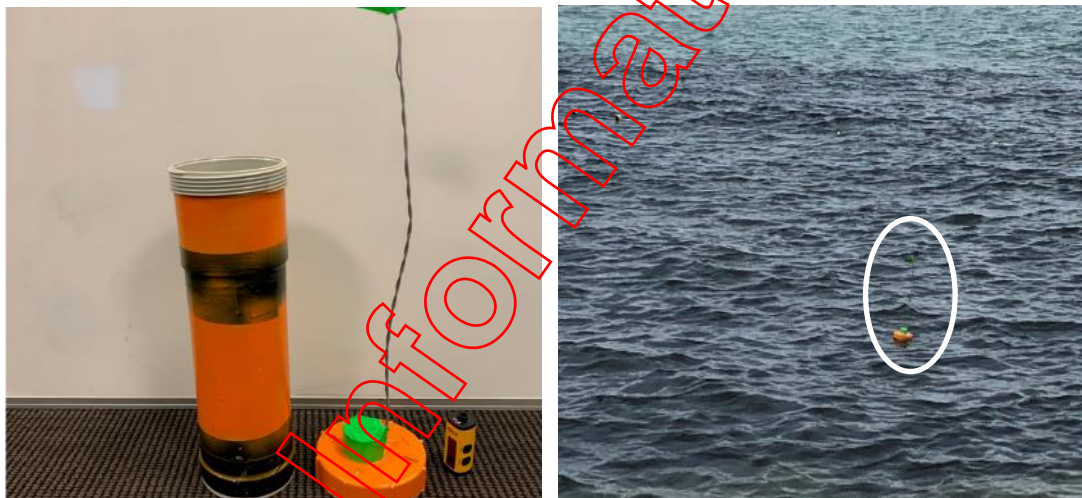
Figure A-1 Floating drifter and GPS unit

In order to keep the drifters in a managed boundary and stop them from floating away in Moreton Bay, a surveyor was at hand on a paddle board to keep track of the drifters. Another surveyor was observing on land for safety and to manage the deployment and re-deployed process within the observation basin.

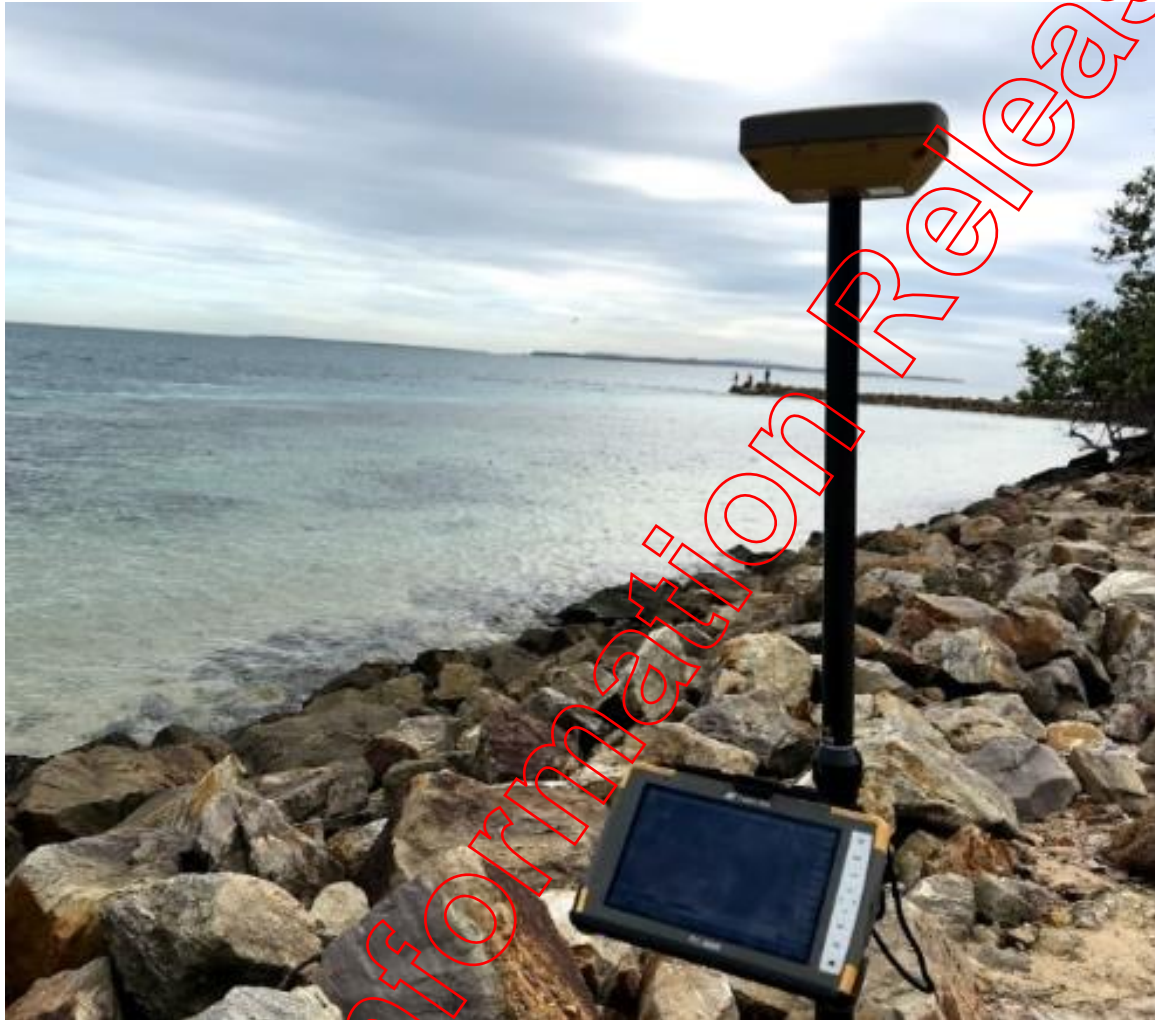
Figure A-5 GPS and GNSS Receiver in use

Surveyed data was analysed to assess the topography of the sea wall (crest and toe) and surrounding area, including the area of erosion at top of bank around the car park of Amity Point Camping Ground, and to derive an indicative tidal plane for the survey area, assessing the topography of the high tide line, the lower tide line and the vegetation line.

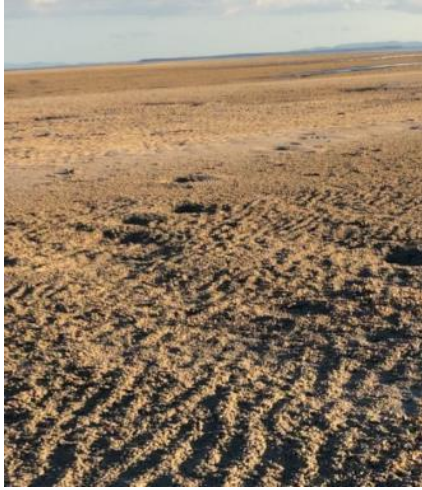
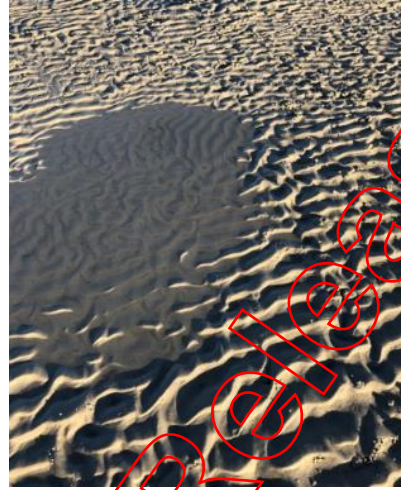
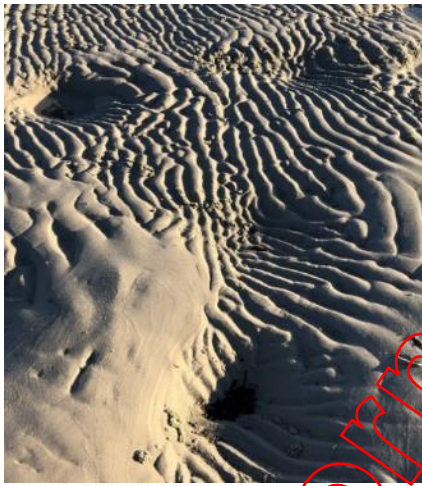
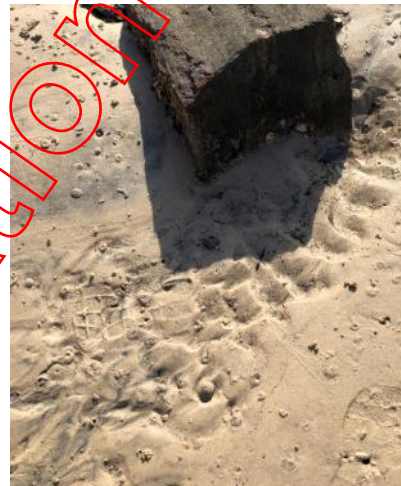
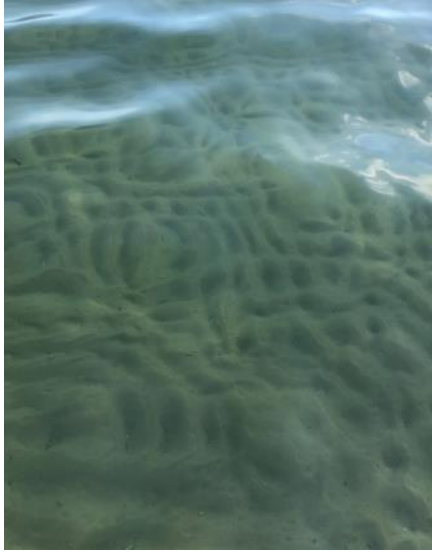
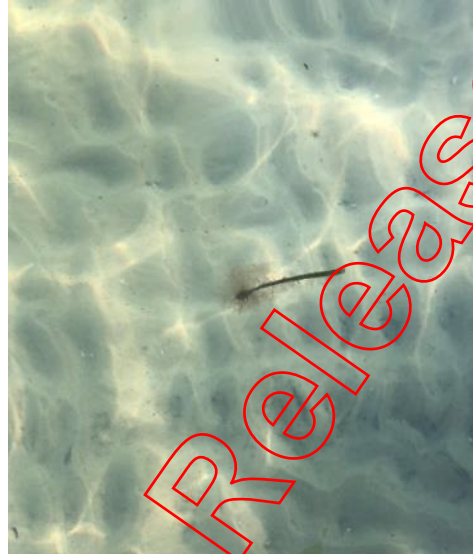
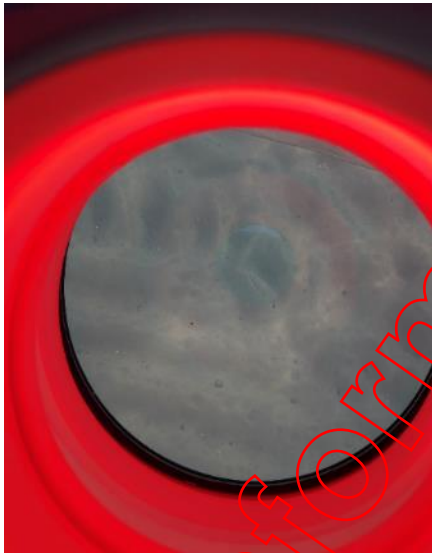
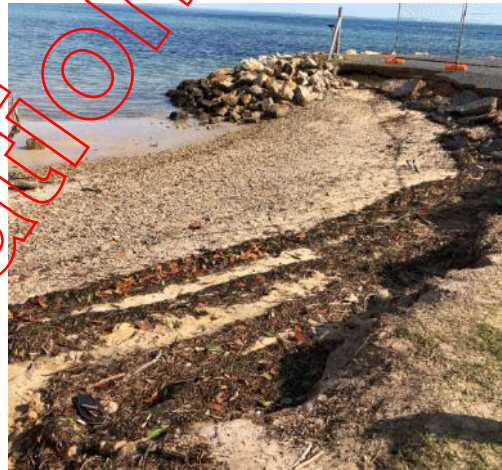
Figure A-7 Photographs of seabed at low tide

(a) Sinuous ripples

(b) Sinuous ripples

(c) Ripple and tidal dip

(d) Ripples concentrated around eddies behind rock (along seawall)

(e) Criss-cross ripple formation

(f) Criss-cross ripple formation

(g) Ripples

(h) Sea grass illustrating high tide lines and shell/rock fragments from sea wall and road base erosion

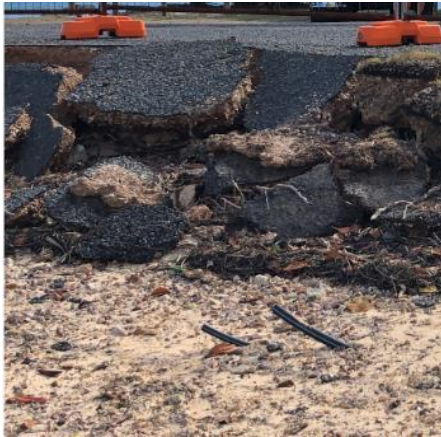
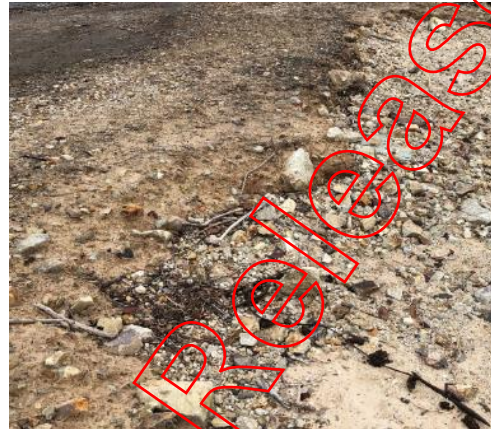
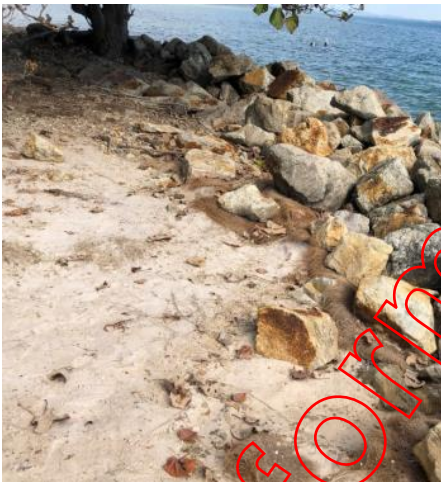
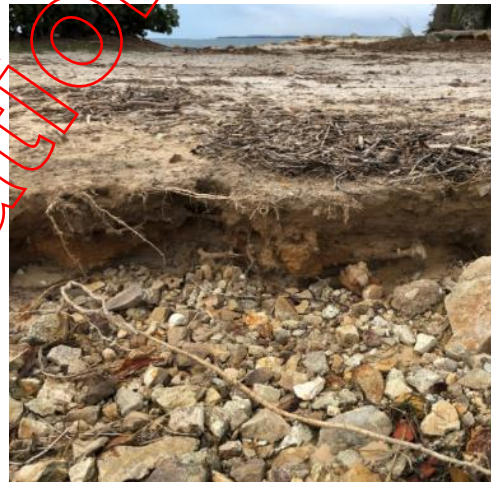
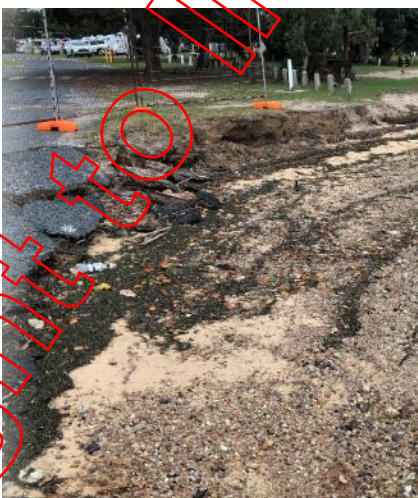
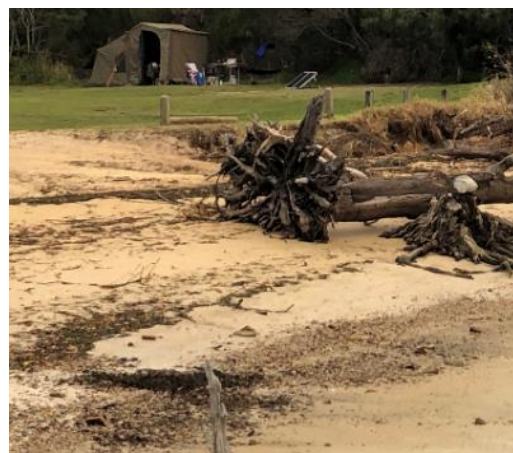
Figure A-8 Images of sea wall condition and evidence of scour in surrounding area

(a) bitumen erosion from tide

(b) Pavement sub-base erosion

(c) sea wall crest

(d) Erosion of sub-base

(e) Bitumen seal cracking along the beach

(f) Park Beach (gravel from road base on the beach)

The crest of the existing seawall should be repaired to meet the State minimum design standard and to reduce on-going maintenance. The crest detail shall include drainage outlets to allow for the camping ground to continue to drain storm water seaward. These formal drainage outlets will be vulnerable to overtopping and therefore need to be reinforced.

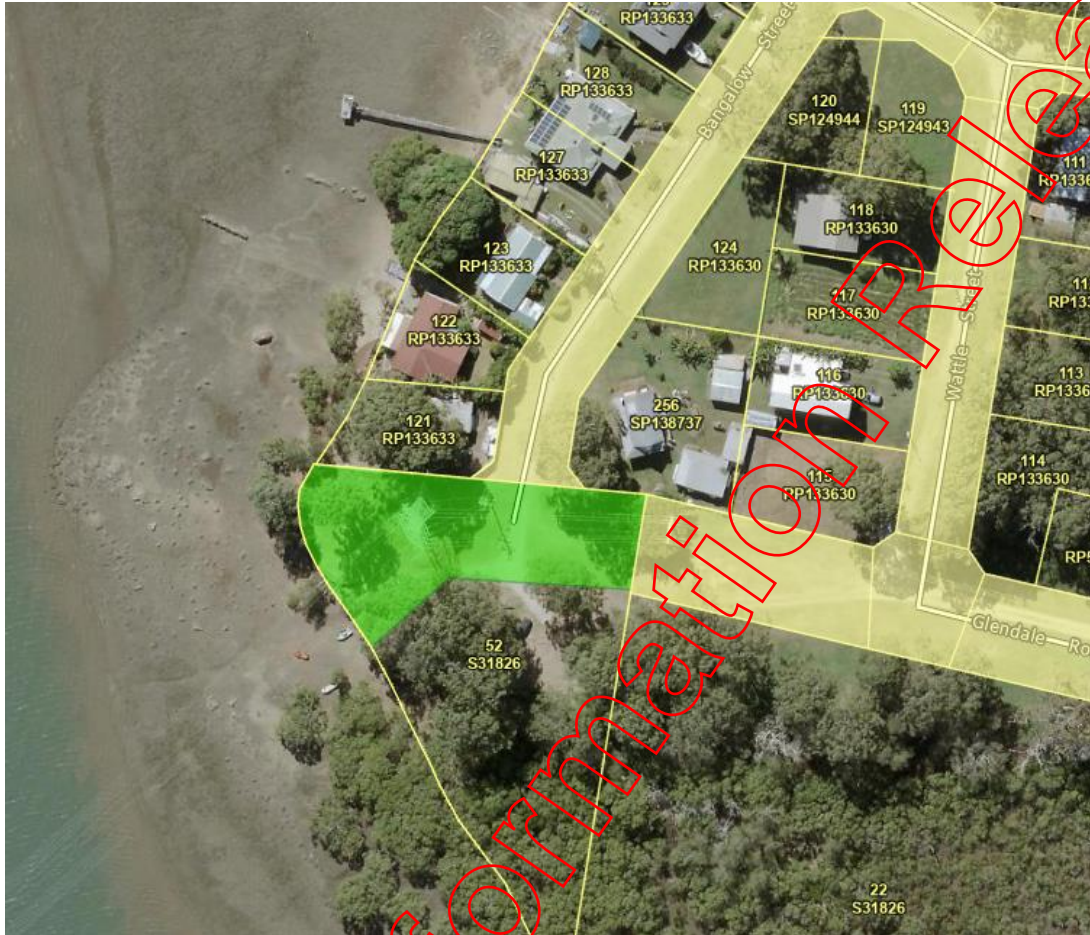
Figure 1: Proposed works location

The site works are located within the Redland City Council Government Area in Queensland. The works are partially within Lot 52 on S31826 and partially in Moreton Bay adjacent to Lot 52. The lot is located on Russell Island.
