Redland Smart Signs and Smart Messages: A Driver Change Behaviour Project – Year 1 Report 2018-2019

Report prepared for Redland City Council

March 2019

Report published by Griffith University's Applied Road Ecology Group

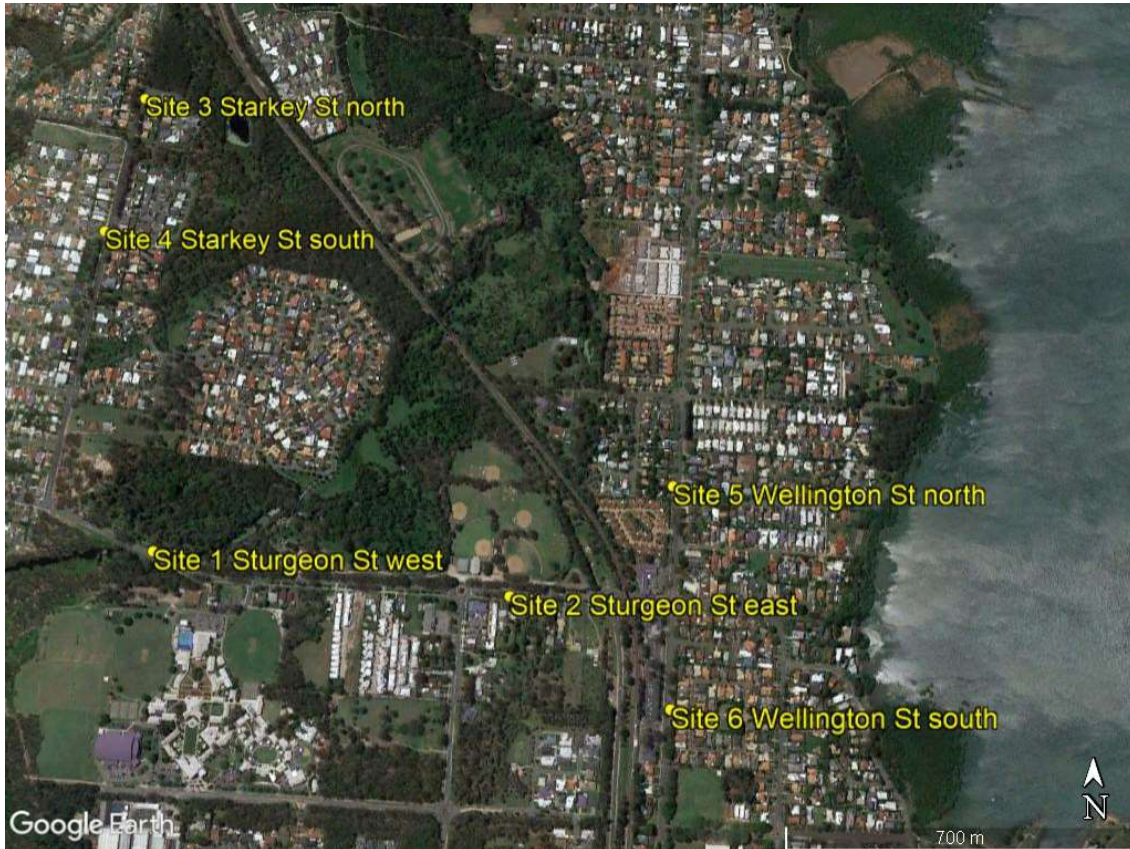
Figure 1. The locations of the sites where signs were erected during the study in Ormiston. GPS Visualizer was used to create this map in Google Earth.

- Site 1: Sturgeon Street west
 - West of Hilliards Creek crossing
 - Displaying to eastbound traffic
 - 60 km/h speed limit
- Site 2: Sturgeon Street east
 - Near house #60
 - Displaying to westbound traffic
 - 60 km/h speed limit
- Site 3: Starkey Street north
 - Near corner of Anhs Place
 - Displaying to southbound traffic
 - 60 km/h speed limit
- Site 4: Starkey Street south
 - Near corner of Gilchrist Street
 - Displaying to northbound traffic
 - 60 km/h speed limit
- Site 5: Wellington Street north
 - Near houses #134 and #136
 - Displaying to northbound traffic
 - 50 km/h speed limit
- Site 6: Wellington Street south
 - Near entrance to Ormiston Springs Estate
 - Displaying to southbound traffic
 - 50 km/h speed limit

It should be noted that site 2 was originally located near #92 Sturgeon Street. The location of this site was moved early in the project due to insufficient sunlight for the solar panels to charge the sign batteries. Figure 1 shows the location of the signs in Ormiston.

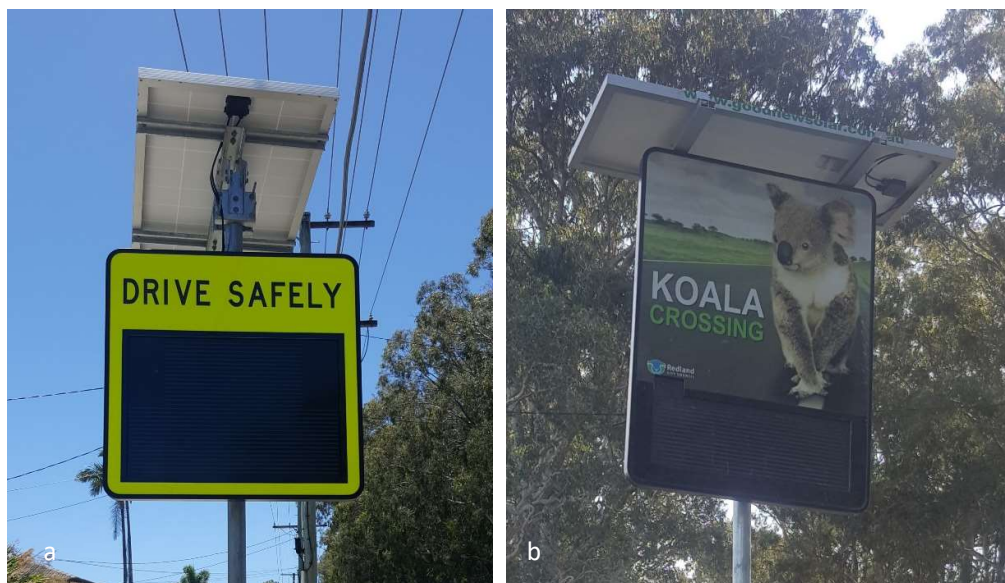
Figure 2. The signs used in the sign trial. a) a smiley sign, Sierzega Speedpacer 4568 C, and b) a koala sign, Sierzega Speedpacer 2368 FC.

- Two Sierzega Speedpacer 4568 C signs with standard fluorescent yellow panels with the wording 'DRIVE SAFELY' (Figure 2b). These signs will be referred to as the smiley signs.
 - Connectivity to these signs was via remote connectivity and/or Bluetooth and all data was stored on the signs, as well as on a server.
 - These signs came with solar panels to be mounted and connected upon installation.
 - Sign IDs 14361 and 14370.
- Two Sierzega Speedpacer 2368 FC signs with custom panels displaying a photo of a koala walking along on a road with the wording 'KOALA CROSSING' (Figure 2a). These signs will be referred to as the koala signs.
 - Connectivity to these signs was via Bluetooth only and all data was stored on the signs.
 - Solar panels were custom fitted and connected to these signs for this trial.
 - Sign IDs 4244 and 4245.

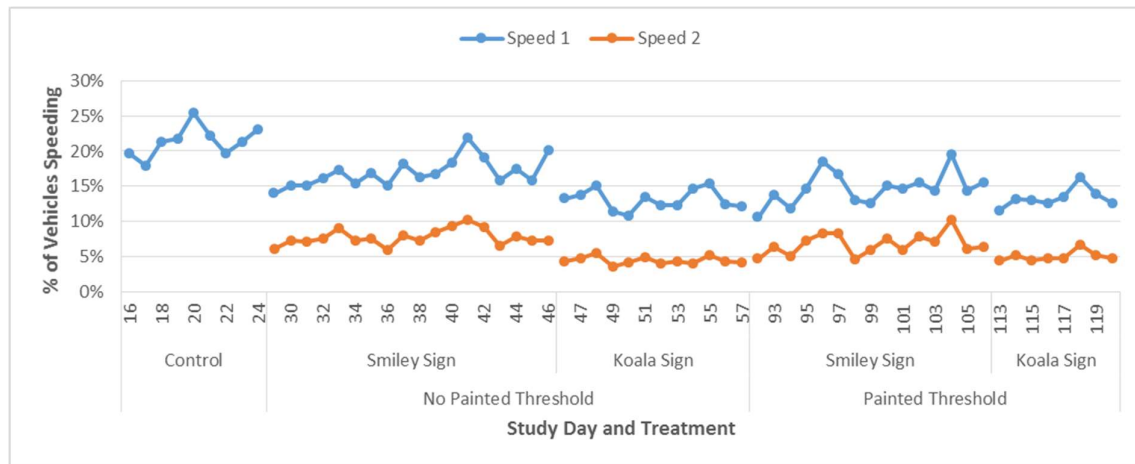
Figure 10. The daily percentages of vehicles speeding for speed 1 and speed 2 during each of the study treatment periods at site 4 Starkey Street south. Study days are consecutive within each treatment period, however, the x-axis is ordered by treatment period for consistency and readability.

The daily percentages of speeding vehicles recorded for each study treatment at site 4 are shown in Figure 10. All treatments show a daily variance in the percentage of speeding vehicles and both speed 1 and speed 2 show similar patterns of variance.

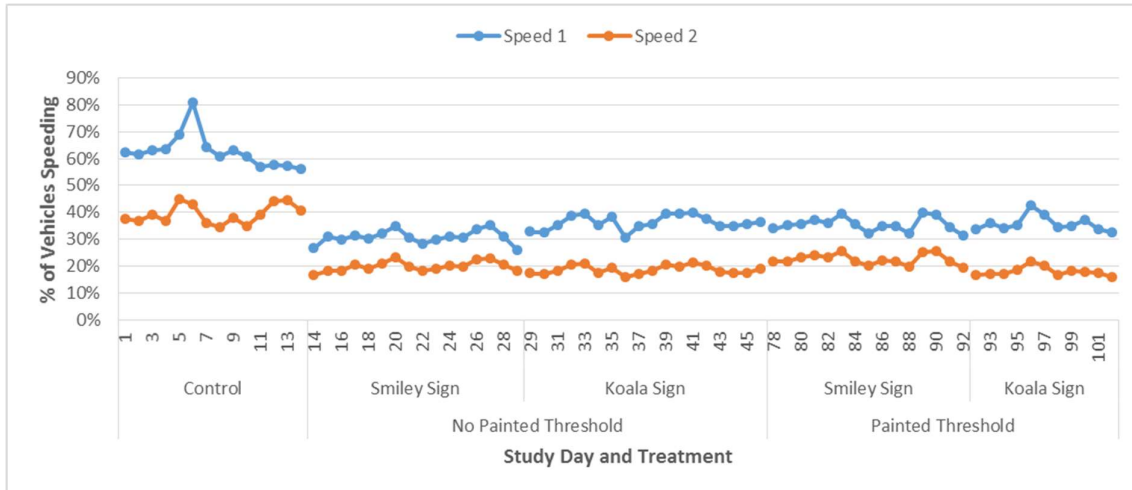
Figure 12. The daily percentages of vehicles speeding for speed 1 and speed 2 during each of the study treatment periods at site 5 Wellington Street north. Study days are consecutive within each treatment period, however, the x-axis is ordered by treatment period for consistency and readability.

The daily percentages of speeding vehicles recorded for each treatment and both signs at site 5 are shown in Figure 12. All treatments show a daily variance in the percentage of speeding vehicles and both speed 1 and speed 2 show similar patterns of variance. The control treatment recorded the greatest range in daily variance for both speed 1 and speed 2.
