**Redland Smart Signs and Smart Messages:  
A Driver Behaviour Change Project – Year 5  
Final Report (2022-2-23)**

**Report prepared for Redland City Council**

**July 2023**

**Report published by Griffith University's Applied Road  
Ecology Group.**

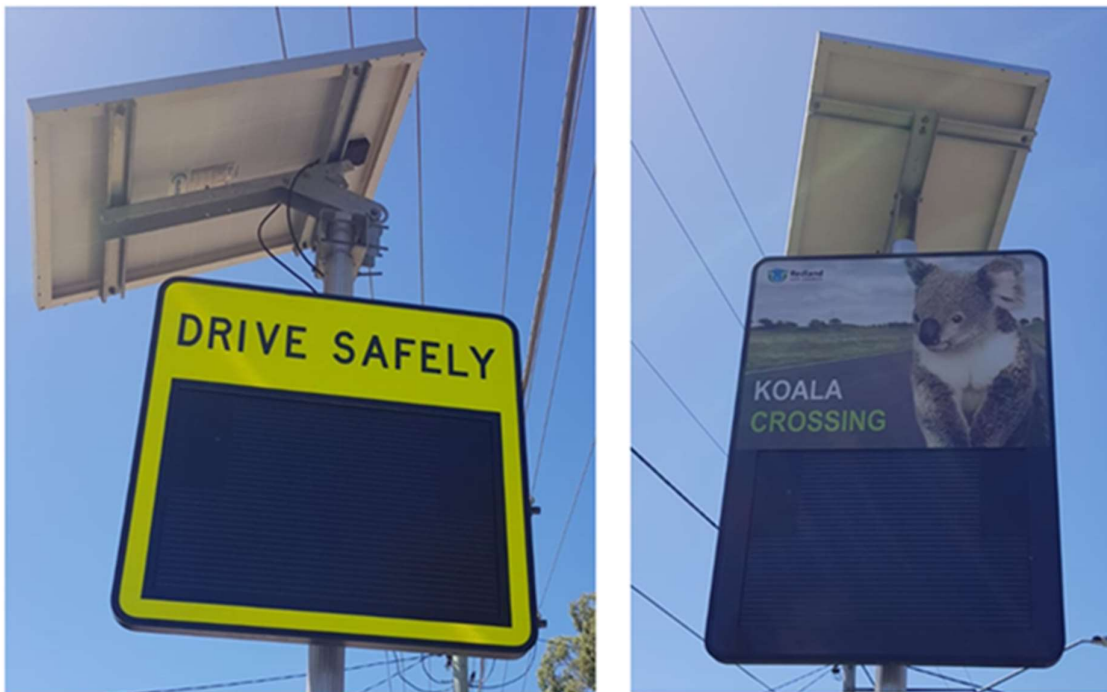
Figure 1 shows each version of the Jenoptik signs side-by-side for comparison.

**Figure 1.** Sierzega brand models of dynamic (variable) message signage, named for this project as Jenoptik 'generic smiley' (left) and 'koala smiley' (right).

The Jenoptik signs were capable of recording the speed of a vehicle both before and as it passed the sign, allowing for a direct comparison of these speeds. These signs recorded vehicles individually, such that one row of the data output pertained to one vehicle, including a time/date stamp accurate down to the second. Since 2020, only Jenoptik 'koala smiley' signs have been purchased and deployed in the Redlands, because they were the most consistent and reliable in terms of performance.

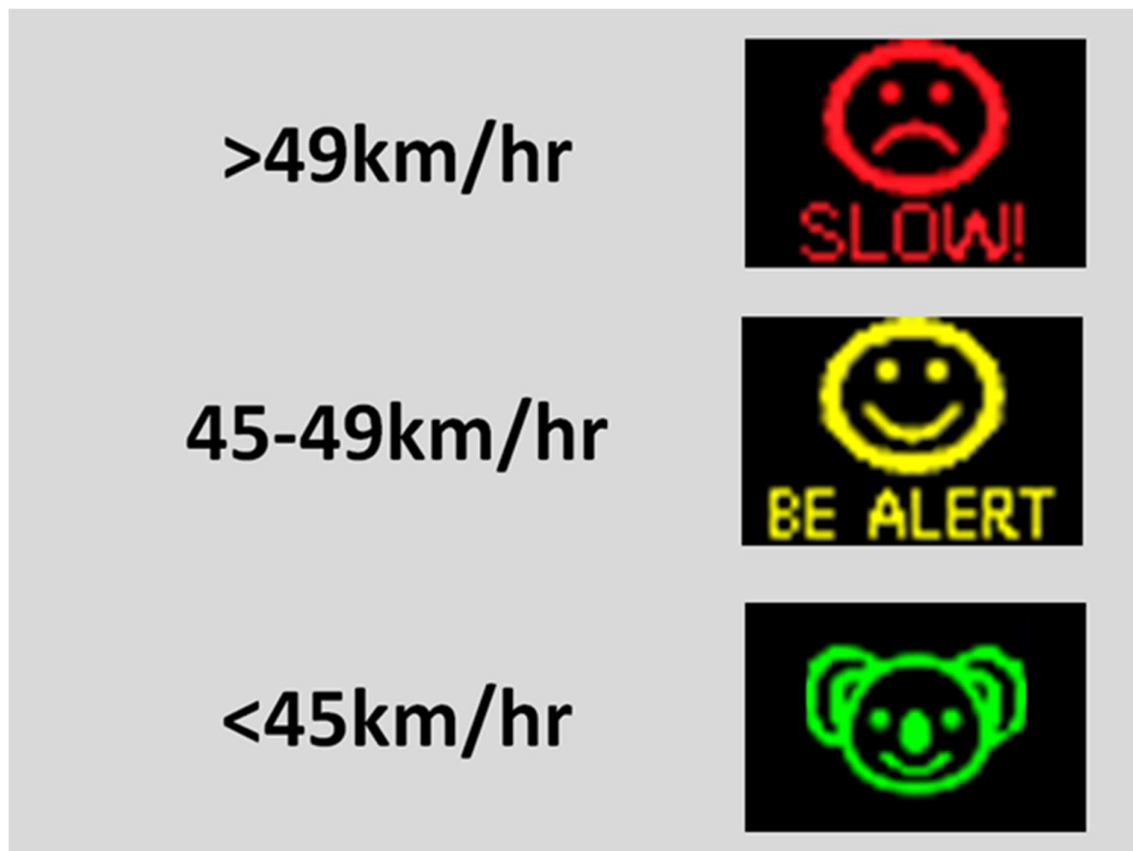
Both types of Jenoptik sign types ('generic smiley' and 'koala smiley') were capable of dynamically changing (often referred to as 'variable') messaging conveyed to drivers depending on their speed. Figure 2 provides an example of the different messages drivers received at different speeds. Note that at the lowest speed threshold, drivers receive a digital koala smiley message.

**Figure 2.** An example of the dynamic, variable sign messaging that greeted drivers given certain measured vehicle speed thresholds, capable with the Jenoptik models. In this example, messaging was tailored to a 50 km/hr posted speed limit zone. For a 60 km/hr posted speed limit zone, each threshold was increased by 10 km/hr. The green koala symbol

In 2022, a new 'mixed' message was trialled on OCRE signs in an effort to expand the utility of signs. Instead of being greeted with the usual messages shown in Figure 2, drivers instead were greeted with images of bicycles (i.e. meant to prompt added awareness of cyclists in the area). Depending on the speed they were travelling, drivers would either receive a green bicycle for driving at least 5 km or more below the posted speed limit), an yellow or amber bicycle for driving 5 km/hr less than or equal to the posted speed limit or else a red bicycle warning them they were driving over the speed limit. These images were displayed between the hours of 5 am to 7 pm each day. Outside of these hours, the sign reverted to the standard koala/smiley face images shown in Figure 2.

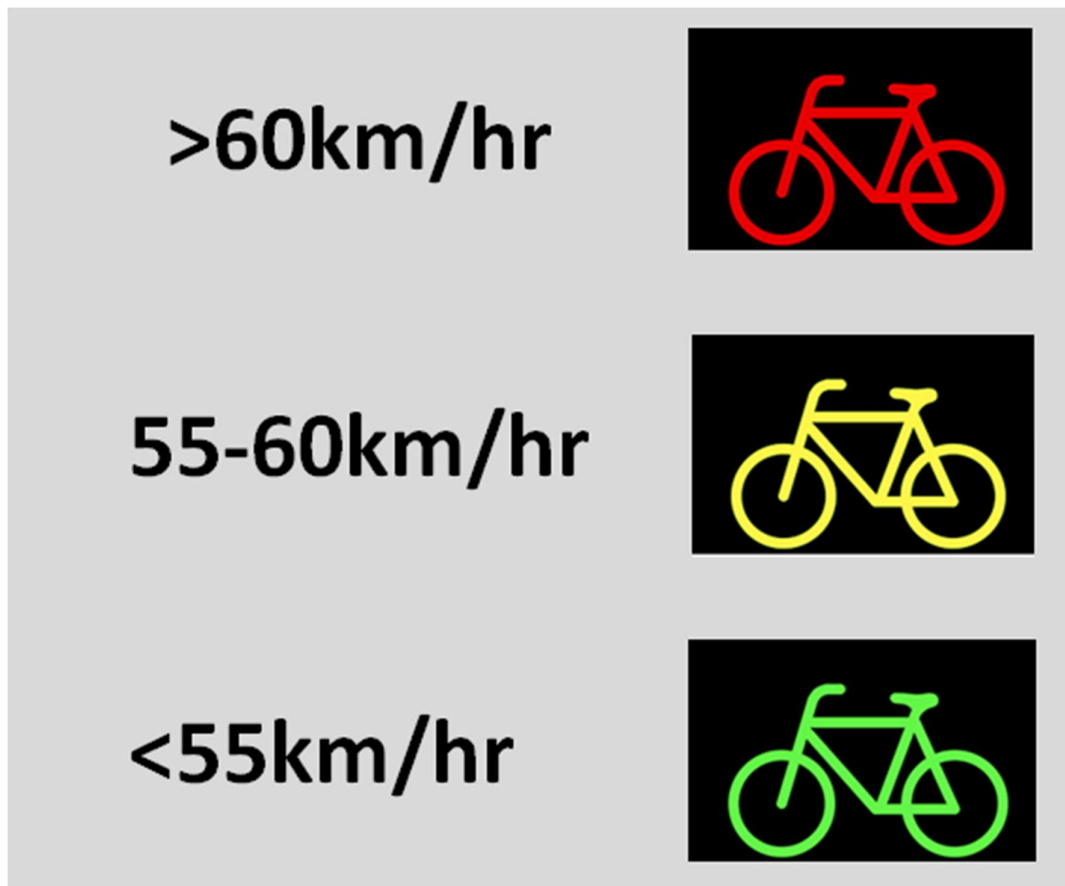
**Figure 3.** Bicycle-style messaging trialled at OCRE during most of February 2023, showing the various speed thresholds and associated images that a driver would see as they pass by.

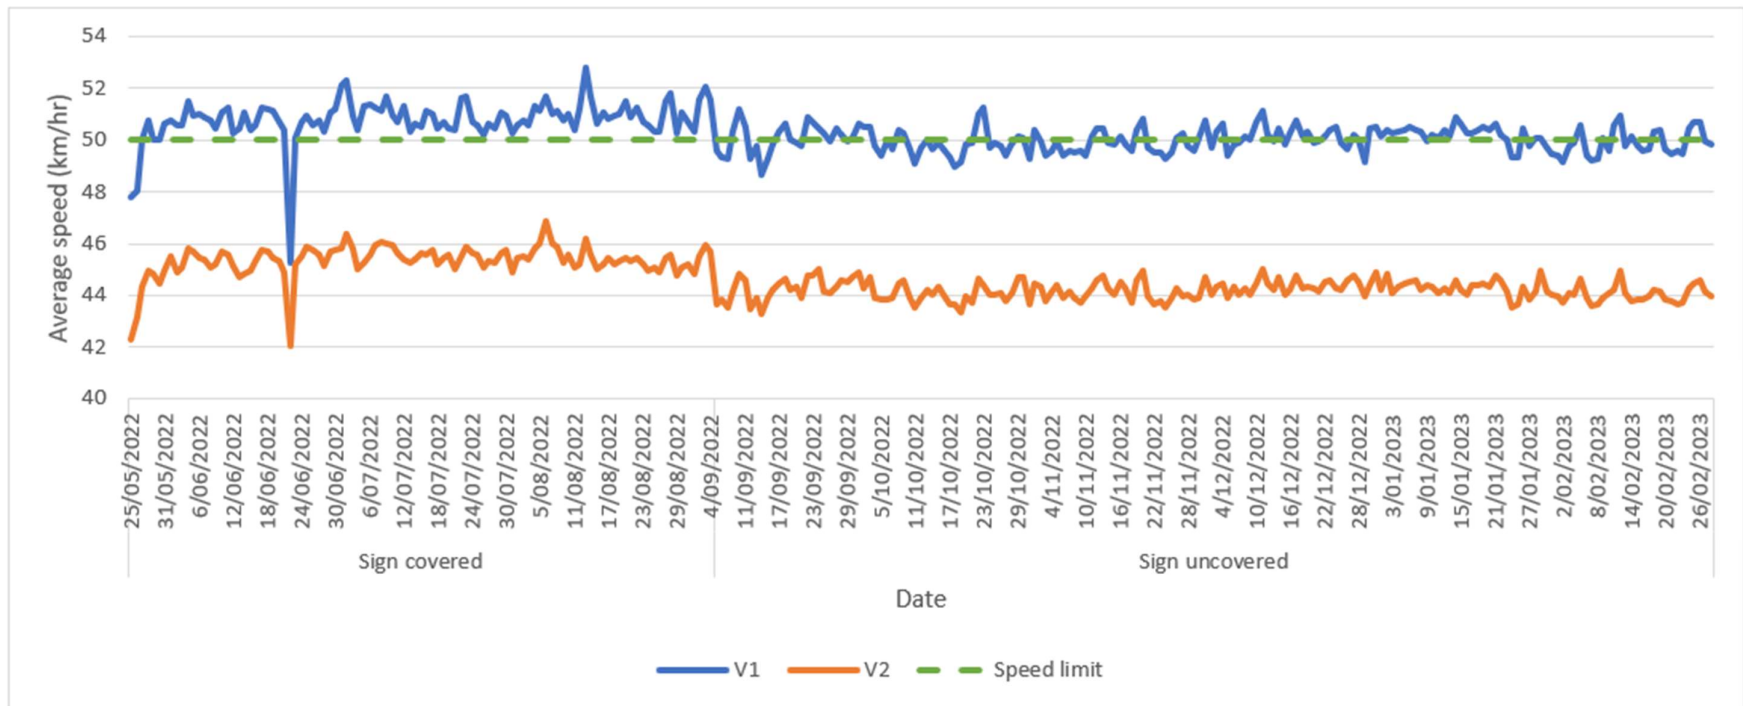
**Figure 16.** South Street west daily average vehicle speeds during the pre-treatment period when Jenoptik ‘koala smiley’ sign 27633 was present but covered, and during the treatment period when the sign was uncovered. Note the pre-treatment plot shows two separate lines for V1 and V2 speeds, possibly due to vehicles slowing in response to pre-existing road infrastructure or conditions, or to the presence of the covered sign. Changes in vehicle speeds between the pre-treatment and treatment periods were therefore calculated using the V2 speeds from each period.

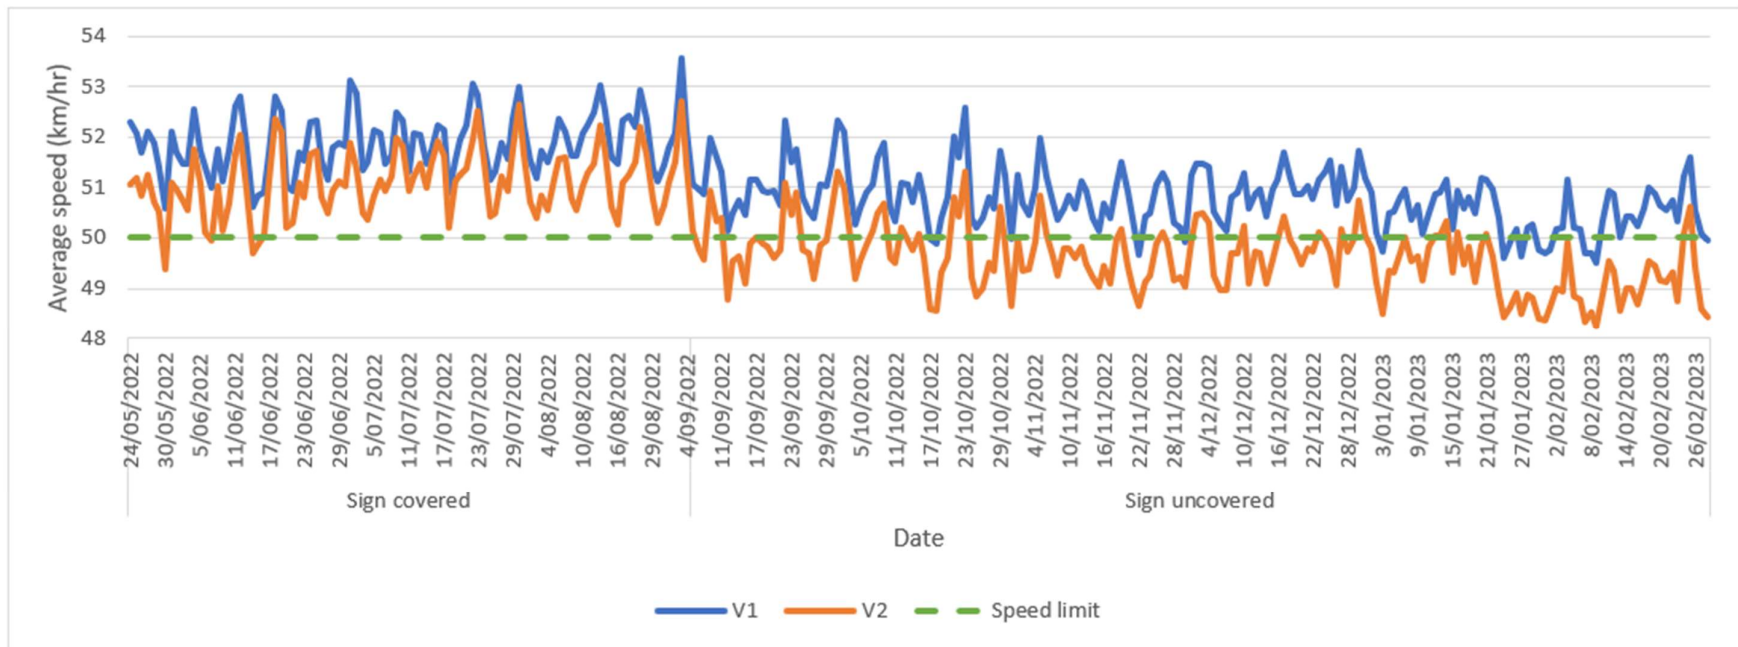
**Figure 17.** Wellington Street north\_2 daily average vehicle speeds during the pre-treatment period when Jenoptik 'koala smiley' sign 26981 was present but covered, and during the treatment period when the sign was uncovered. Note the pre-treatment plot shows two separate lines for V1 and V2 speeds, possibly due to vehicles slowing in response to pre-existing road infrastructure or conditions, or to the presence of the covered sign. Changes in vehicle speeds between the pre-treatment and treatment periods were therefore calculated using the V2 speeds from each period.

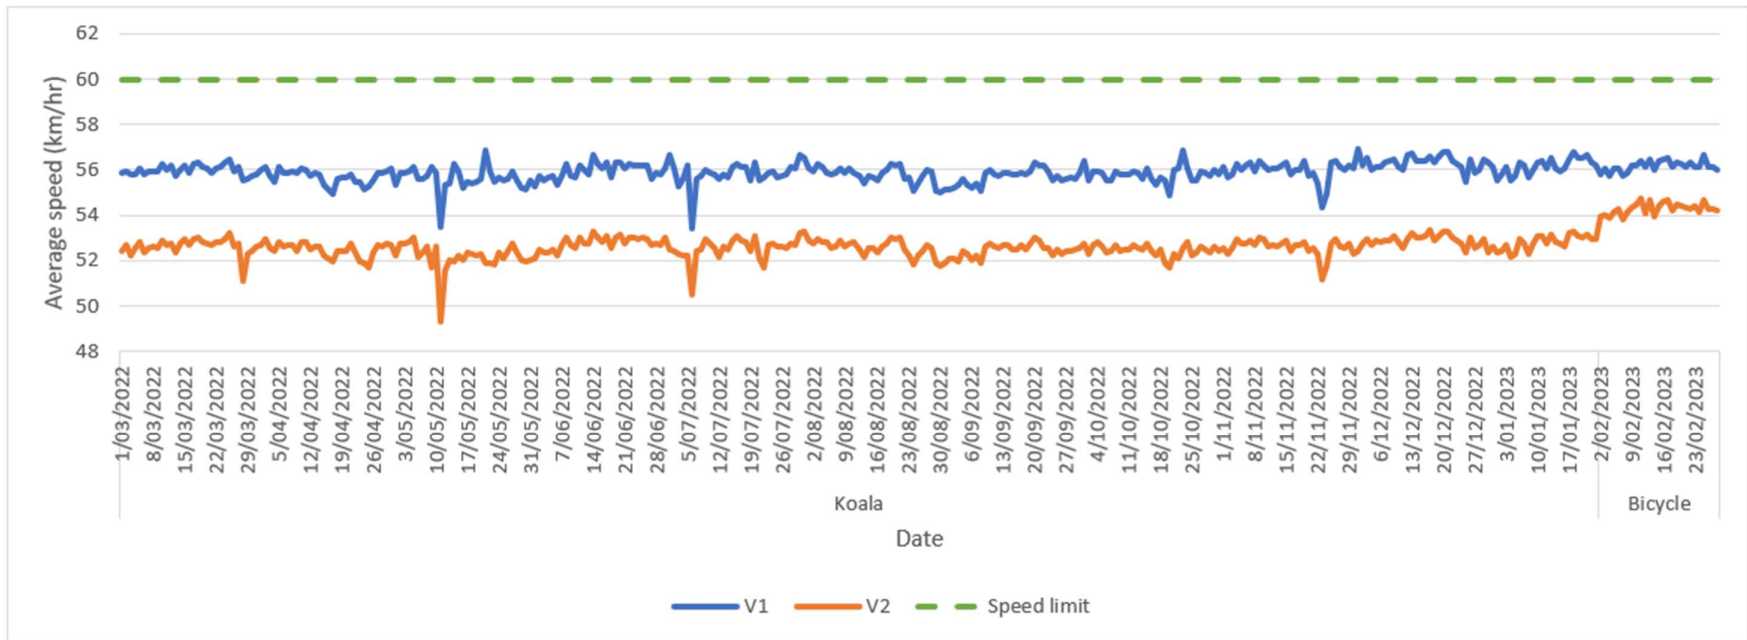
**Figure 19.** Old Cleveland Road East east average daily vehicle speeds during the 2022/23 treatment period ('Koala') when Jenoptik 'generic smiley' sign 14370 was present and uncovered (1/03/2022-23/01/2023), and during the 'bicycle messaging' treatment period ('Bicycle') when the sign was uncovered but changed to display the bicycle images shown in Figure 3 (from 5AM-6:59 PM), rather than the koala/smiley faces shown in Figure 2 (2-28/02/2023). Changes in vehicle speeds between the two treatment periods were calculated using the V2 speeds from each period.

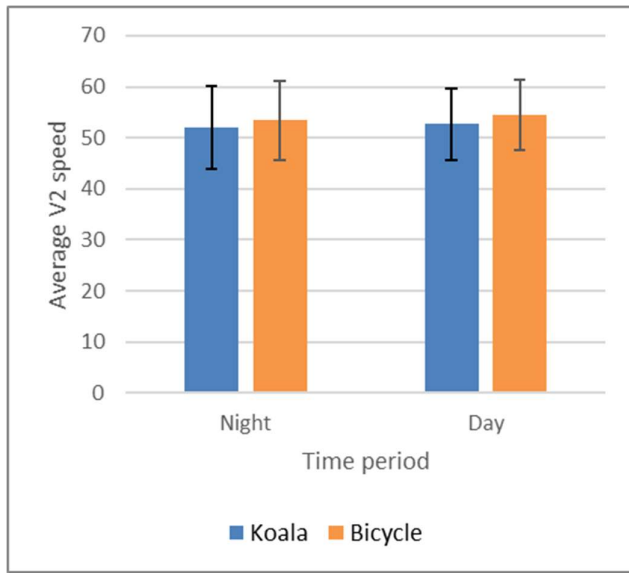
Figures 20 and 21 show a visual representation of the difference in average speeds between the two messaging treatment periods ('Koala' and 'Bicycle'), again broken up into 'Day' and 'Night' groupings. Regardless of whether it was night or day time, the koala/smiley messaging resulted in slower average speeds, albeit only modestly, compared to the bicycle-specific messaging time periods. Note that this was true for night time speed comparisons when bicycle messaging was never displayed (i.e. there was no difference in messaging being compared, regardless of treatment period). Despite this, there was a modest difference in average night time speed most clearly demonstrated for OCRE east at night during the bicycle treatment, and much less so for OCRE west during the same treatment. The point of comparison that arguably matters most however, was between daytime averages across treatment periods, when bicycle-specific messaging was displayed during the bicycle treatment period. Here, as was suggested in Table 7, the differences are notable (increases in average speeds of 1.74km/hr and 2.16km/hr during the bicycle-specific messaging compared to koala/smiley messaging). The smallest difference was for the OCRE west sign at night time (when the signs were displaying koala/smiley messaging across both treatment periods). Average speeds for bicycle-specific messaging periods were still below the posted speed limit of OCRE (60km/hr).

**Figure 20.** Comparison of average V2 vehicle speeds for Jenoptik 'generic smiley' sign (14370) on Old Cleveland Rd East east, between night time ('Night': 7pm - 5am) and day time ('Day': 5am - 7pm) periods for both the 2022/23 treatment period ('Koala') when koala/smiley faces were exclusively shown on the signs, and the 2023 bicycle messaging period ('Bicycle') when images of bicycles were shown on the signs between the hours of 5am and 7pm (reverting to koala/smiley faces during the night).

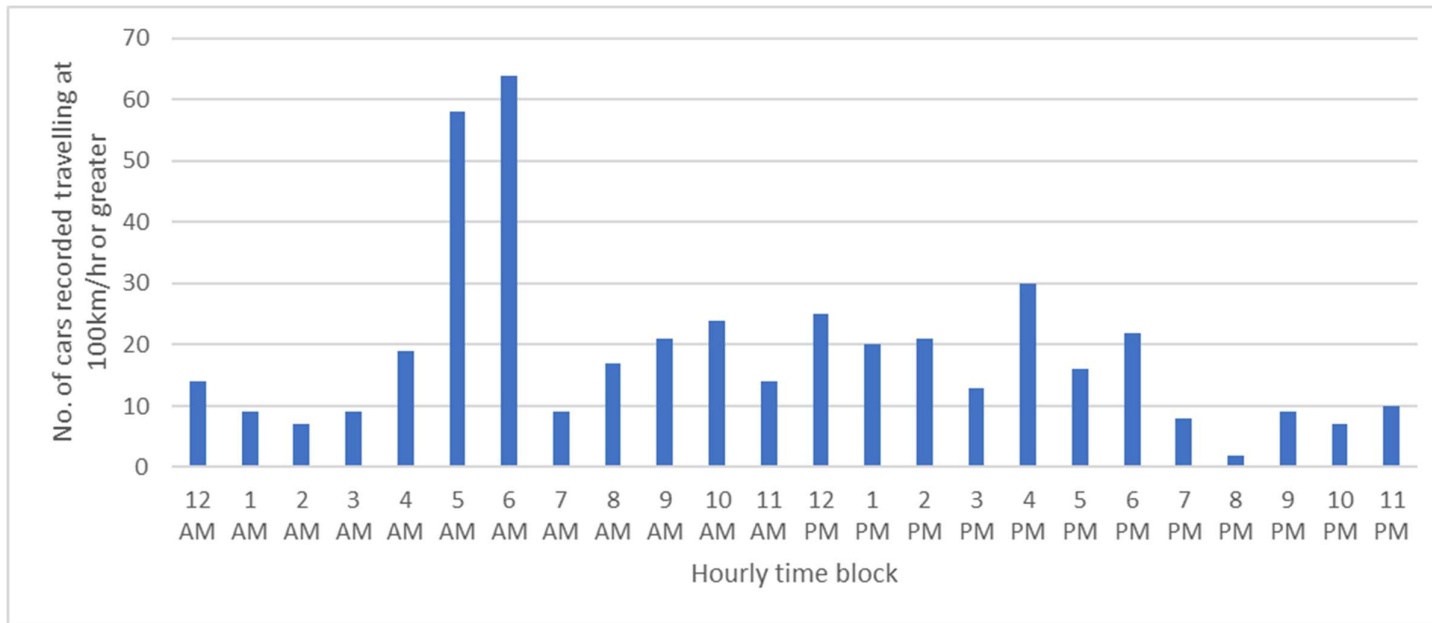
**Figure 23.** Counts of the number of cars travelling at 100km/hr or greater on Collingwood Road (speed limit 60km/hr) during each hourly time block for the period 24/05/2022 - 28/02/2023. Speeds were recorded by Jenoptik sign 26986.

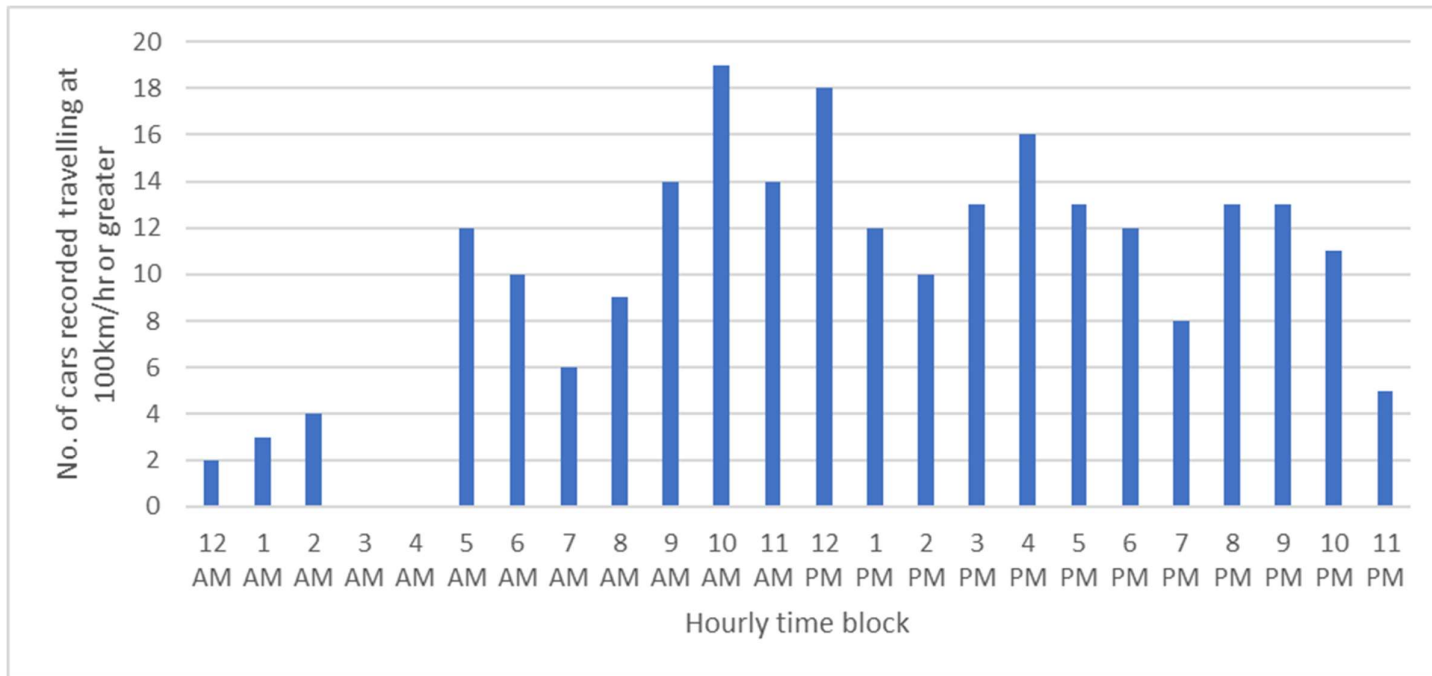
**Figure 25.** Counts of the number of cars travelling at 100km/hr or greater on Nelson Road (speed limit 60km/hr) during each hourly time block for the period 24/05/2022 - 28/02/2023. Speeds were recorded by Jenoptik sign 26978.

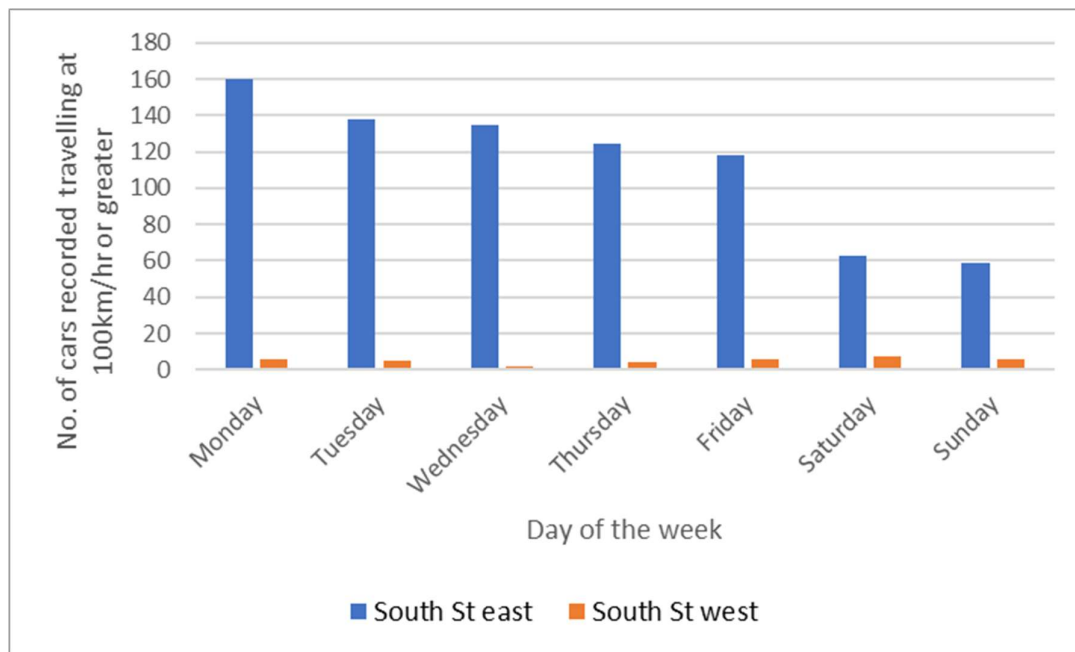
As with the previous year, numerous records of people driving at excessive speeds were again observed for all signs and on all roads. Figures 22 to 35 provide the frequencies (counts) of all vehicles traveling at or above 100 km/hr on each day of the week and for time of day (in hourly blocks) recorded by each sign. The sign at Old Cleveland Road East west (Figure 30) had the highest overall number of excessive speeders, with over 2400 offending records taken over the sampling period. The sign at Old Cleveland Road East east had approximately half as many offending vehicles, but this still equated to over 1000 instances. Frequency appeared to peak in the early evening and early morning each day for some signs, although this was not consistent across all signs. In contrast to most other signs, the sign at South Street west (Figure 26) had comparatively few excessive speeders.

**Figure 26.** Counts of the number of cars travelling at 100km/hr or greater on South Street (speed limit 50km/hr) during each day of the week for the period 24/05/2022 - 28/02/2023. Speeds were recorded at two sites by Jenoptik signs 26987 (South Street east) and 27633 (South Street west).

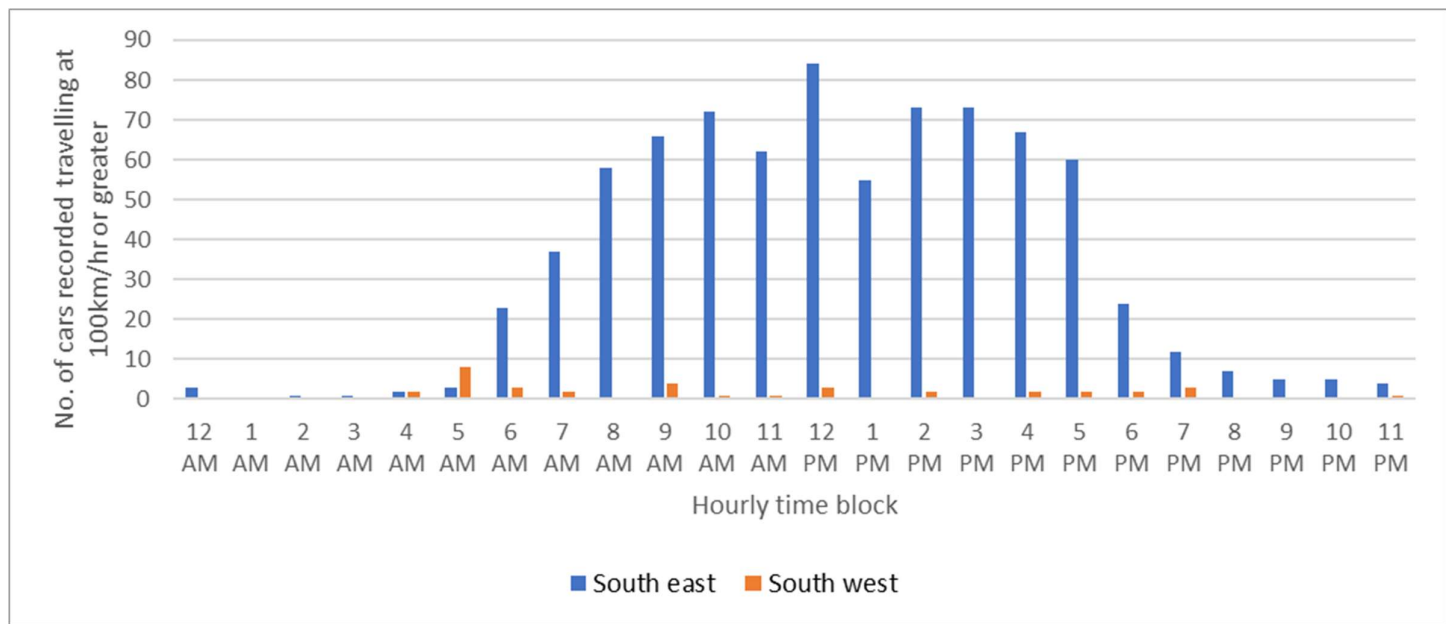
**Figure 27.** Counts of the number of cars travelling at 100km/hr or greater on South Street (speed limit 50km/hr) during each hourly time block for the period 24/05/2022 - 28/02/2023. Speeds were recorded at two sites by Jenoptik signs 26987 (South Street east) and 27633 (South Street west).

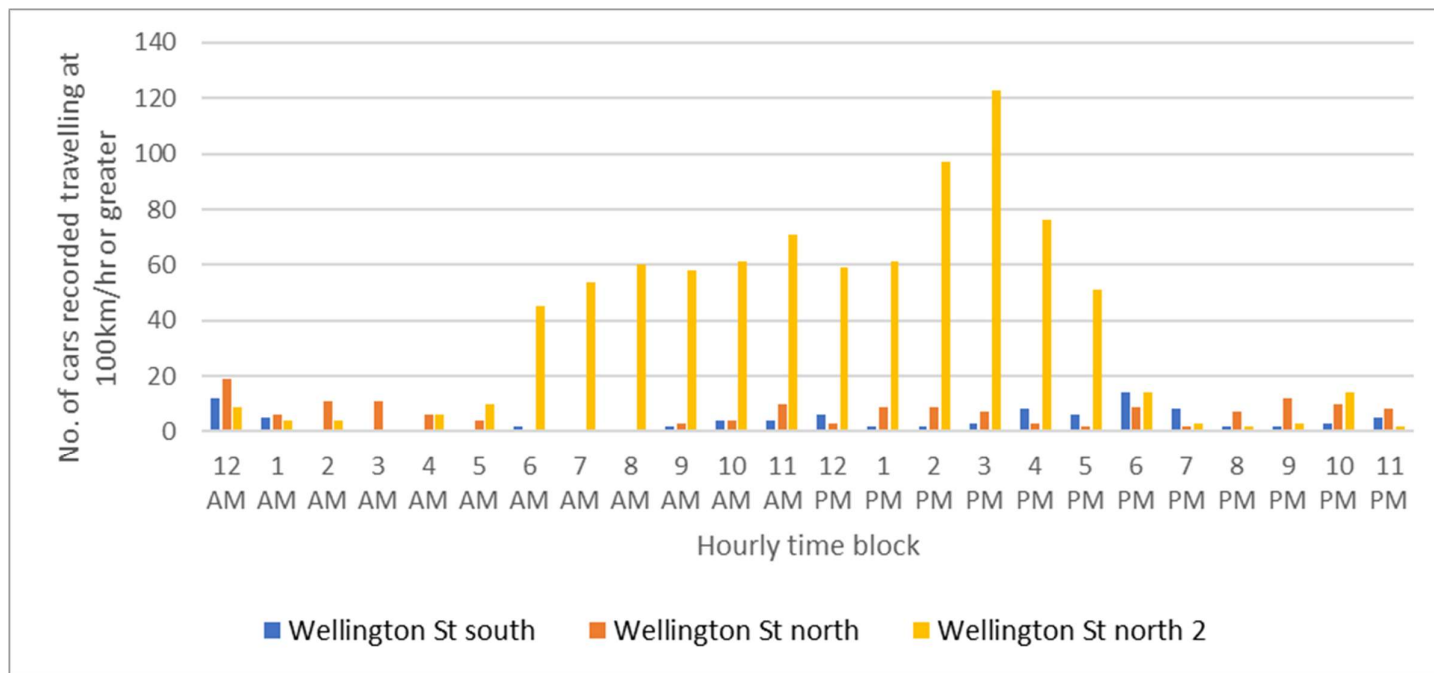
**Figure 29.** Counts of the number of cars travelling at 100km/hr or greater on Wellington Street (speed limit 50km/hr) during each hourly time block for the period 24/05/2022 - 28/02/2023. Speeds were recorded at three sites by Jenoptik signs 19540 (Wellington Street south), 19541 (Wellington Street north), and 26981 (Wellington Street north 2).

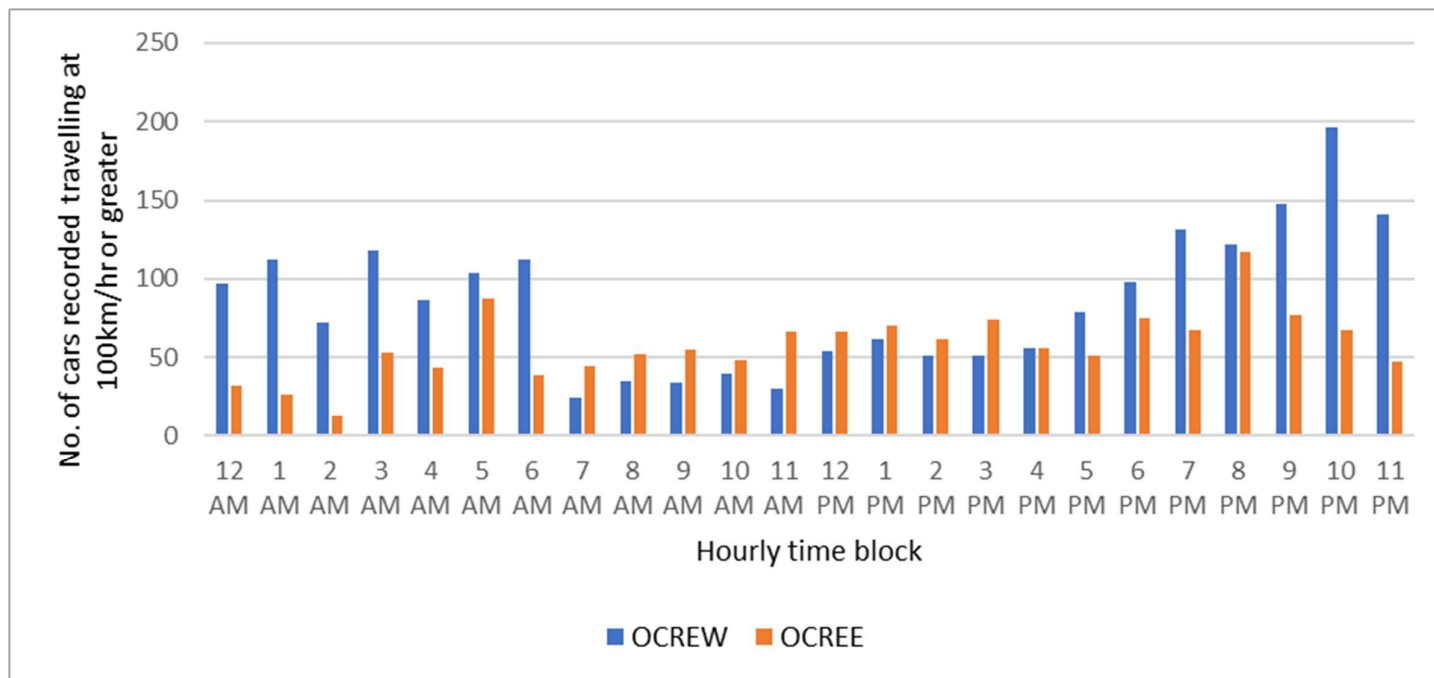
**Figure 31.** Counts of the number of cars travelling at 100km/hr or greater on Old Cleveland Road East (speed limit 60km/hr) during each hourly time block for the period 1/03/2022 - 28/02/2023. Speeds were recorded at two sites by Jenoptik signs 14361 (Old Cleveland Road East west) and 14370 (Old Cleveland Road East east).

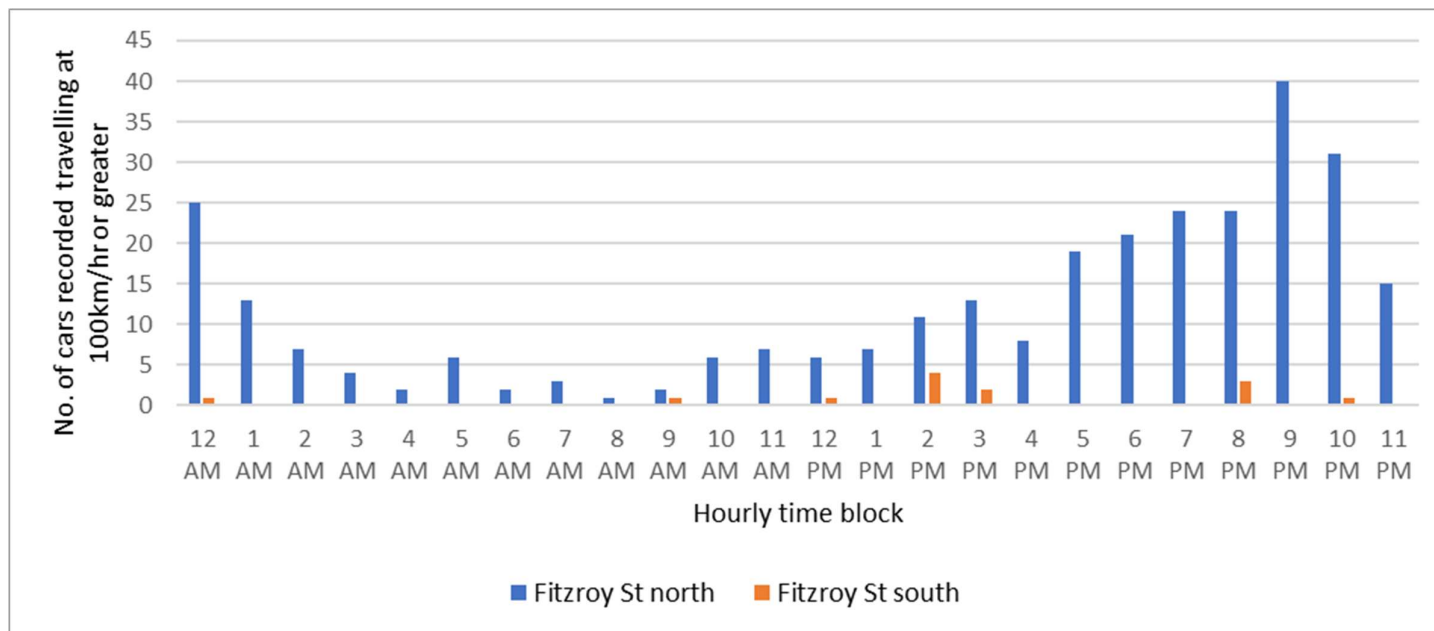
**Figure 33.** Counts of the number of cars travelling at 100km/hr or greater on Fitzroy Street (speed limit 50km/hr) during each hourly time block for the period 1/03/2022 - 28/02/2023. Speeds were recorded at two sites by Jenoptik signs 16718 (Fitzroy Street north) and 18935 (Fitzroy Street south).

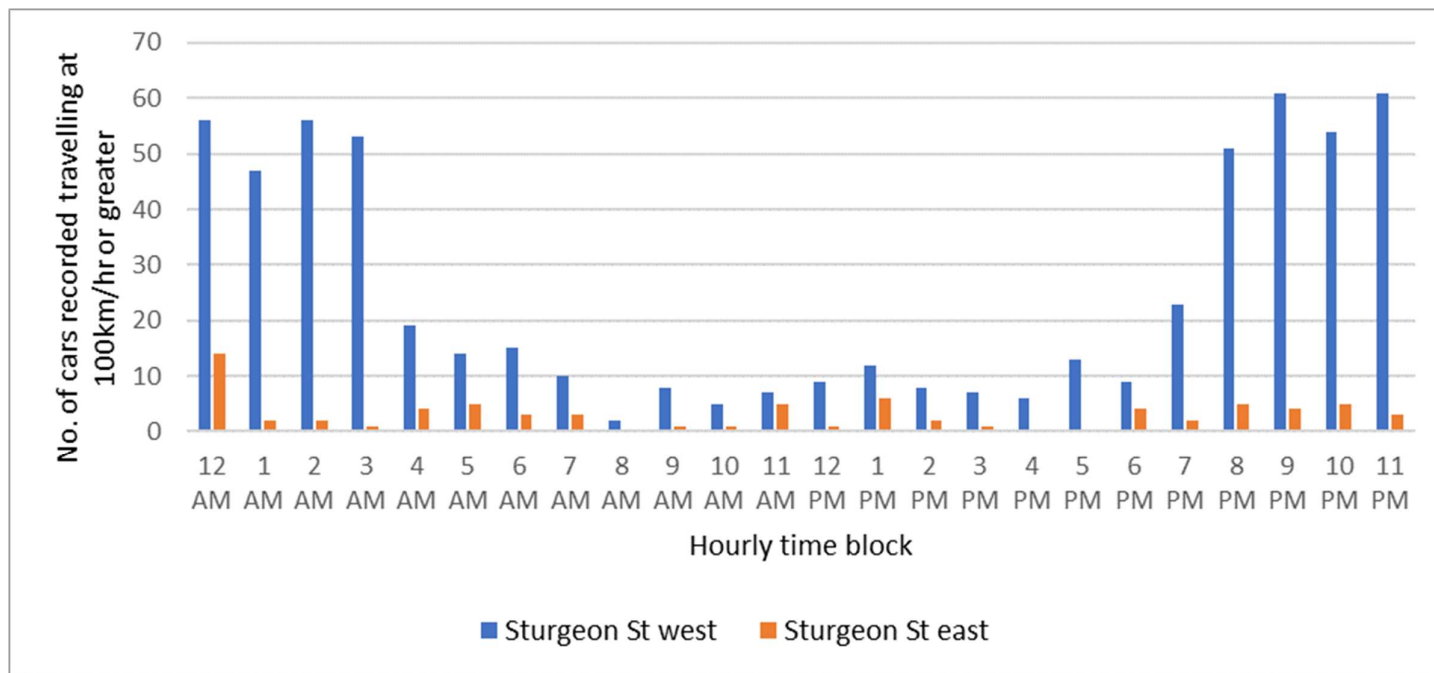
**Figure 35.** Counts of the number of cars travelling at 100km/hr or greater on Sturgeon Street (speed limit 60km/hr) during each hourly time block for the period 1/03/2022 - 28/02/2023. Speeds were recorded at two sites by Jenoptik signs 16720 (Sturgeon Street west) and 19543 (Sturgeon Street east).

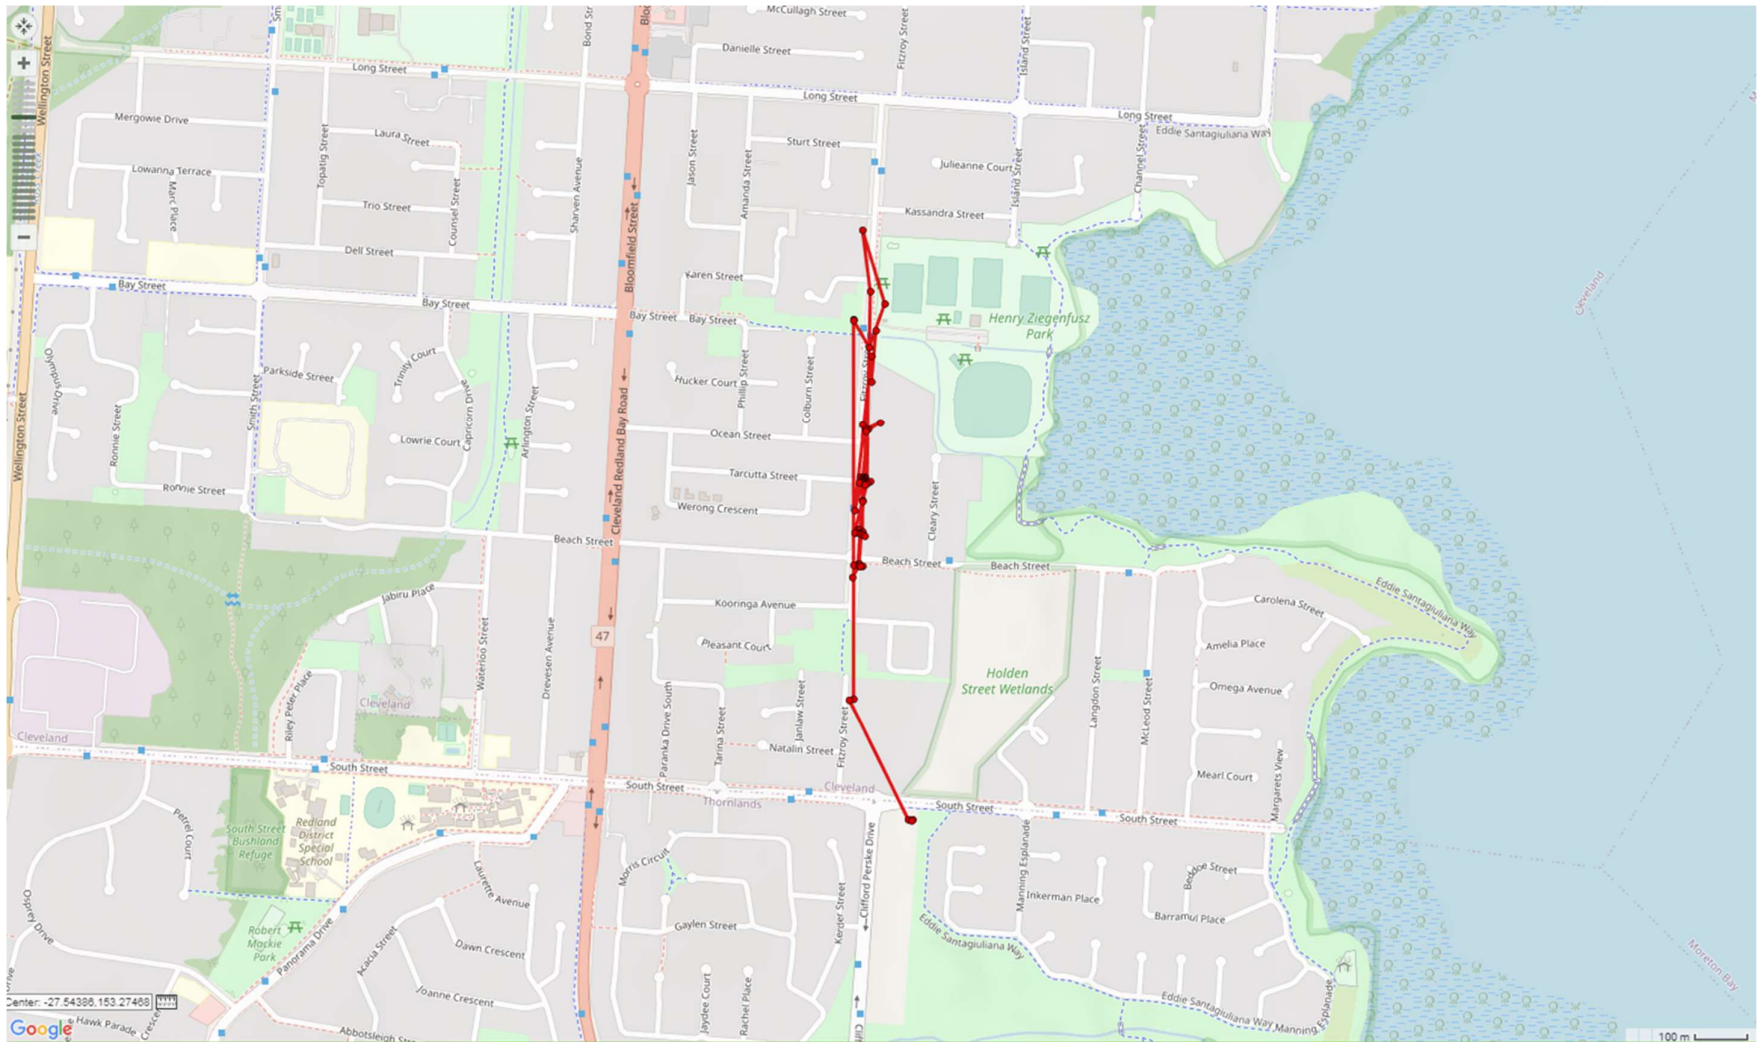
**Figure 37.** A map of GPS collar waypoints and tracks of the koala Benson crossing Fitzroy Street and other nearby roads.
