REPORT

Geophysical Survey of Flow-slide Barrier

Amity Point, North Stradbroke Island

21453805-001-R-Rev0

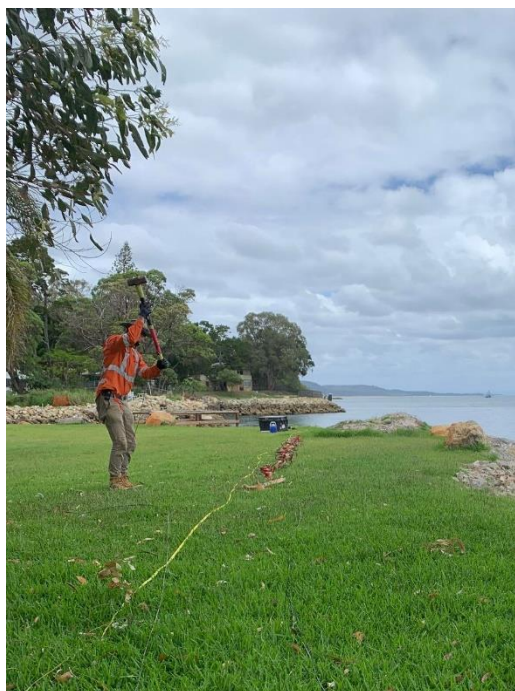
Inset 1: MASW streamer set-up on FSB, using sledge hammer seismic source

Vibrations of the S-waves were recorded using 4.5 Hz Geophones arranged along the streamer in a linear array of 24 channels, spaced 0.5 m apart. The data was logged using a Geometrics Geode seismograph. MASW soundings were spaced at 1 m intervals in straight lines both parallel and perpendicular to the wall frontage. The hammer impact location, or “shot offset”, was positioned 1 m from the final geophone of the array.

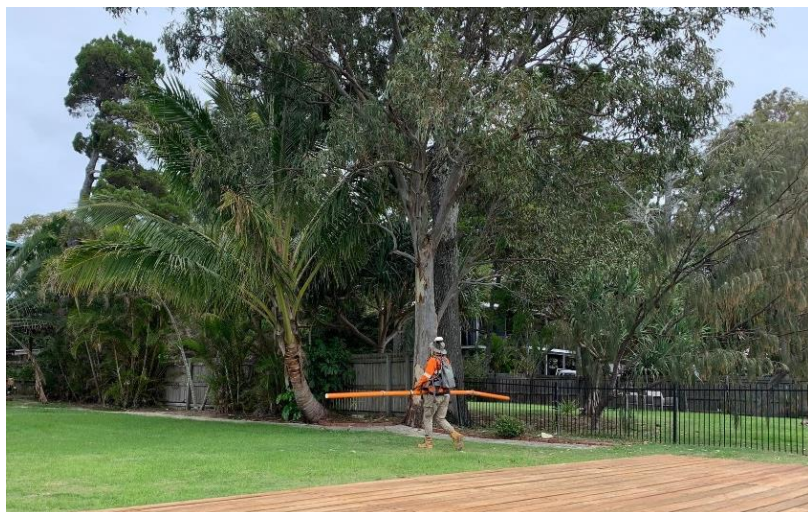
Inset 2: EM conductivity meter harnessed to operator, showing typical site conditions

The EM survey was completed using the GF Instruments CMD-Explorer frequency domain electromagnetic conductivity meter. The CMD-Explorer measures apparent conductivity (in milli-siemens per metre, mS/m) of the subsurface at 2.2 m, 4.2 m, and 6.7 m below the instrument level, simultaneously. The rock wall was screened with EM by completing lines spaced approximately 5 m apart and extending approximately 5-20 m from the edge of the wall, dependant on site access. Lines were completed on foot, with the conductivity meter harnessed on to the operator (see Inset 2).

The CMD-Explorer was used in the horizontal coplanar (HCP) configuration, where the dipole orientation is vertical. This maximises the penetration depth of the instrument. The instrument was set up approximately 1 m above surface level and carried at walking pace (~5 km/hr), logging continuously at a measurement frequency of 2.5 Hz. The system was integrated with a backpack mounted DGPS for positioning information, accurate to 1 m.

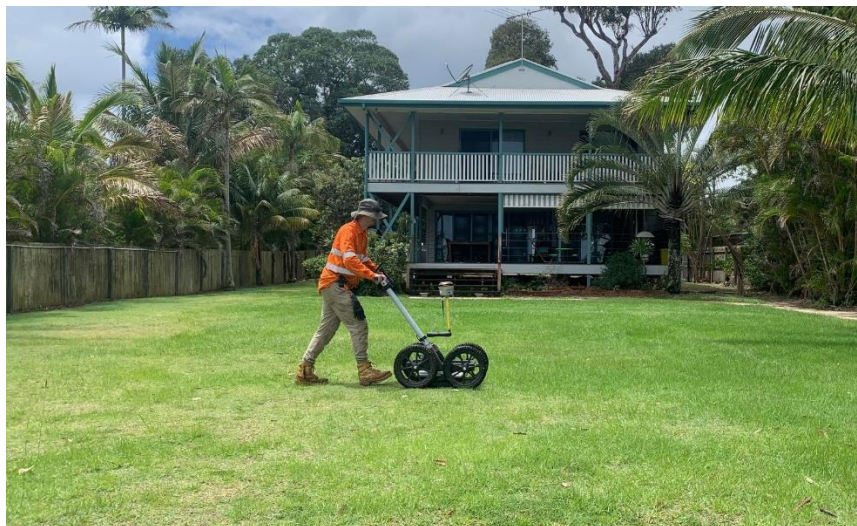
Inset 3: GPR survey underway in typical site conditions

In ideal conditions, the 450 MHz antenna can provide reasonable resolution of anomalies down to a depth of approximately 2 m to 4 m. The odometer attached to the rough terrain cart accurately measures surveyed distances, and the collected data was positioned using a cart-mounted DGPS system.

The survey was completed on foot, pushing a cart mounted GPR antenna along continuous lines, both parallel and orthogonal to the rock wall alignment (see Inset 3).

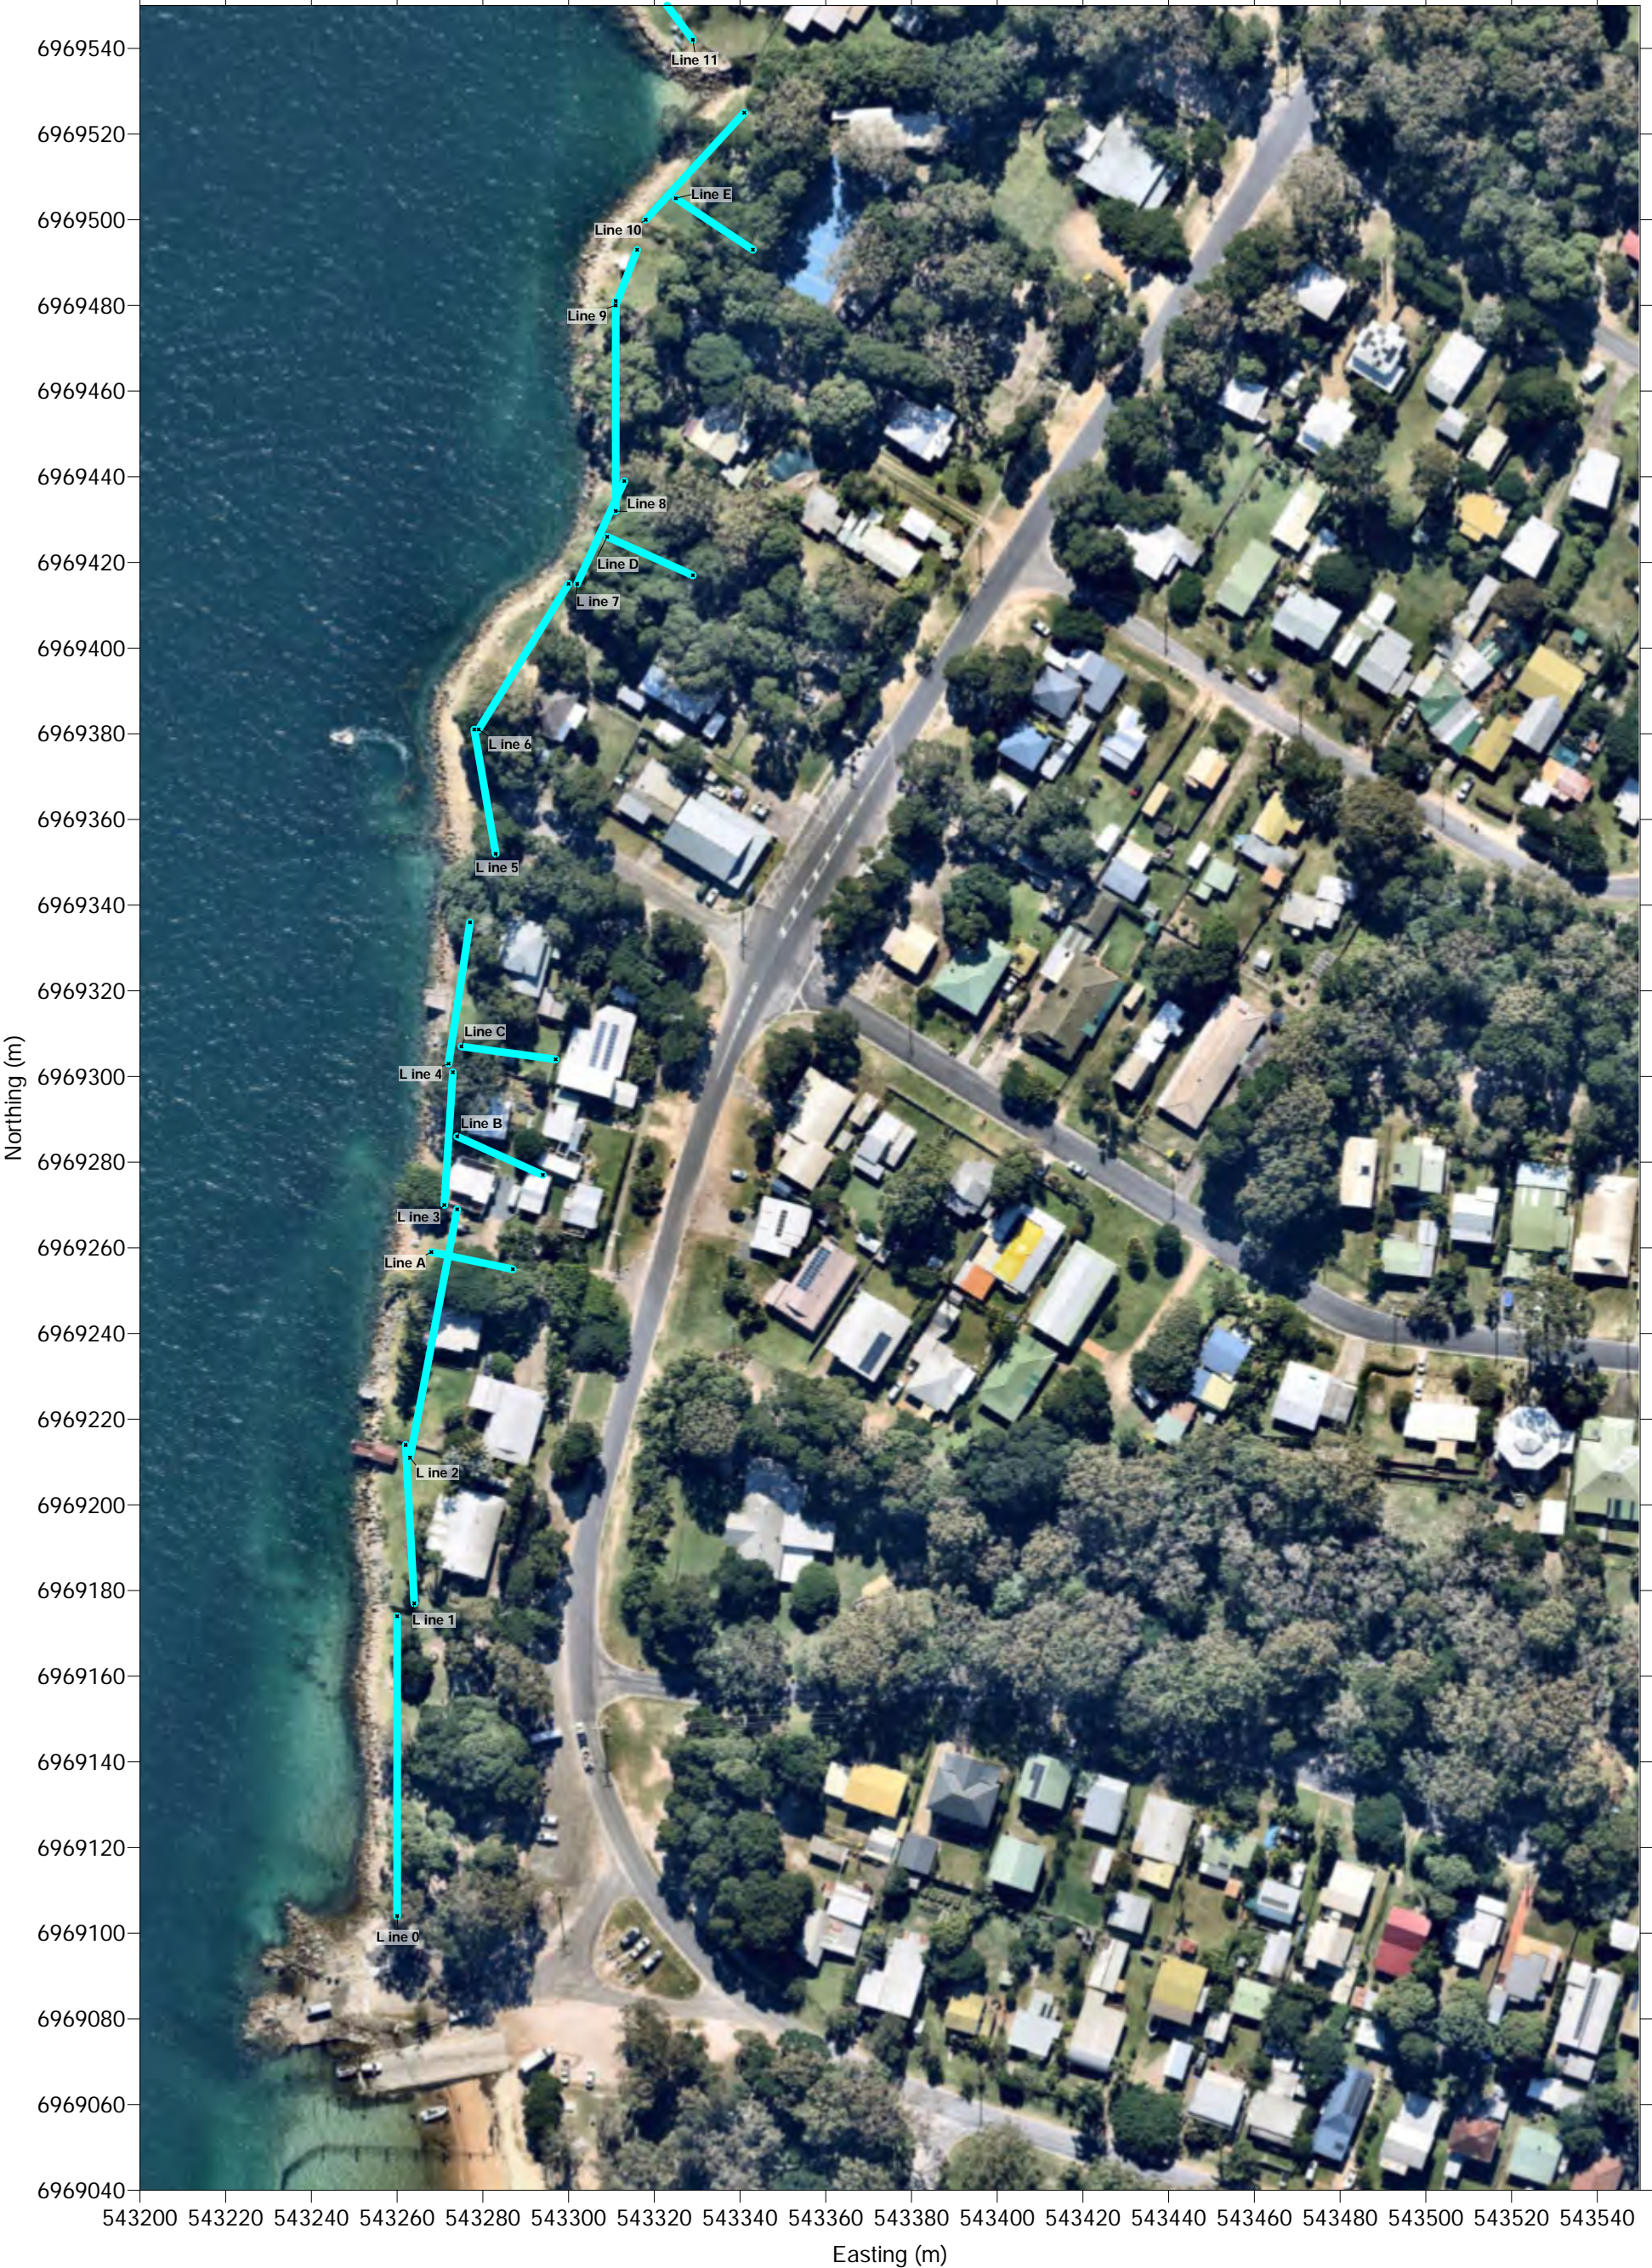
PROJECT NO.	DELIVERABLE	REV.	FIGURE
21453805	001	Rev0	04

TITLE
EM TRACKPLOT - NORTH
