Discoveries on coastal retrogressive breach failures inspired by failure of an underwater fixed platform

Xiamei Man^{a,*}, William R. Dally^b, David P. Callaghan^a, Peter Nielsen^a^a School of Civil Engineering, The University of Queensland, St Lucia, Queensland, Australia^b University of North Florida, Florida, United States of America

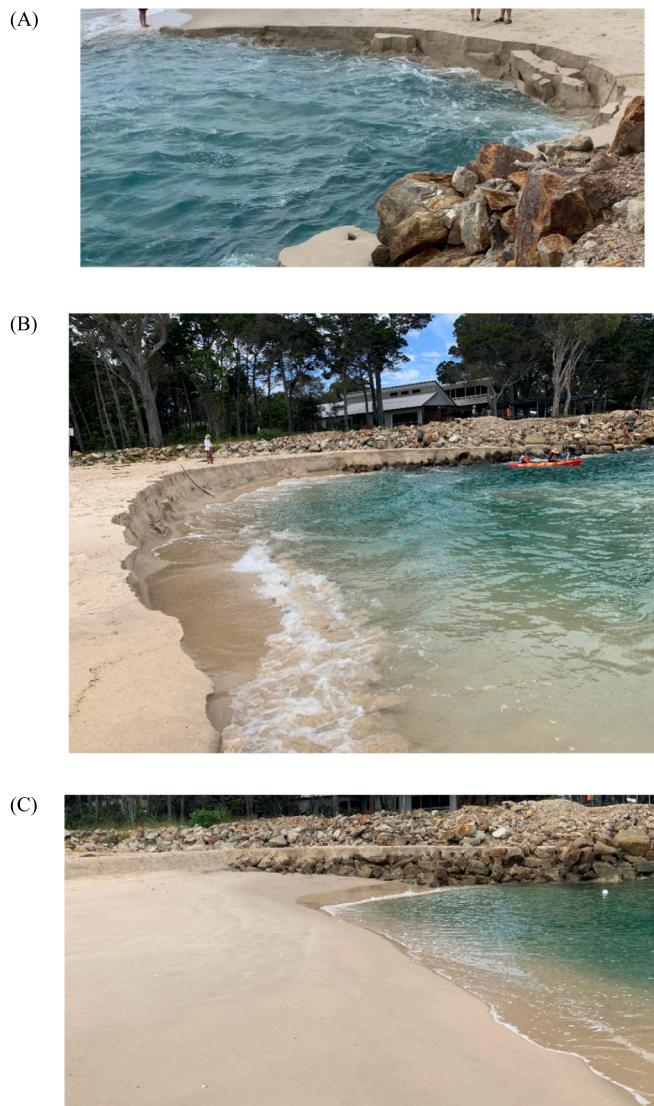
Fig. 2. (A) Propagating phase (B) termination phase (C) the recovery phase in a flow slide event recorded on 14/01/2023 at Amity Point field site.

After the RBF event is triggered, a retrogressive breach is formed and propagates upslope (Fig. 2(A)). The breach can reach the shoreline and then propagate onto the beach if not interrupted by sand characterization change or unsustained density current (Fig. 2(B)). Fig. 1(A) is a photo of RBF at the propagating phase at Amity Point, Queensland, Australia, where large blocks of sand fell into water. The propagating phase remained for approximately 30 min in the photographed event and the peak retreating velocity was of the order 5 mm/s. The event had an underwater breach of 7 m high measured by a fishing line by Beinssen et al. (2014).

When the density current is not sustained anymore by erosion and the breach that is reducing in height, the RBF event terminates (Fig. 1(B) and Fig. 2(C)). After the termination phase, the beach eroded by the RBF

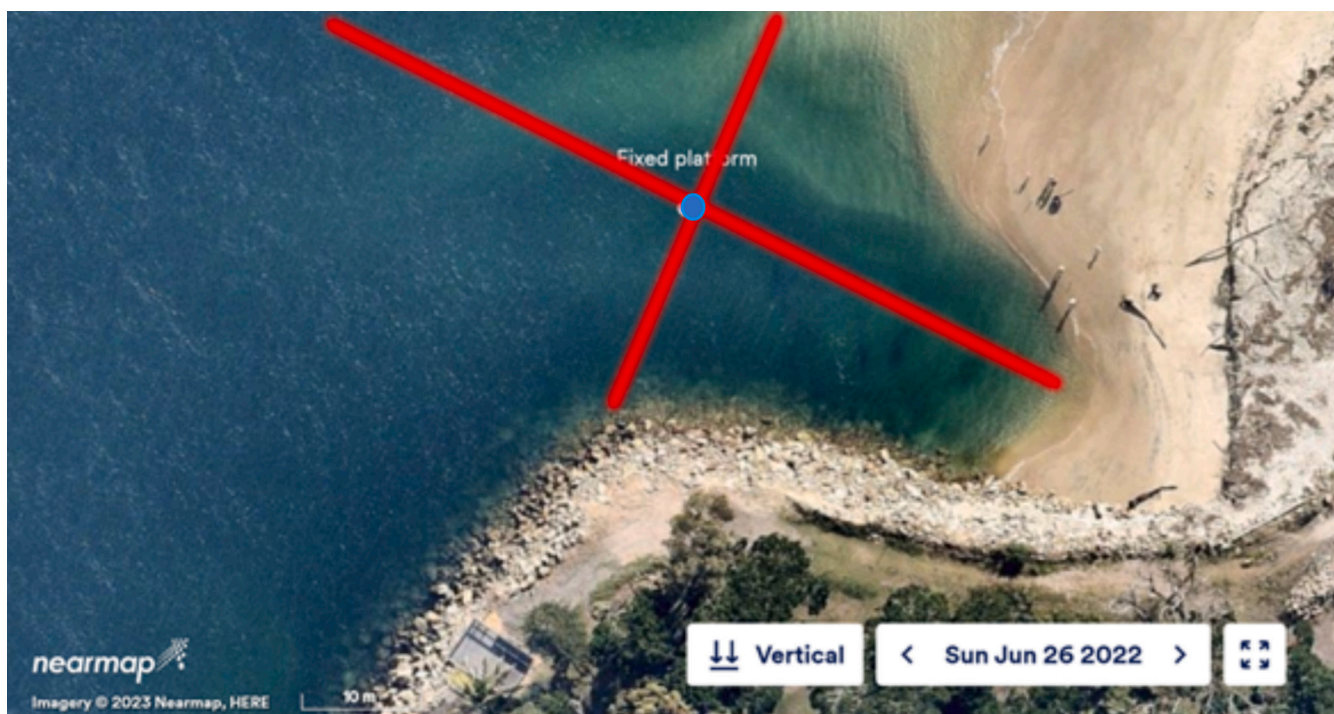
Fig. 3. Nearmap image of Amity Point field site shortly after a flow slide event. The blue dot indicates the location of the fixed (and the floating) platform installed in this study. Image date June 26th, 2022 (Nearmap, 2014). The two red lines represent the cross-shore and along-shore profiles the profilers will record. (For interpretation of the references to color in this figure legend, the reader is referred to the web version of this article.)

The continuing threat of RBF events at Amity Point has got attention from both Redland City Council and residents. The rock wall on Fig. 3 is a flow slide barrier built and managed by Redland City Council to protect foreshore properties. Both Redland City Council and residents desire knowledge regarding RBF event triggers to improve the flow slide management protocol. There have been speculations on a high groundwater table being the trigger among the residents based on their gardening experience. Beinssen et al. (2014) have communicated with Redland City Council regarding the importance of periodical monitoring the seabed and the Dutch Safety Assessment rules for levees (Flood Defence Act, 2017) where damage is expected if the average slope from the beach/toe of the seawall to the deepest point in the approaching tidal channel is more than 1.15.

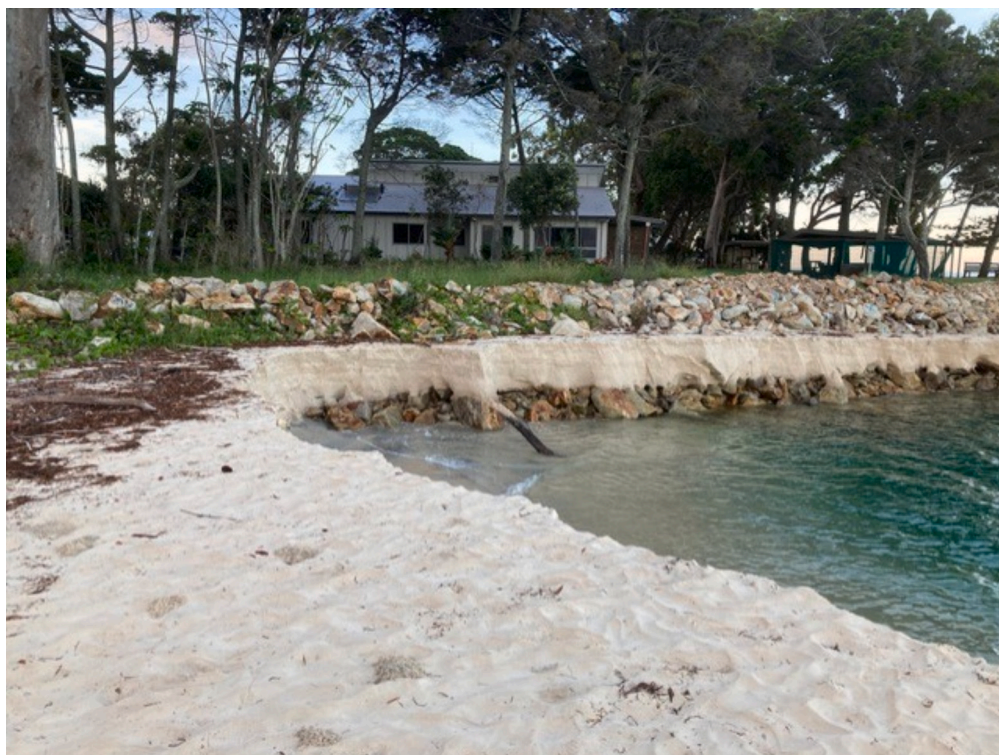
Fig. 4. The significant RBF event 05/01/2024, which is the largest erosion recorded in the past 5 years. The floating platform survives the event and stays safe on the water surface 50 m away from the beach.

This study aims to measure the underwater data for Amity Point flow slides using a fixed platform for discovery of the triggering mechanism. The fixed platform failed, but the failure reveals new knowledge on flow slides presented in the next section. It is emphasized here the fixed platform is an important attempt for RBF in situ triggering study. After the failure of the fixed platform, a floating platform is in testing progress at Amity Point. The floating platform design is to great extent inspired by the knowledge obtained from the fixed platform study. The floating platform consists of two anchors on the seabed and a hobie cat. The platform managed to survive a significant RBF event in early 2024, which was the largest erosion recorded in the past 5 years (Fig. 4).

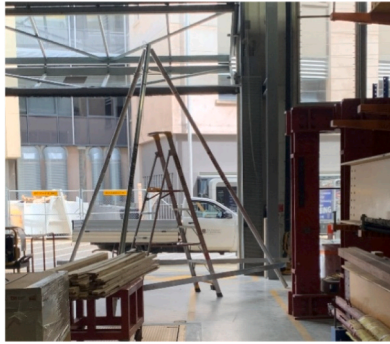
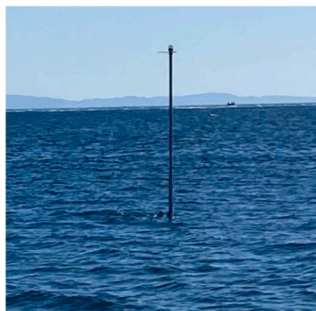
Fig. 5. (A) Photo of half of the fixed platform (i.e. three 4-m legs and three cross members.) (B) Drawing of the fixed platform including the legs, cross-members and helical anchors. (C) Photo of the installed submerged platform with a navigation light ~2 m above mean sea level.

The fixed platform was an 8.0 m tall, 8.0 m wide tripod structure made of aluminium pipes. Three cross-sections were bolted in the middle of each tripod leg as a support frame for acoustic sonars. Fig. 5 (A) presents a photo of the upper half of the tripod; Fig. 4(B) is the drawing of the tripod and Fig. 5(C) is a photo of the tripod navigation light after installation.

Three square helical anchors were installed (1.5 m × 40 mm × 40 mm) as anchors for the fixed platform. The tripod legs were connected to the helical anchors by box connectors. The fixed platform was installed in ~8 m bathymetry referring to mean sea level. The installation position was designed to be a balance point at Amity Point event site where sand is neither eroded nor accreted referring to previous study (Beinssen et al., 2014). The tripod was designed to endure the maximum turbidity current which occurs at the balance point where the bathymetry change is minimal according to Beinssen et al. (2014). The drag force of a density flow (assume which has a 5 m/s velocity and 1500 kg/m³ density) is ~225 kN. The pressure from the force onto the tripod (~22.5 MPa) is much less than strength of aluminium (276 MPa).

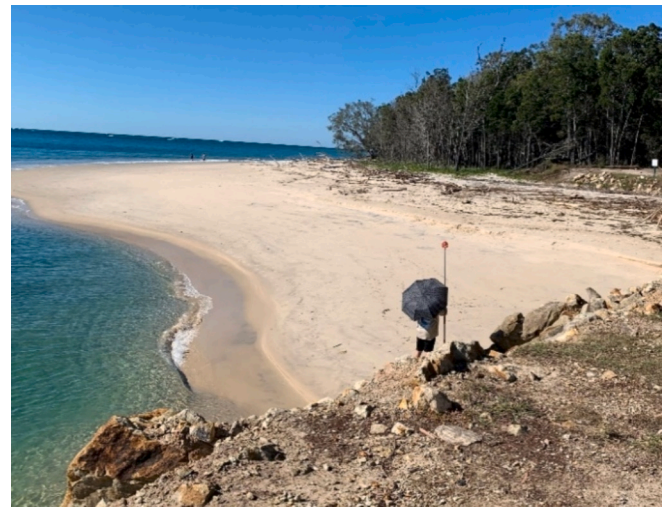
Fig. 6. Small above water RBF event photo (04/05/2023) correspond to significant erosion underwater. The onshore vertical sand wall height is only several centimetres.

The crew went to site on May 4th, 2023, and the tripod navigation light disappeared. At the shoreline, a small, negligible RBF event was observed (Fig. 6). A large sand movement in comparison with the negligible RBF event onshore, was observed by a snorkeler underwater. Referring to the fact that the tripod fails, it can be deduced that the sand erosion at the bathymetry of 8 m is more than 1.5 m. It also suggests the trigger of RBF events is further than 20 m offshore, where the bathymetry is 8 m.

comprehensively describe the triggering conditions at the current study site. In Fig. 6, a short, vertical sand wall (whose slope steeper than the repose angle) stands for days without triggering a larger RBF event. In Fig. 9, the 4 h profile does not trigger an RBF event despite its steepness. The RBF event occurred between 124 and 170 h after the previous RBF event indicates that RBF event triggering does not require a fully recovered beach. More reports on different study sites and events are required to determine a comprehensive RBF triggering conditions that applicable to worldwide. Both in laboratory and in situ.

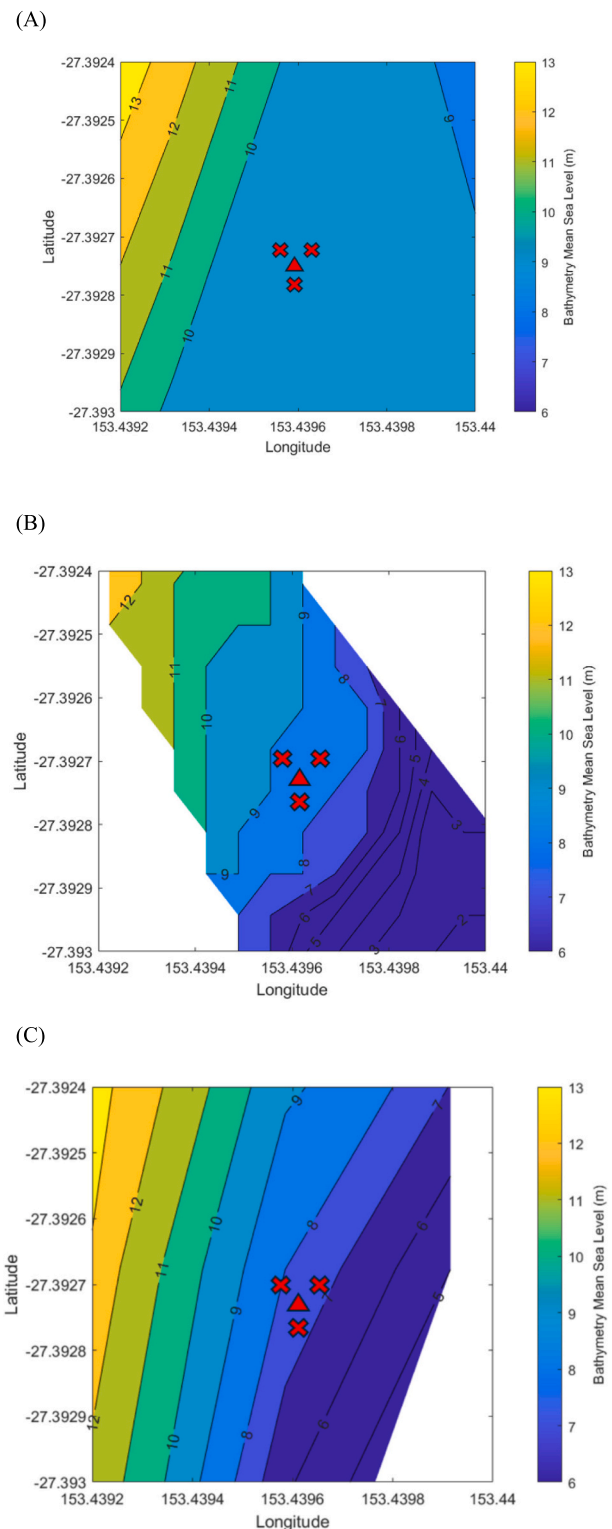
Fig. 8. Bathymetry survey results on 22/04/2022 (A) and 23/01/2023 (B) and 05/05/2022 (C) with tripod location (the red triangle) and tripod anchors location (the red crosses). (For interpretation of the references to color in this figure legend, the reader is referred to the web version of this article.)

graduated staff. Kayak-based bathymetry survey was conducted on January 23rd and May 5th, 2023, using a Garmin GT20 Transducer to obtain bathymetry in different stages of RBF events. The bathymetry maps are presented in Fig. 8.

Besides the tripod collapse, kayak and boat-based bathymetry also proves the occurrences of underwater RBF events. Fig. 8(A) is the boat-based bathymetry contour surveyed in 04/2022 as the seabed level at the recovery phase. The tripod is placed between 9 m and 10 m contour line where the seabed is relatively flat. RBF events can be observed in both Fig. 8(B) and Fig. 8(C), adopting the bathymetry contours in Fig. 8(A) as a baseline for comparison. Interestingly, the two RBF events present different characteristics regarding propagating directions, vertical sand wall heights and spatial ranges. In Fig. 8(B), a steep slope (where the bathymetry drops from -2 m MSL to -7 m MSL) presents close to the shoreline. This RBF event was also captured by beach profile surveys and beach volume calculation in Fig. 9. While in Fig. 8(C), the bathymetry contour lines shift directions where the tripod was deployed, indicating an RBF event not propagating cross-shore and it

eroded ~3 m sand comparing to the recovery phase seabed level in Fig. 8 (A). The slight shift in contour line directions may indicate there have been two RBF events in different directions. It should be noted that the kayak-survey date (05/05/2024) is earlier than the tripod retrieval date (09/05/2024). Referring to the tripod retrieval photos (Fig. 7), there possibly was an along-shore RBF event between 05/05/2024–09/05/2024, that deposited sand at the NNW anchor while eroding more sand at the WNW and the offshore anchor.

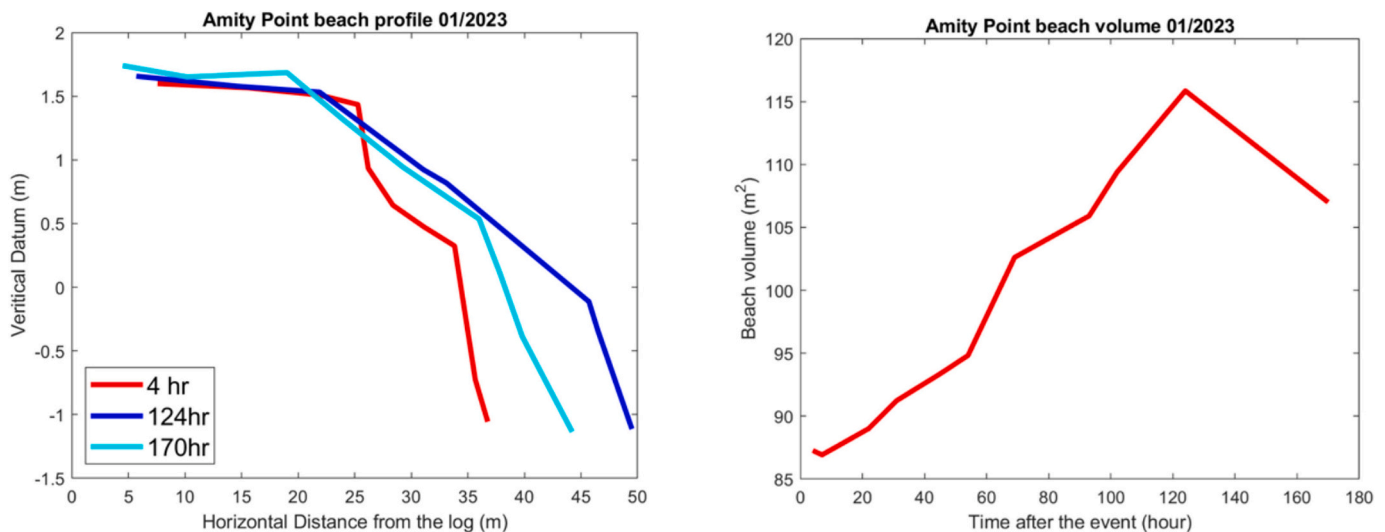
Fig. 9. (A) Beach profiles 4–170 h after the RBF event on 14/01/2023. (B) Beach volume after the RBF event.

Fig. 9(A) and (B) present the beach profiles and beach volume after the RBF events on 14/01/2023, respectively. The beach profile 124 h after the RBF event was fuller than the beach profile 170 h after the event, which indicates an underwater RBF event. The beach volume suggests the same as it decreased at 124 h after the RBF event. Fig. 10 presents a beach photo after 124 h after the RBF event: there was a vertical, short wall of several centimetres on the beach. The photo presents a minor RBF event extremely similar to that in Fig. 6, indicating that major underwater slides without eroding the beach occur frequently at the field site. The minor RBF occurs between 124 h – 170 h after the previous RBF event and eroded approximately 15 m³ beach volume for each meter width, which is before the beach completely recovered. This is another new observation on RBF events given the

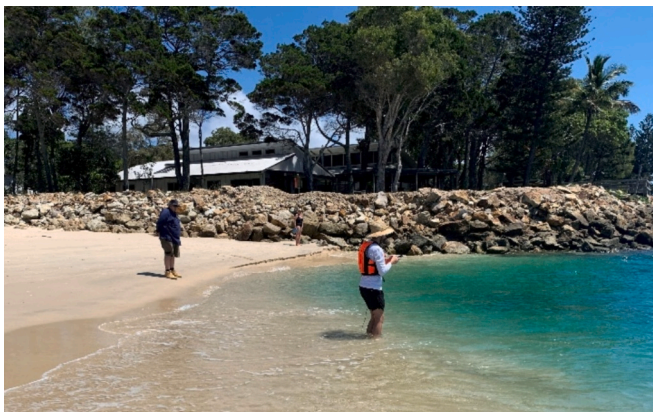
Fig. 10. Small above water RBF event photo (19/01/2023) correspond to significant erosion underwater.
