### RABY BAY CANAL BATTER STABILITY UPDATE

### Geotechnical Investigation Analysis Report

24 June 2013

BEJ809.002-W-REP-003 Rev. 0

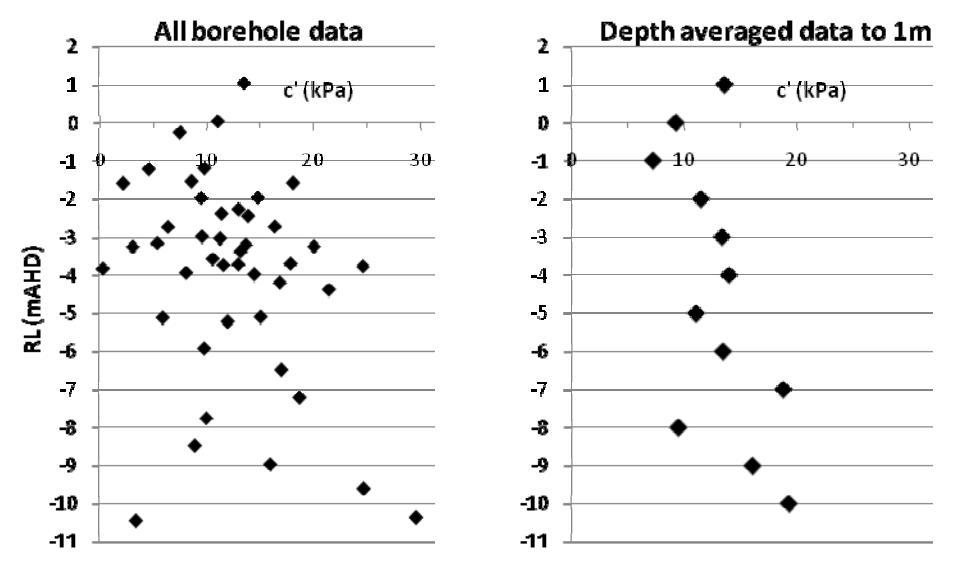
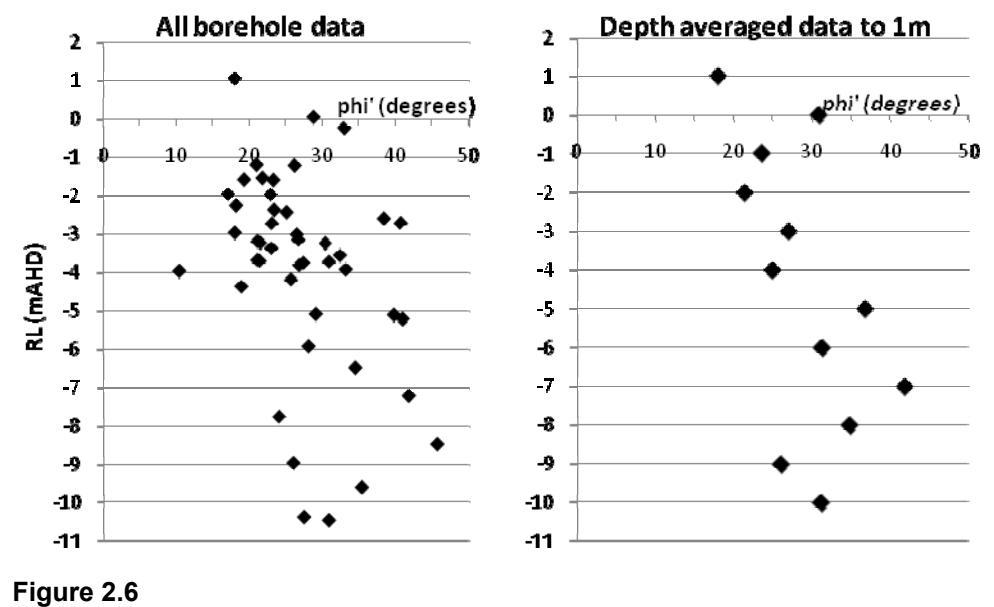
Figure 2.5 DRAINED SHEAR STRENGTH VALUES FROM TRIAXIAL TESTS

Note that the tested shear strength of the stiff clay can be affected by the presence / absence of fissures in the test samples (Bowles 1988, p81)

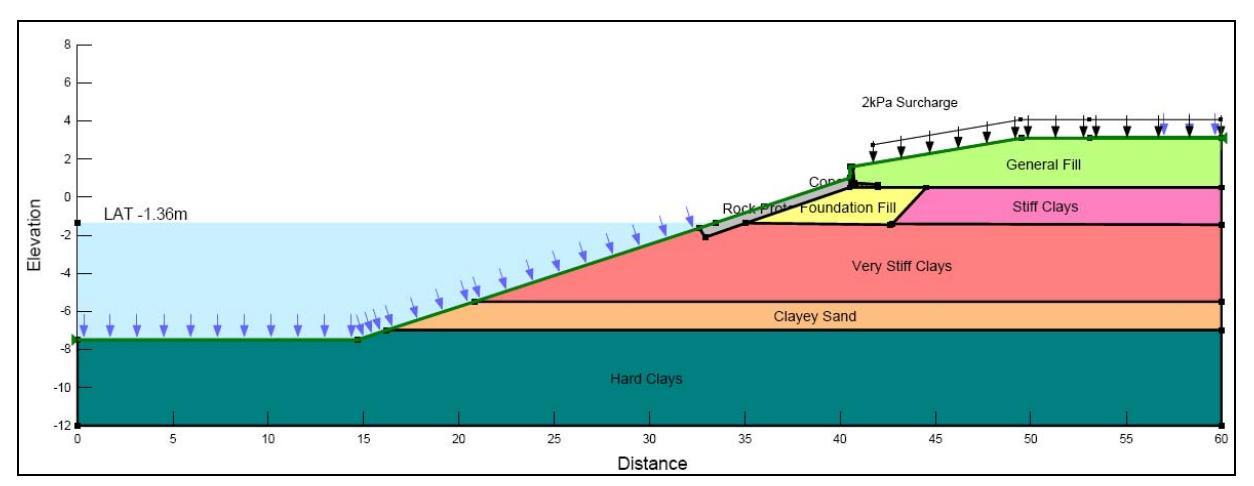
Figure 3.1 SLOPE/W MODEL LAYOUT

The Slope/W model is shown in Figure 3.1. The assumed soil strength parameters are shown in Table 3.1.

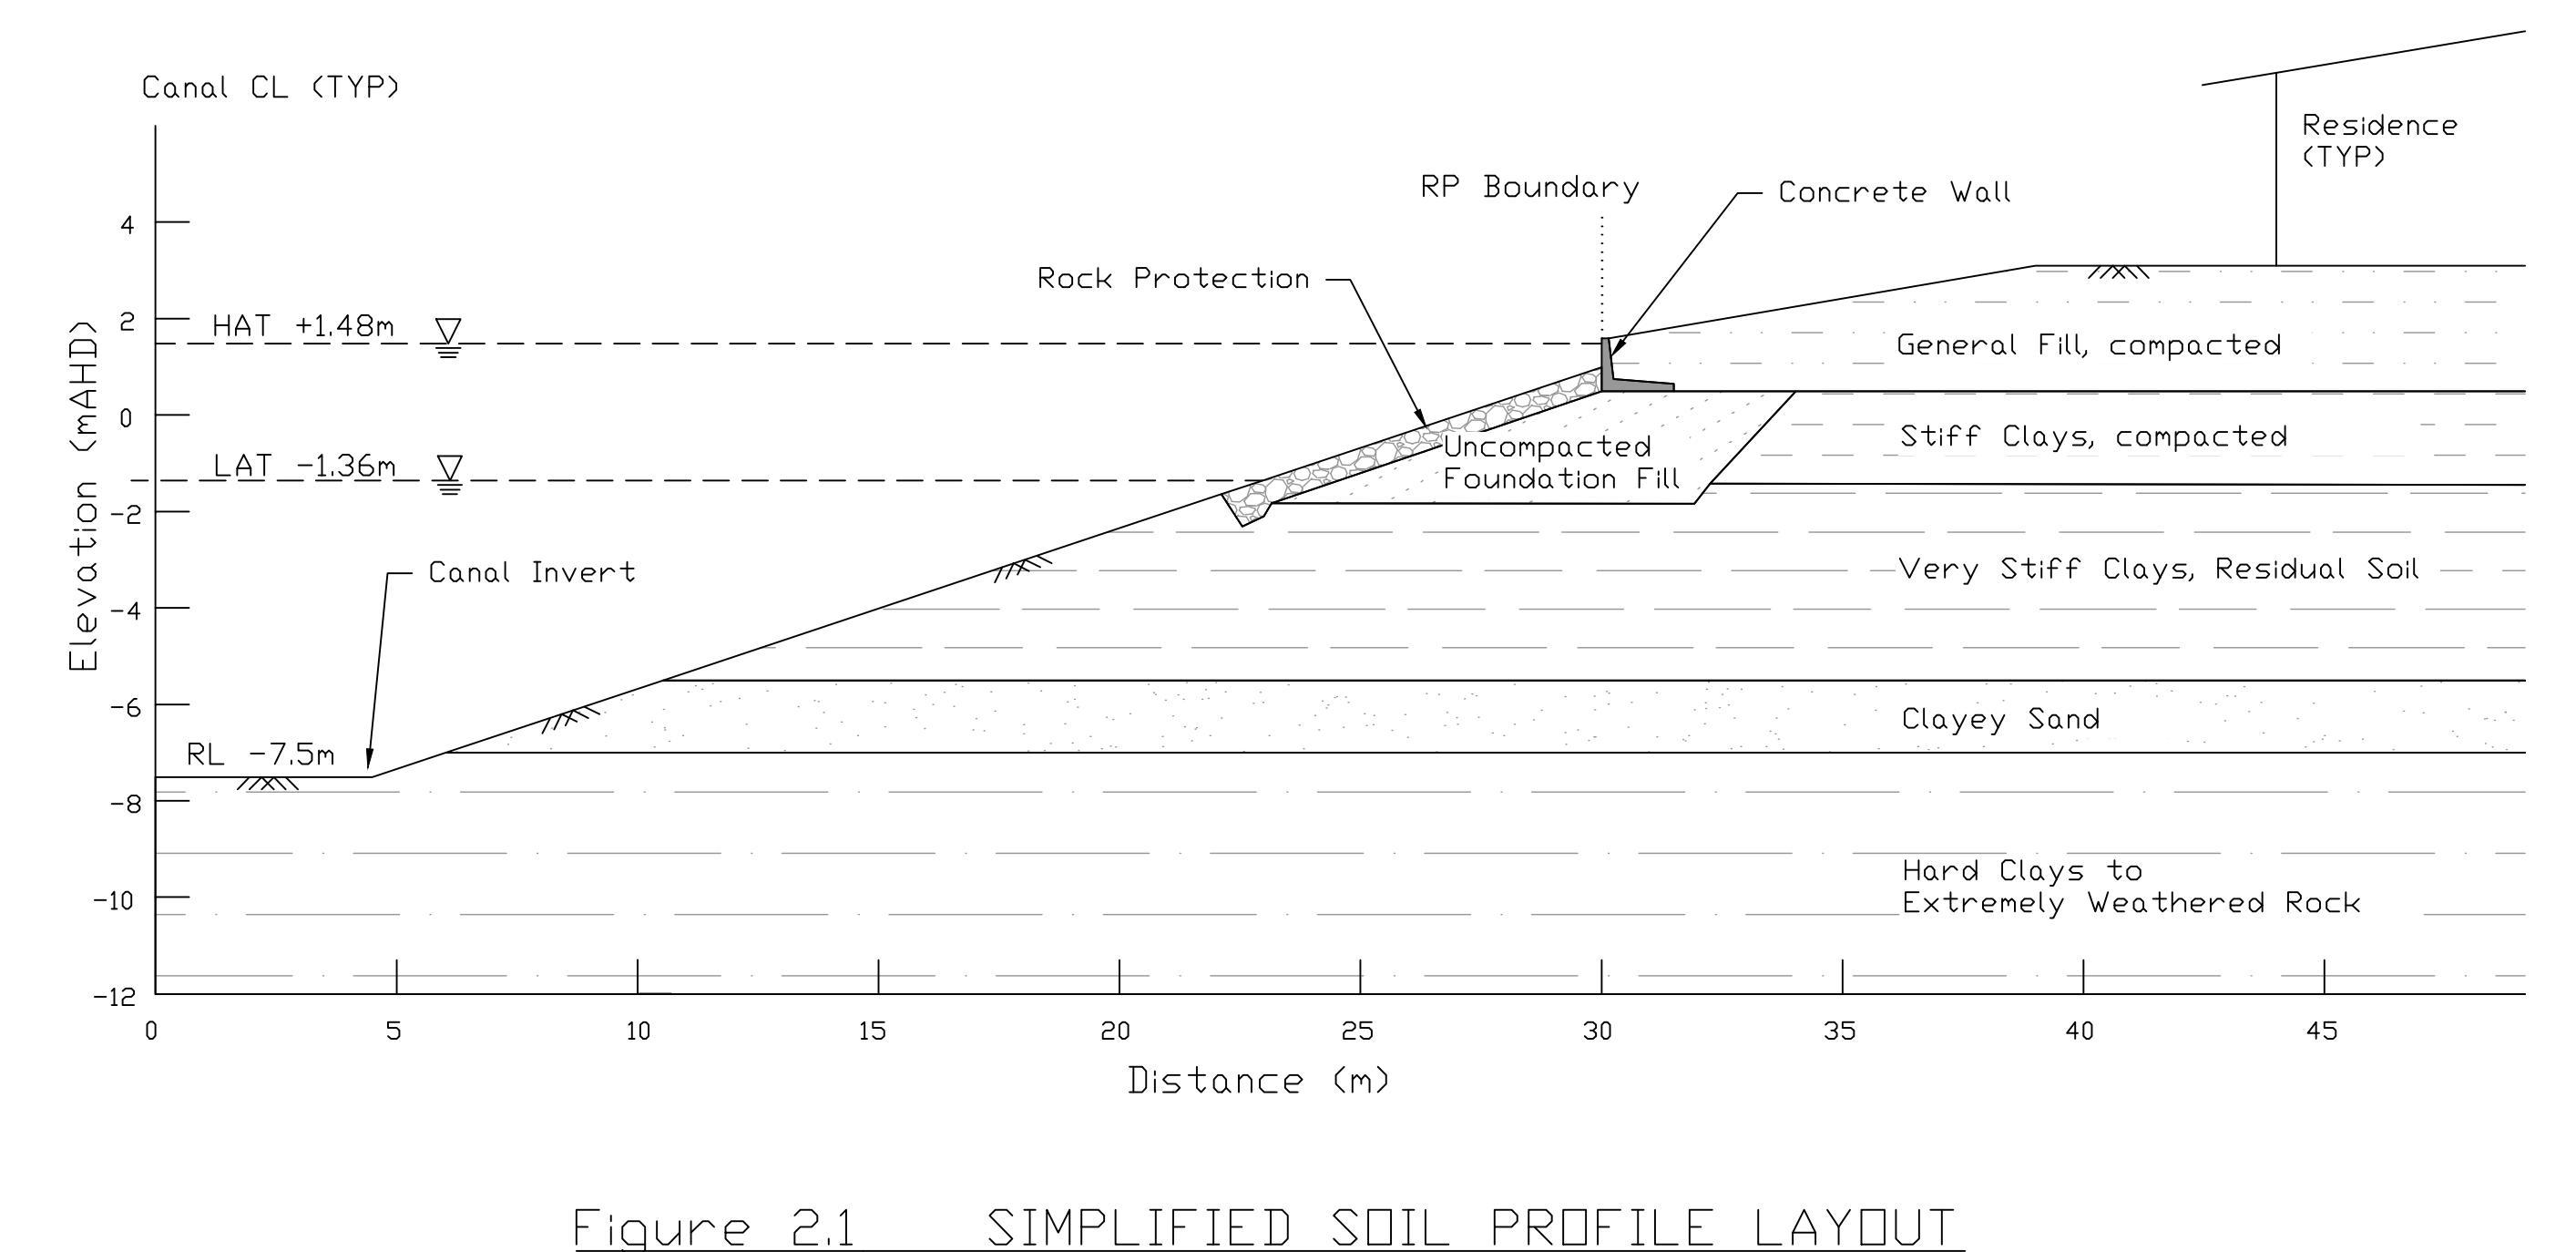
### rigure c.i. SIMPLIFIED SUIL PRUFILE LATUUT

- 'general fill' was imported and compacted under house platforms and roads
- in order to build the rock armour and concrete wall, the fill in this area had to be brought up to profile. The usual method is to overfill this area slightly with the 'stiff clay' or the imported 'general fill' and compact with rollers in 300 mm layers. After compaction the profile is cut using an excavator. Instead it appears that 'foundation fill' was pushed into the 'wedge' between the 'stiff clay' batter and the design profile and not compacted (i.e. left loose). This 'wedge' is difficult to compact; a vehicle roller might not have safe access so hand rollers or compaction plates or the addition of cement would have to be used all of these are expensive; hence it appears many Raby Bay canal frontages have an uncompacted fill wedge under the rock protection and concrete wall

- the author's interpretation of the geotechnical data is the observed slope failures are largely confined to this uncompacted 'foundation fill' wedge, thus the slips appear to be shallow and short in length.
