briefing note

Record of site inspection matters raised by

Macleay Island foreshore east of the barge ramp.

Subject: Inspection results - Foreshore adjacent to 36 Russell Tce, Macleay Island

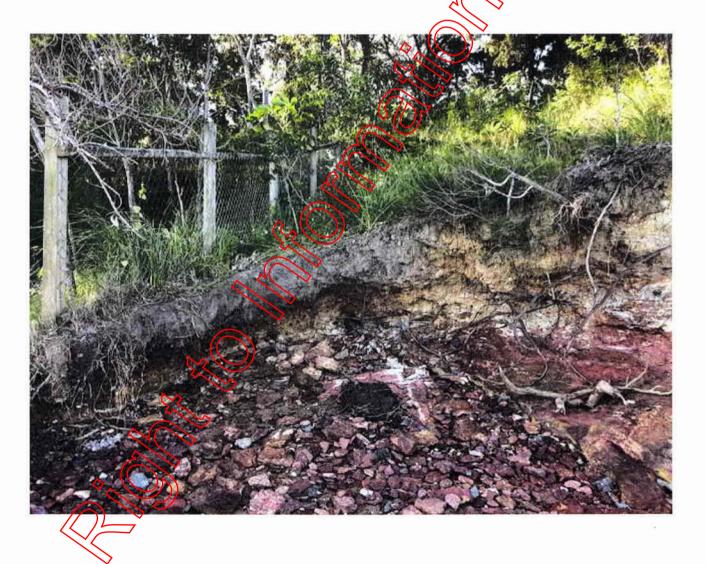
- 1 fence is down
- 2 scour at toe
- 3 undercut causing bank collapse
- 4 evidence of recent collapse
- 5 undercut exposing footings this stairway landing is now unsafe and should be closed
- 6 Seawall construction next door
