CLEVELAND AQUATIC CENTRE UPDATED POOL CONDITION ASSESSMENT

AND MAINTENANCE PLANS

(July 2014)

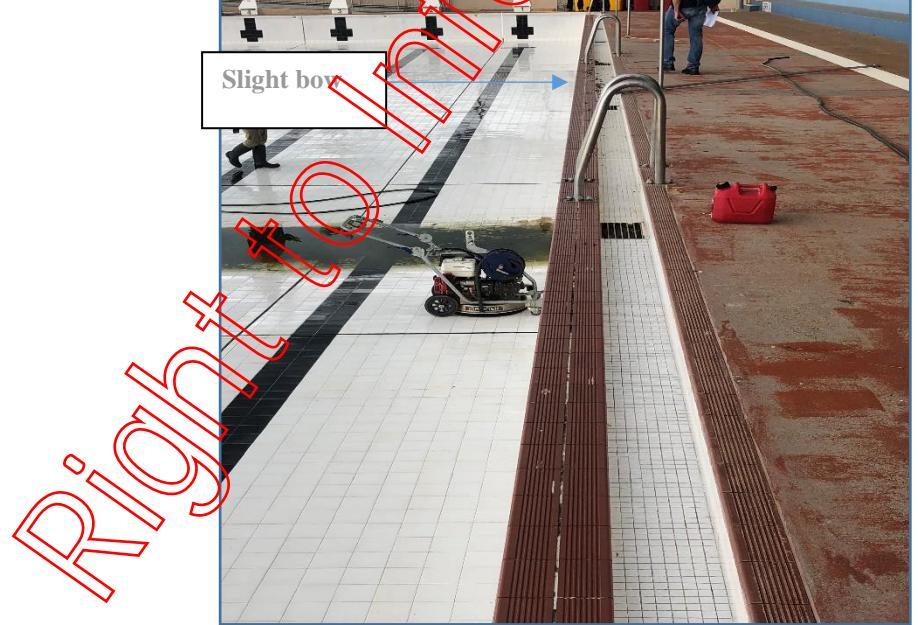
detected by eye (refer photo 2) it was not of a magnitude for concern. Tapping of tiles a the sase of these bowed sections found no damage.

Photo 2 Slight bow in southern wall line

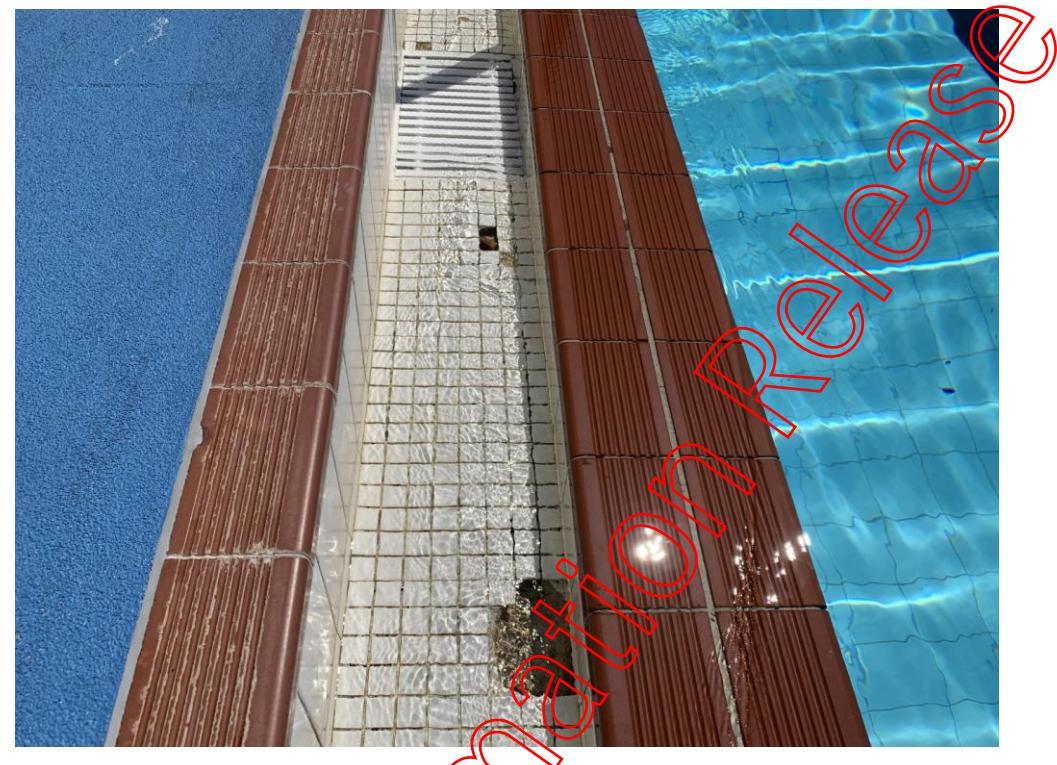
Figure 5: Daninged tiling in open gutter

- Undertake a survey of the pool wall levels and repeat in 12 months to determine if there is any movement.
- Replace the tank lids with lighter lockable items such as Terra Firma lids.
- Rectify failed tiling. Undertake a detailed grout inspection on the pool and repair / replace as necessary.
- Consult with operational staff regarding floor tiling slip level and identification of any operational issues experienced.
- Consider providing grated covers to the open channel wet decks.
- Undertake circulation dye testing in accordance with the Model Aquatic Health Code. It dead spots are identified, improvements may be required to the filtered water return system.

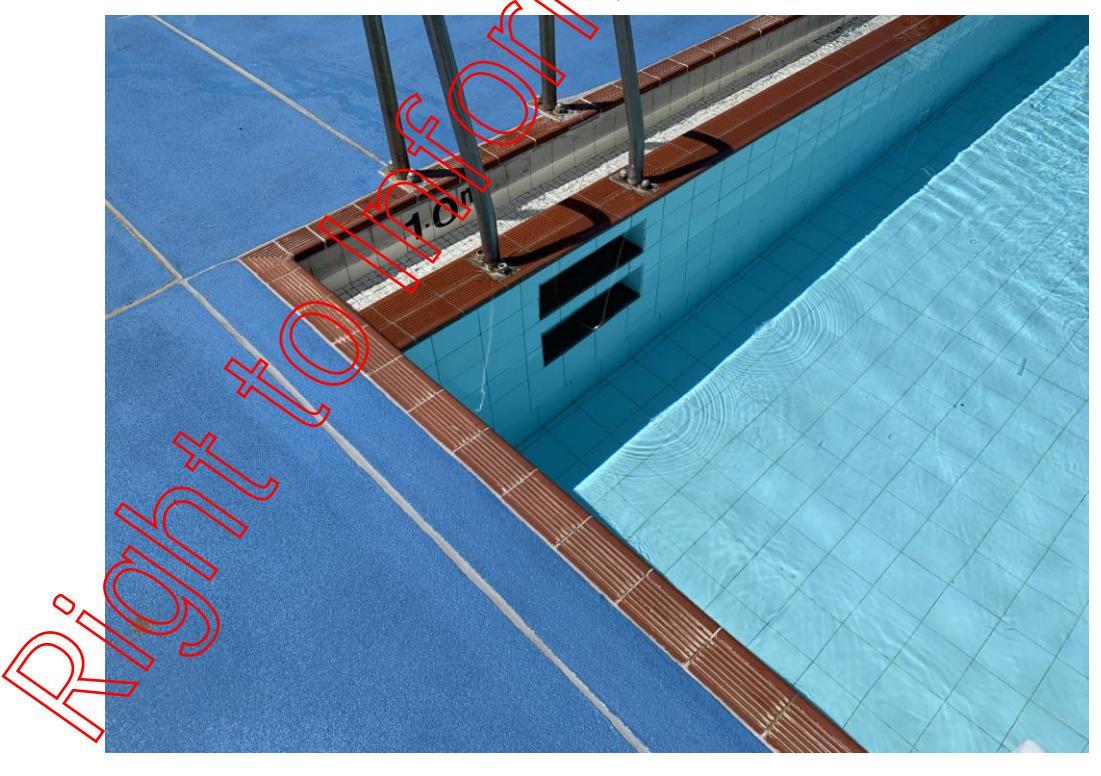
Figure 6: Steps into pool over gutter presenting injury risk

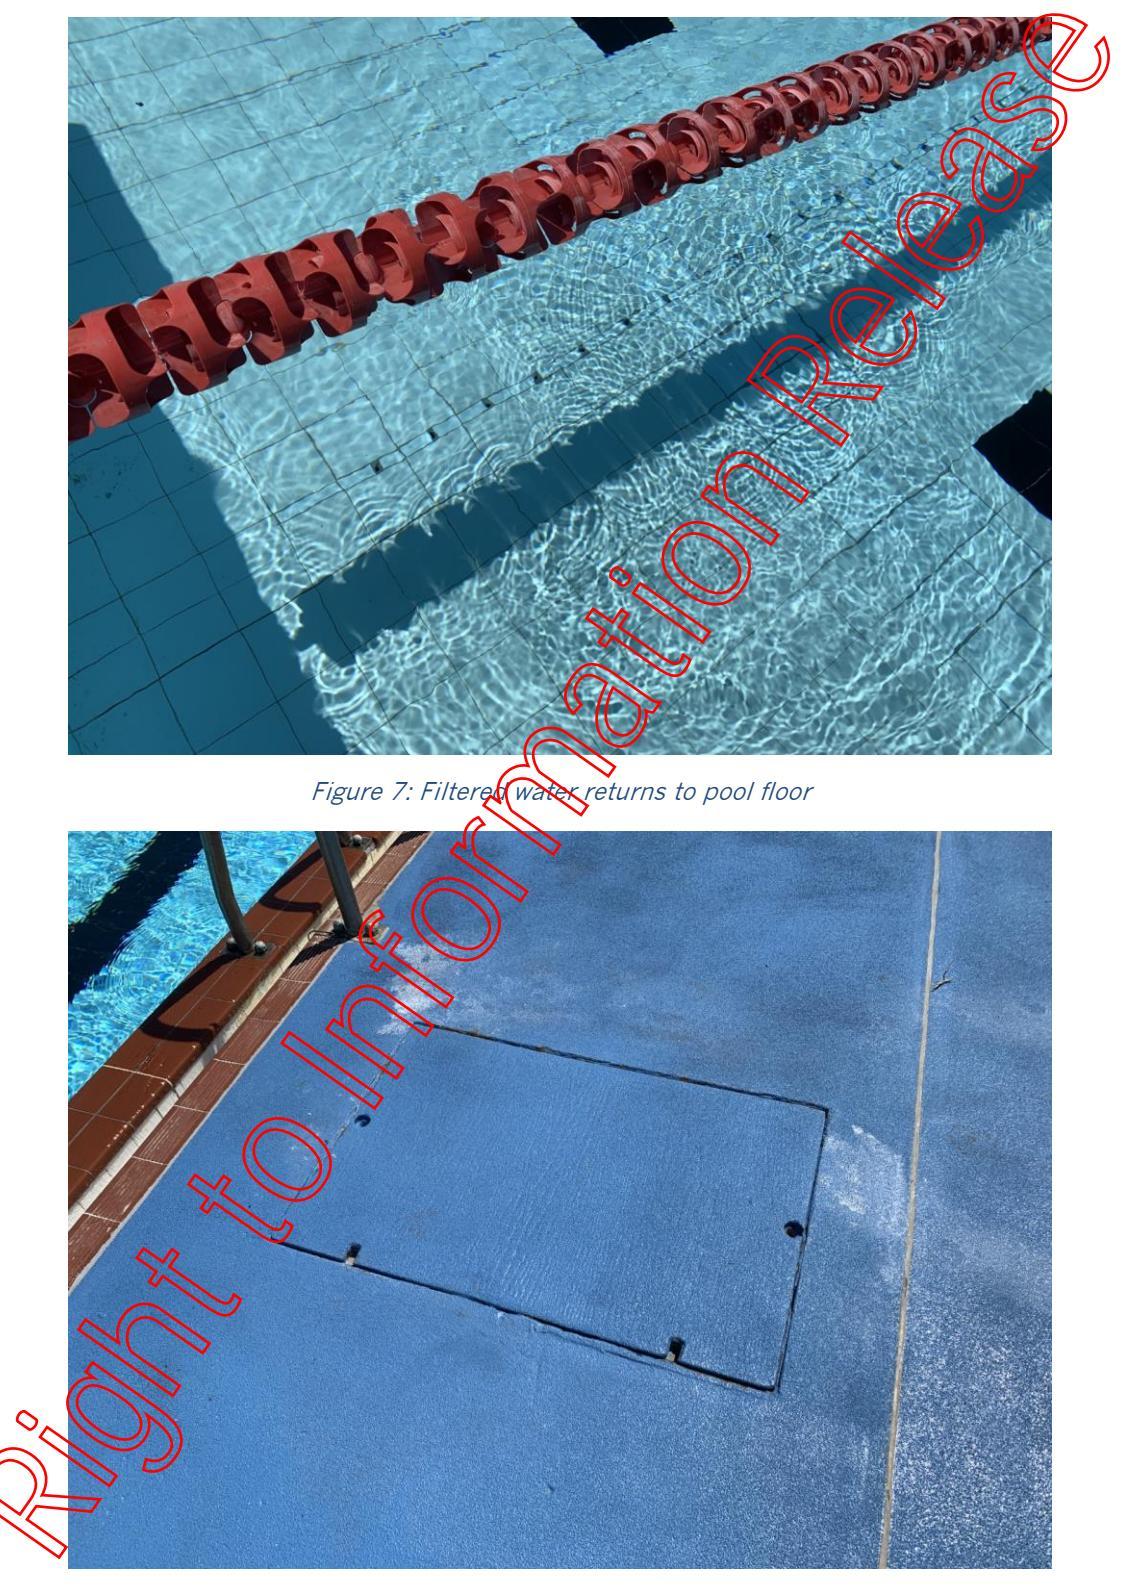
Figure 8: Heavy balance tank lid

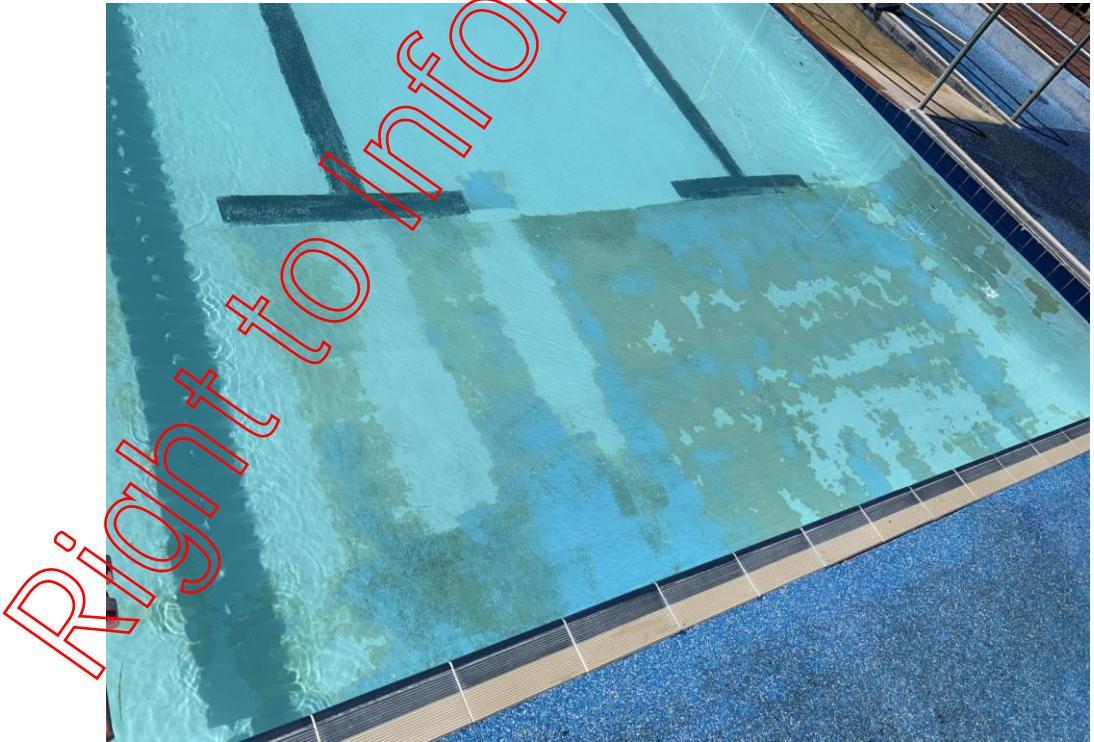
Figure 12: Region of failed finish in pool

- The painted finish in the pool is at the end of life and requires replacement, noting that also the fiberglass liner below the pool may be problematic due to its age. A higher-level approach towards the pool finish is required as discussed in the *Conclusions* section.
- The low flow through the filtration system is impacted by several factors, including the pipework, plant and poor fittings. This is discussed further in the *25m Filtration Plant* section.
- Provide strainer baskets to the skimmers.
- Provide eyeball fittings to the outlets
- Review access in and around the pool and apply a risk assessment to mitigate movement and access risks.
- If the liner is to be removed, undertake a detailed structural assessment of the underlying structure.

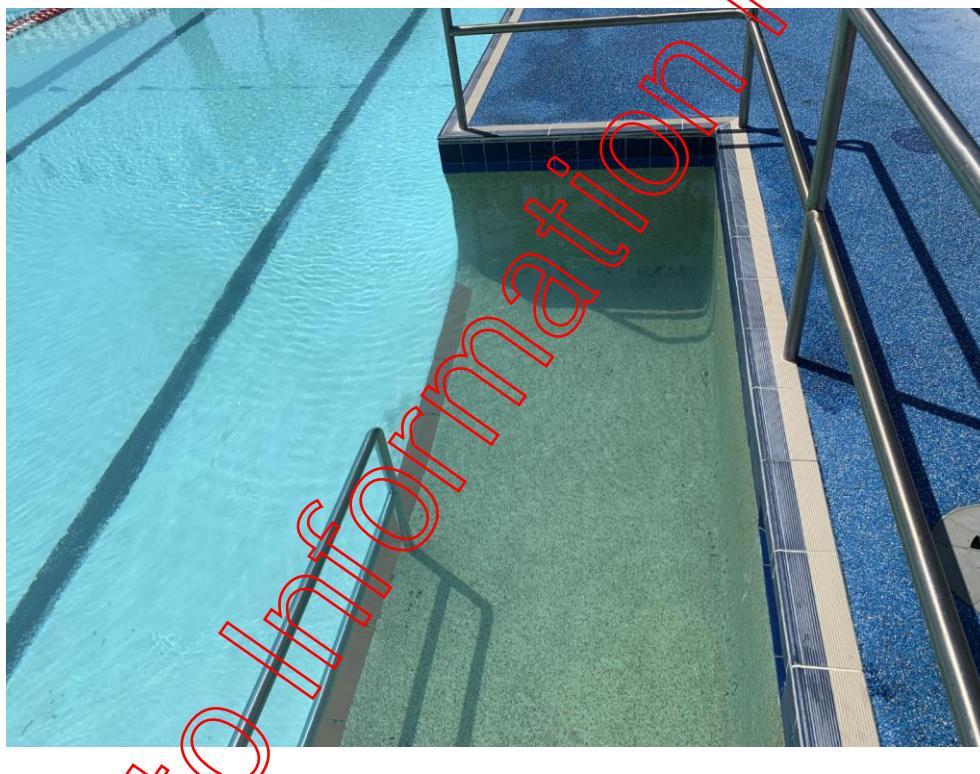
Figure 17: Bottom landing of ramp

- \circ The slip resistance of the ramp should be investigated \bigcirc .
- The profile of the ramp should be confirmed (primarily the ramp gradient)
- A compliant access method (such as a platform life) prould be maintained.
- Appropriate signage should be adopted to inform patrons of the ramp compliance.

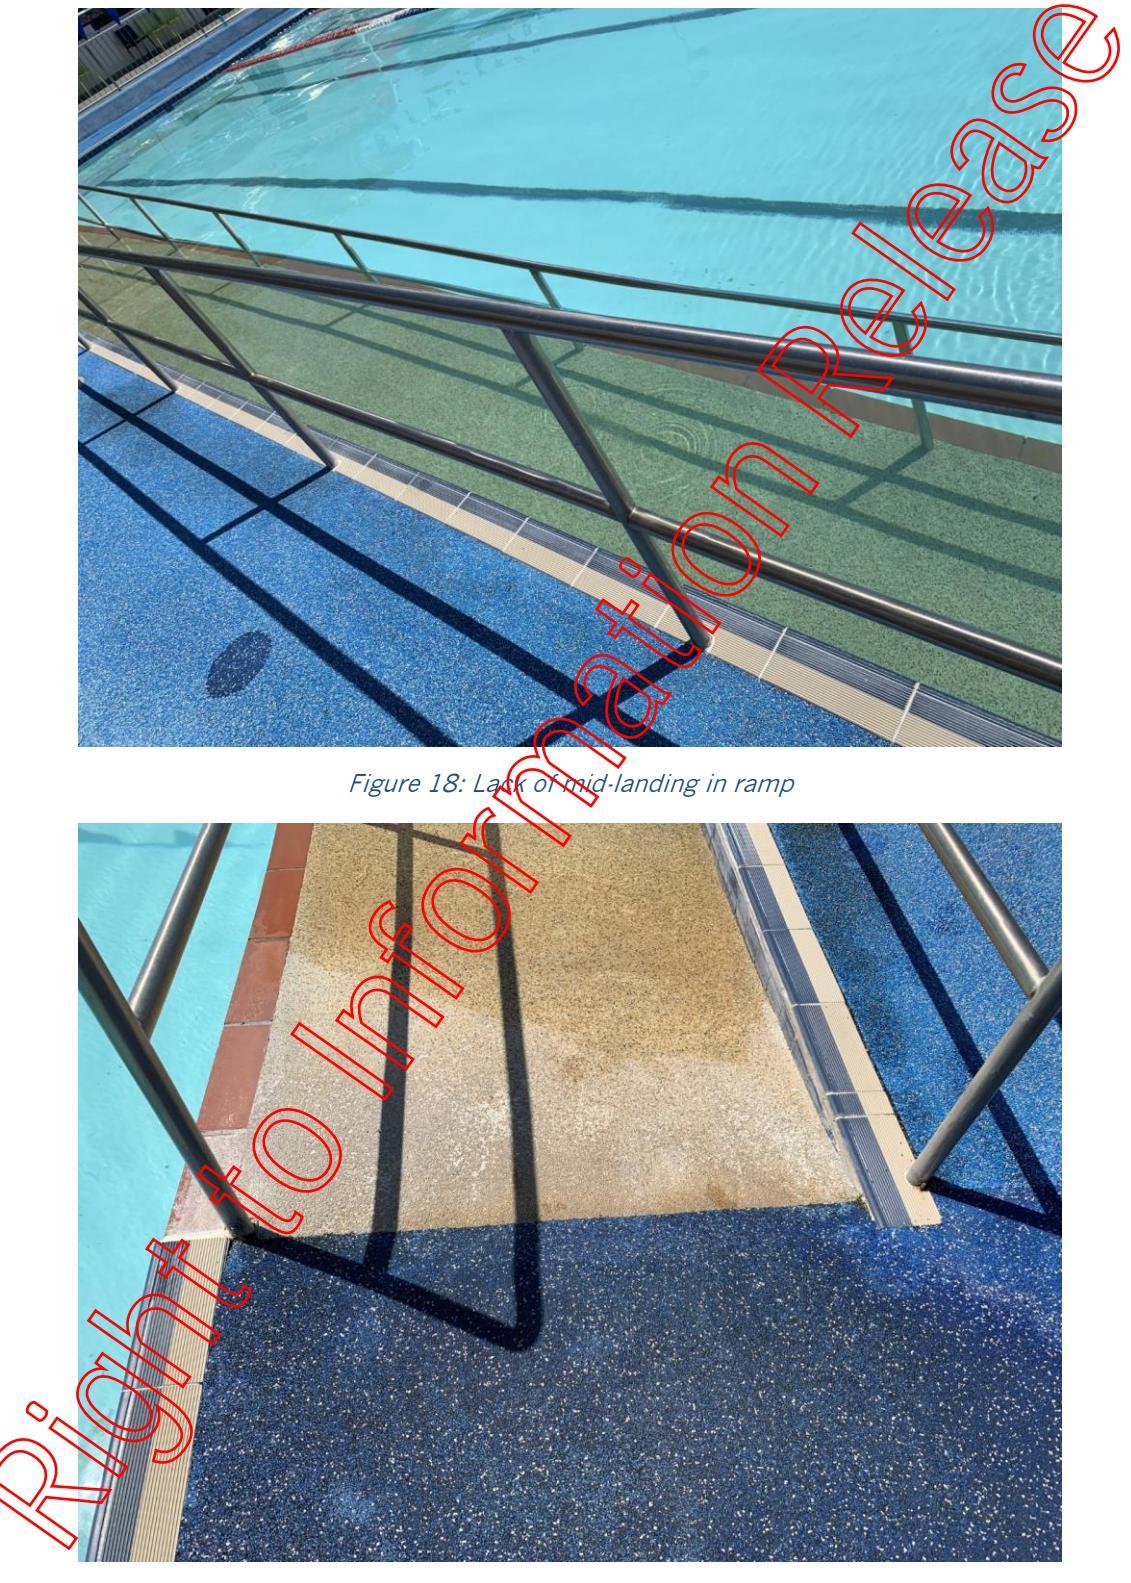
Figure 19: Initial transition into ramp identified as slippery

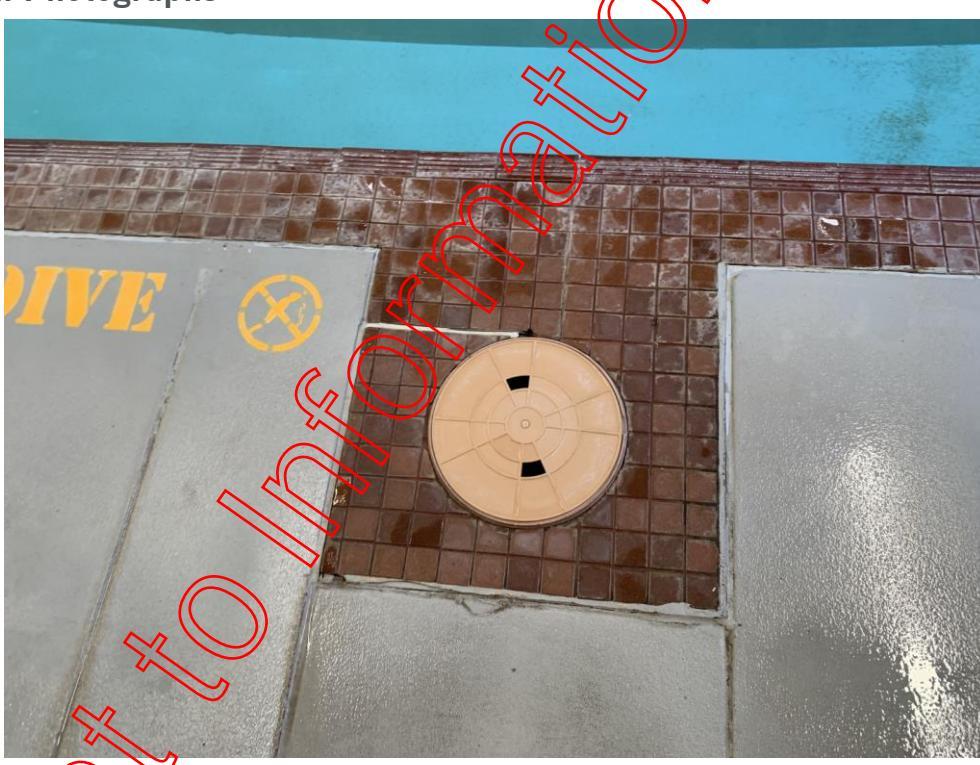
Figure 21: Skimmer in pool

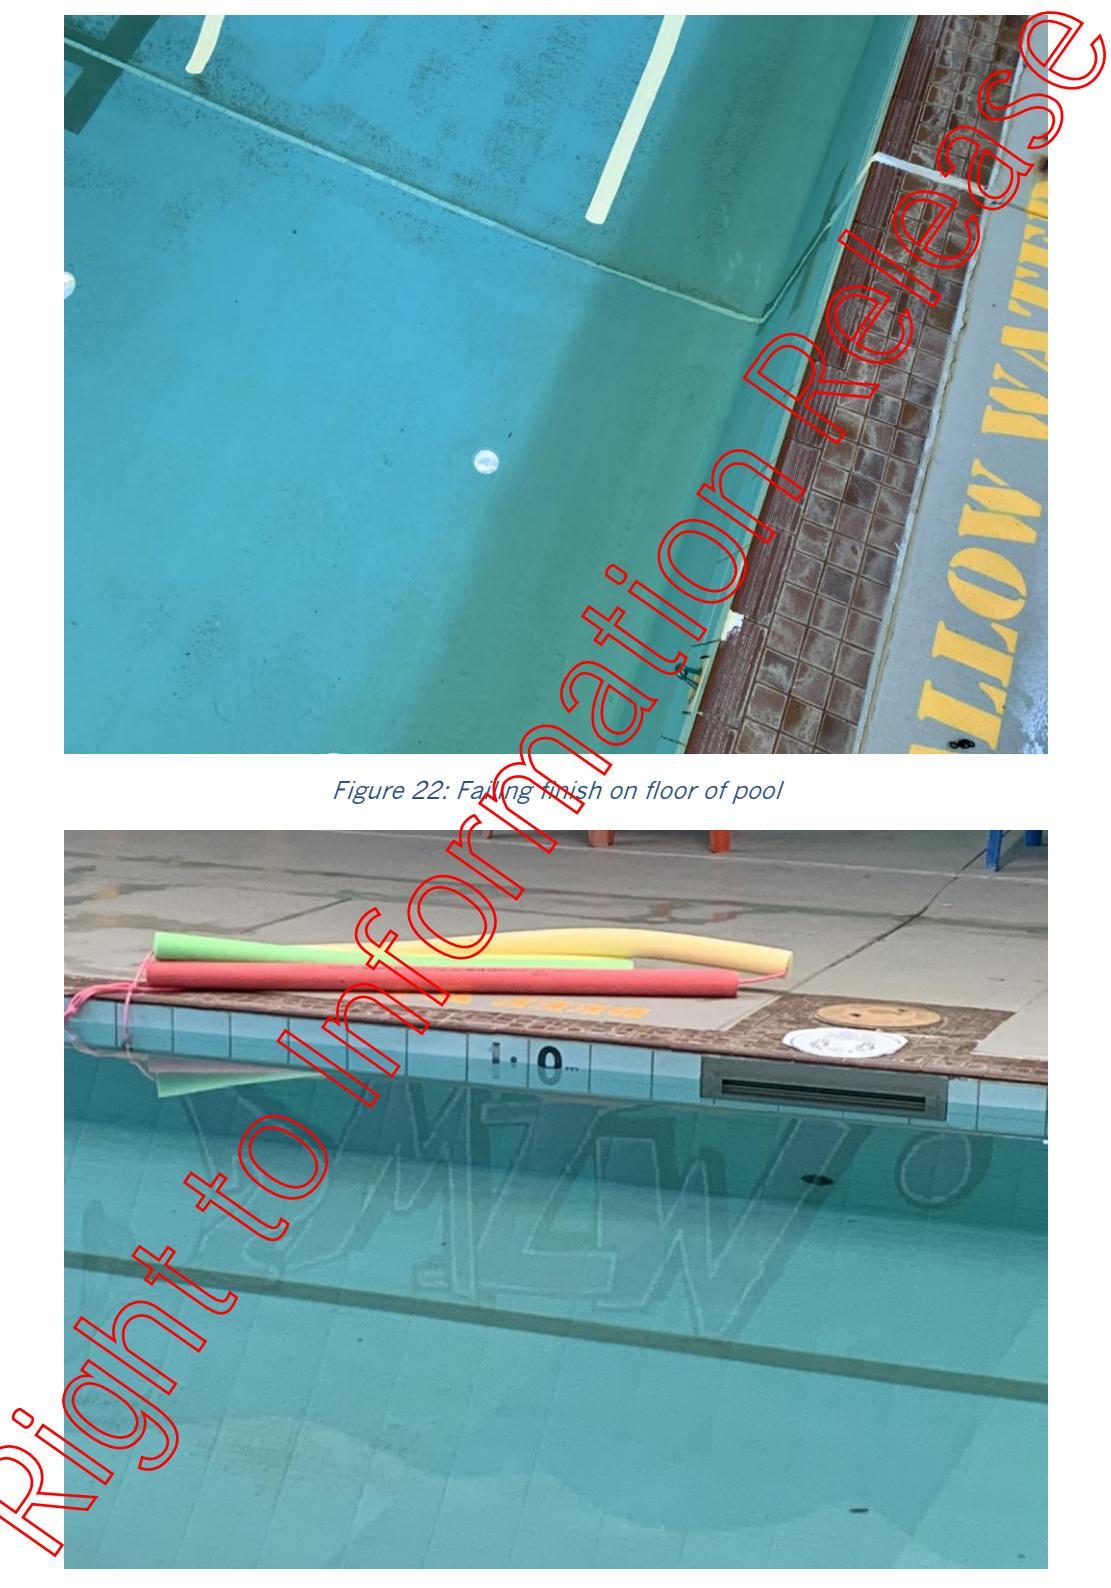
Figure 23: Submerged depth marker

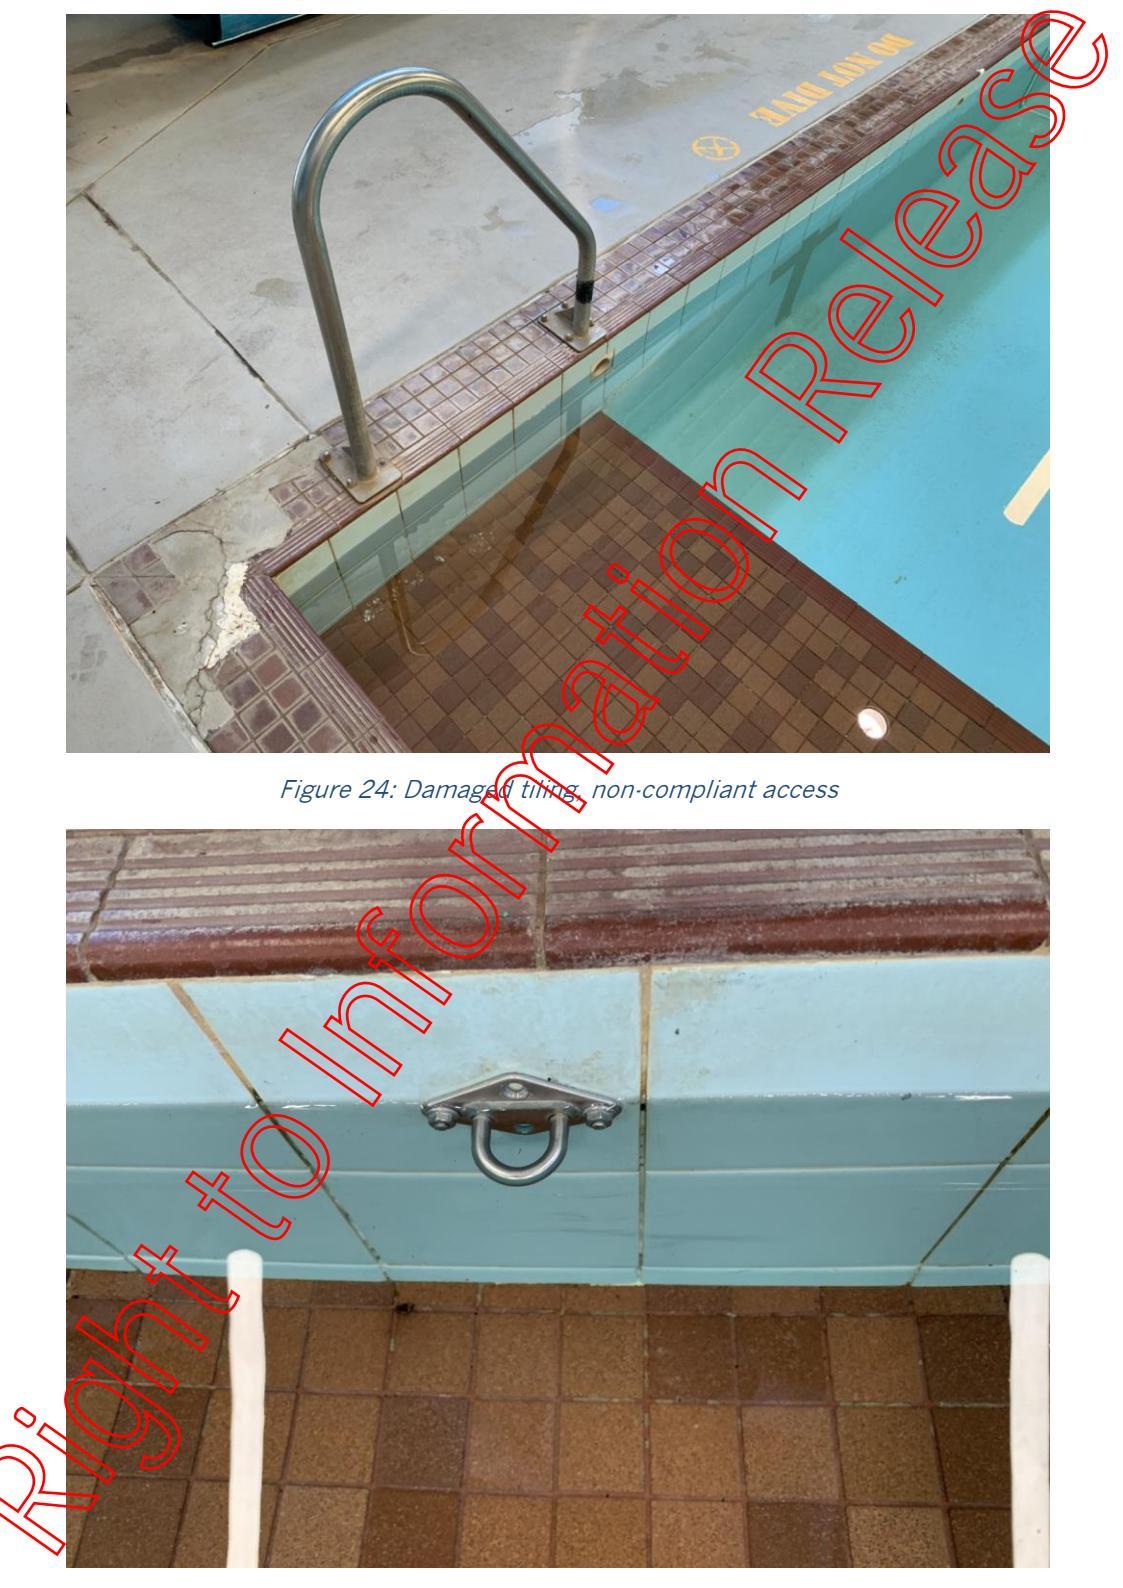
Figure 25: Prominent anchor point

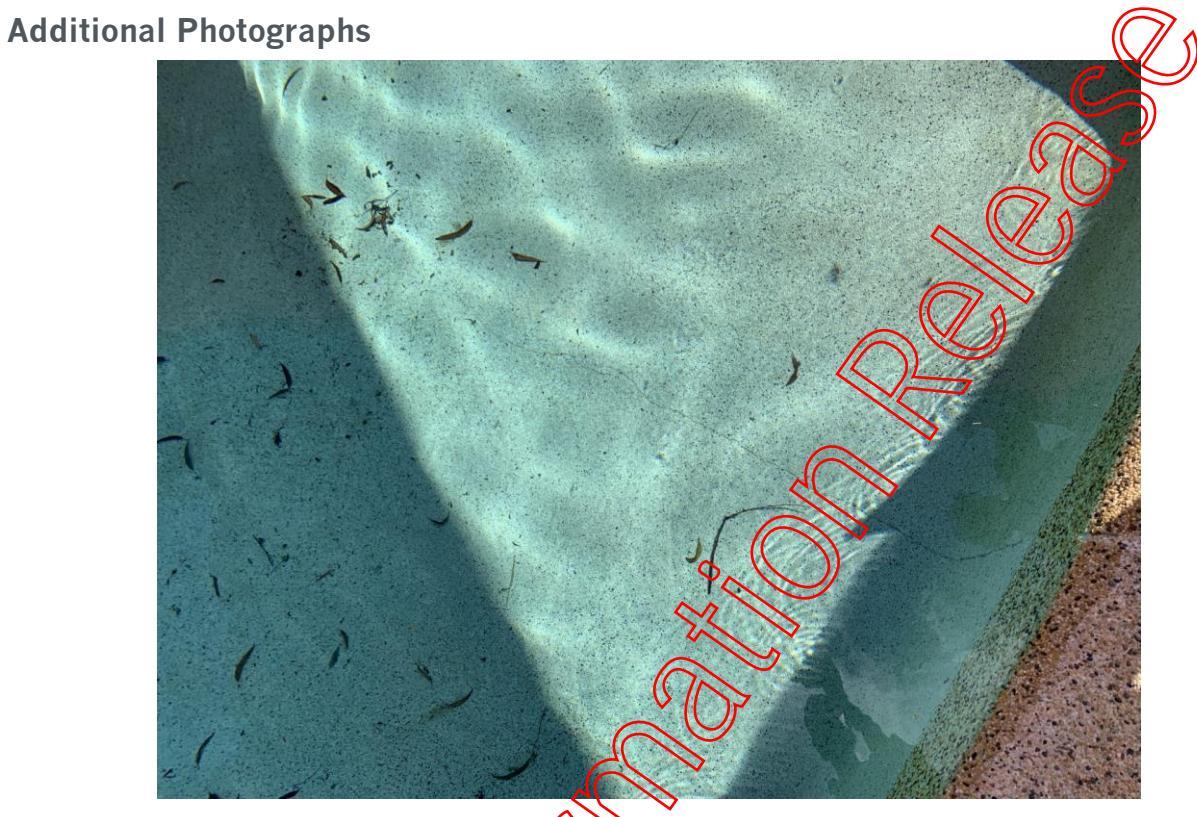
Figure 29: Crack across pool floor on eastern side

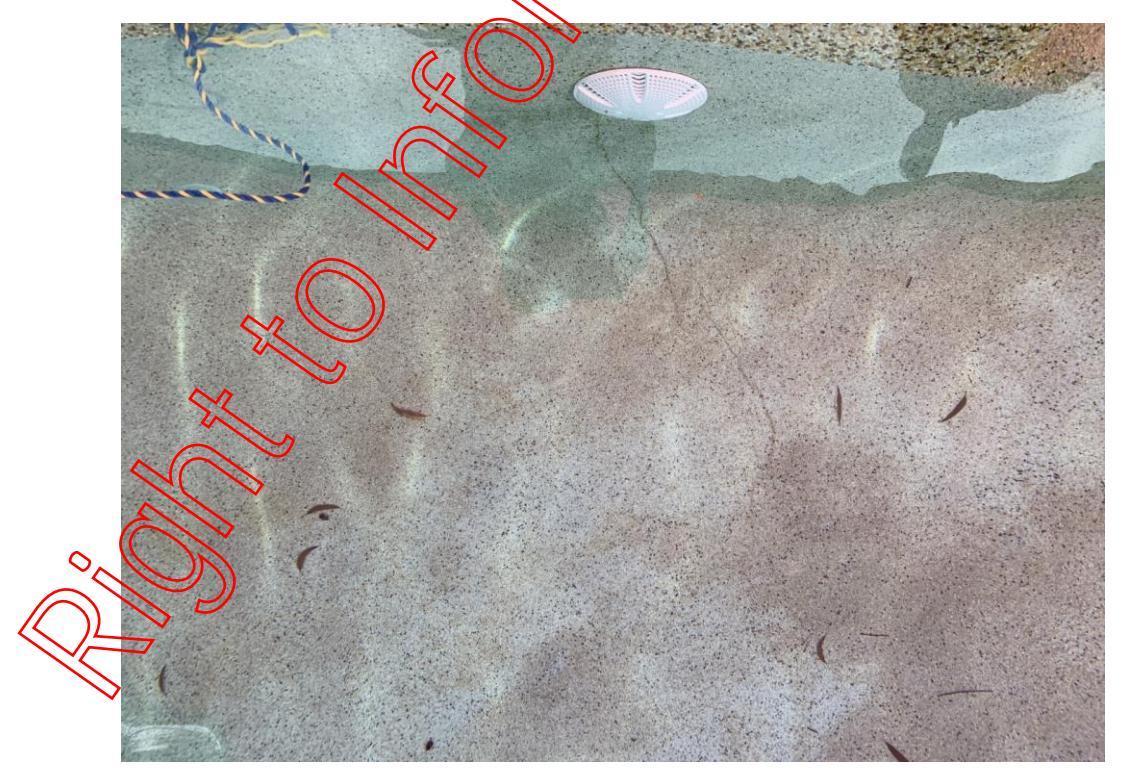
Figure 30: Crack across pool floor on western side

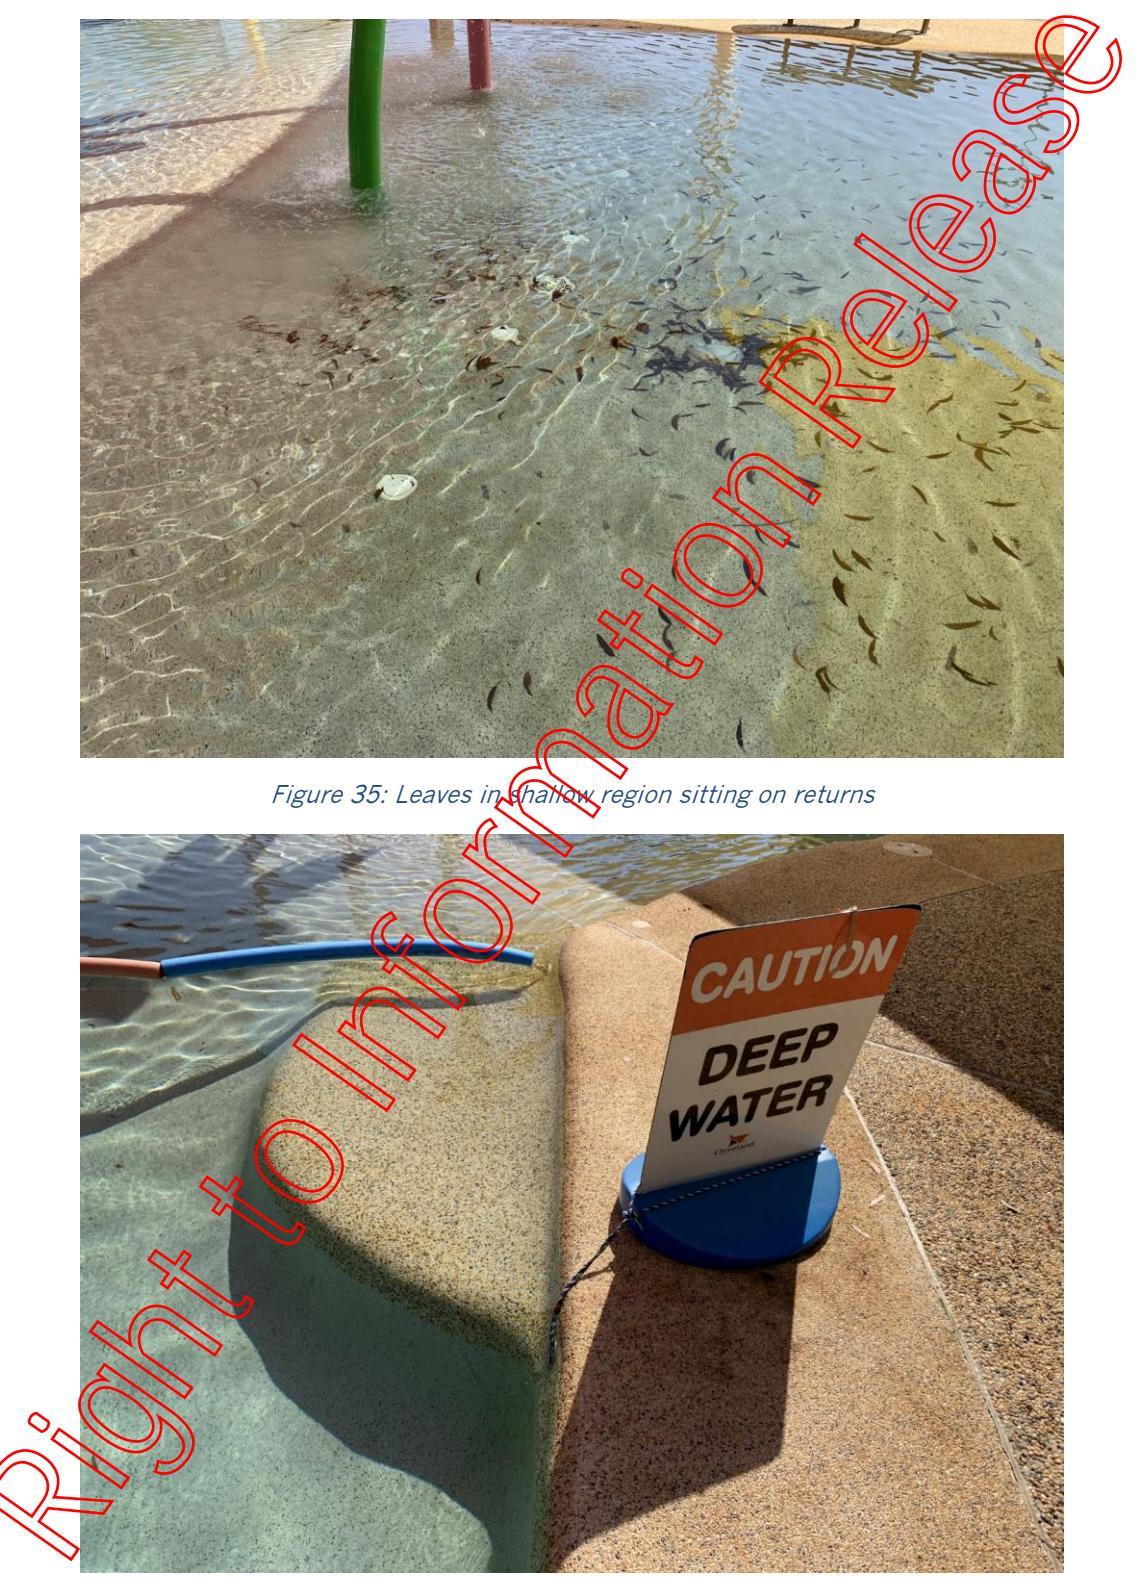
Figure 36: Deep water sign adjacent shallow water

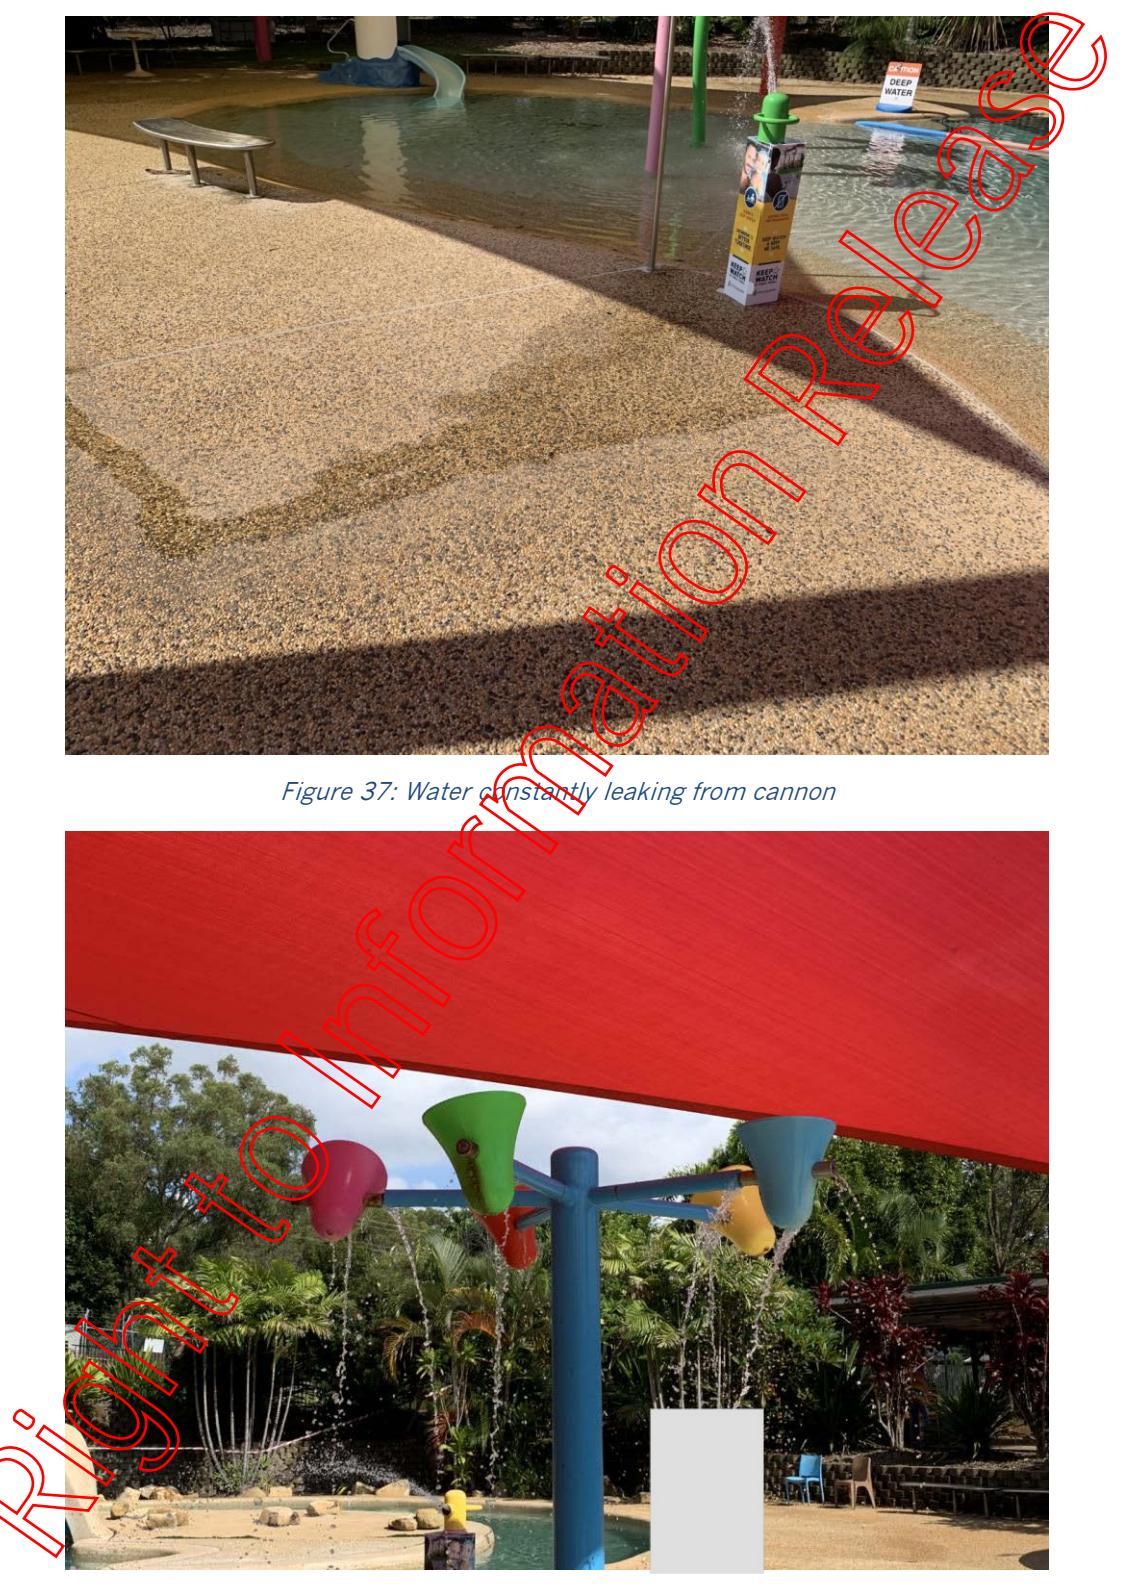
Figure 38: Jammed bucket

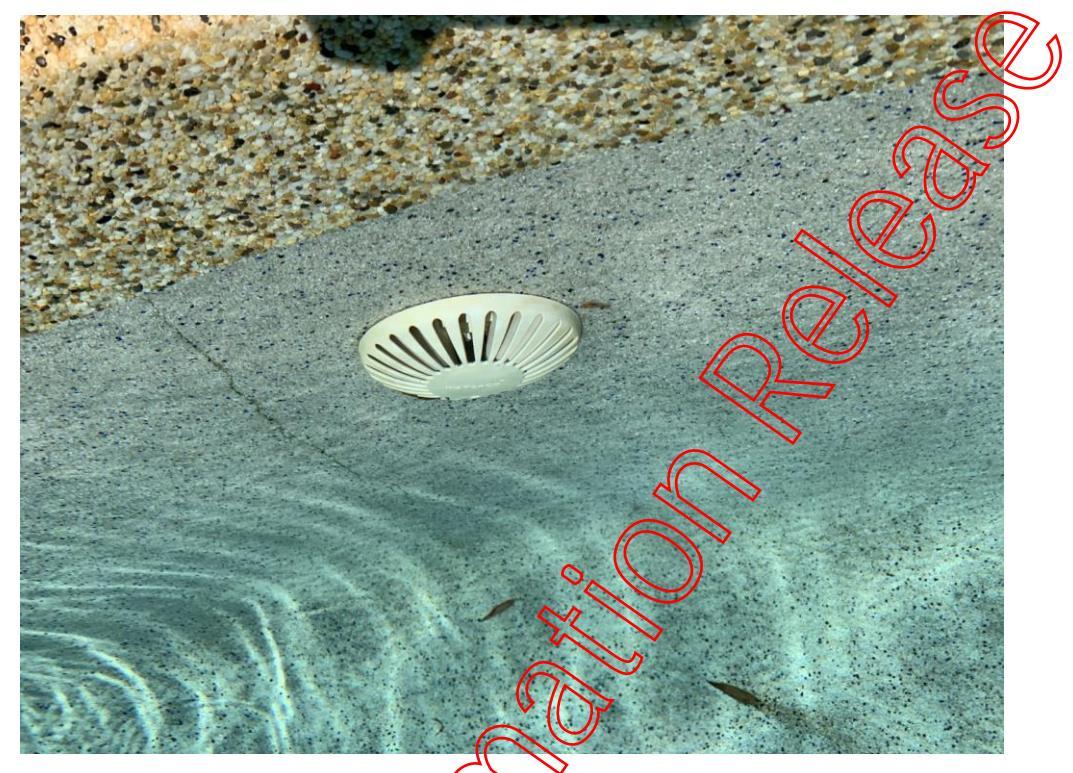
Figure 39: Older area suction, crack in wall

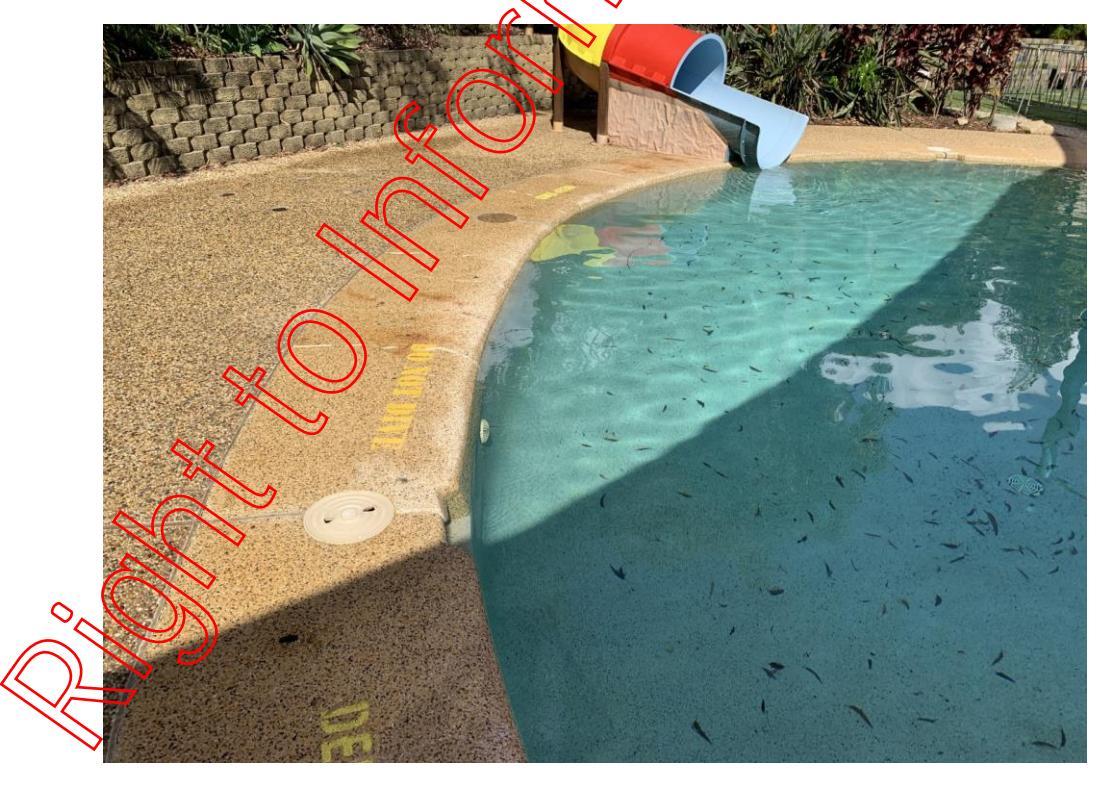
Figure 40: Cracks in coping

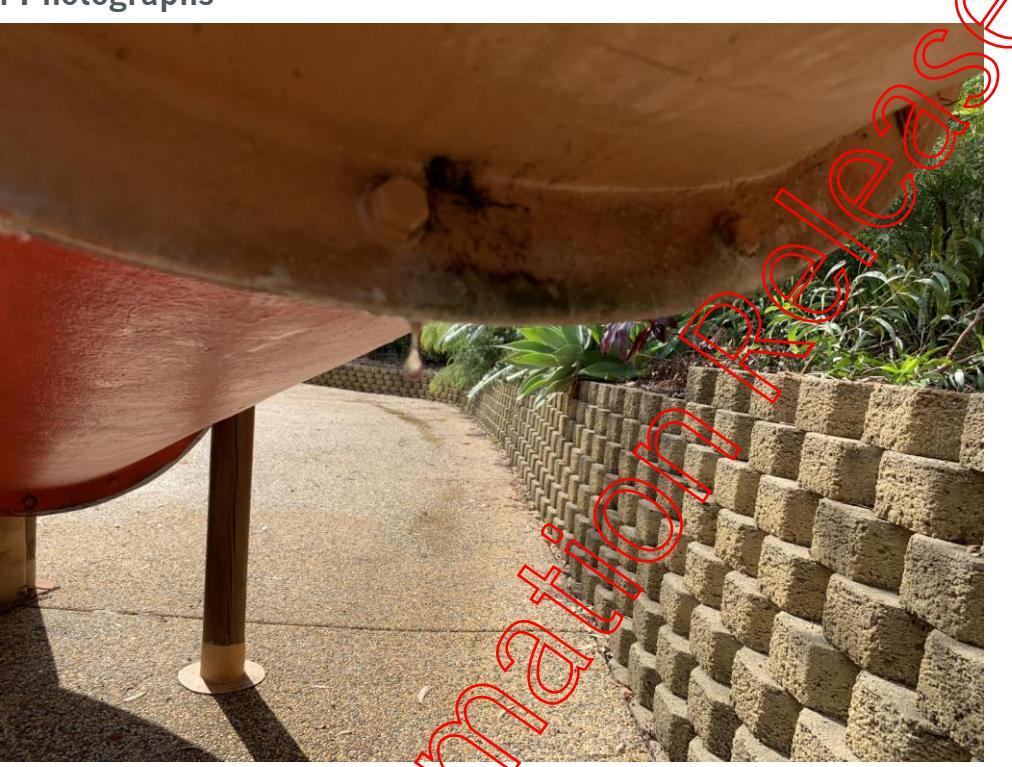
Figure A: Leaks from slide flume

As a minimum, refurbish the slide and access way and undertake regular inspections of the timber support posts for rot and degradation. For long term planning, consider whether the slide is fit for purpose and the risks are considered appropriate.

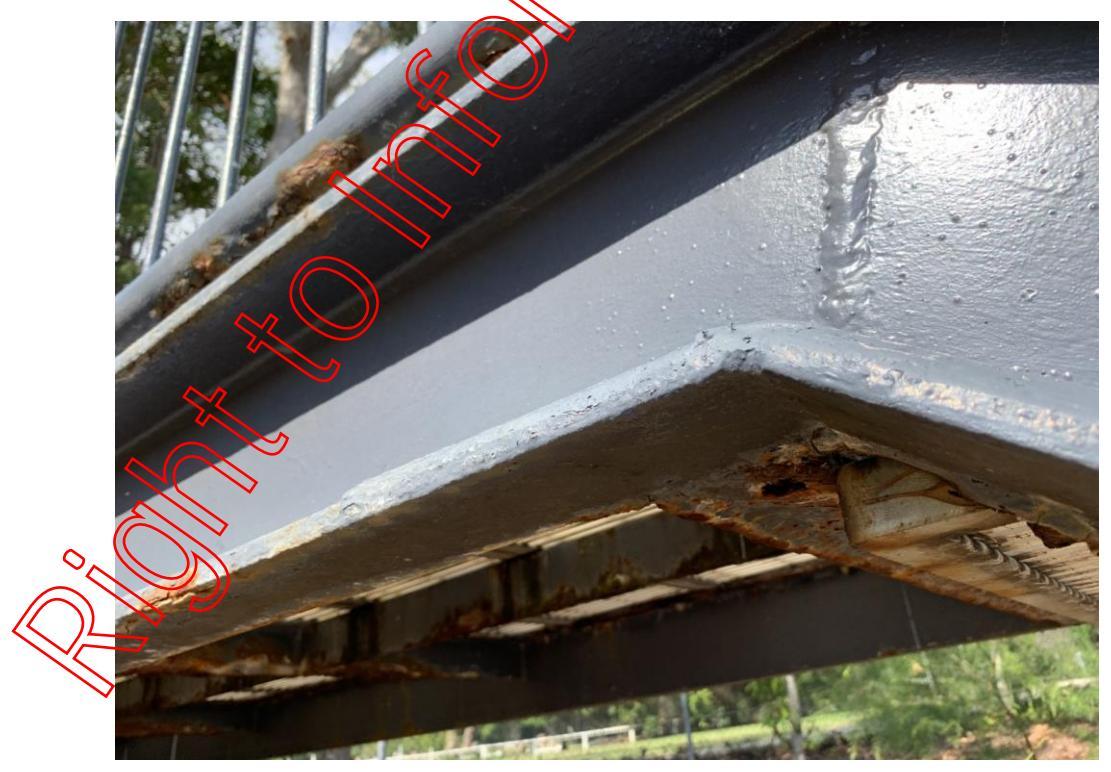
Figure 43: Rust under slide access way

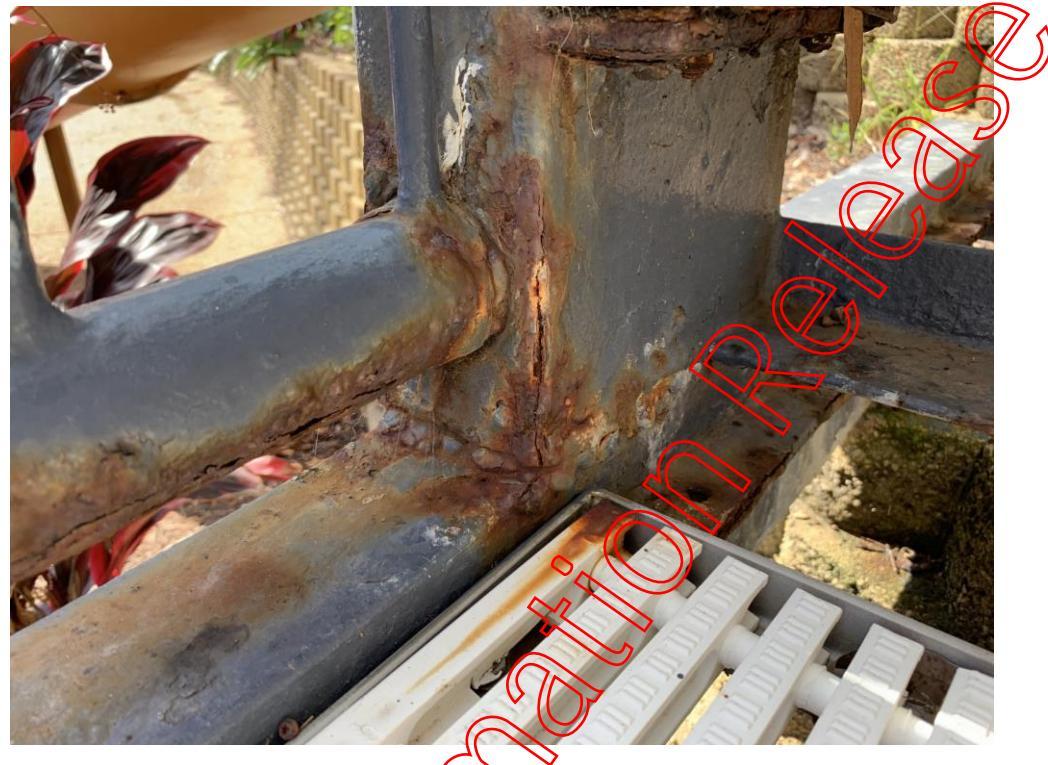
Figure 44: Rust in slide access way

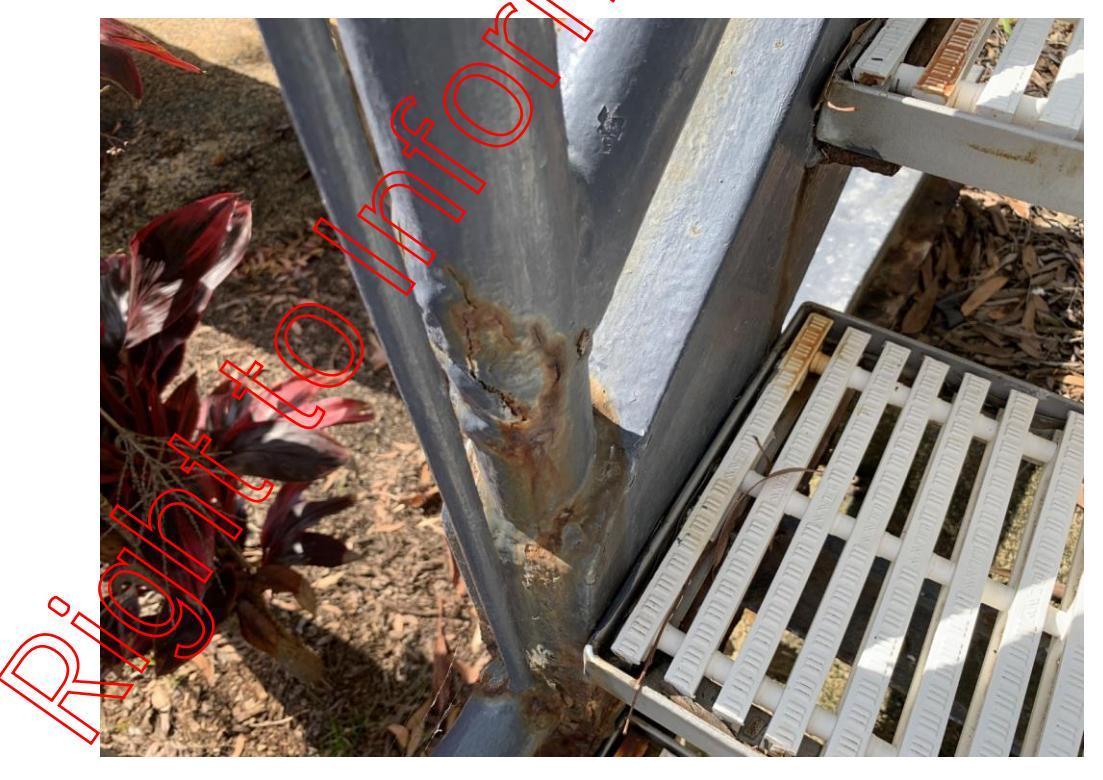
Figure 45: Rust in slide access way
