CLEVELAND AQUATIC CENTRE UPDATED POOL CONDITION ASSESSMENT

AND MAINTENANCE PLANS

(July 2014)

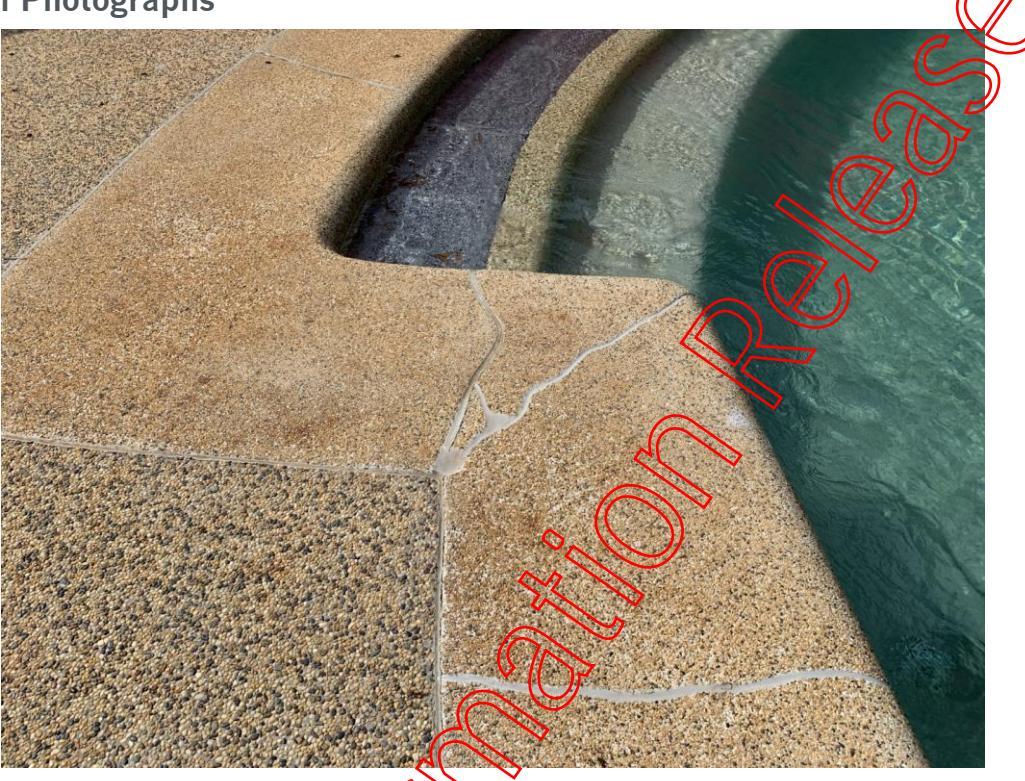
• A significant number of cracks are observed in the pool structure. The coping of the pool is regularly cracked with hairline cracks that appear to be relatively minor and likely a result of under-reinforcement in the coping. Several larger cracks are present in the walls of the pool which are larger than hairline that raise concern regarding the structural integrity of the pool. These cracks are vertical in the wall on the island and across the coping around the outlet grate. Additionally, a mass concrete bench is present in the pool which has large cracks at one end, indicating it is unremoted.

Figure 47: Nomerous cracks in pool coping

- Undertake dye testing on the poor cracks to determine if there's leaks. Inspect the cracks closely during the dye testing to measure the width and attempt to determine if the cracking continues through the substructure or is primarily in the firstes level. Obtain specific direction following these works.
- Provide a proper access ladder to the pool, ensuring that it does not form an obstruction to patrons utilizing the river. This may be better off provided as a set of stairs constructed into the bench region with a handrail.
- Repair the failed floor finishes sections as a short-term rectification and consider full finishes replacement as a long term. For the repairs, it's recommended to drain the pool, remove any additional loose areas, make good the remaining and inspect the finishes for any other drummy sections.
 Undertake a signage audit as discussed later in this report.

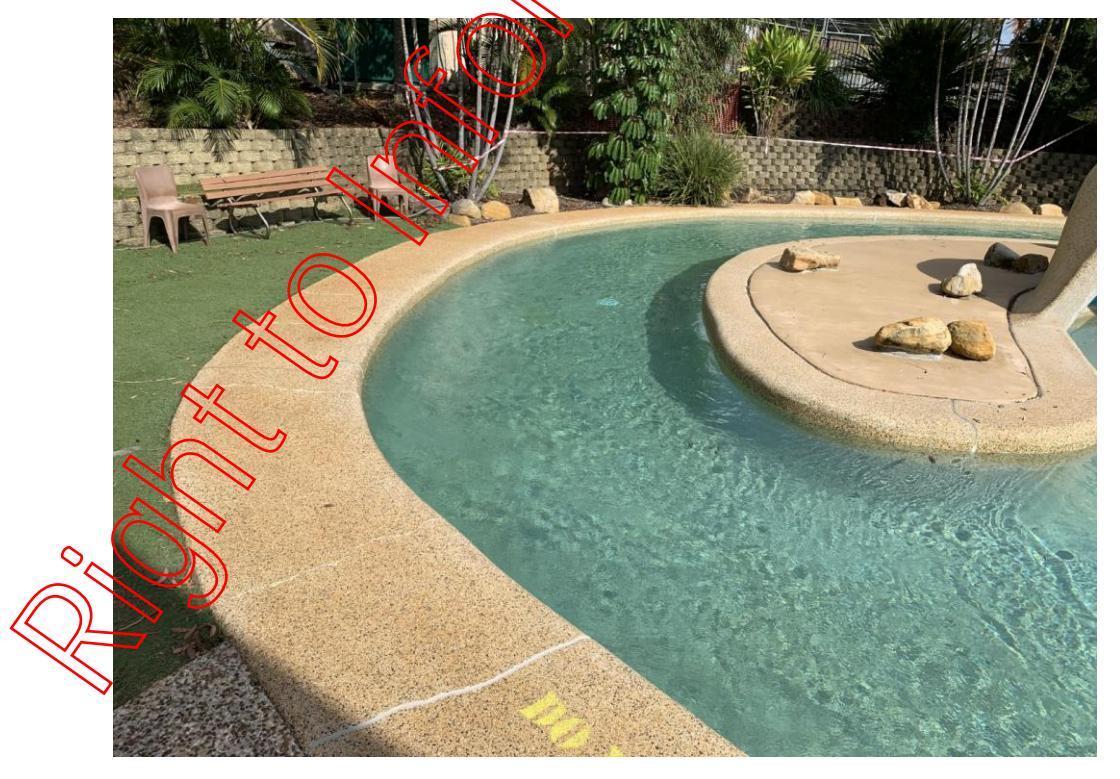
Figure 48: Cracks in coping

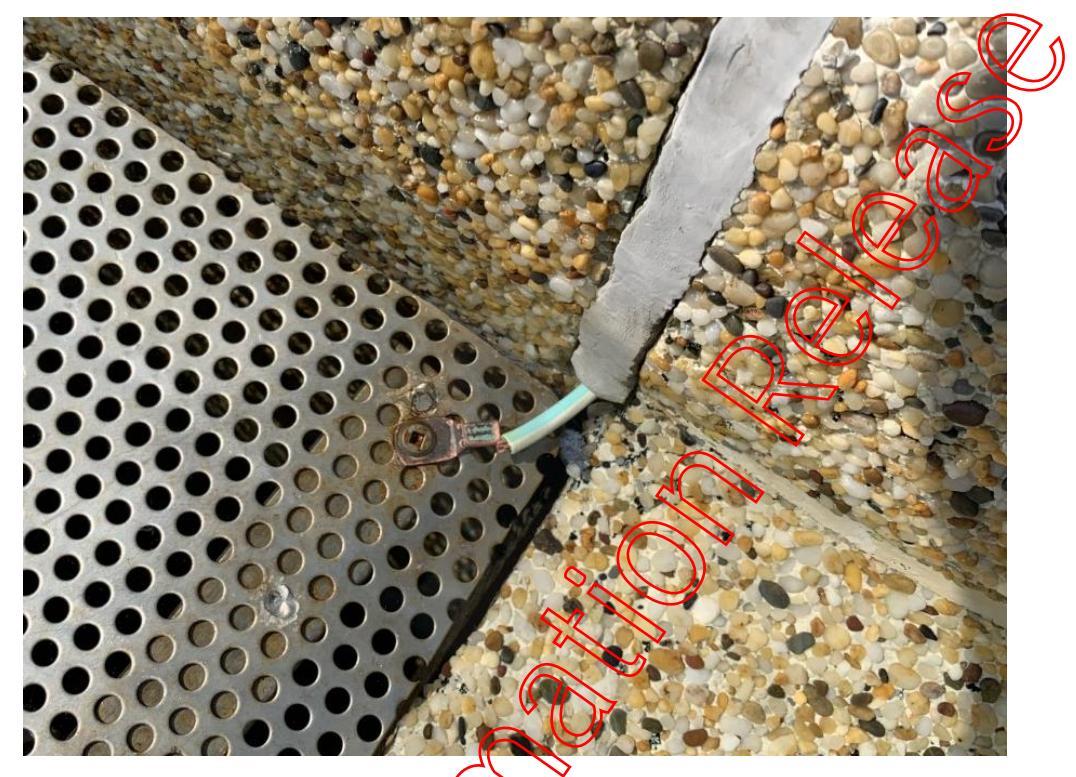
Figure 51: Broken earth connection to overflow grate

- Repair the broken earthing connection
- Provide a cover system to the floor jets

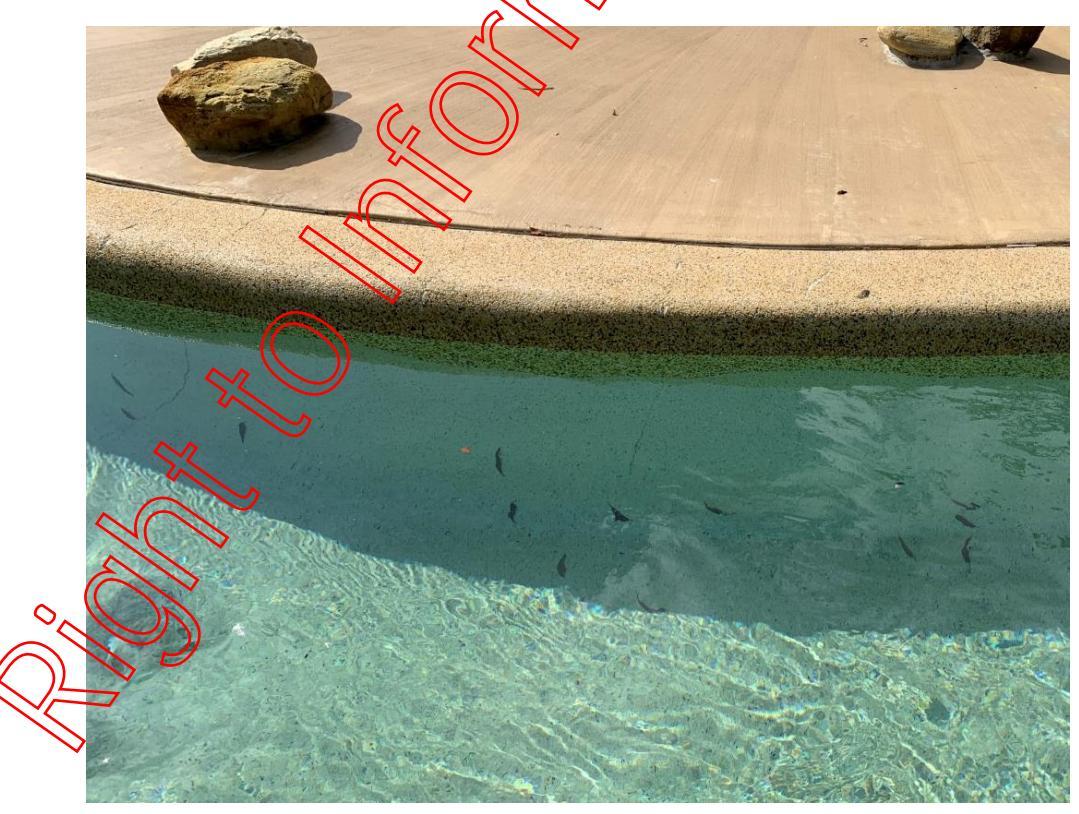
Figure 52: Cracks in pool wall

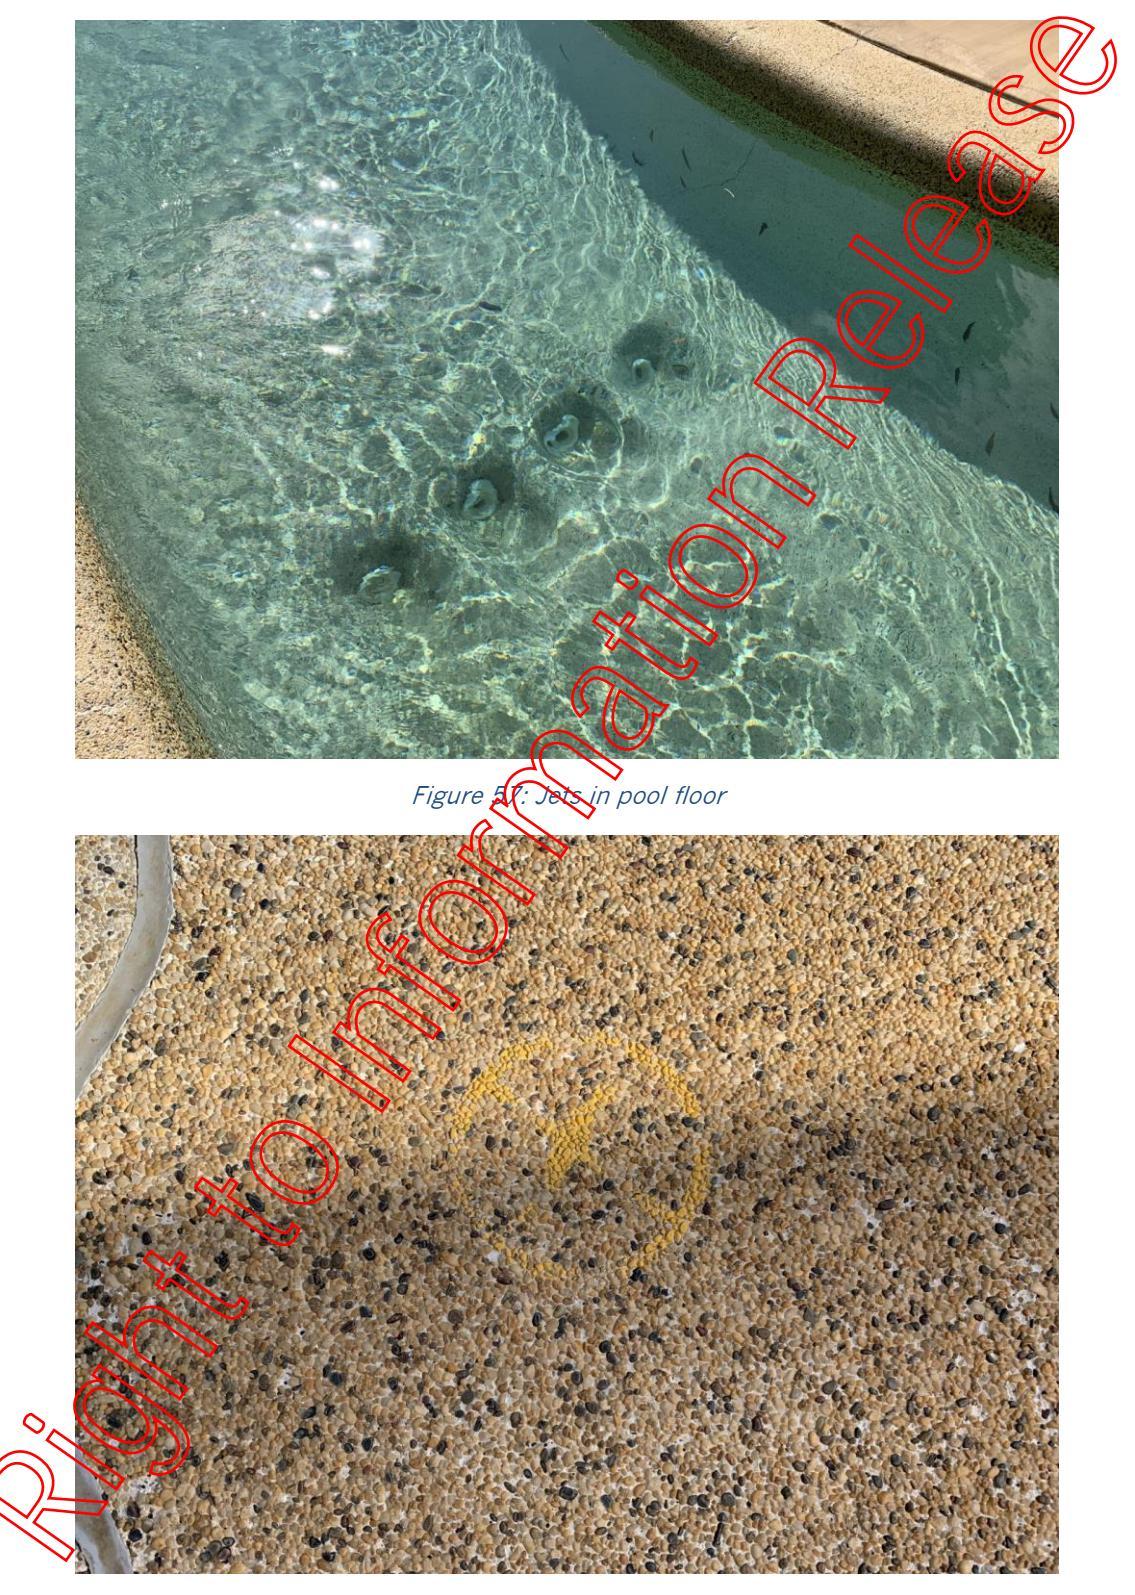
Figure 58: Faded signage

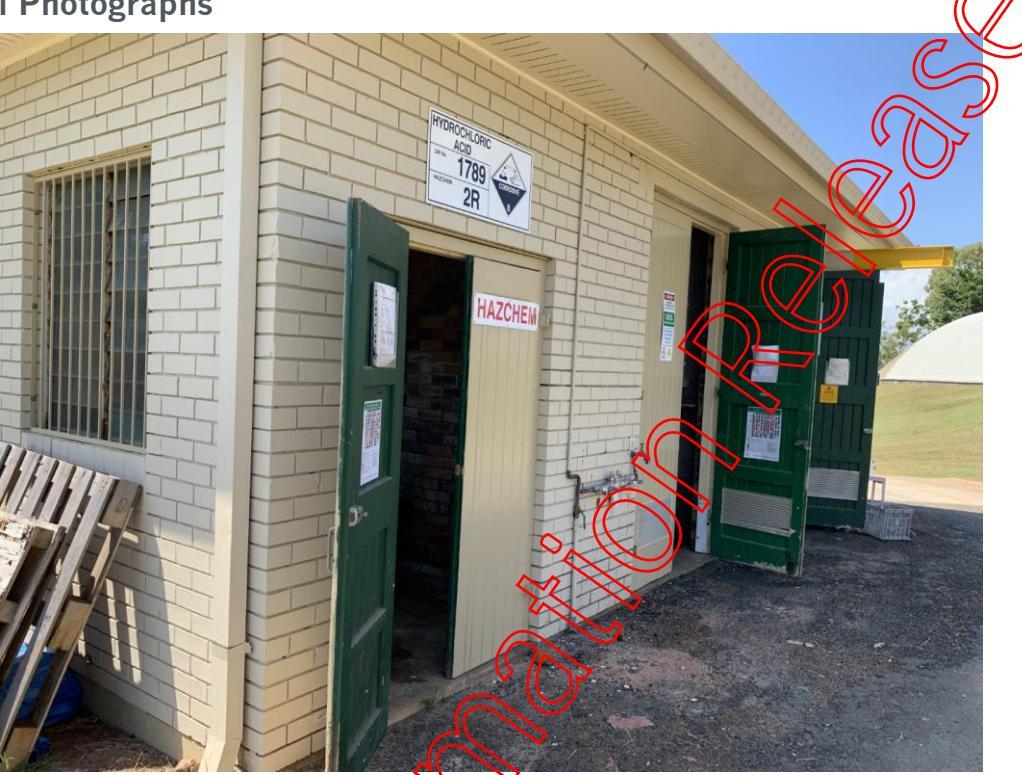
Figure 6 Chlorine unloading area

- Consider converting from bulk liquid chlorine (discussed in the *Conclusions* section) or provide a bunded truck unloading area in accordance with AS3780 *The Storage and Handling of Corresive Substances*.
- Provide adequate signage to all chemical storage areas including the equipment room exterior and chemical dosing areas. Ensure MSDS's are located adjacent relevant chemical stores and that clear access is available to all chemics.
- Label all pipes with their flow direction and contents and label all valves clearly.
- Re-run the heater circulation pipework to be neater, correctly supported and functional.
- Engage an electrical softractor to provide a full internal condition and compliance audit on the boards and electrical installation.

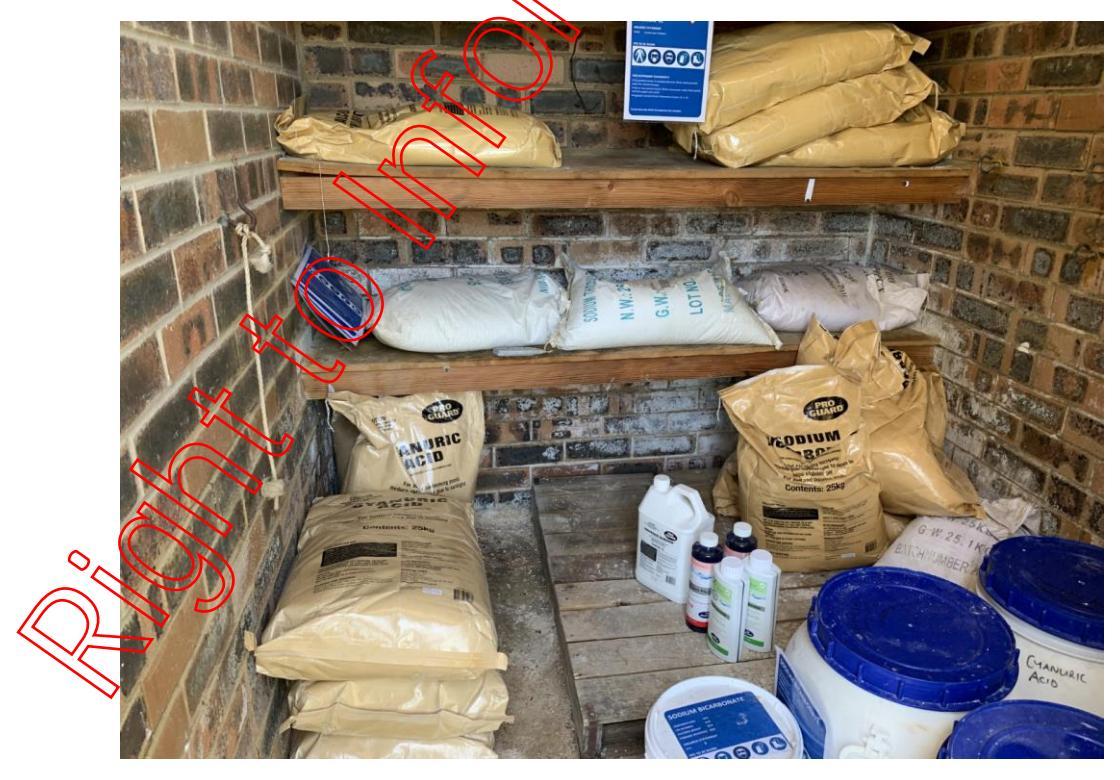
Figure 62: Crowded chemical storage, poorly labelled

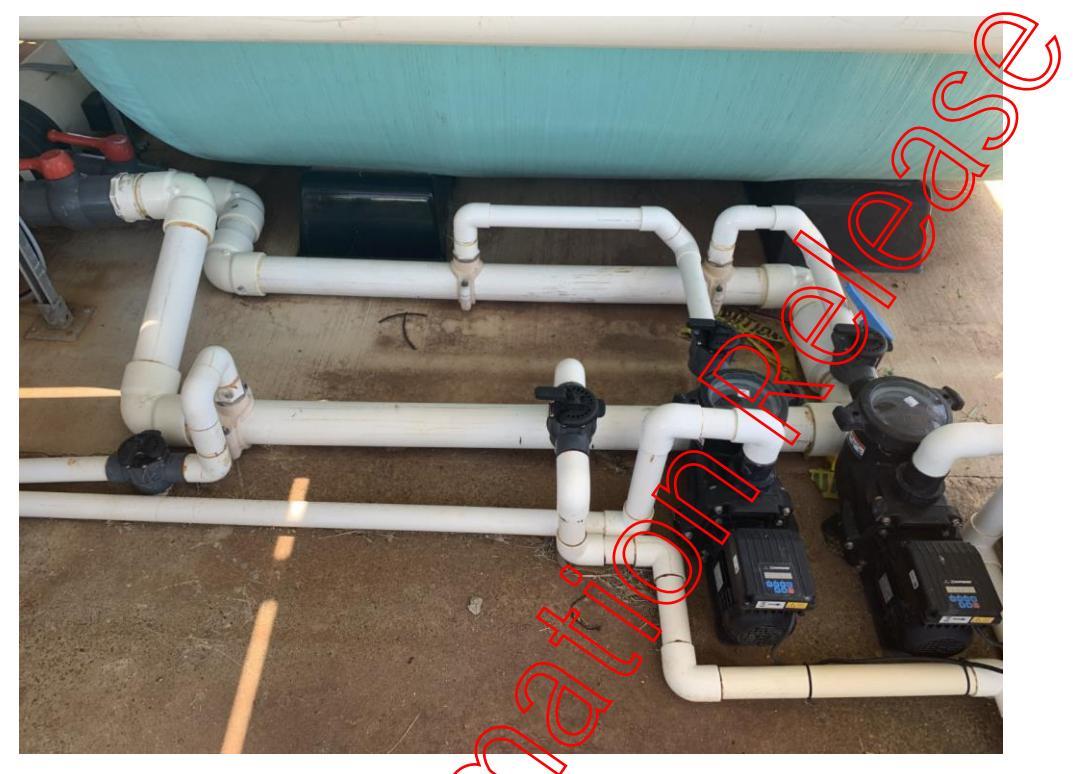
Figure 63: Unlabeled for configured heater pipework

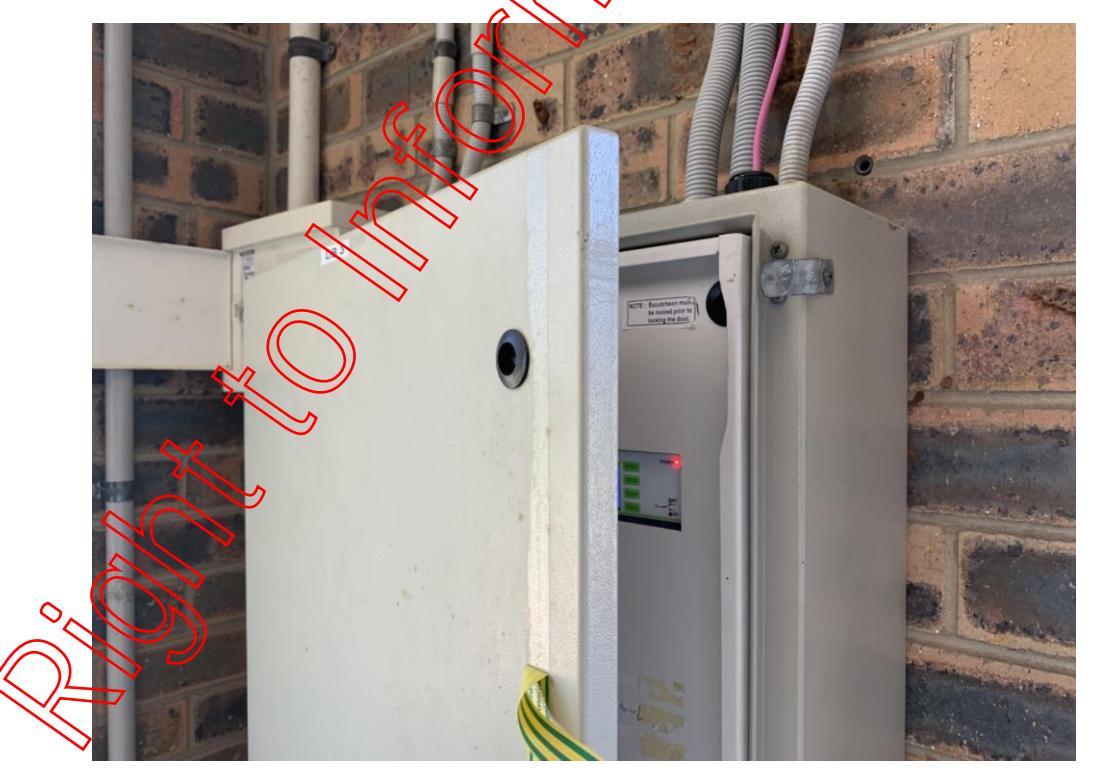
Figure 64: Conduit clip to hold door closed

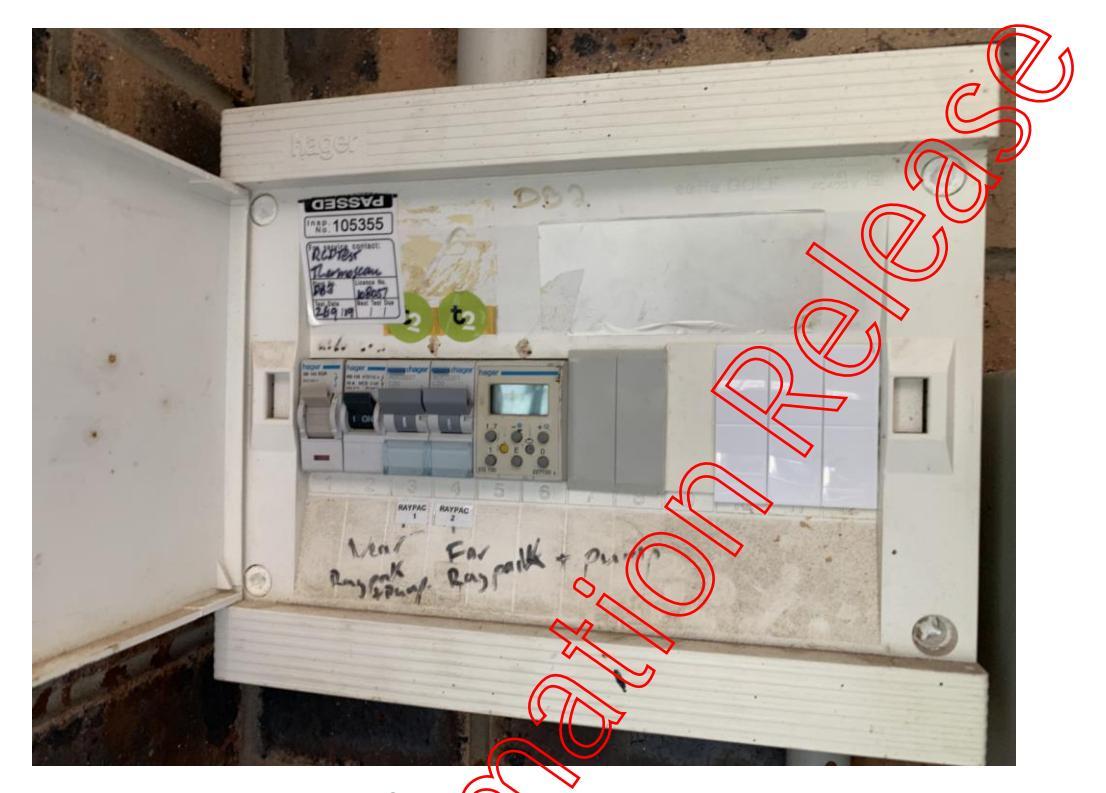
Figure 65: Porty Appelled control panel

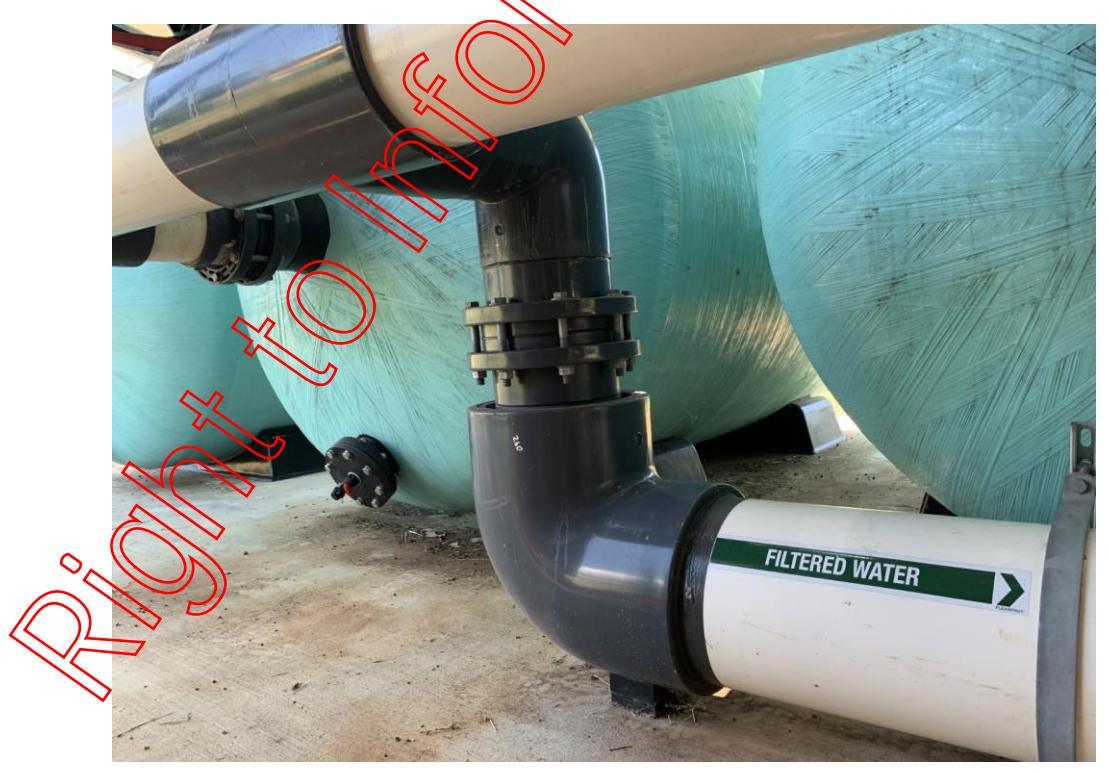
Figure 68: Late increase in pipe size

- Rebuild the filtration system manifold to be correctly sized and to avoid trip and head strike issues in areas through walkways.
- Review the operational procedure for removing the hair and lint basket for cleaning and consider the addition of a lifting davit.
- Provide a new chemical controller.
- Consider replacement of the gas heating system with electric heat-pumps.
- Replace failed pressure and tow measurement equipment.
- Label chemical injectors.
- Run all chemical dosing hores in sealed conduits from dosing controllers/pumps to injection points.

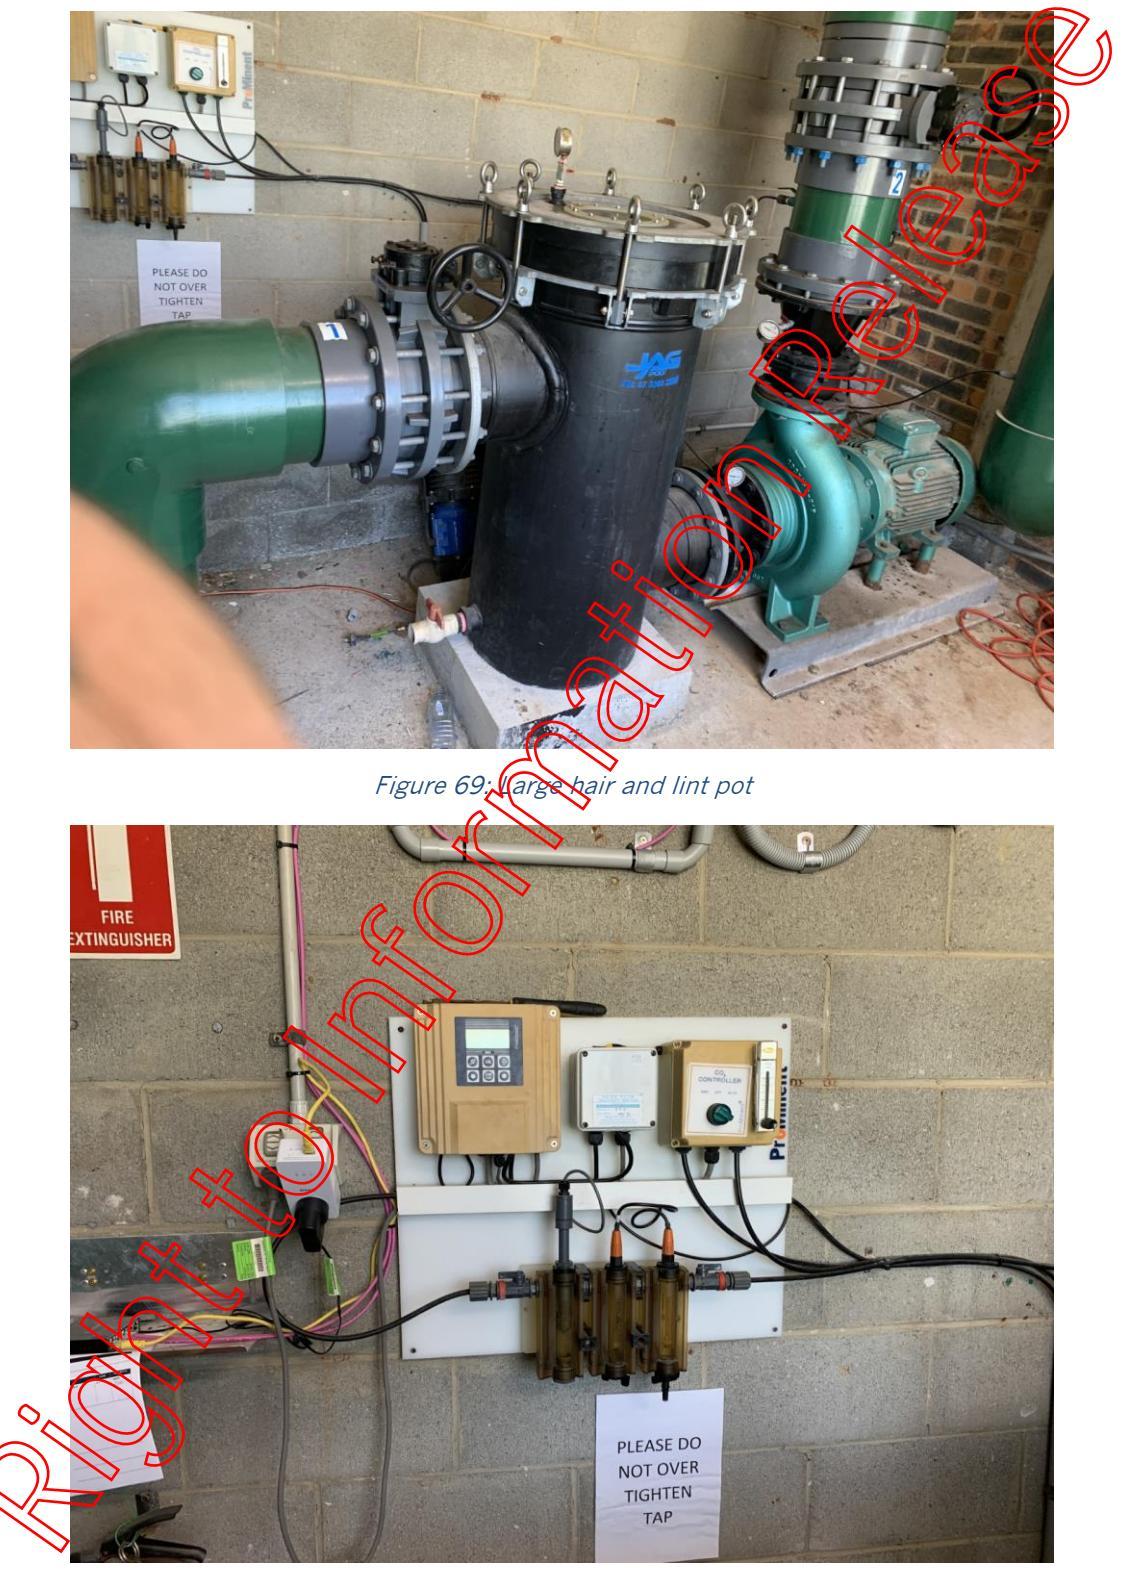
Figure 70: Obsolete chemical controller

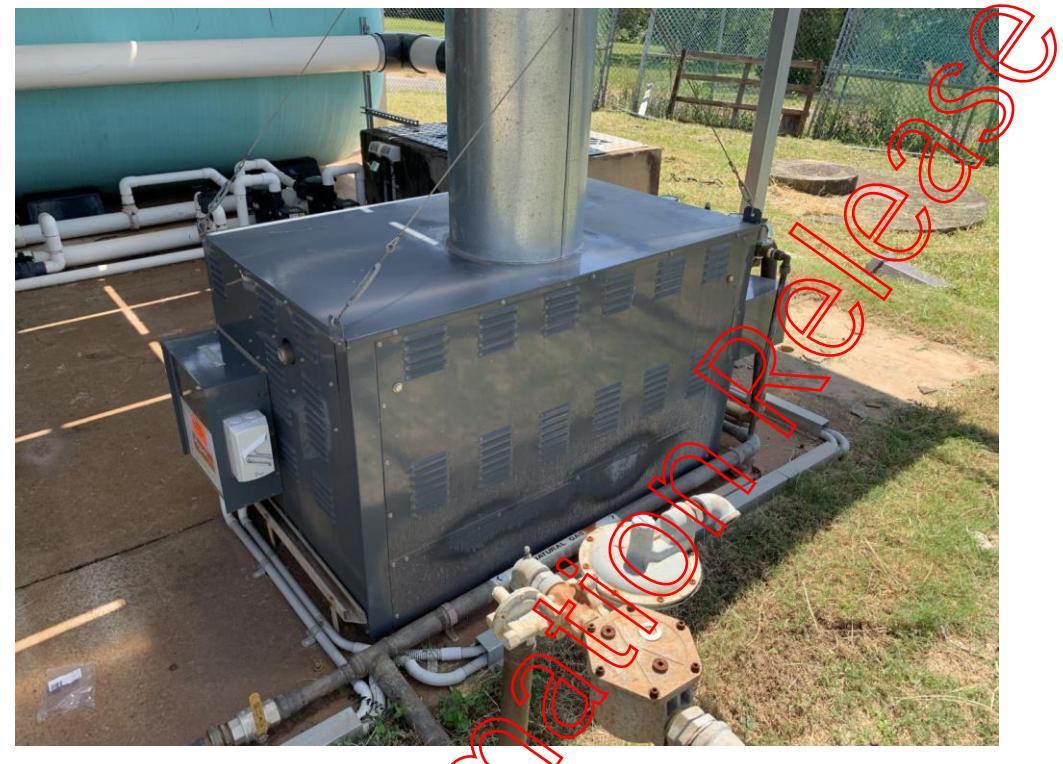
Figure 71: nettoient gas boilers

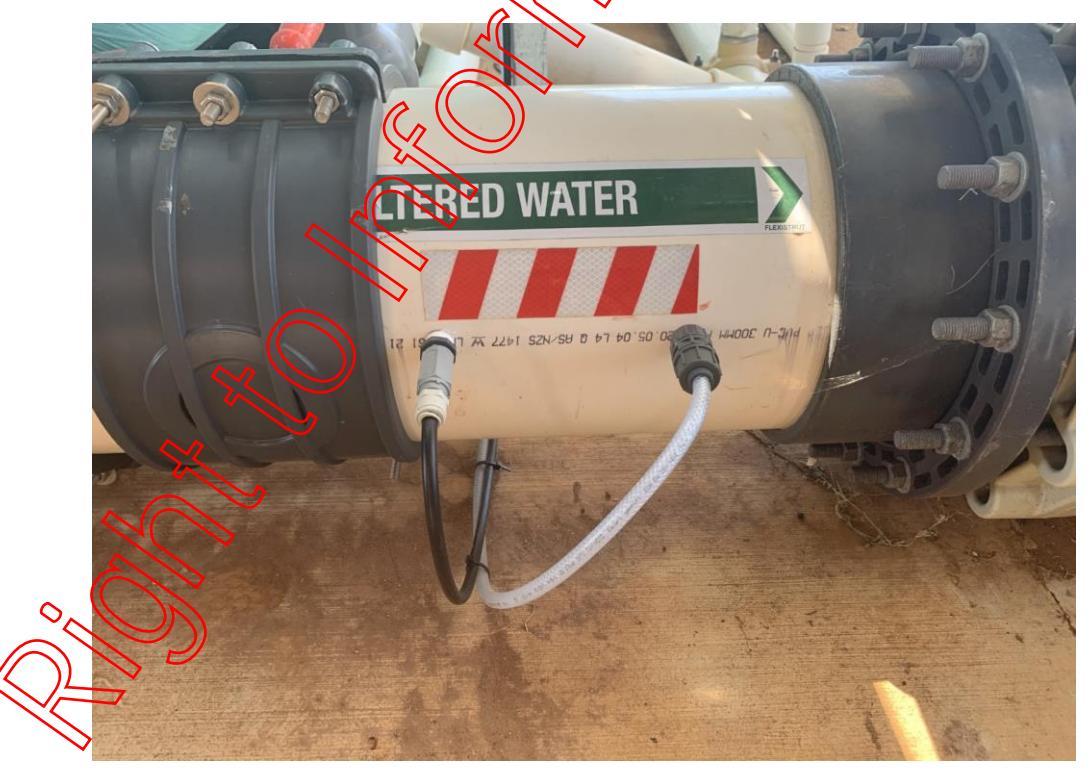
Figure 72: Unlabeled chemical injectors

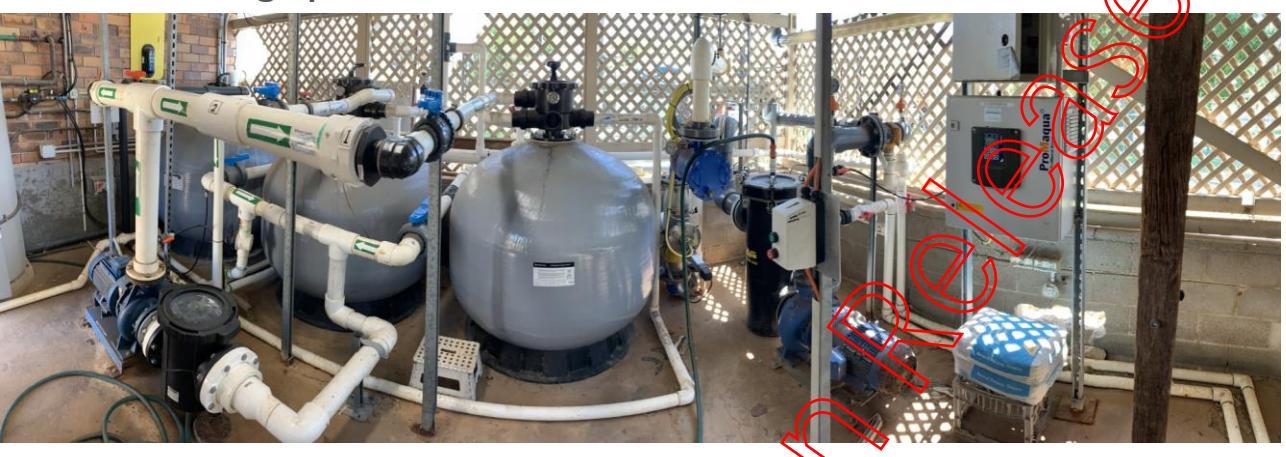
Figure 75: Poor access through equipment room

- Consider replacement of the entire equipment room with a properly designed room considering actual equipment size requirements (to suit correct equipment for 25m and LTS), access pathways, chemical storage, chemical unloading and the tike.
- Consider converting from bulk liquid chlorine (discussed in the *Conclusions* section) or provide a full refurbishment to the chlorine storage including new tank and bund as well as a bunded truck unloading area in accordance with AS3780 *The Storage and Handling of Corrosive Substances*.
- Provide adopting to all chemical storage areas including the equipment room exterior and chemical dosing areas. Ensure MSDS's are located adjacent relevant chemical stores and that clear access is available to all chemics.
- Label all pipes with their flow direction and contents.

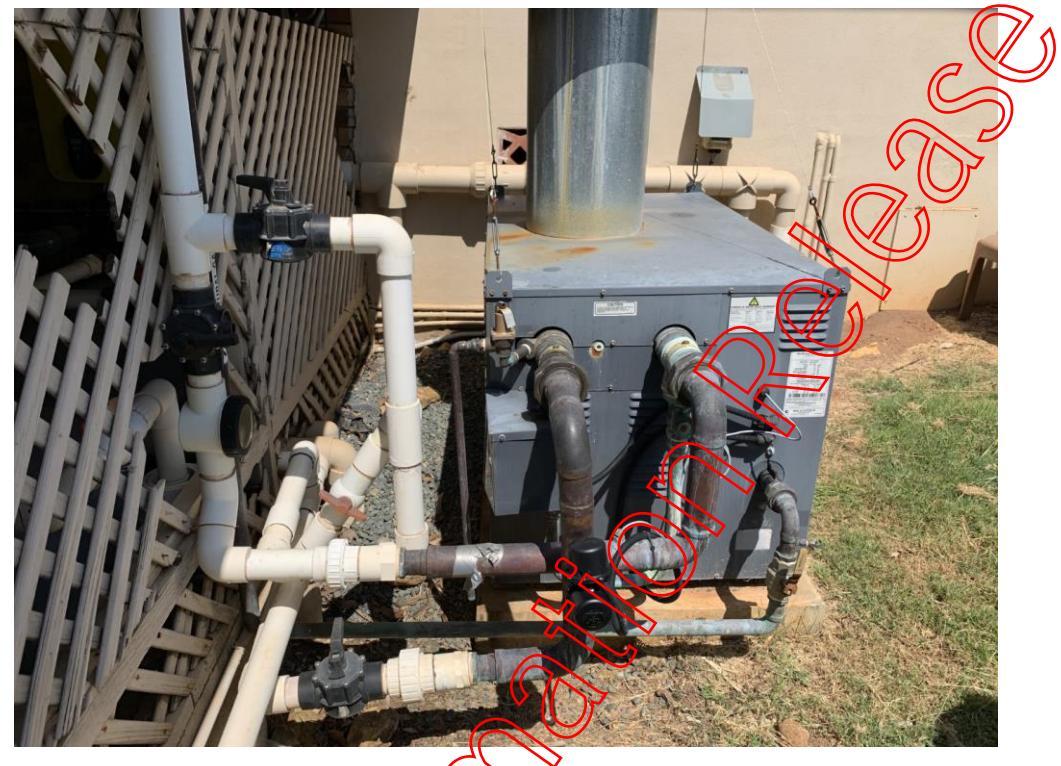
Figure 77: Poorly installed and supported pipe

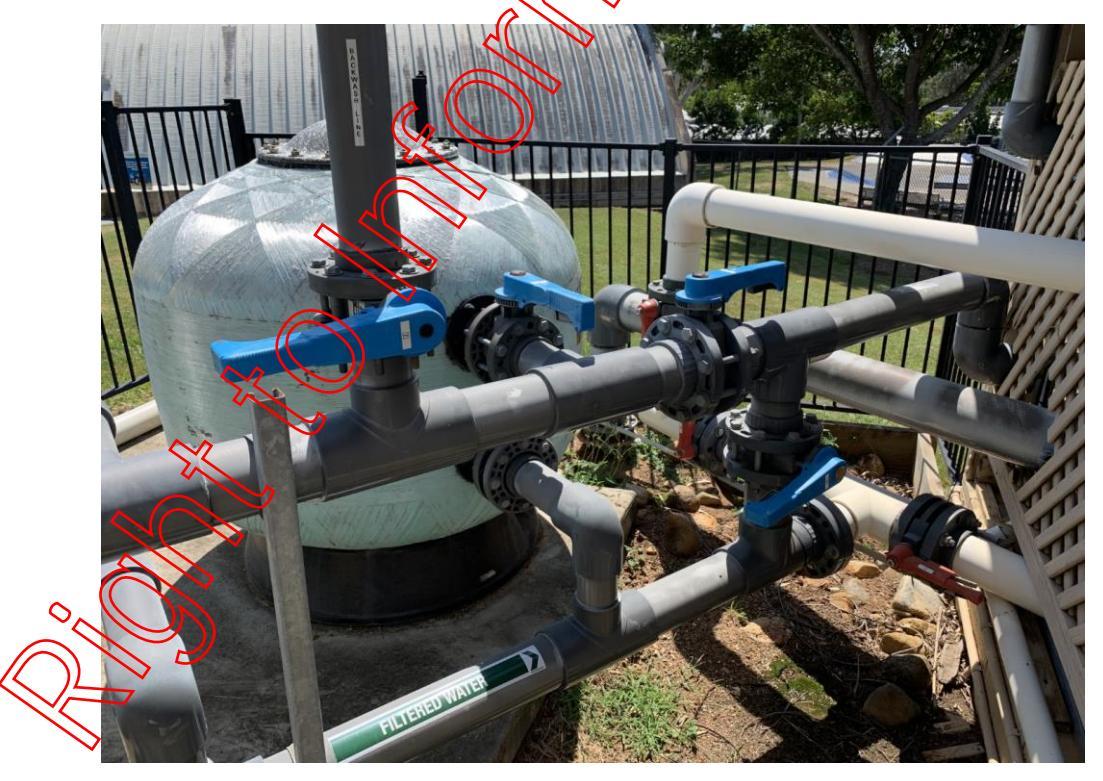
Figure 78: Poorly installed and supported pipe

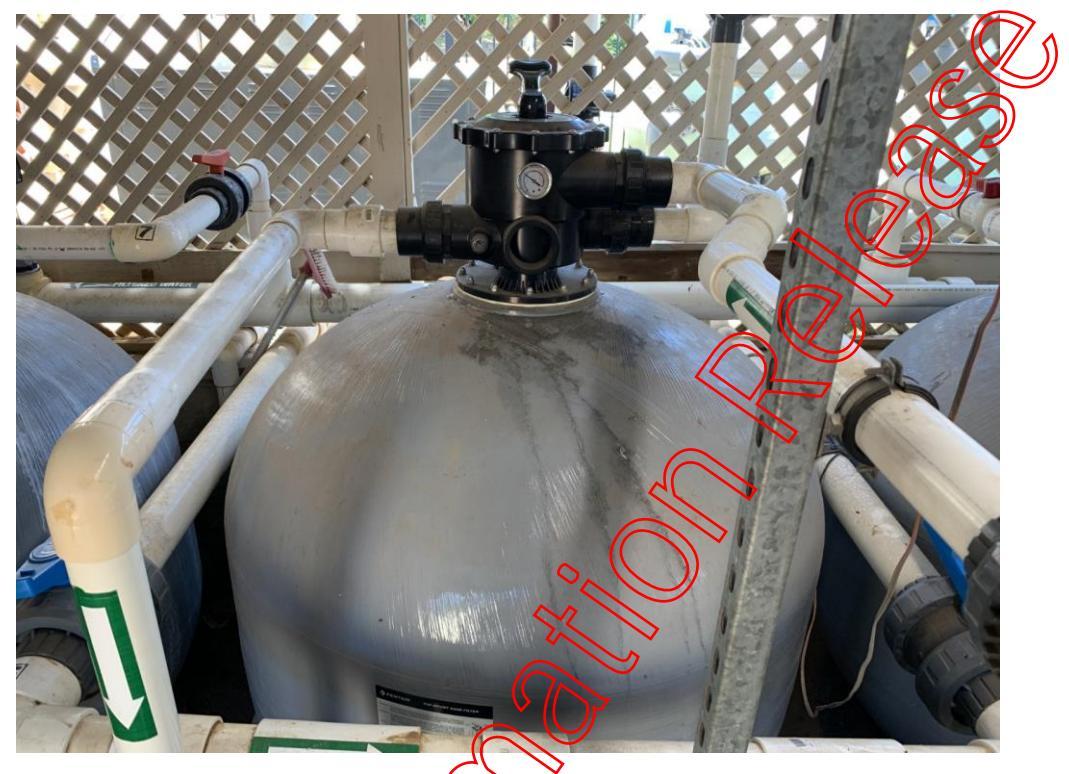
Figure 79: Poorly installed wipework, inaccessible multiport valve

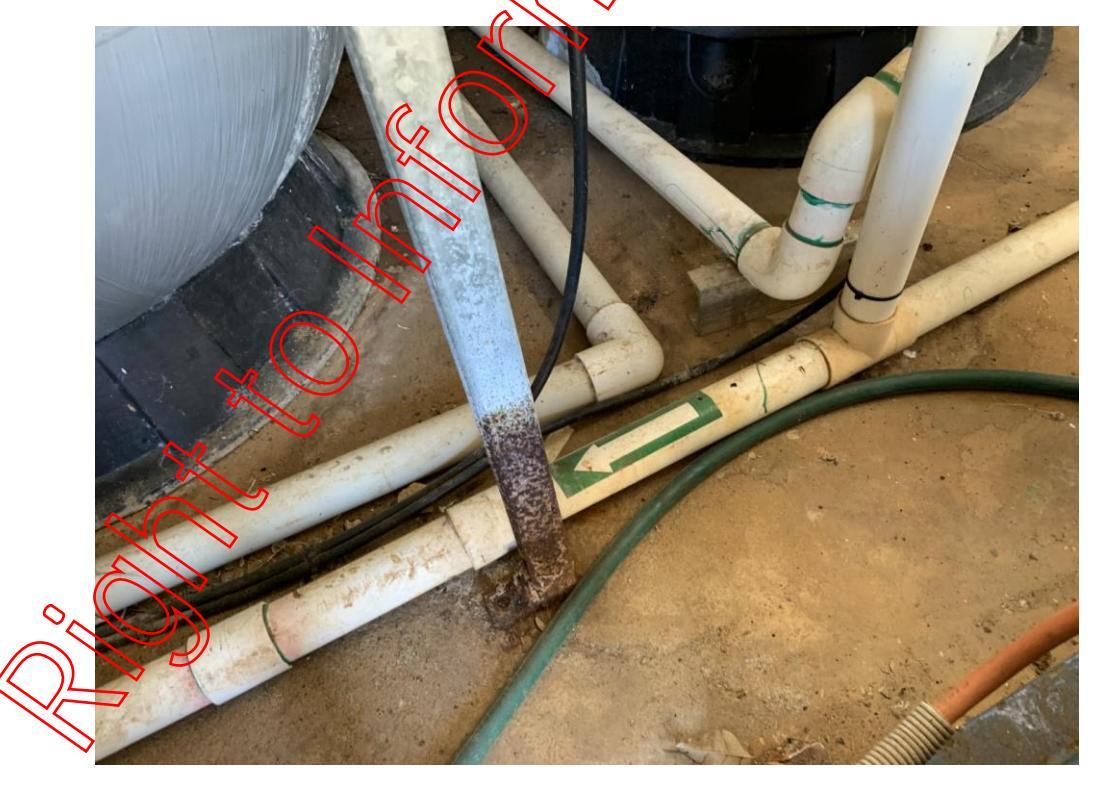
Figure 80: Rusted pipe supports, unsupported pipework

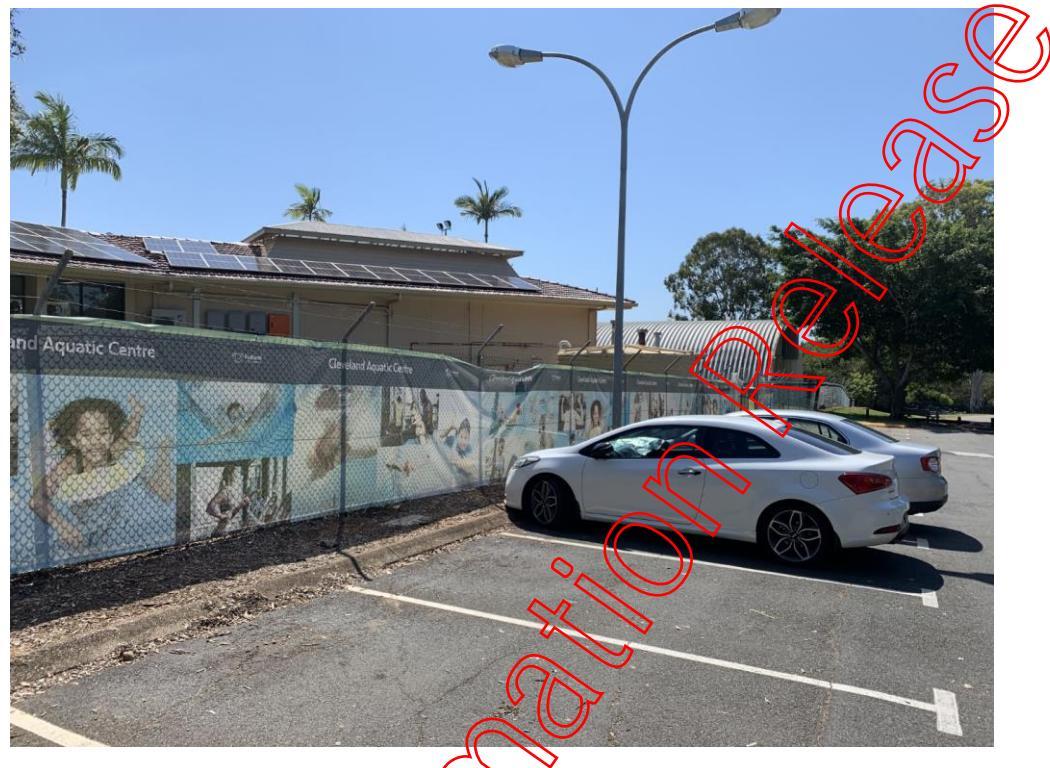
Figure 83: Public carter there chlorine truck unloads

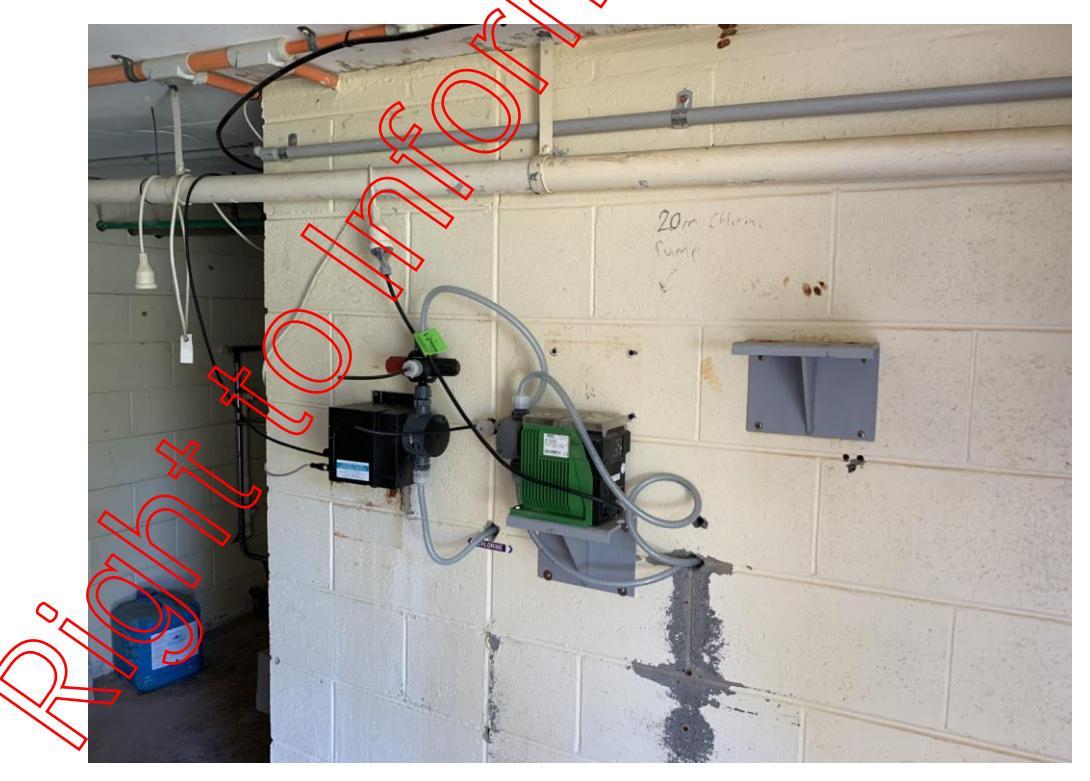
Figure 84: Unlabeled equipment in equipment room, loose extension cord

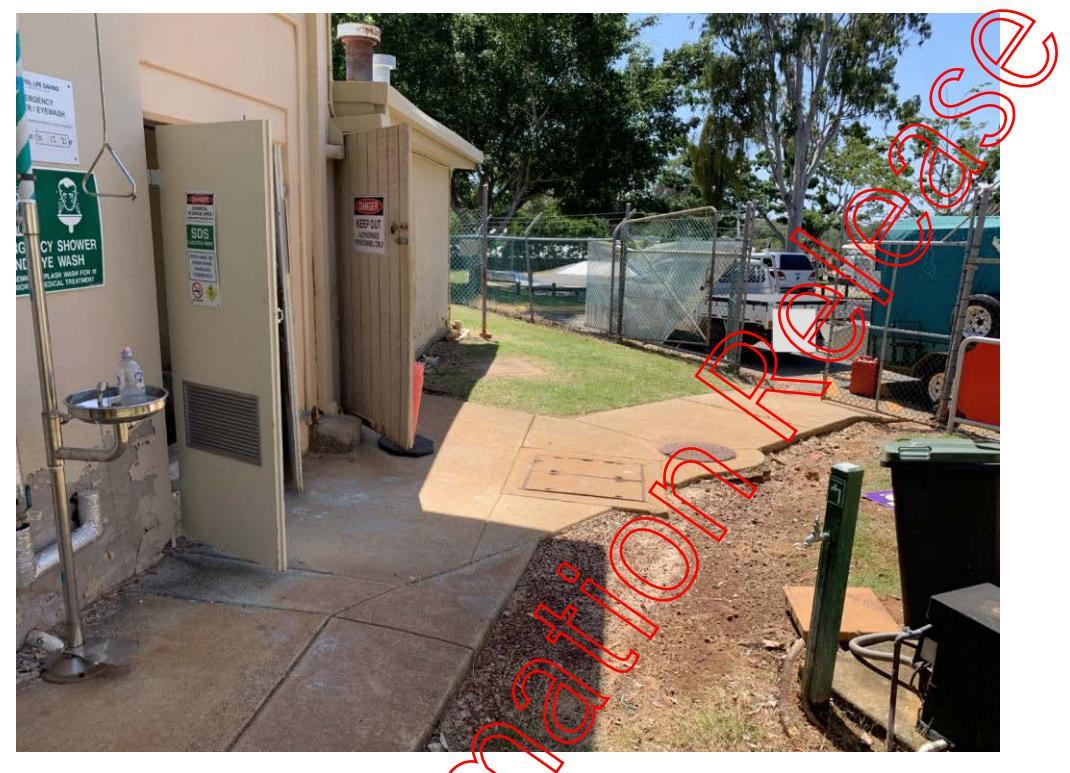
Figure 85: Unsafe working surface between plant and truck unloading area

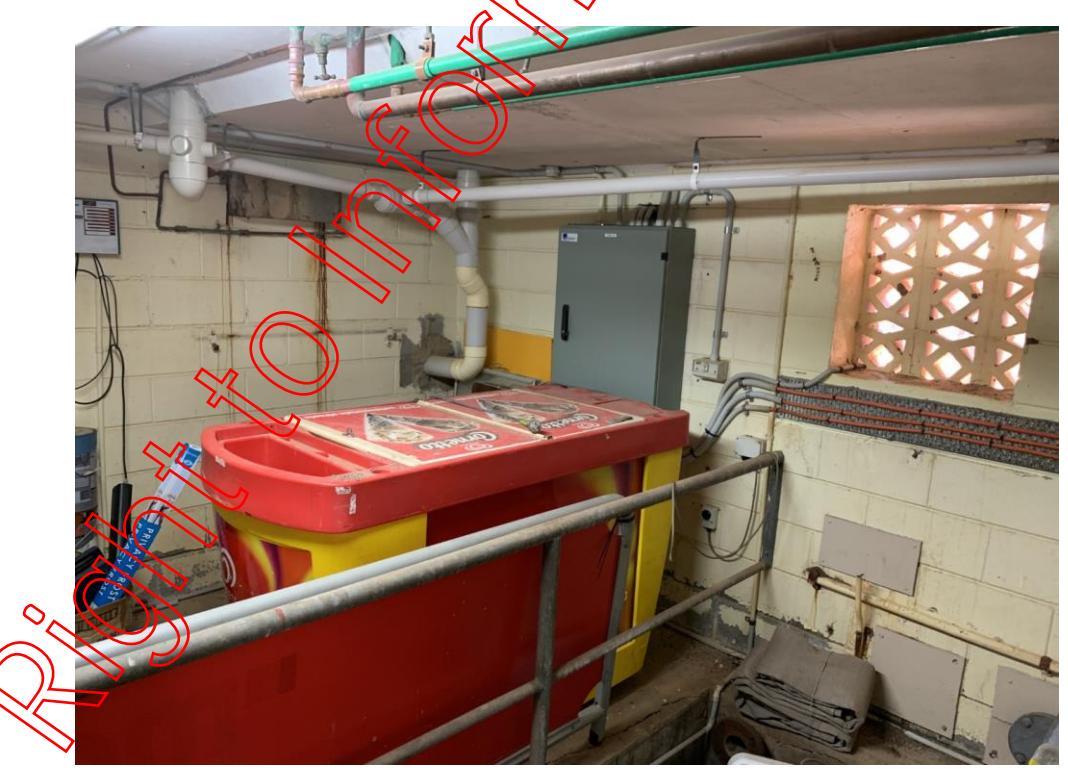
Figure 86: Obstructed main distribution board

• Engage an electrical contractor to provide a full internal condition and compliance audit on the boards and electrical installation.
