CLEVELAND AQUATIC CENTRE UPDATED POOL CONDITION ASSESSMENT

AND MAINTENANCE PLANS

(July 2014)

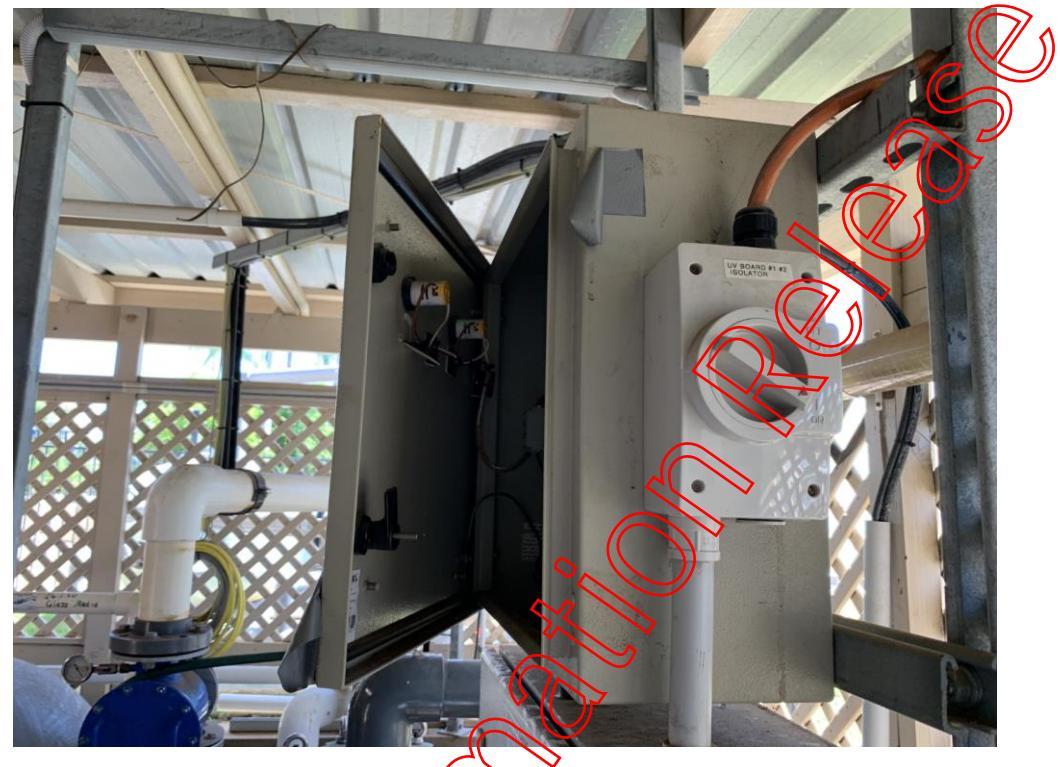
- The latch on the UV control panel in the pump area has failed with tape holding the door shut. Electrical equipment is exposed behind the door.
- The electrical installation is poor in general, with inadeq are signage, disused equipment and aged components.
- The chlorine storage tank produces several compliance and condition issues:
 - No tank vent or overflow are provided as per AS3780
 - No labelling is provided on the tank as per AS3780 such as volume indicators
 - The bund is in poor condition, unlikely to be sealed in the event of a spill.
 - The fill point for the tank is poorly supported and may break during a tank fill.

Figure 87: Open UV sontrol panel with broken latches

• Engage an electrical contractor to provide a full internal condition and compliance audit on the boards and electrical installation.

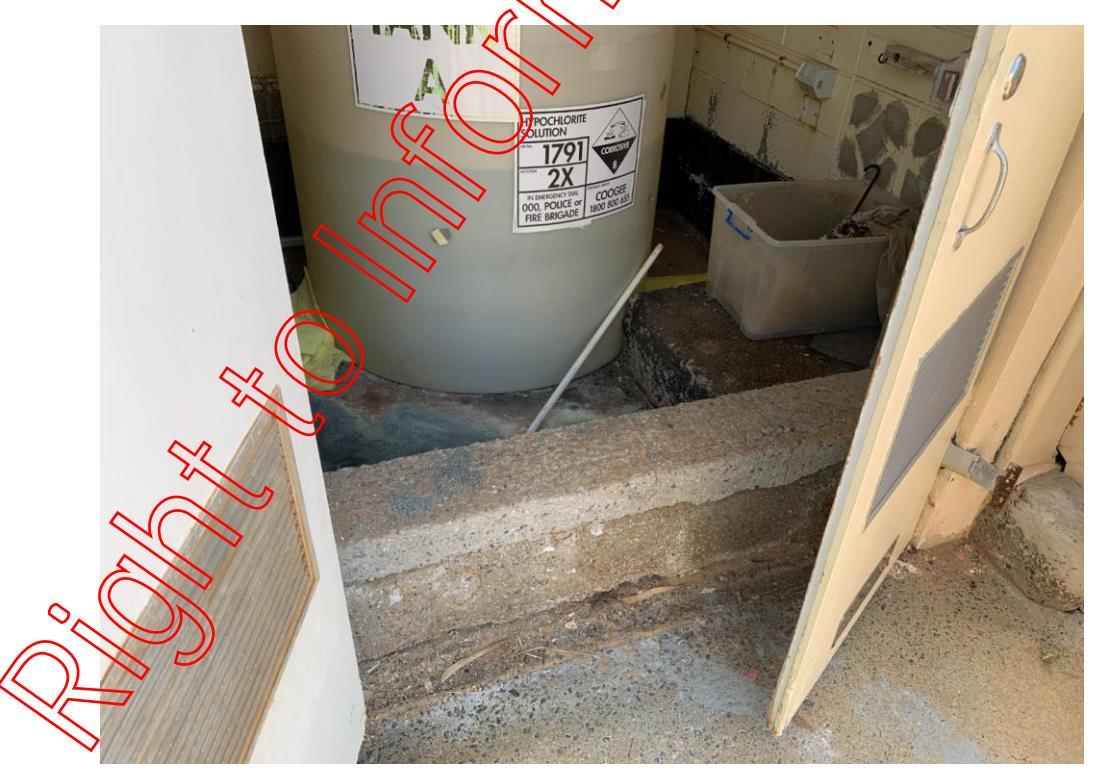
Figure 88: Poor condition bund wall

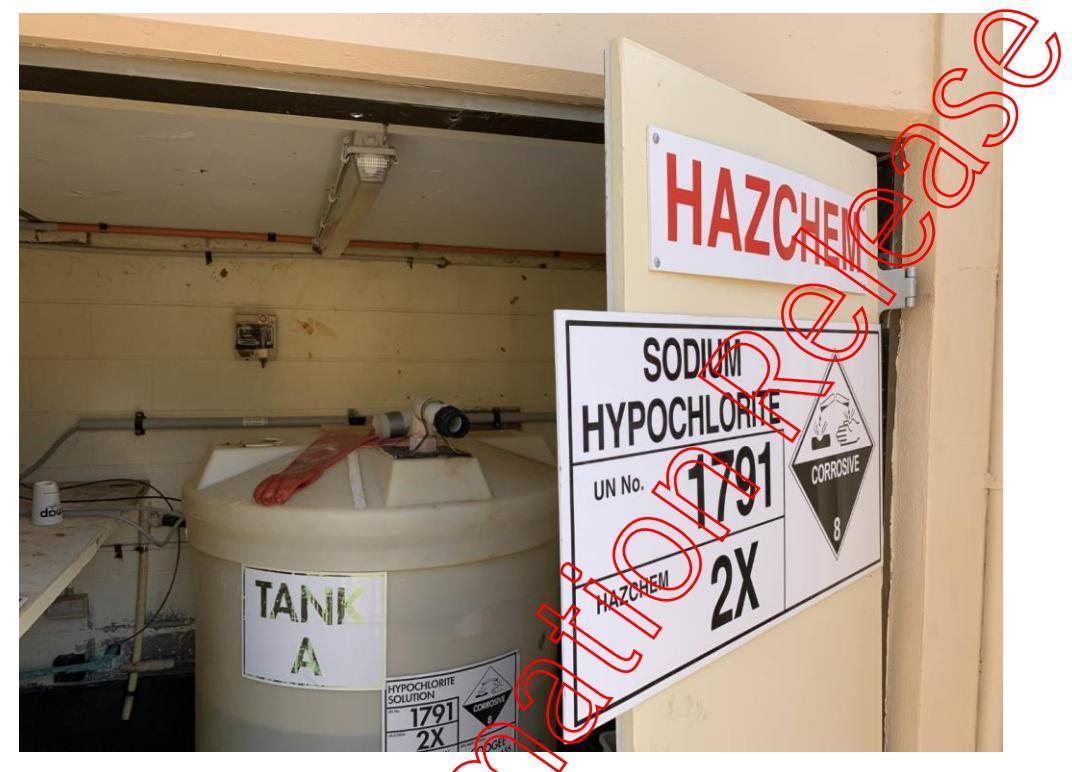
Figure 89: Poorly installed signage on broken door

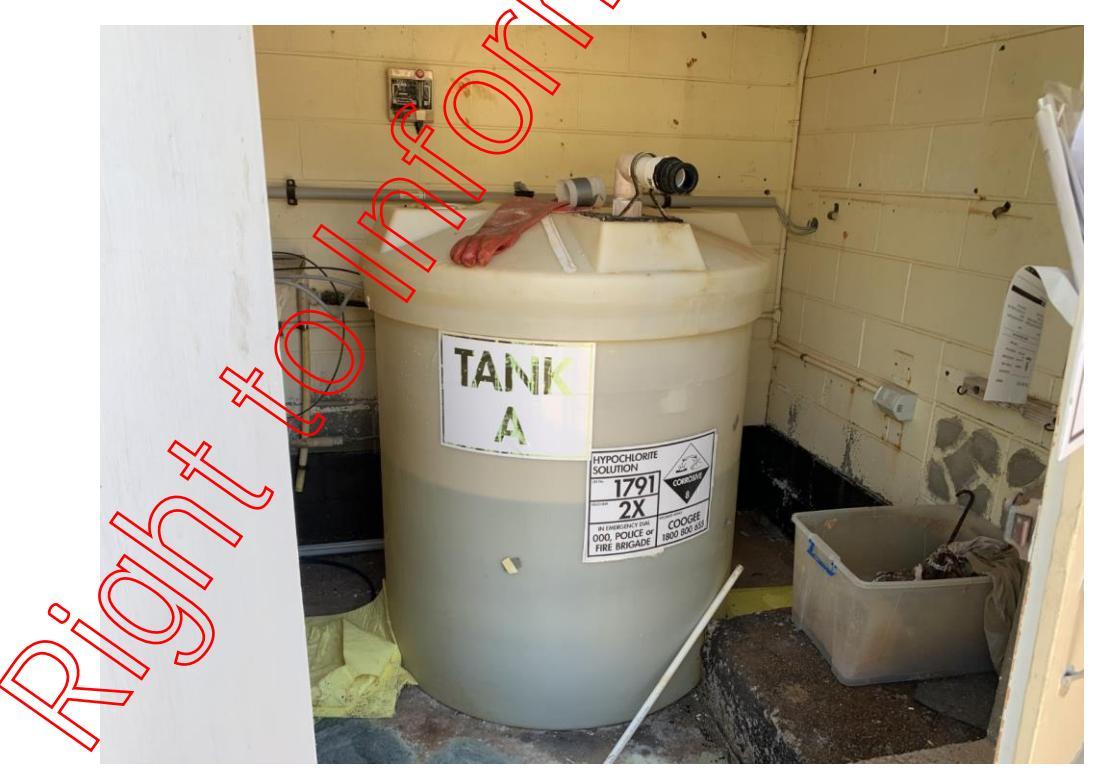
Figure 90: Tank with no level markings or solid plumbing connections

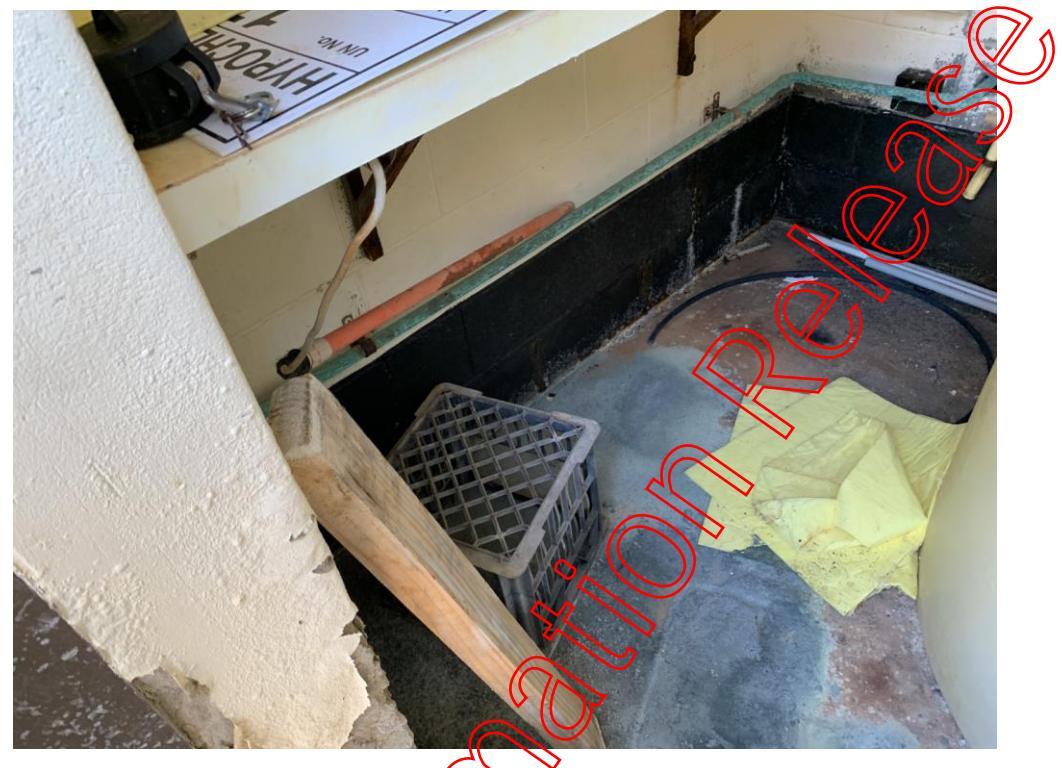
Figure 91: Poor condition bund with debris

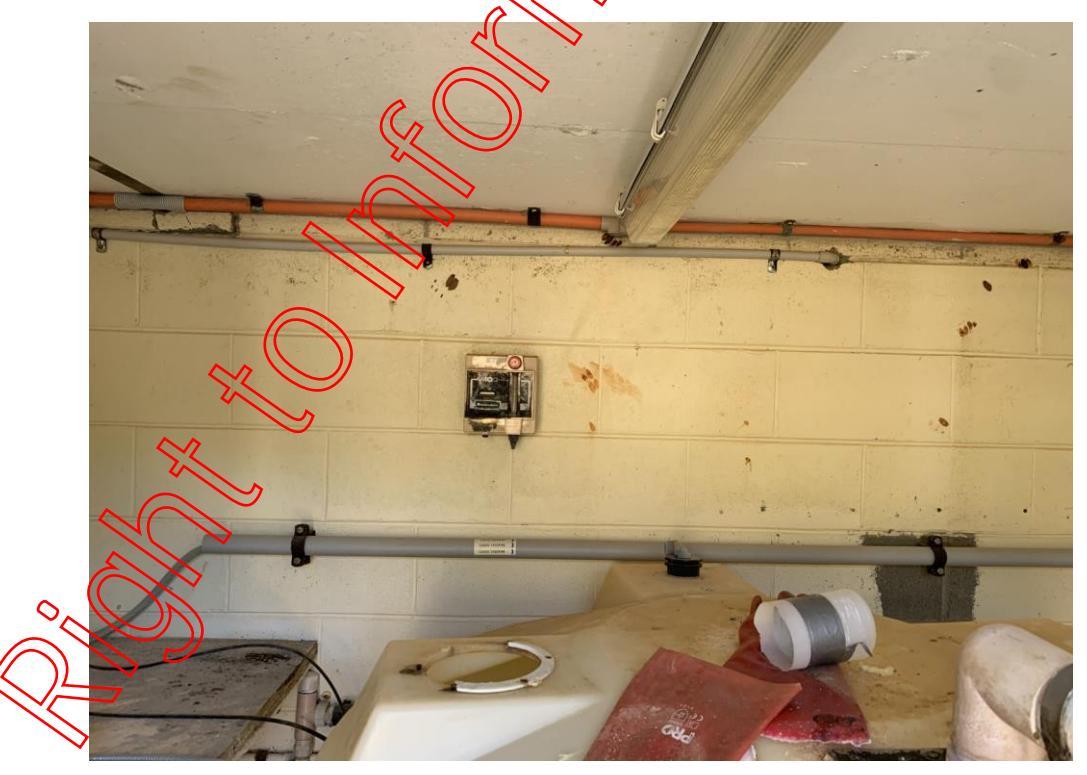
Figure 92: Disused equipment, open inlet to tank

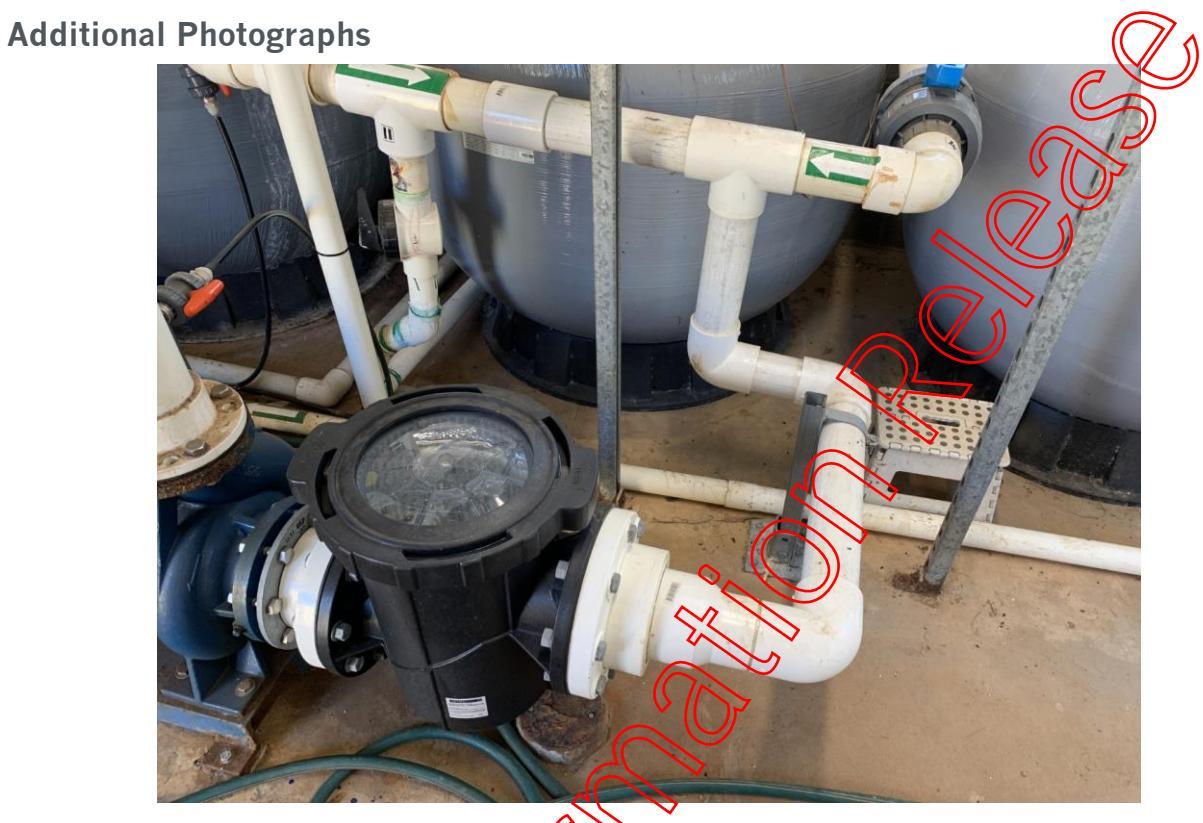
Figure 94: Restriction in filtration pump inlet

- Provide reliable flow monitoring equipment and confirm the system flow.
- As part of the equipment room replacement, provide a new correctly designed filtration system, rated to suit the required flow for the pool. Pipework upgrades to the pool may be required for this. Due to the numerous issues with access, pipework configuration and the like, minor refurbishment works are difficult to provide.
- Divert the backwash to the holding tank.
- Rectify the chorice dosing pump situation.

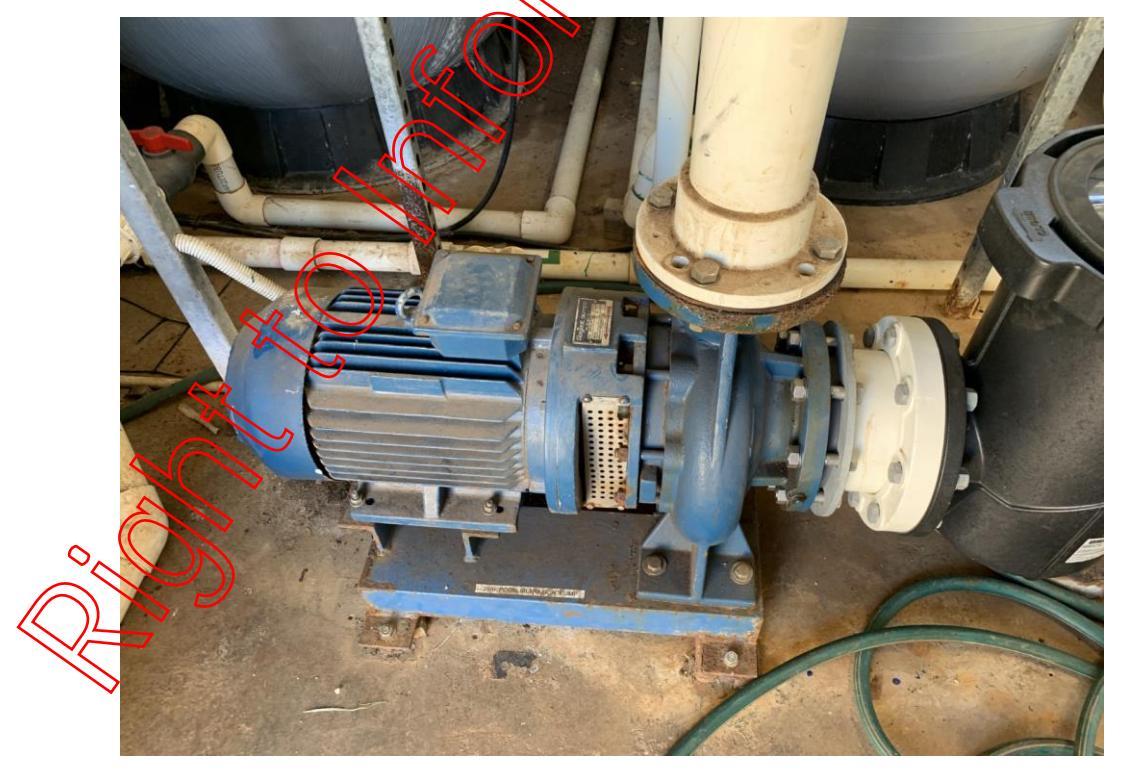
Figure 95: Filtration pump installed direct to slab, rusty baseplate

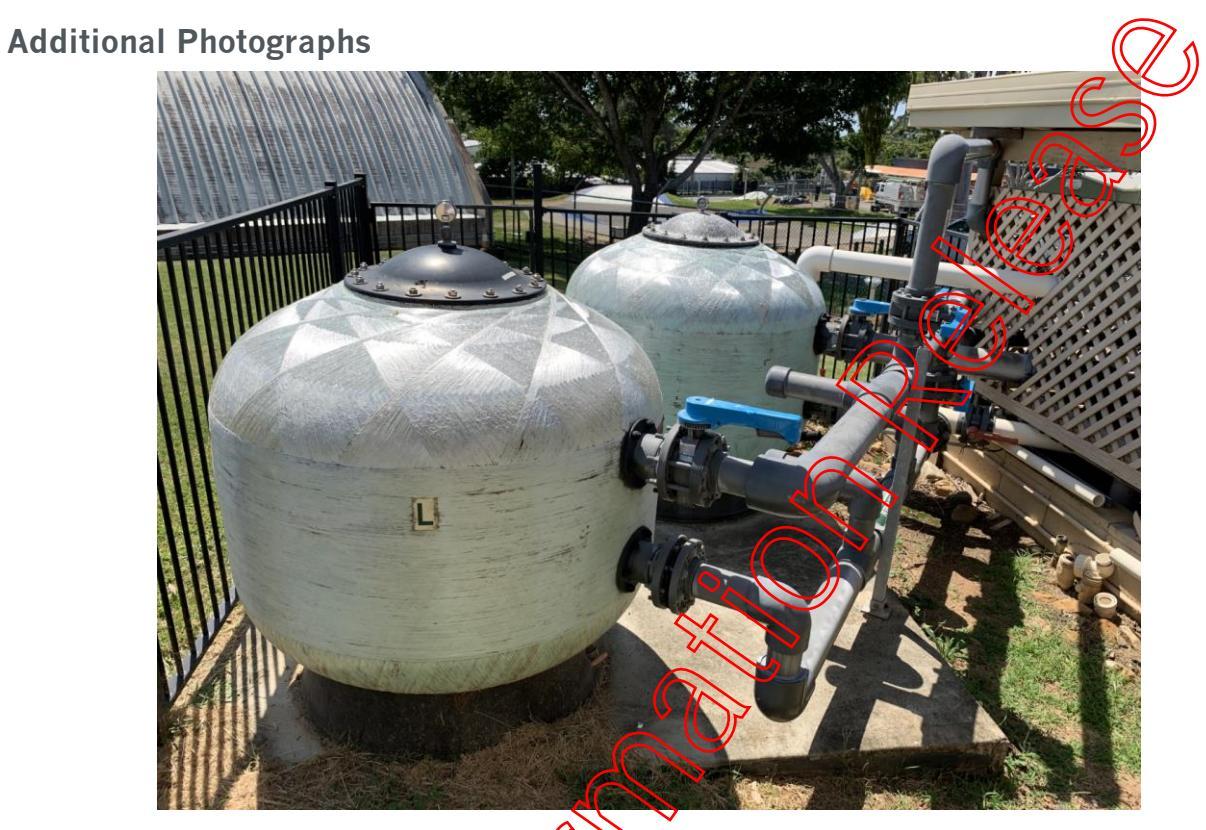
Figure 100: Pool filters with unsafe access, UV degradation to filters

- Provide reliable flow monitoring equipment and confirm the system flow.
- As part of the equipment room replacement and LTS pool replacement, provide a new correctly designed filtration system, rated to suit the required flow for the pool. Due to the numerous issues with access, pipework configuration and the tike, minor refurbishment works are difficult to provide.
- Rectify the chlorine desing pump situation.

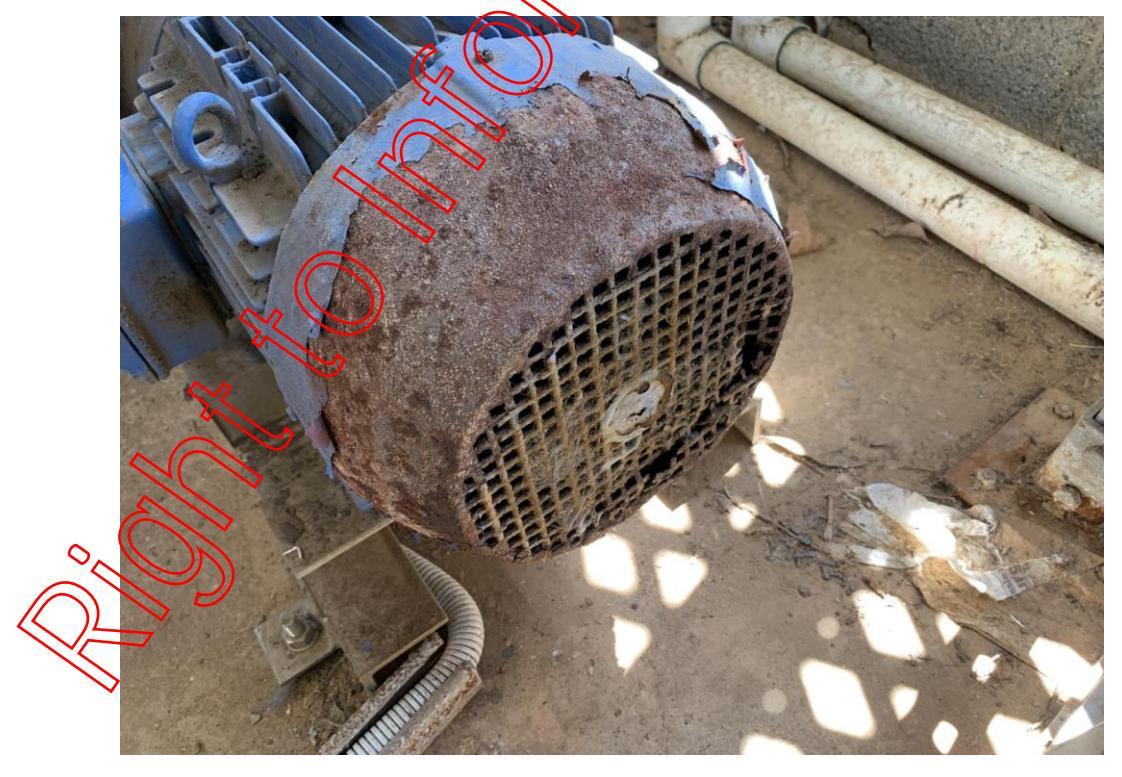
Figure 101: Poor condition pump motor

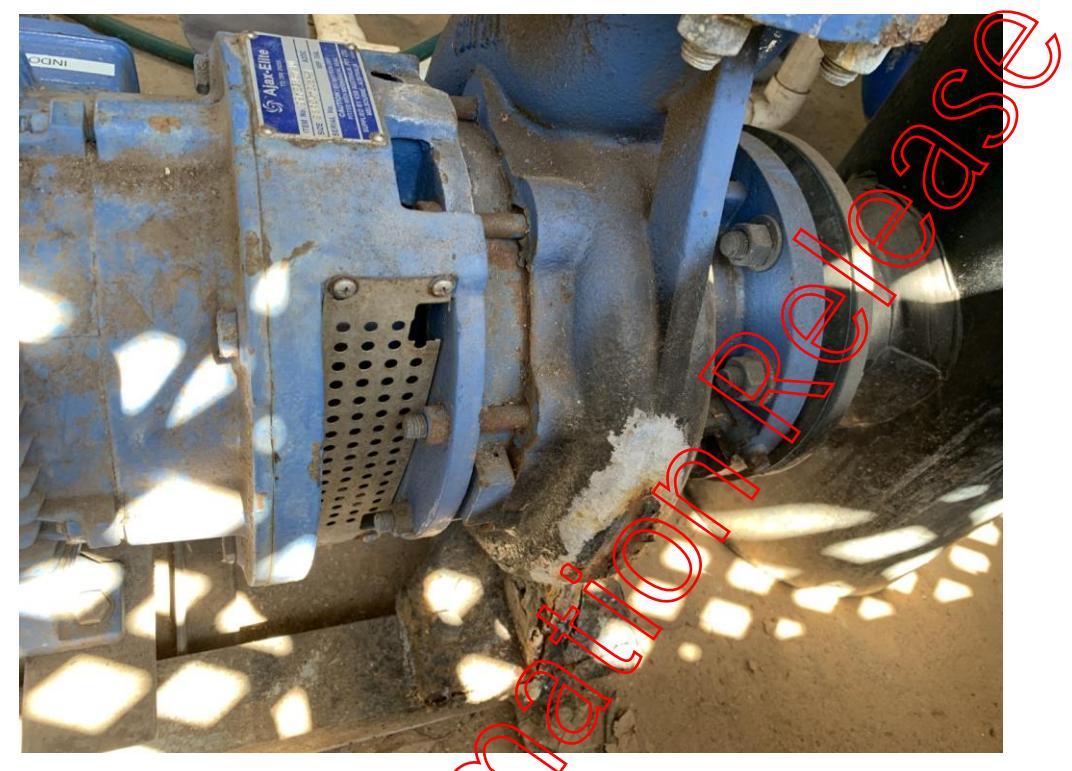
Figure 102: Pour condition pump housing

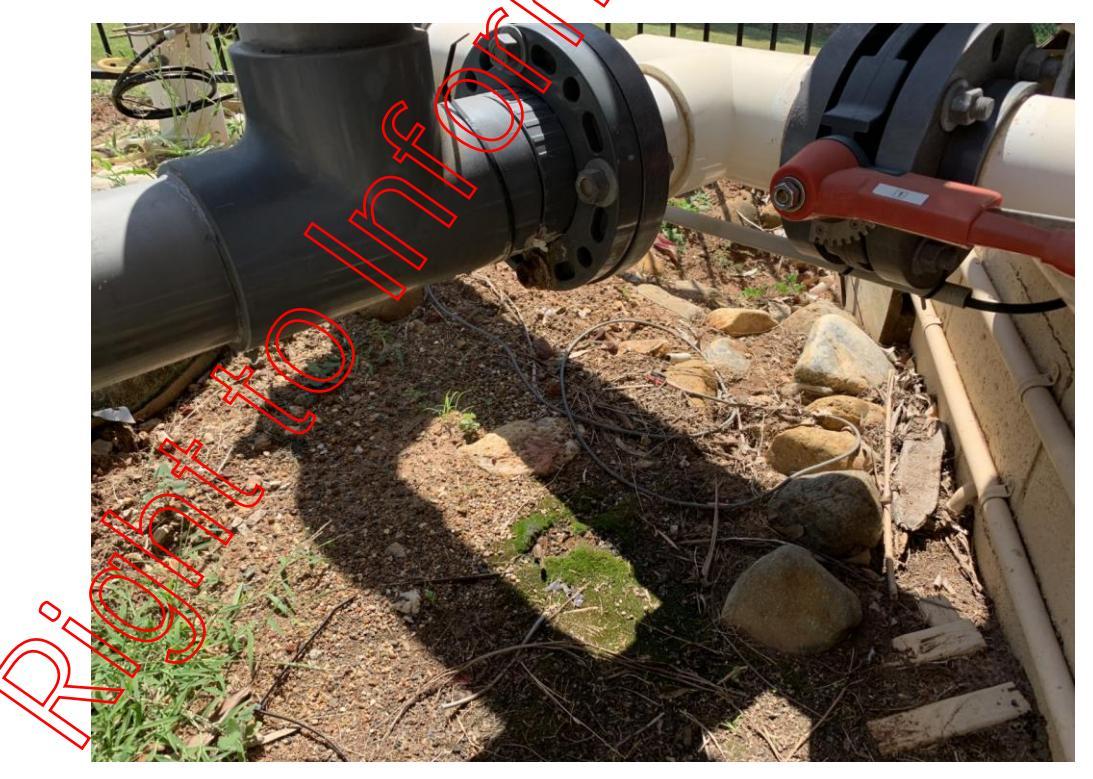
Figure 103: Leak in pipework

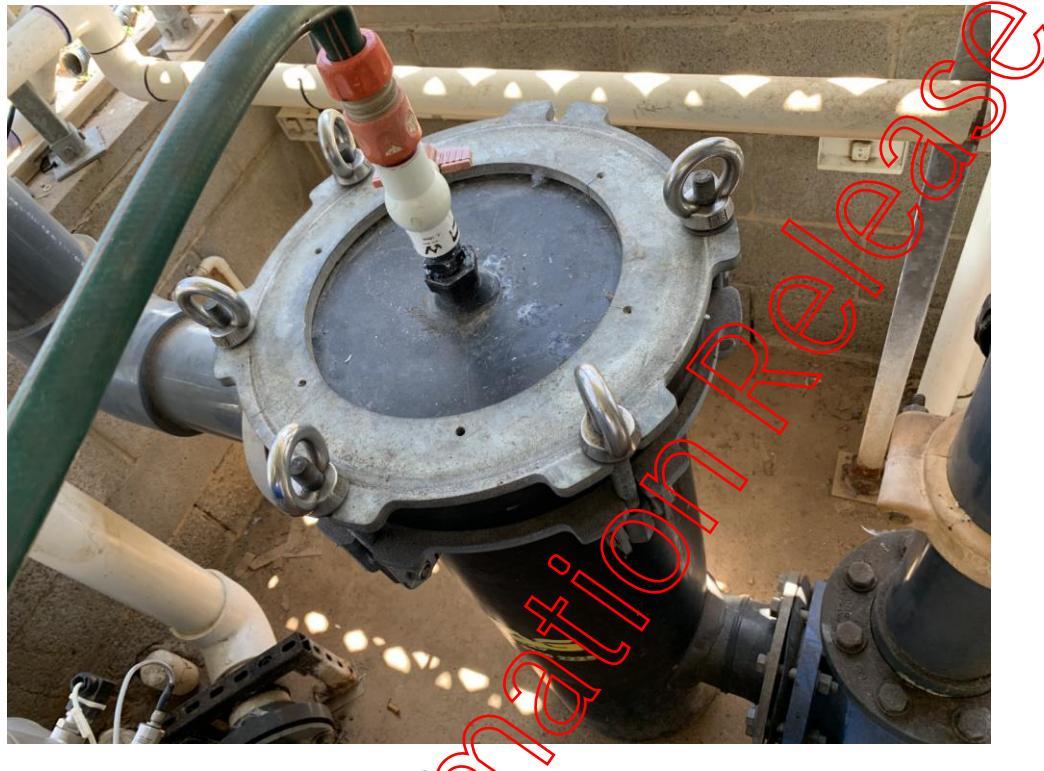
Figure 104 Sold lid on strainer

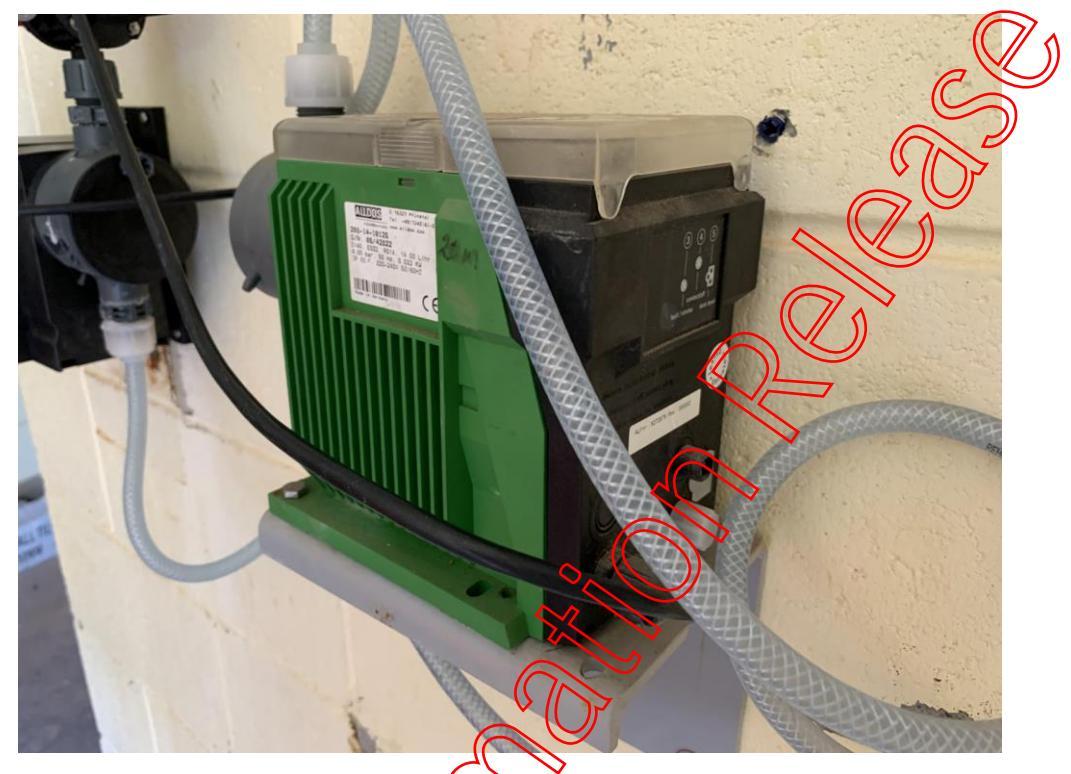
Figure 106: Chlorine dosing pupp with no multifunction valve

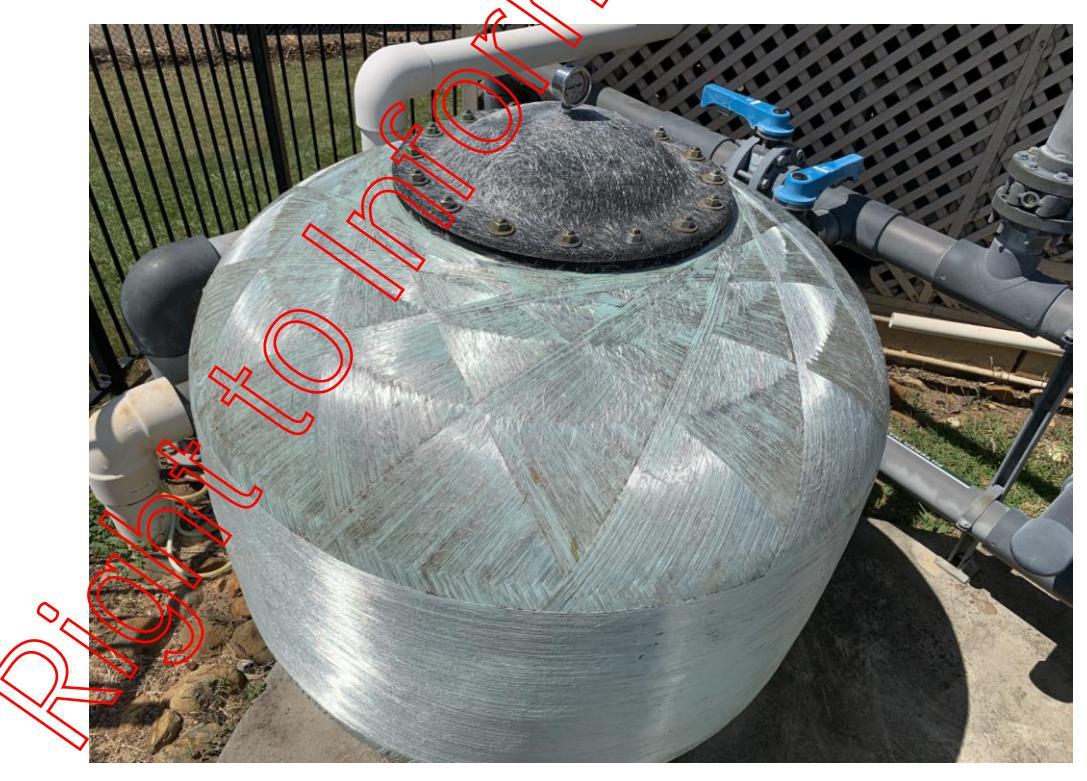
Figure 107: UV degraded filter

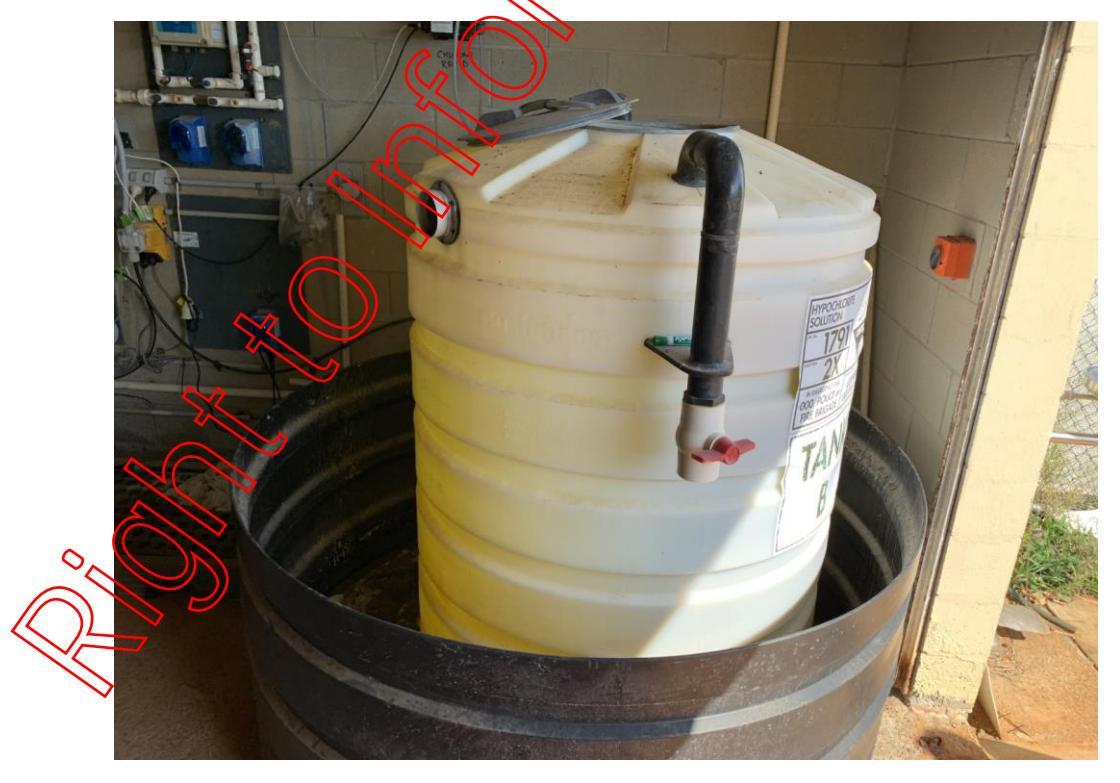
- Chemical injection points are not labelled.
- The chlorine storage tank produces several compliance and condition issues:
 - The tank vent discharges to the room instead of the plant room exterior.

Figure 110: Chlorine tank with no fill point, overflow or level markings

- Consider converting from bulk liquid chlorine (discussed in the *Conclusions* section) or provide a bunded truck unloading area in accordance with AS3780 *The Storage and Handling of Corrosive Substances*.

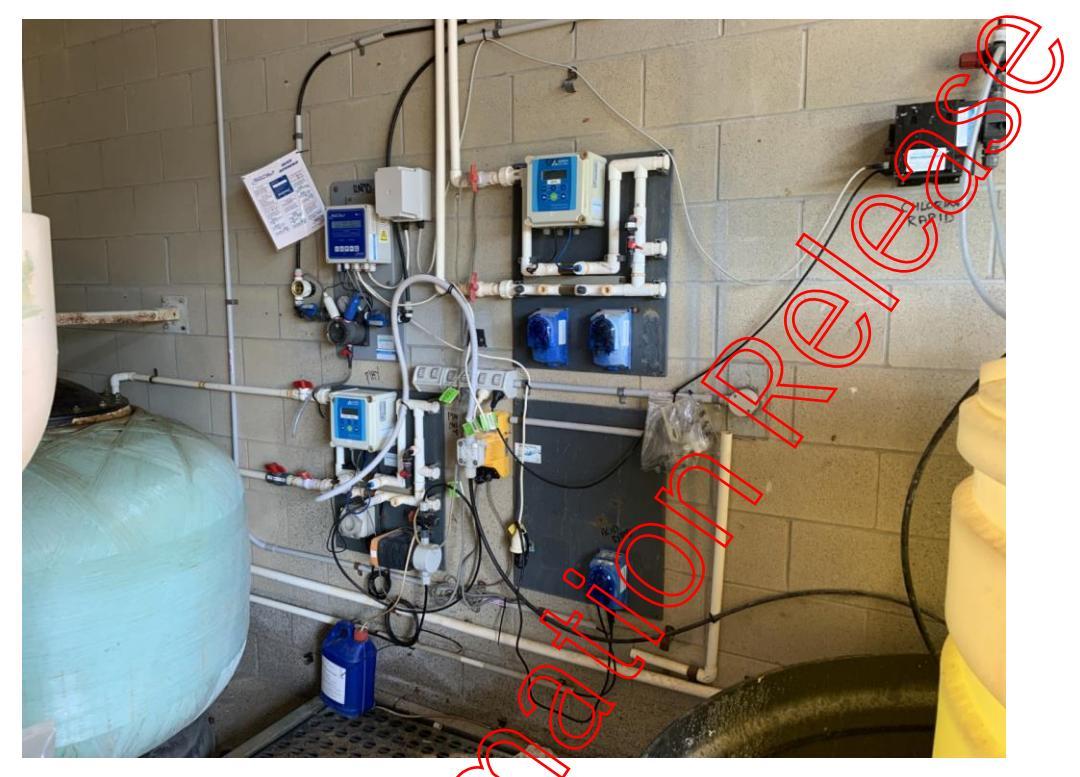
- Obsolete equipment is present in the room.
- There's a concrete pad outside the equipment room however the ground has subsided around it. This generates a trip hazard.

Figure 111: Chemical control and desing area with disused equipment

- Remove all obsolete equipment
- Fill around the concrete step.
- Replace the flow meters and provide in the correct locations to measure full flow of the systems.

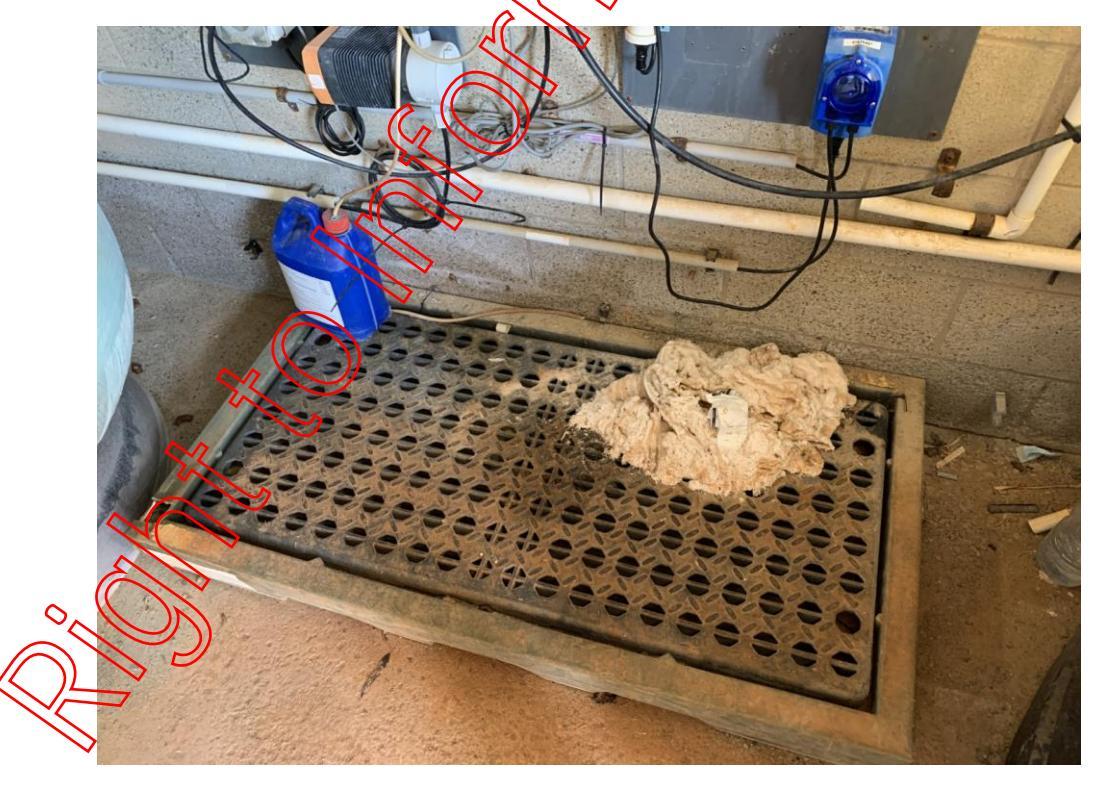
- A drip tray is provided below the chemical measurement and toging area. Both chlorine and acid injectors are present, meaning that is a leak occurs in both and acid and chlorine line the incompatible substances can mix and cause a dangerous environment.

Figure 112: Chemical tub below dosing area

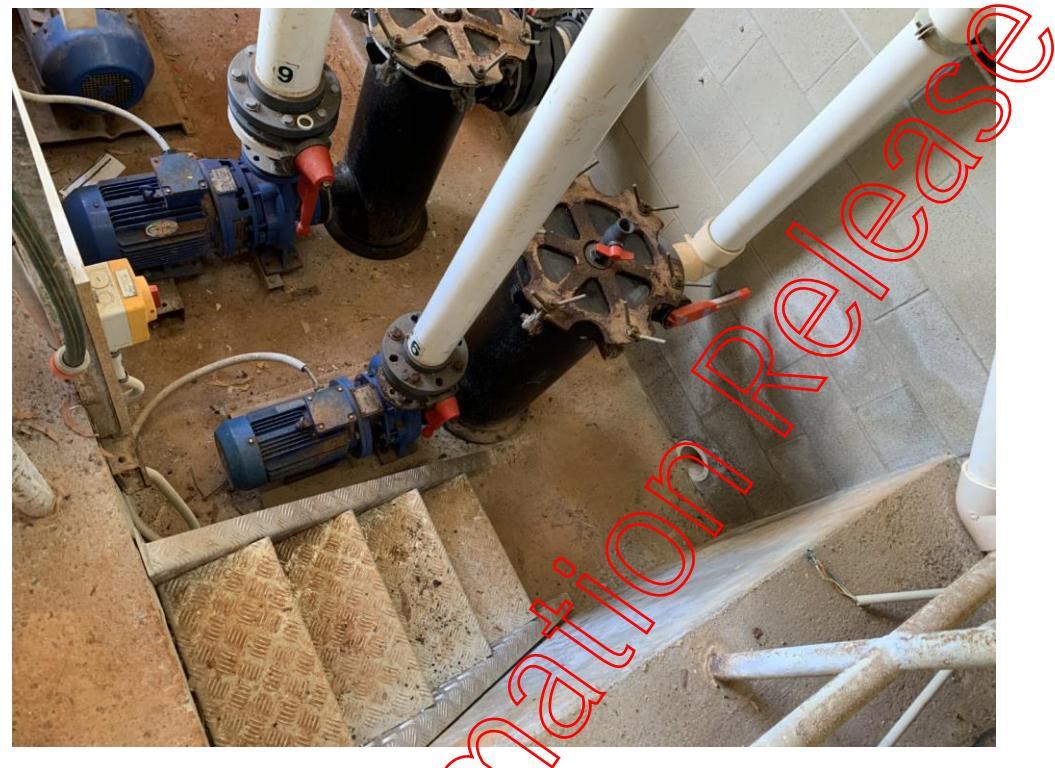
Figure 113: Stairway into four well with no access at bottom

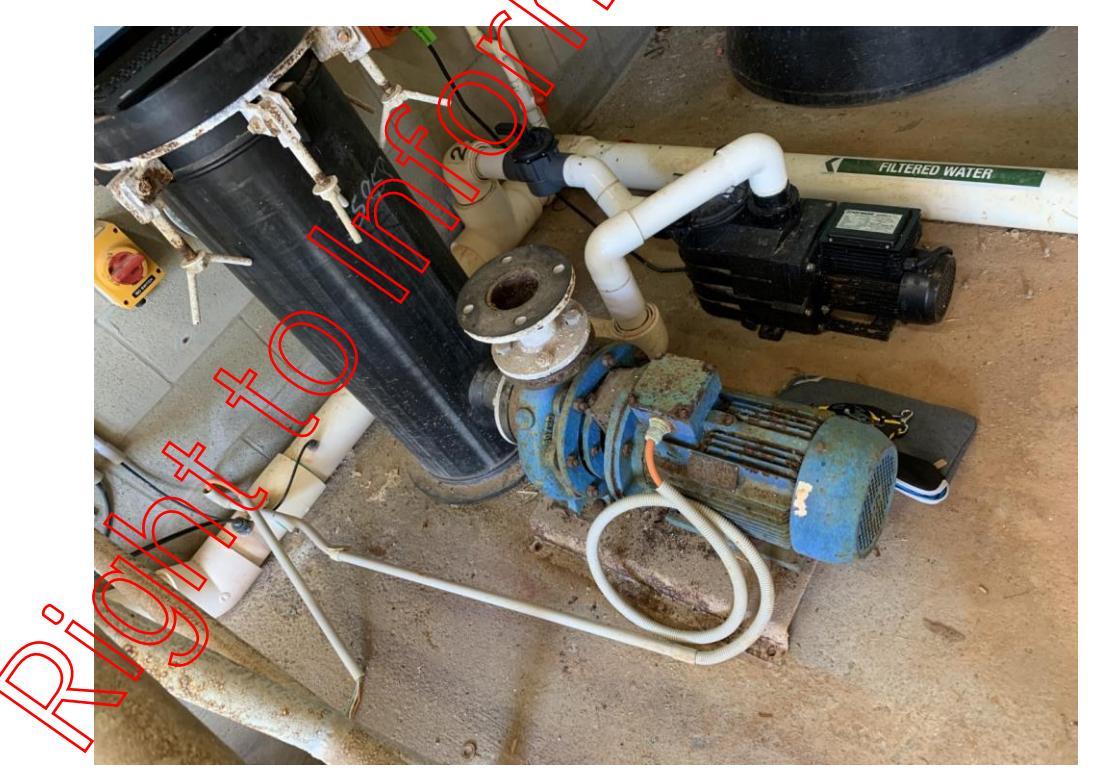
Figure 114: Disused equipment in room

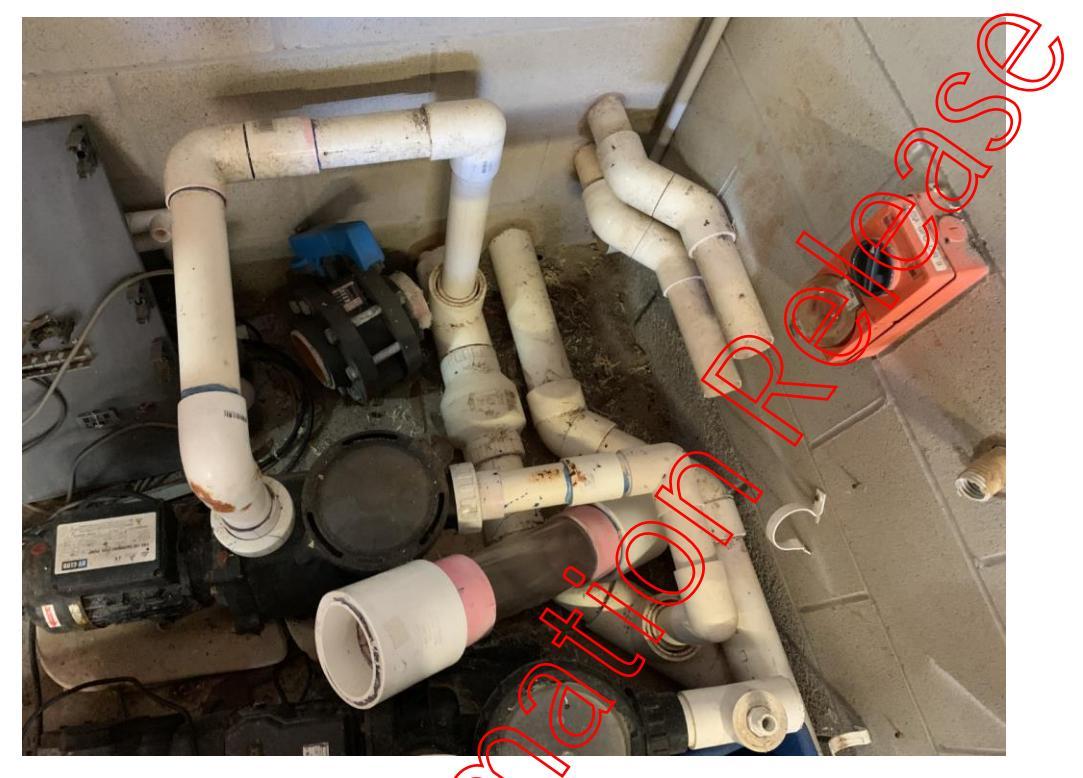
Figure 115: Obsolete equipment, poor labeled pipework, disconnected heater pipework

- Label all pipes with their flow direction and contents.
- Engage an electrical contractor to provide a full internal condition and compliance audit on the boards and electrical installation.

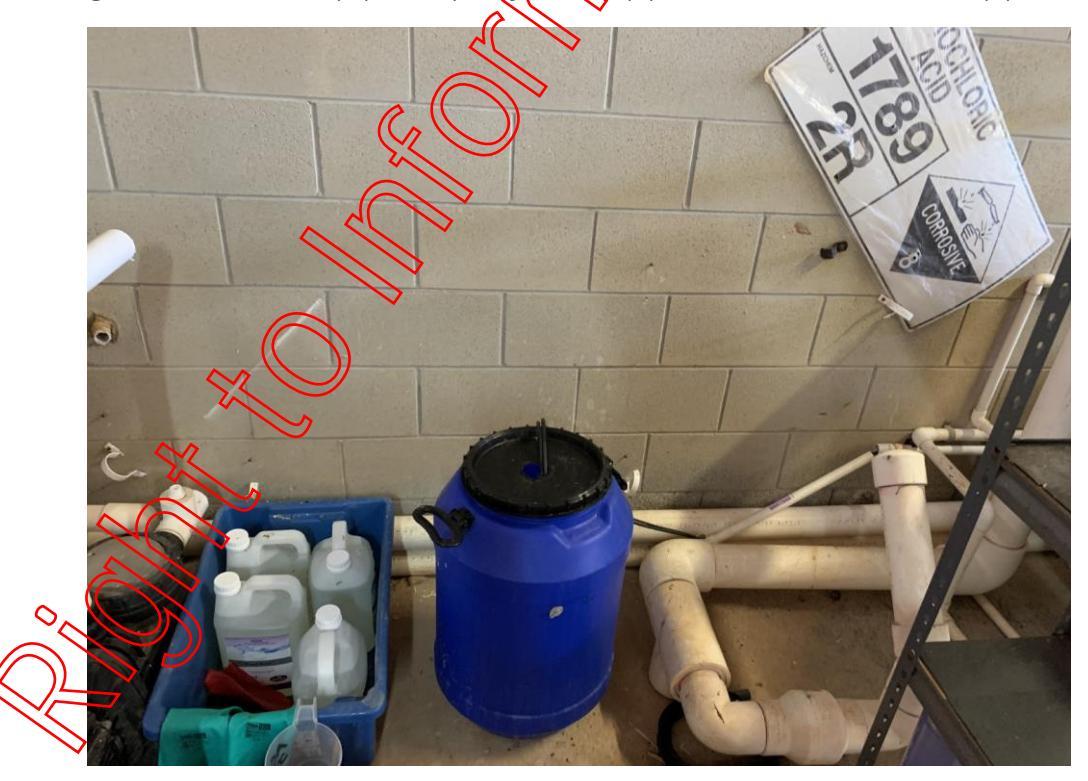
Figure 116: Poorly managed acid storage

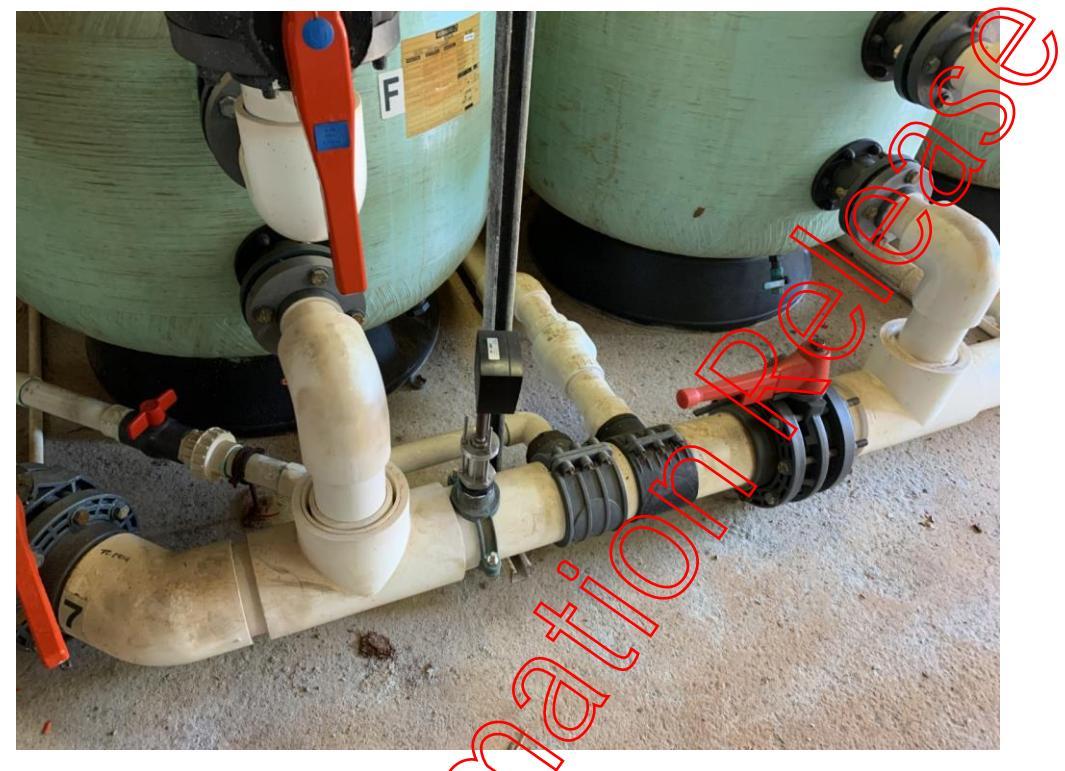
Figure 117: Flow mater restalled in wrong location

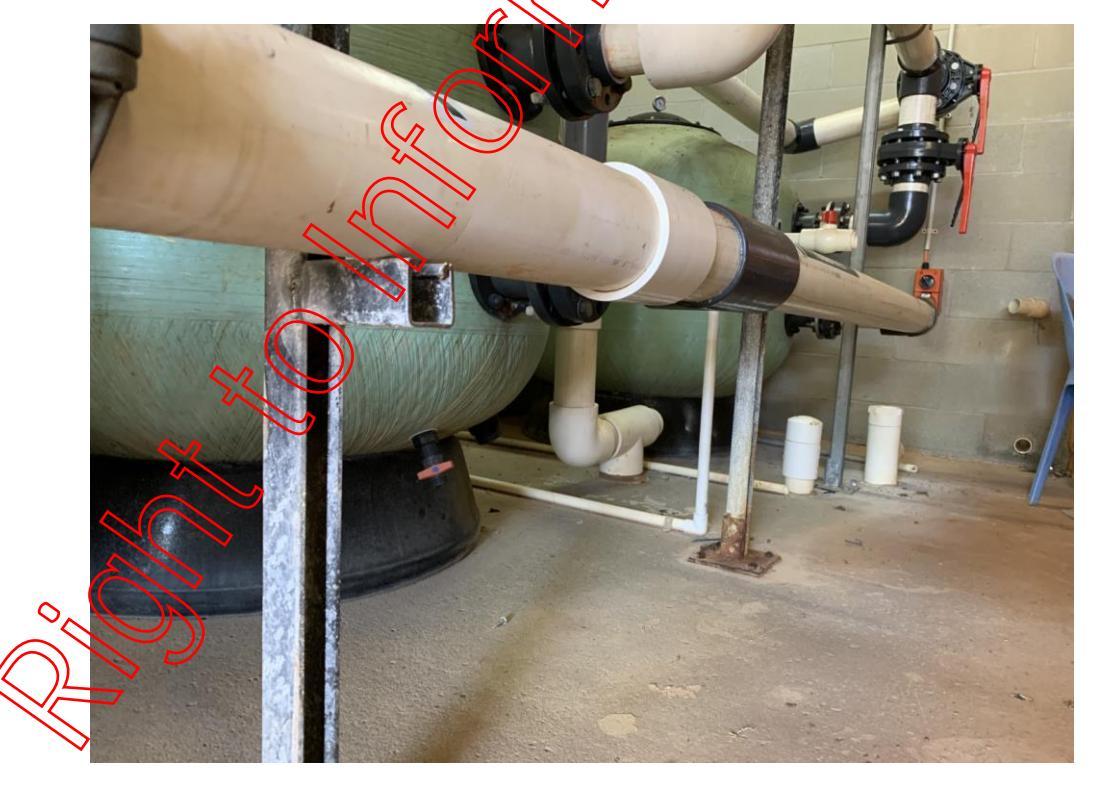
- Pipework support is inadequate with filter manifolds practically unsupported.
- No positive ventilation system is present to the plant room. Many items inside are corroded.

Figure 118: Inadequate pipe supports in filter manifold

- Provide pipework supports in accordance with pipe supplier instructions so that no load is placed on equipment from pipework.
- Provide a mechanical ventilation system.

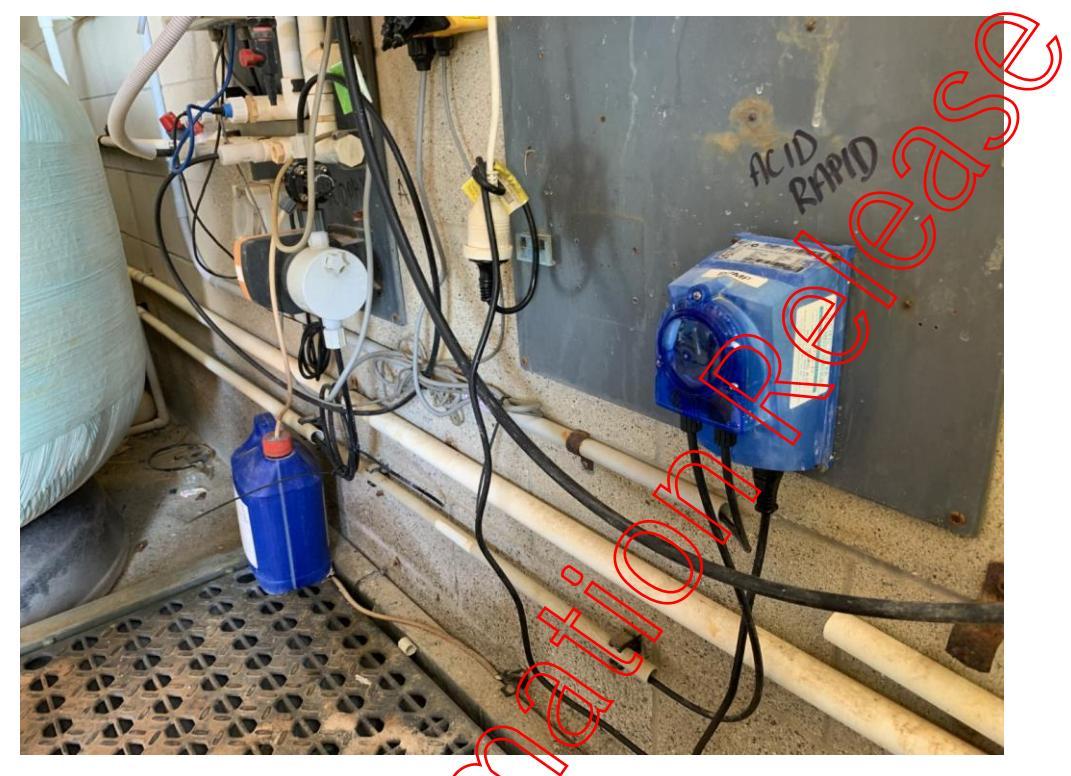
Figure 119: Poorly Reperted and installed equipment
