CLEVELAND AQUATIC CENTRE UPDATED POOL CONDITION ASSESSMENT

AND MAINTENANCE PLANS

(July 2014)

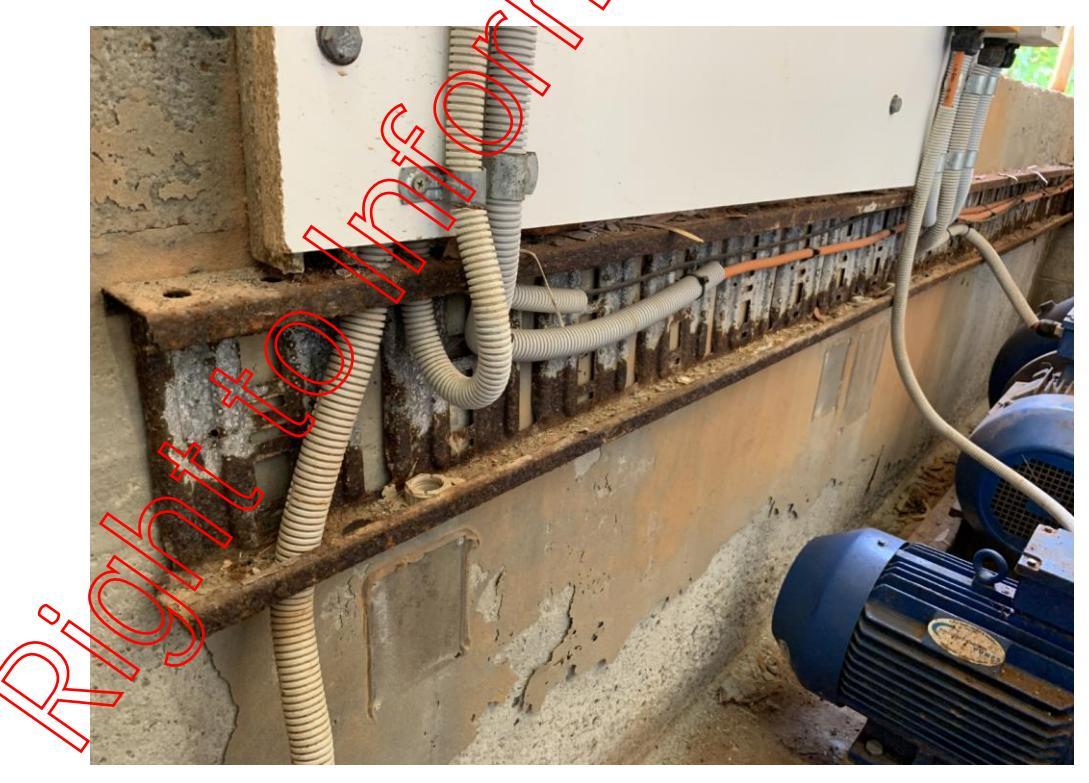
- The electrical installation is poor in general, with inadequate signage, disused equipment and aged components. Cable trays are rusting and the switchboard contains obsolete equipment.

Figure 120: Rusty cable tray

- Label all pipes with their flow direction and contents.
- Engage an electrical contractor to provide a full internal condition and compliance audit on the boards and electrical installation.

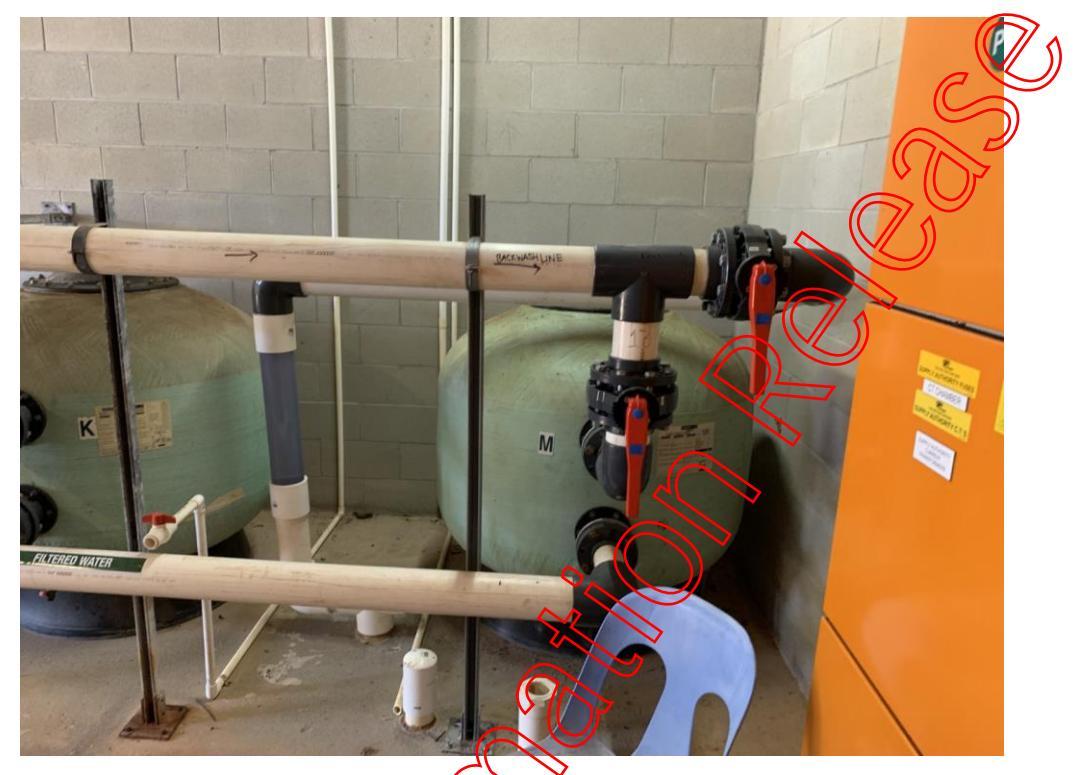
- Heating for the pool is currently shut down, with the heaters in pool condition. It's not known as to why.
- Some obsolete pipework is present, mainly due to the heating disconnection and the integration of the spa filter into the system.
- The chlorine dosing pump is located overhead which increases the risk of chlorine contact with maintenance personnel.

Figure 131: Spa filter newsparted into main manifold

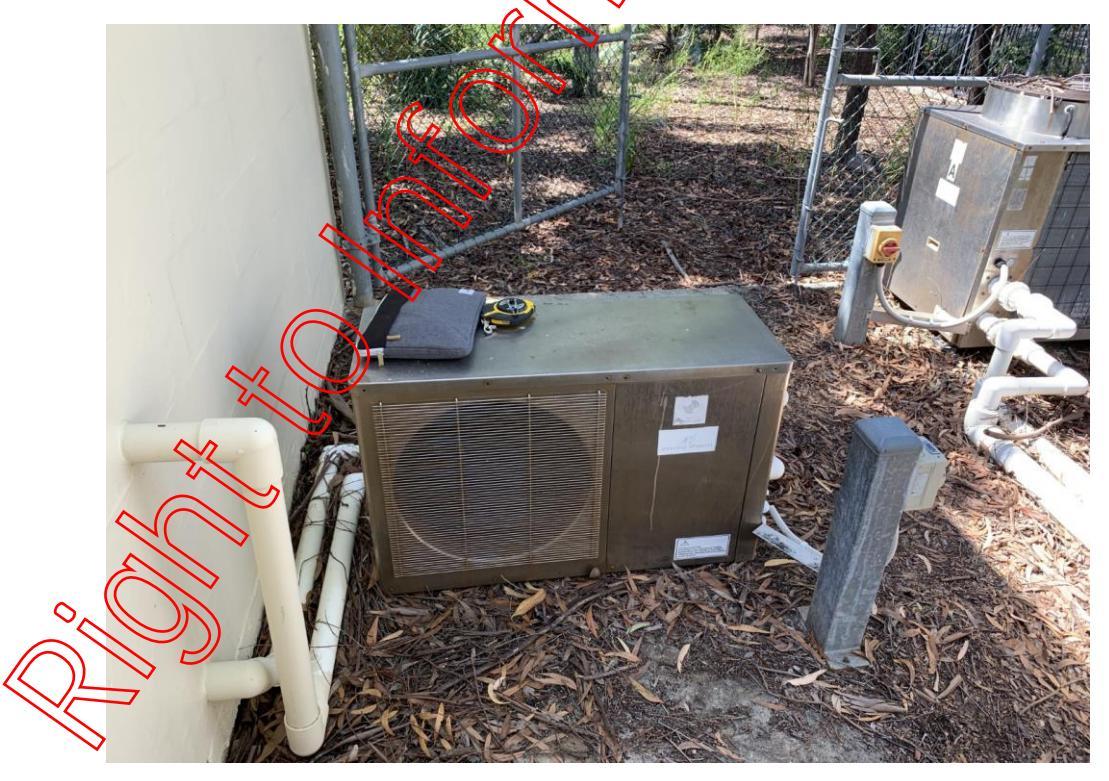
Figure 132: Disused heating

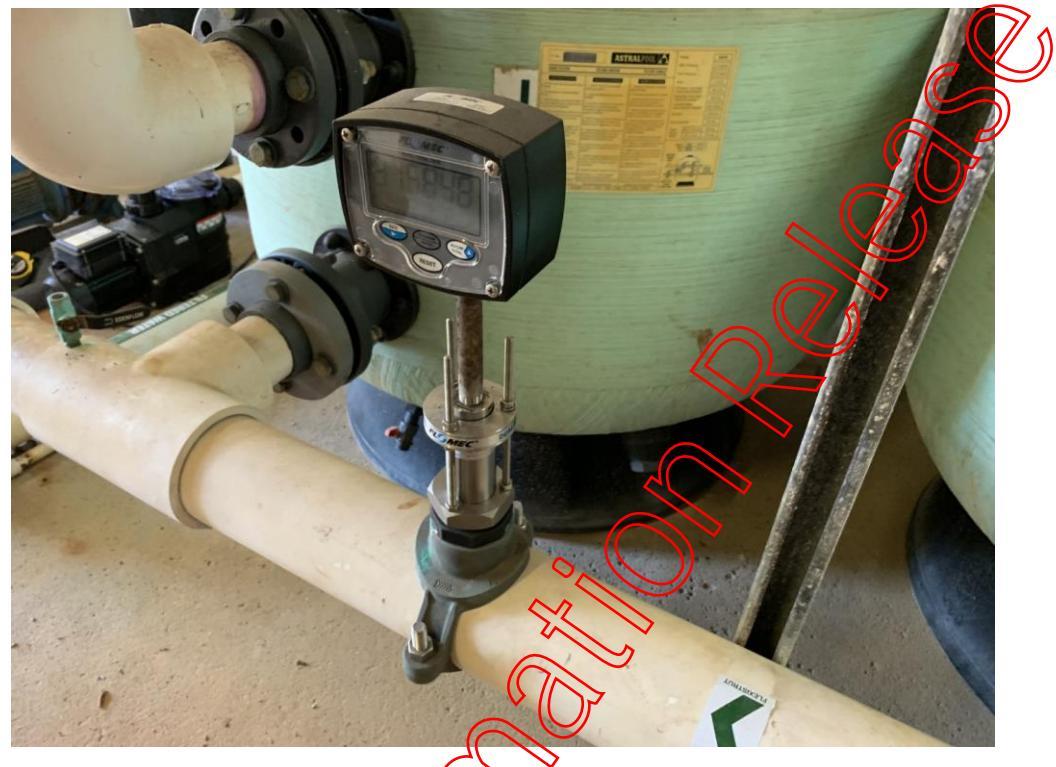
Figure 133: Flow matter restalled upstream of filter

- Provide reliable flow monitoring equipment and confirm the system flow.
- Consider relocation of the pumps to a more appropriate location as discussed above.
- Relocate the chlorine dosing pump.
- Relocate acid dosing pumps, lines and storage to the opposite end of the equipment room and neaten up over

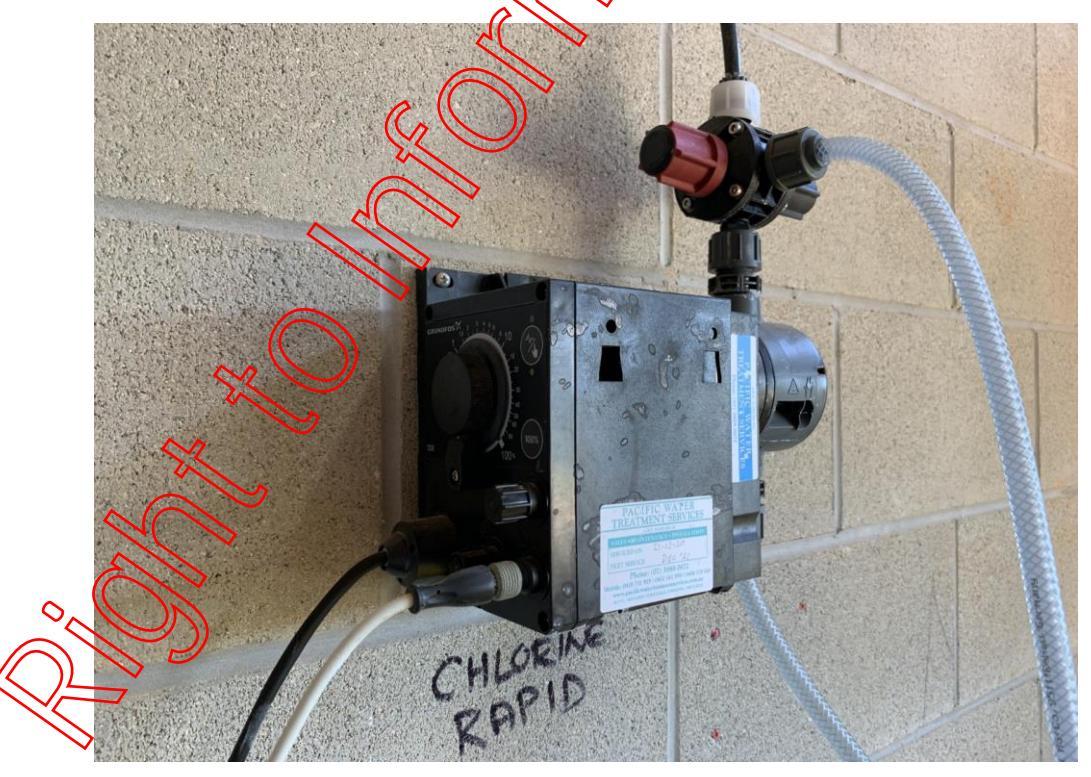
Figure 134: Chlorine pump installed at high level

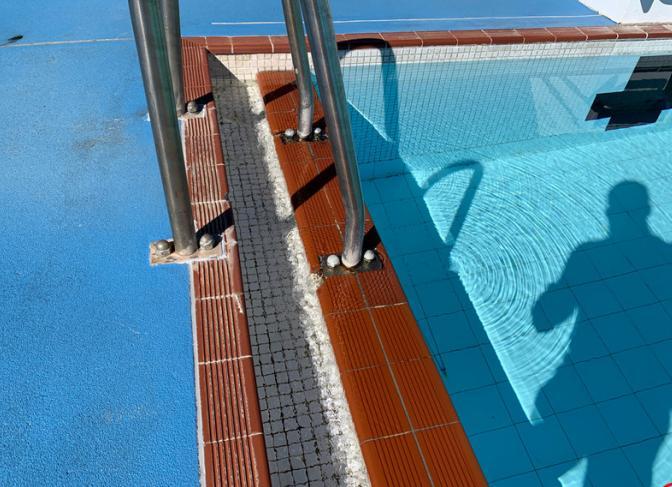
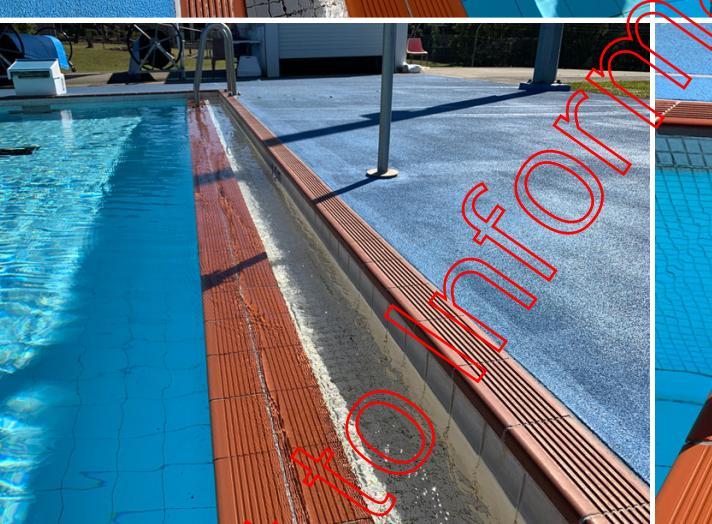
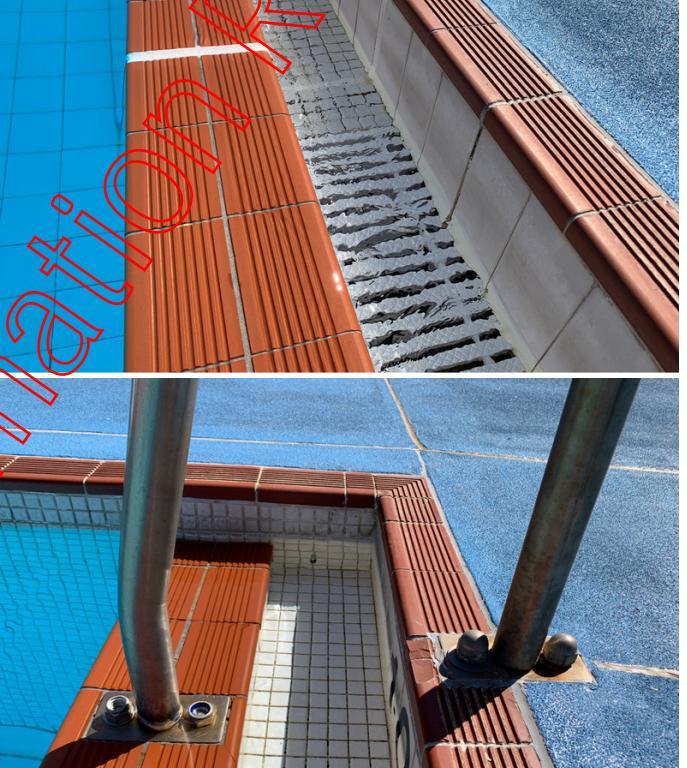
SCUM GUTTER

Observation Description	Scum Gutter	
Observation Details	The scum gutter is of an aged design. The system is running full, indicating the flow is at maximum capacity. Additionally, more water is flowing over the northern wet edge, with this side being out of level along the length indicating structural movement of the pool.	
Recommendations	Consider an upgrade to the 50m pool	
Critical Item?	Νο	
Observation Photos		\bigcirc

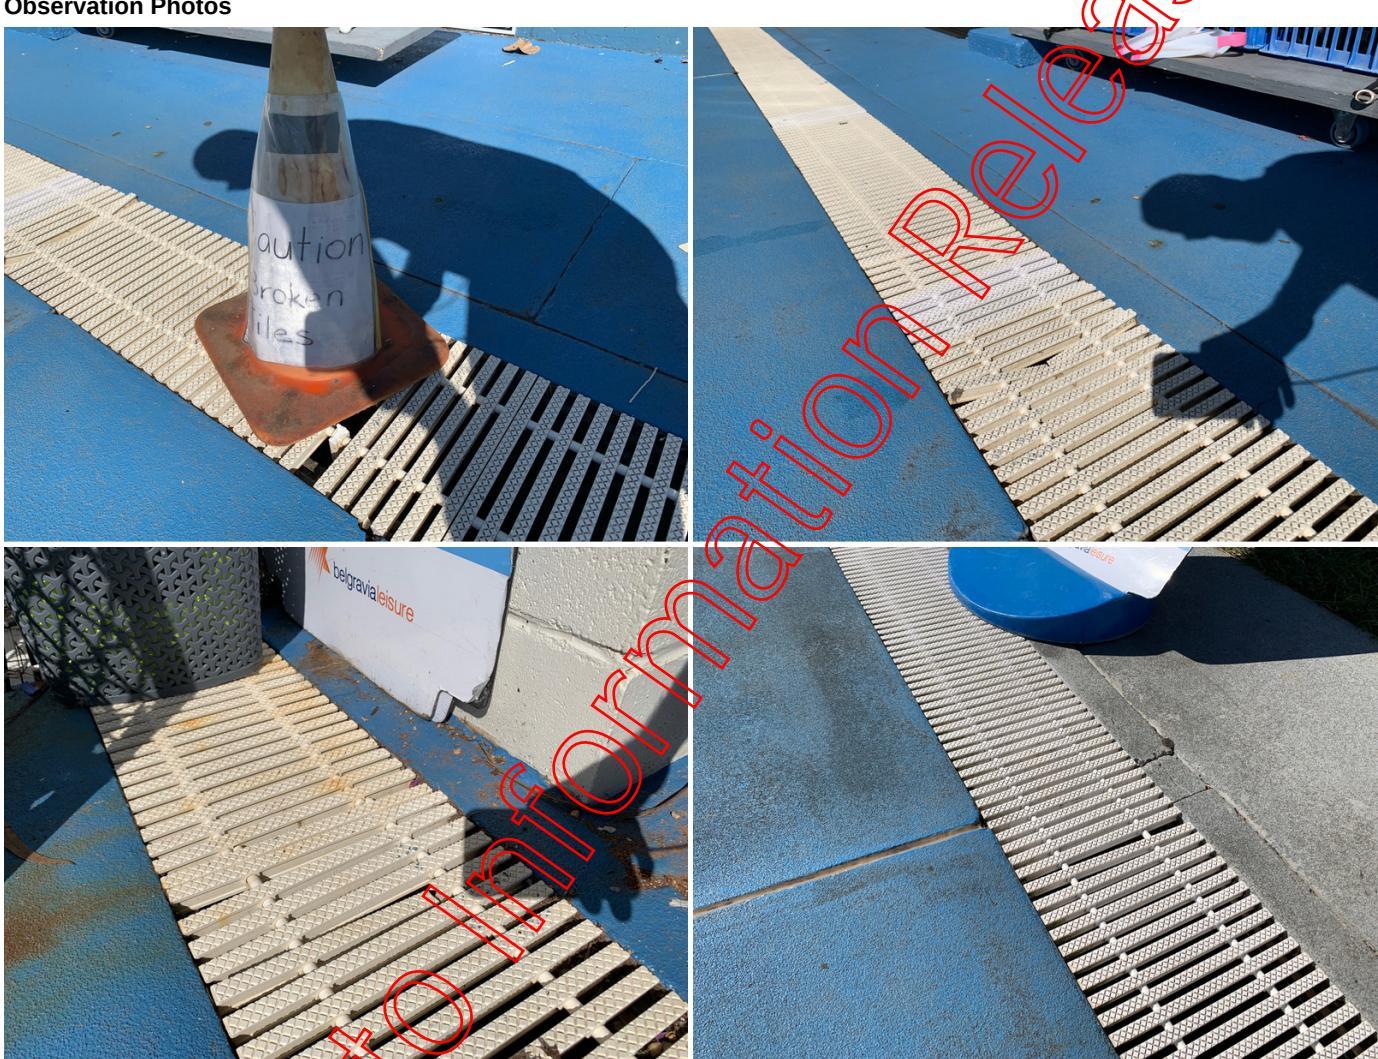
DRAIN GRATING

Observation Description	Drain Grating	
Observation Details	Wet deck grating covering the drain adjacent the pool is	s aging and broken in places
Recommendations	Replace the grating	
Critical Item?	Yes

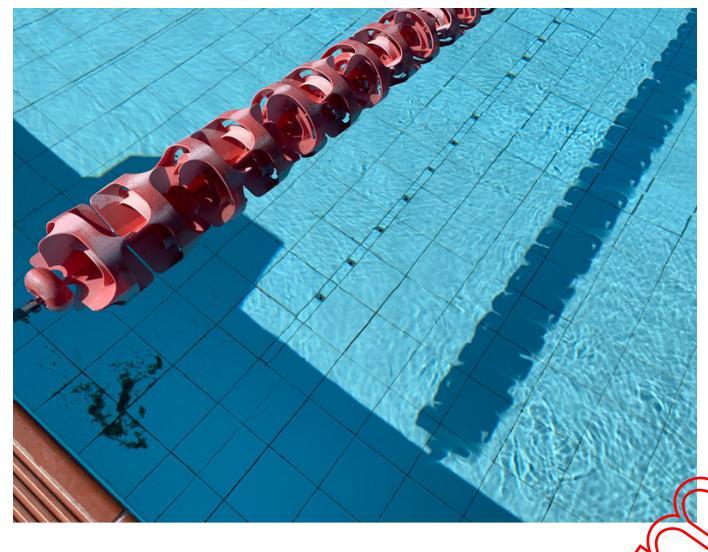
FILTERED WATER RETURN

Observation Description	Filtered Water Return
Observation Details	Filtered water is delivered to a central channel along the pool which is fitted with small holes in the top to deliver water. This type of return will have little impaction pool circulation beyond the outlets.
Recommendations	Undertake a dye circulation test in accordance with the model advance health code to visualise and confirm the circulation. Undertake rectification works as required.
Critical Item?	No

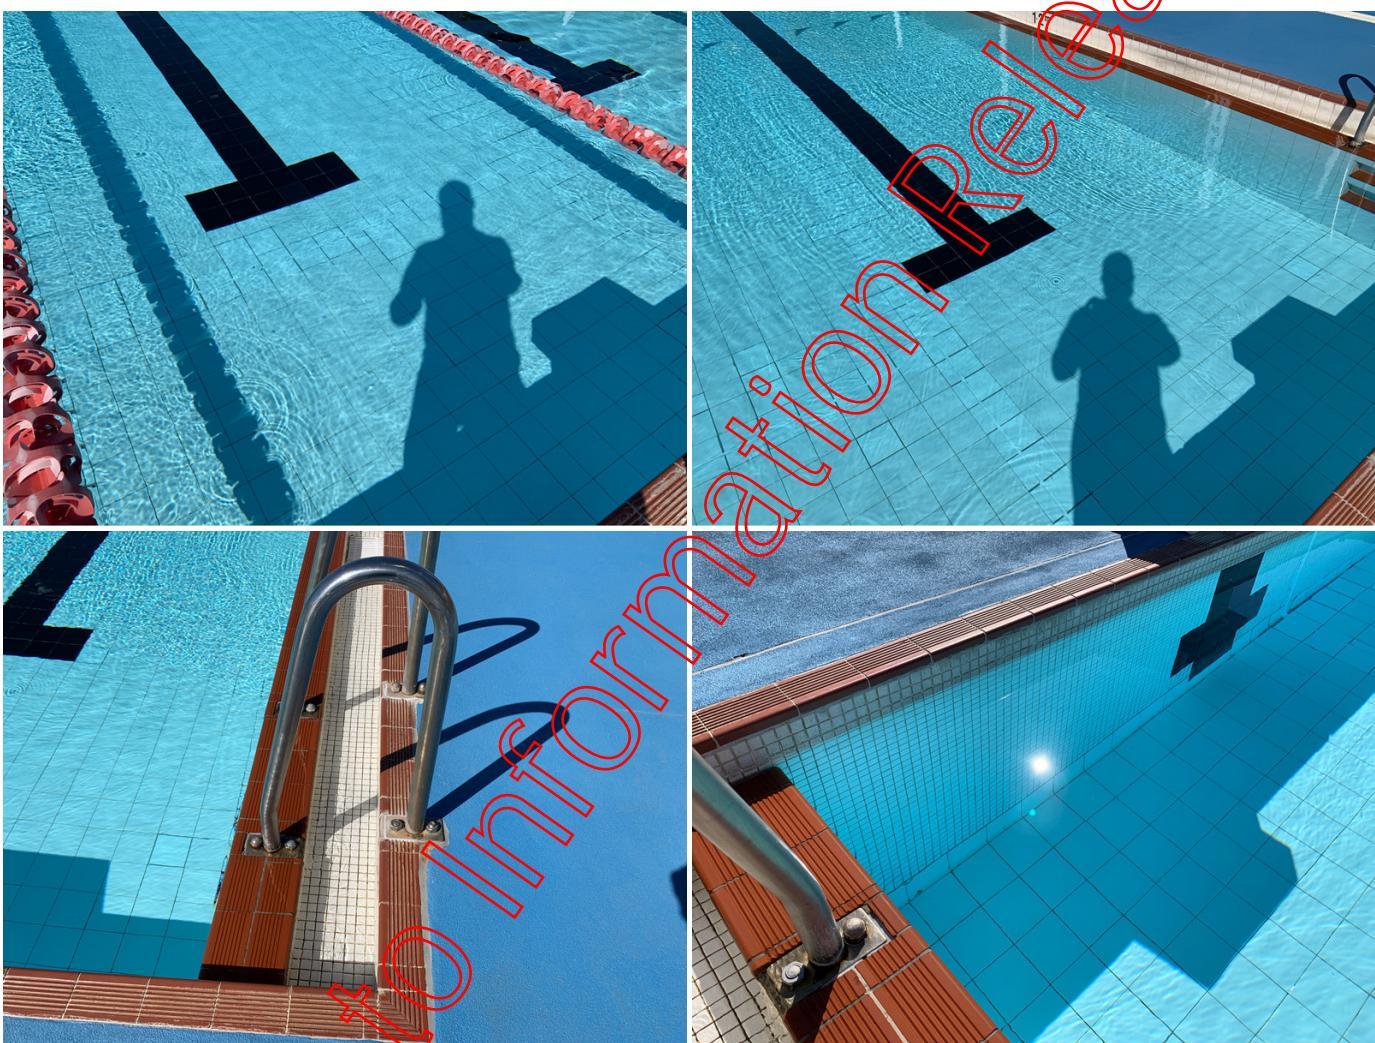
TILING

Observation Description	Tiling
Observation Details	The tiling provided in the pool is aging and not slip resistant. This is an issue for activities requiring grip on the pool floor
Recommendations	Replace the pool tiling
Critical Item?	No

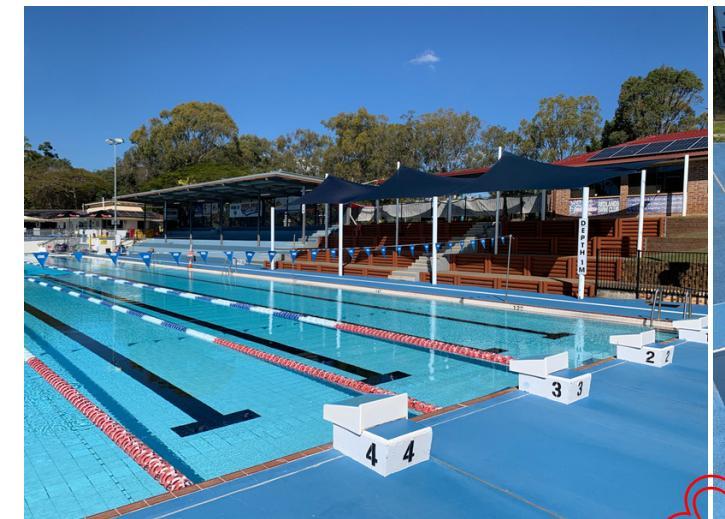
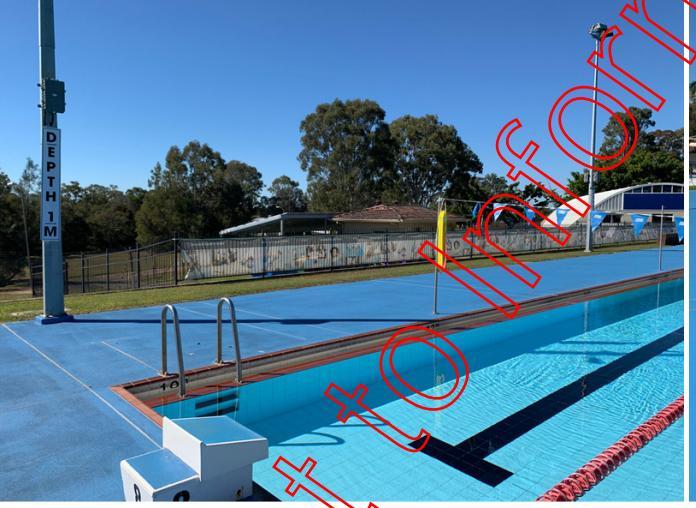
DEPTH AND WARNING SIGNAGE

Observation Description	Depth and Warning Signage	
Observation Details	Applicable to all the pools onsite, current signage does not comply with the Royal Lifesaving guidelines. Depth markers are inconsistent or not legible while advisory signage is not provided.	
Recommendations	Engage Royal Lifesaving to undertake a signage audit at the factive mouding pools and plant rooms	
Critical Item?	Yes

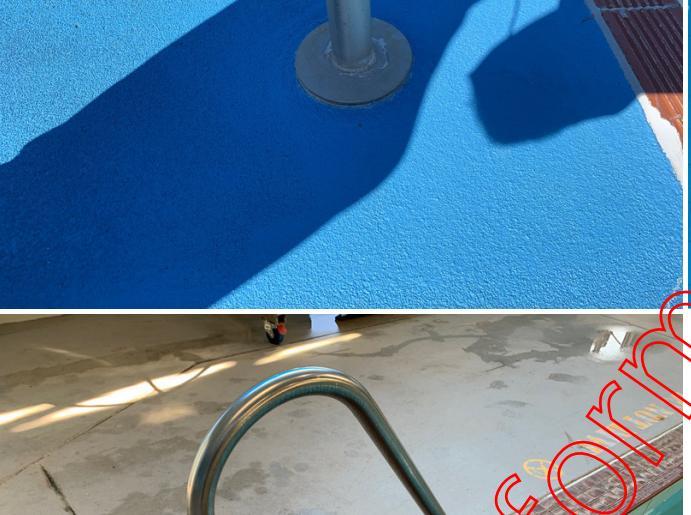
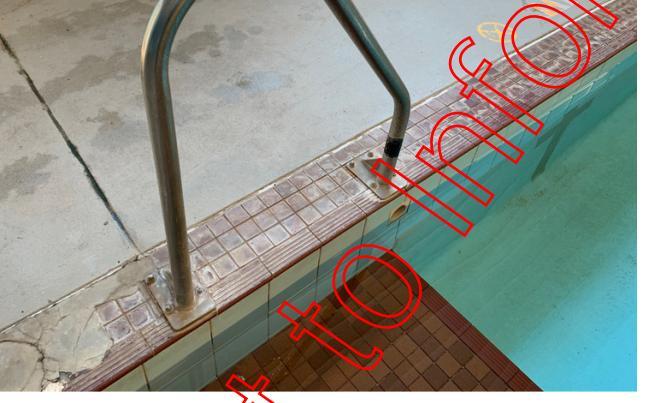
EQUIPOTENTIAL BONDING

Observation Description	Equipotential bonding	
Observation Details	Conductive items are present within arms reach of most pools, requiring equipotential bonding. This extends to all pools.	
Recommendations	If not provided within the past 12 months, engage an electrician to undertake an earth bonding test of all items as required by AS3000	
Critical Item?	Yes

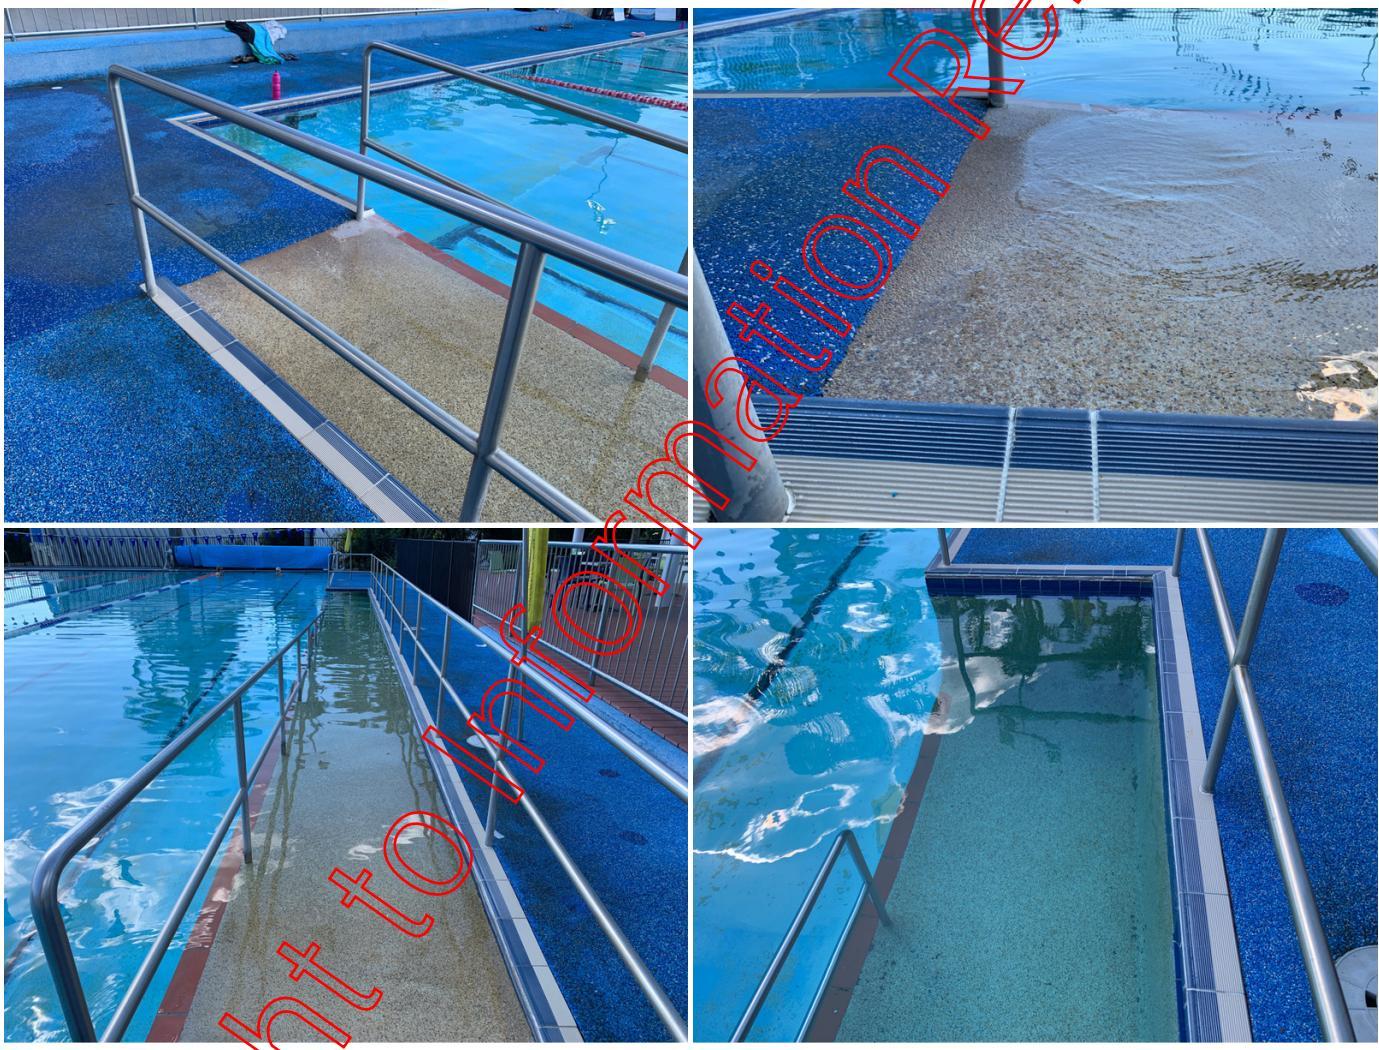
RAMP COMPLIANCE

Observation Description	Ramp Compliance
Observation Details	The disabled access ramp is not compliant with AS1926.3: o No mid landing is provided o Only one handrail is provided, with the other handrail being non-compliant o The entry to the ramp is too steep o The ramp delivers too deep
Recommendations	Replace the ramp. In the interim, provide signage to inform patrons of the issues with the ramp.
Critical Item?	No

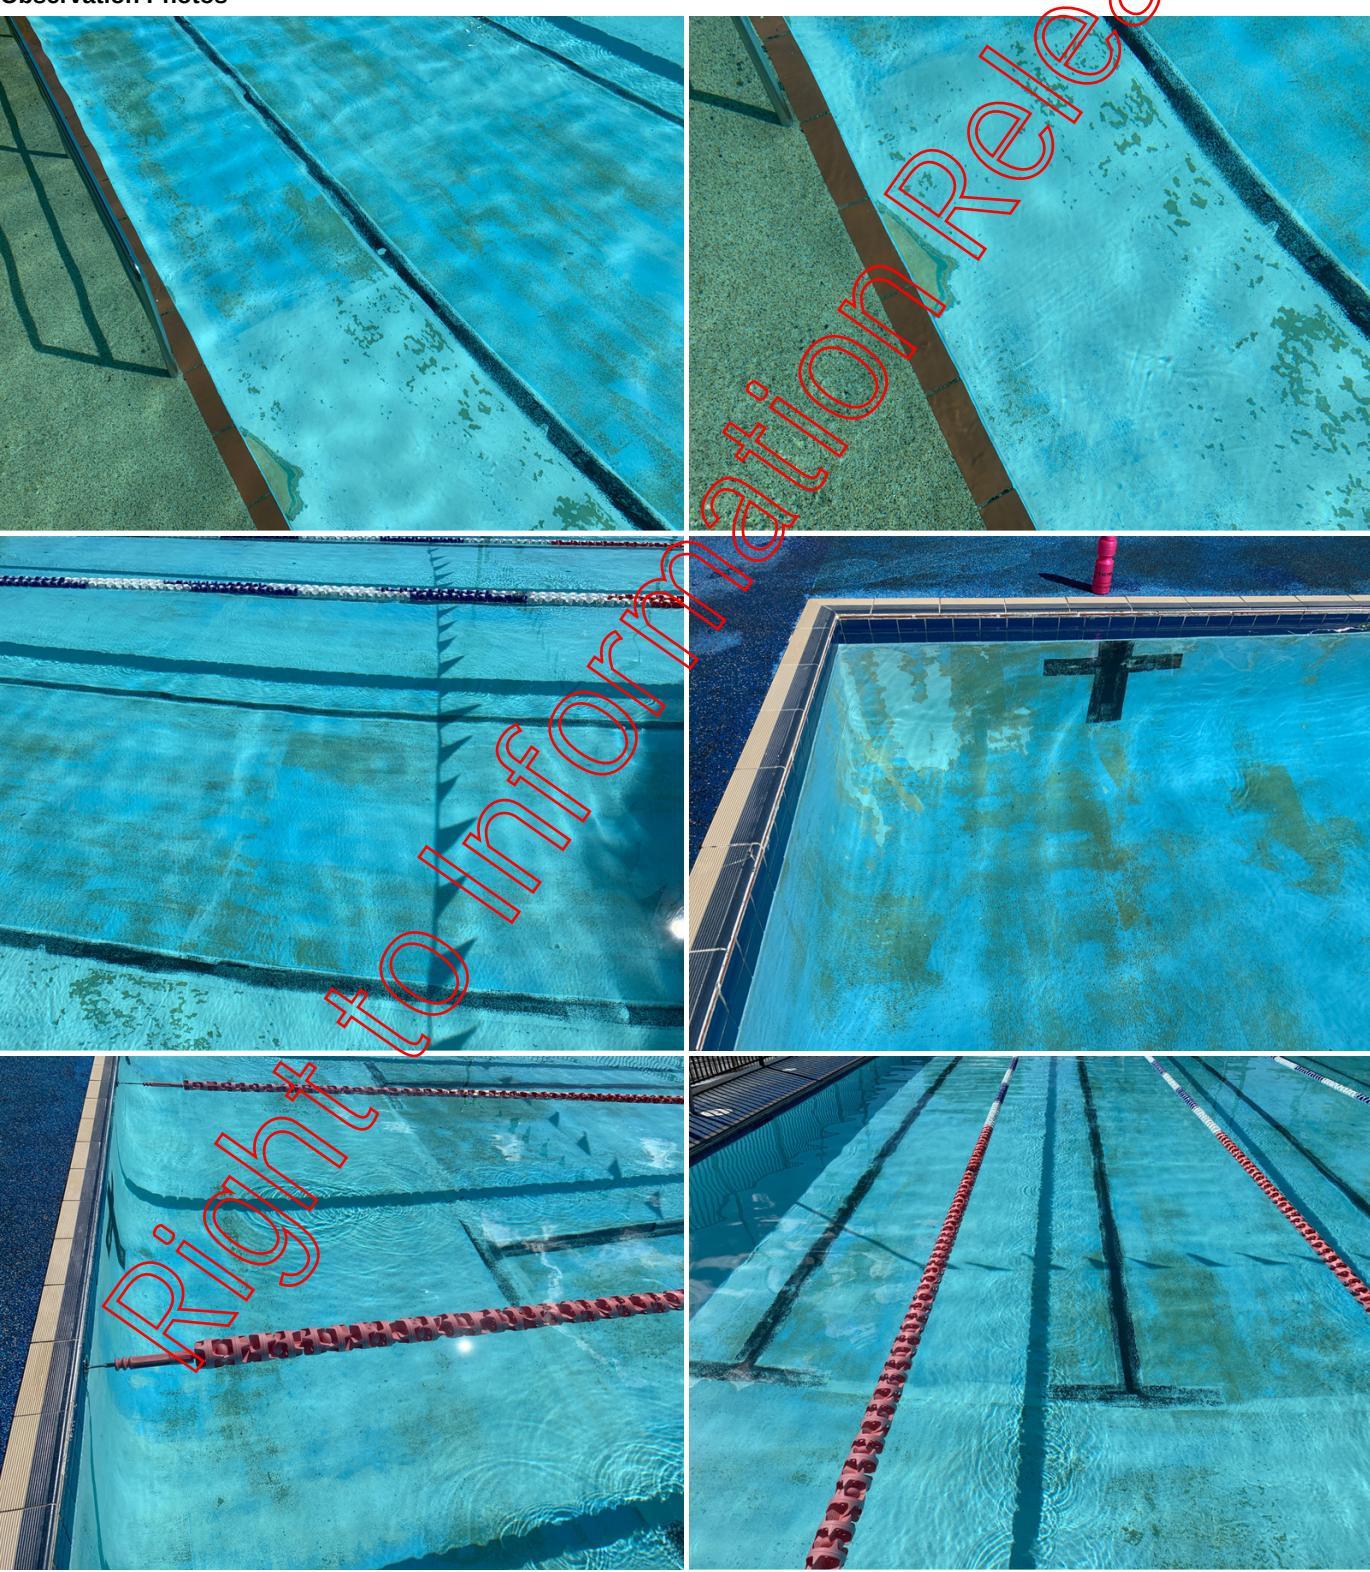
POOL FINISH

Observation Description	Pool Finish
Observation Details	The painted finish is in very poor condition with the underlying fibreglass liner appearing very worn in places.
Recommendations	Remove the fibreglass liner and refinish the pool
Critical Item?	No

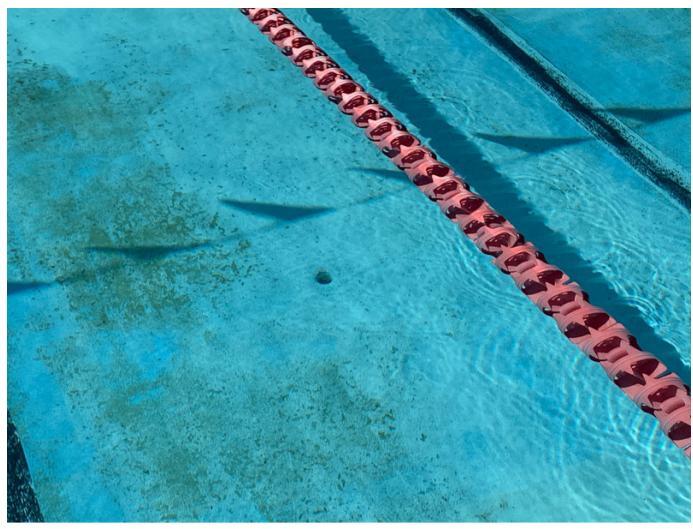
CIRCULATION FITTINGS

Observation Description	Circulation Fittings	
Observation Details	The marjority of circulation fittings are missing in the pool with j	ust bare pipe showing
Recommendations	Provide eyeball and floor rerun fittings to all bare pipes	
Critical Item?	Yes

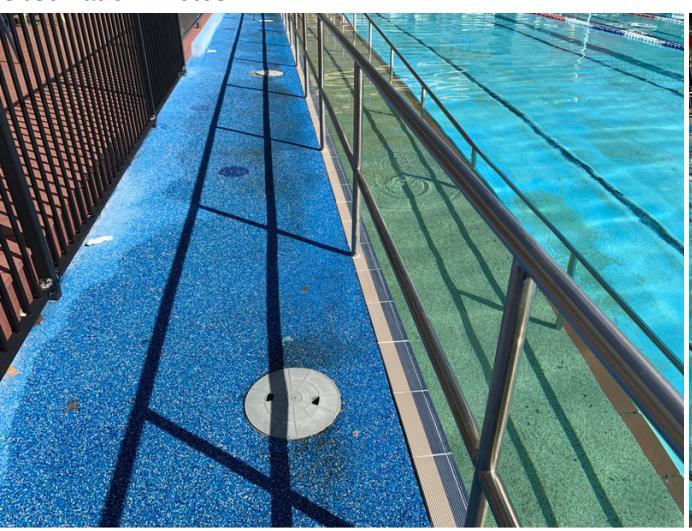
POOL CIRCULATION

Observation Description	Pool Circulation	
Observation Details	Circulation through the pool is likely poor due to the low flow and the poor number of fittings	
Recommendations	As with the 50m pool, provide a circulation dye test	
Critical Item?	No

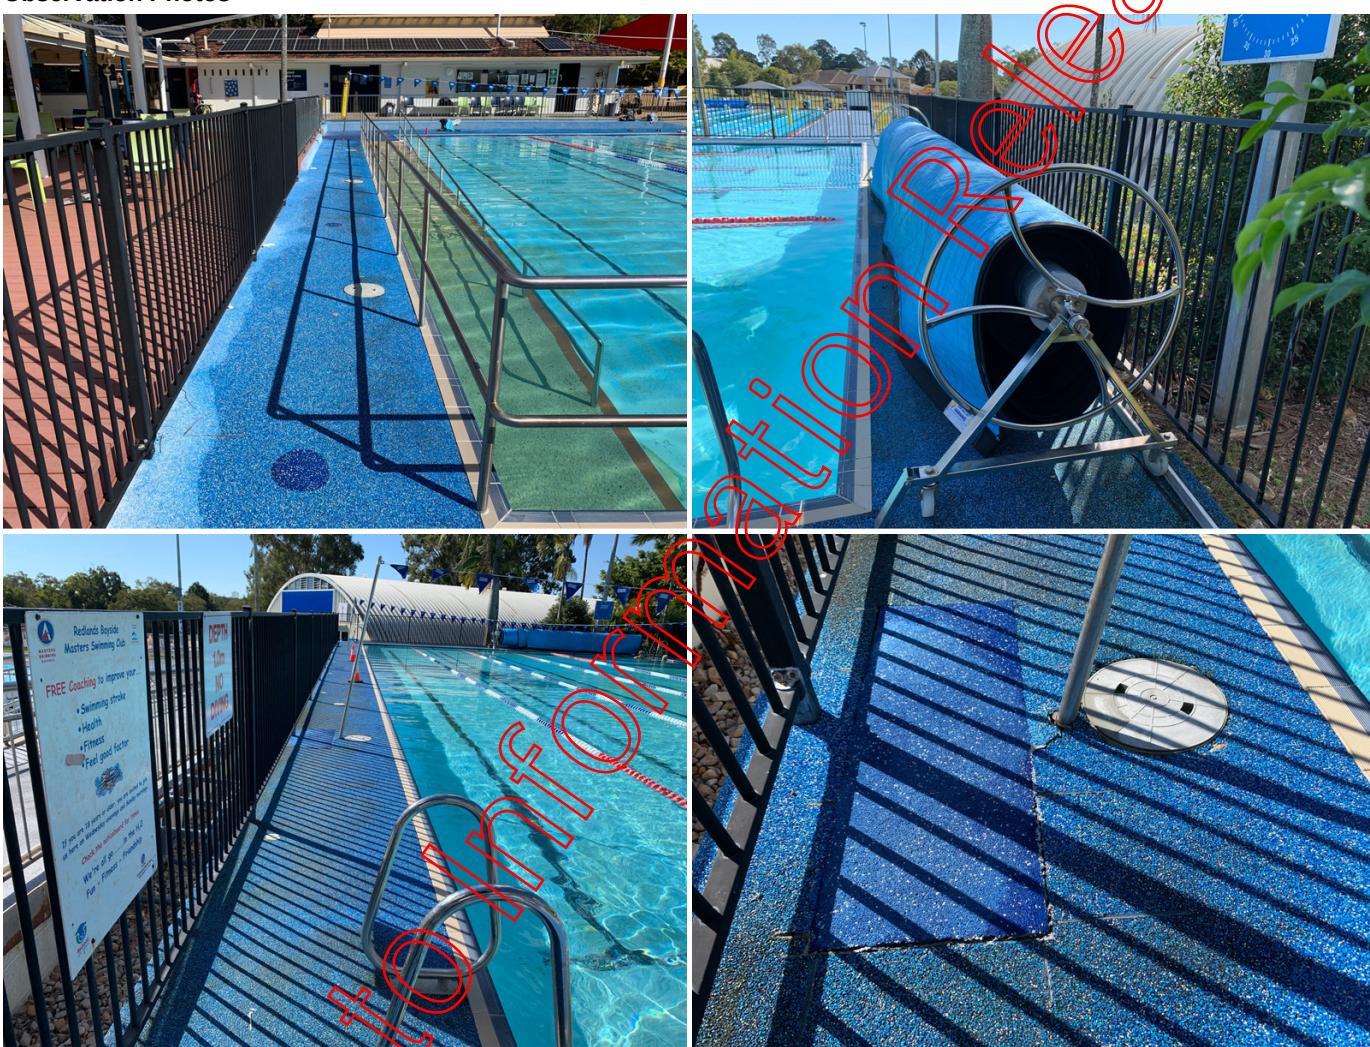
CONCOURSE CIRCULATION AND CONDITION

Observation Description	Concourse Circulation and Condition
Observation Details	Concourse circulation space is very tight, especially with instructions from blankets. Additionally the rubberised coating is in poor conditions
Recommendations	Review circulation around the pool and look to improve. Replace the ruberised coating.
Critical Item?	Yes

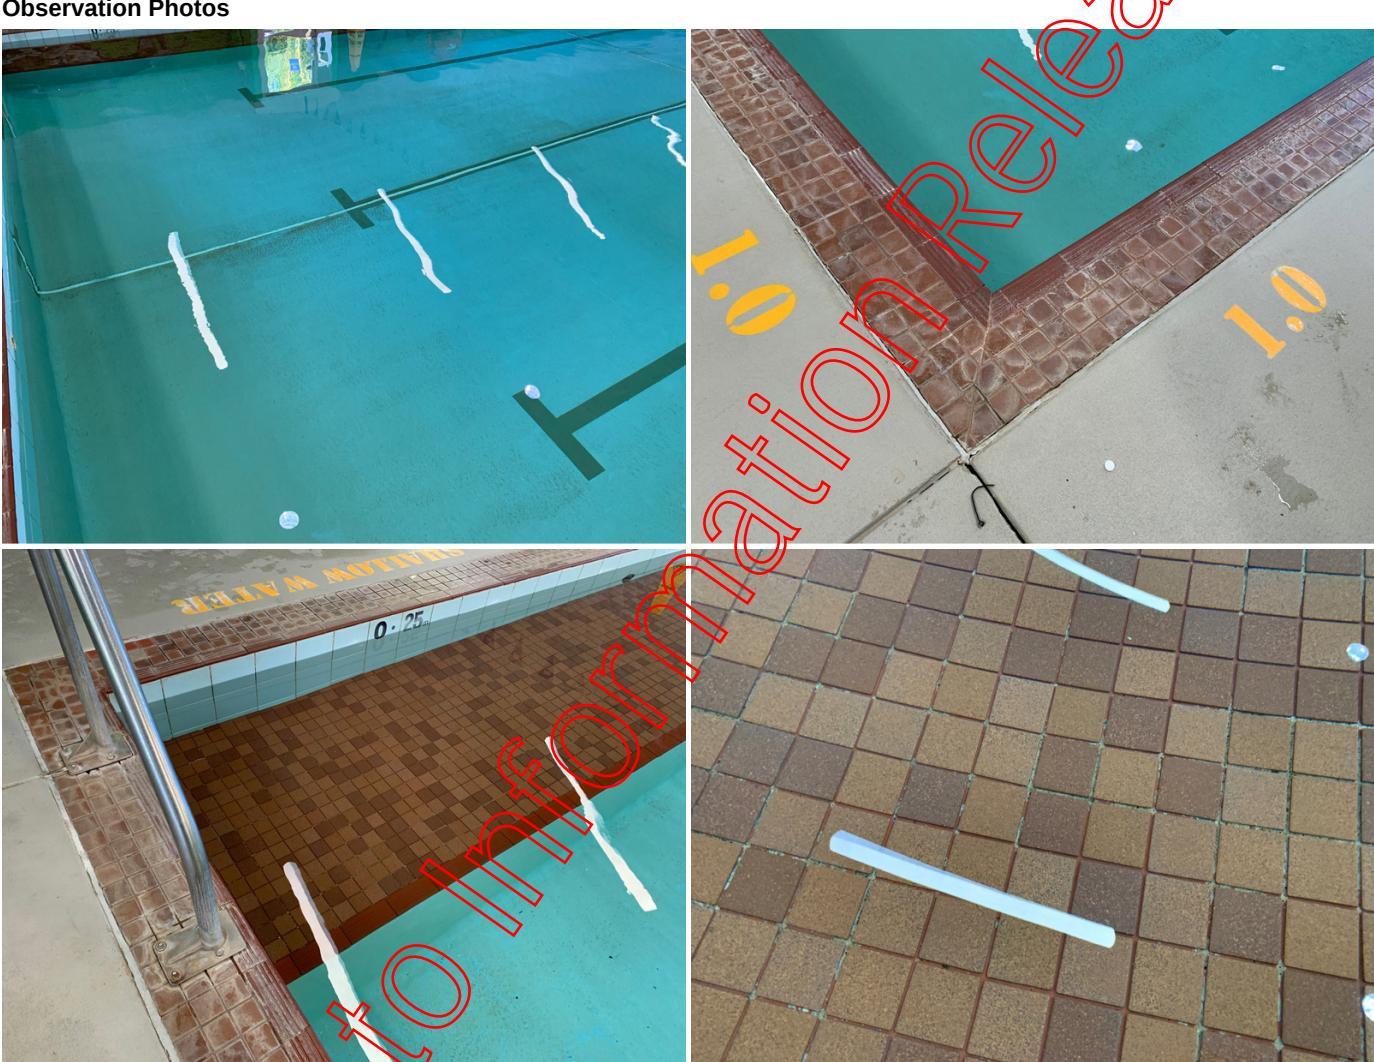
FINISHES CONDITION

Observation Description	Finishes Condition	
Observation Details	The finishes are in poor condition overall. The painted finish has failed with fibreglass visible through. Grout on the bench is generally missing whilst coping the are stained.	
Recommendations	Replace the pool finishes	
Critical Item?	No

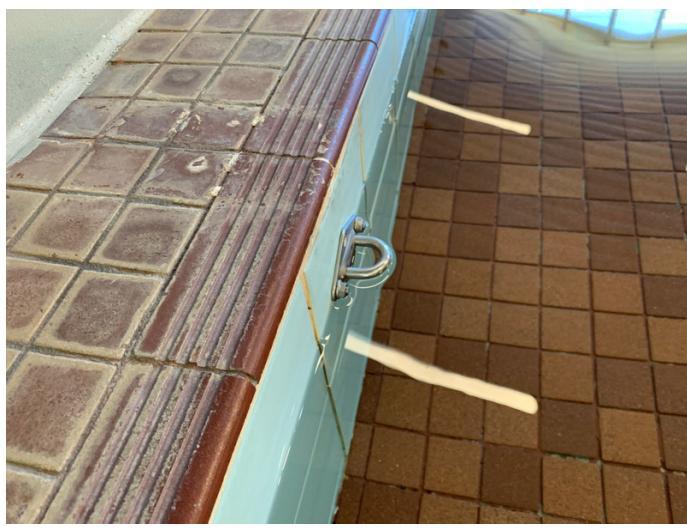
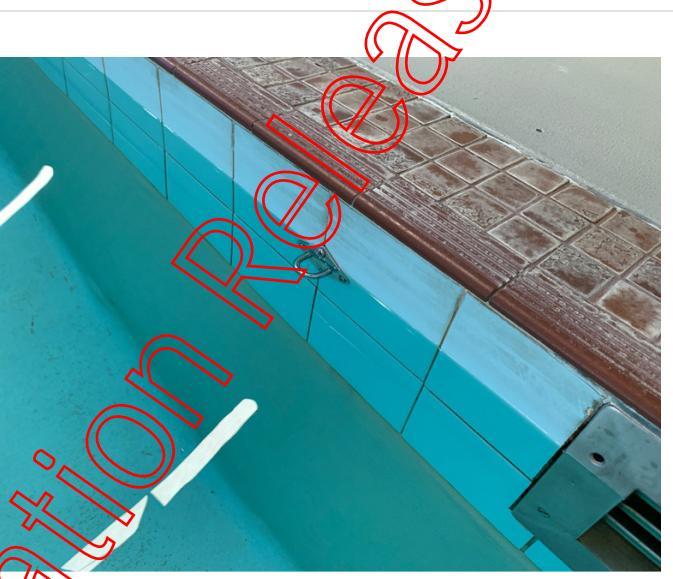
ANCHORS

Observation Description	Anchors	
Observation Details	Lane rope anchors protrude from the wall which create	a finger and toe entrapment risk
Recommendations	Replace with flush anchors	
Critical Item?	Yes

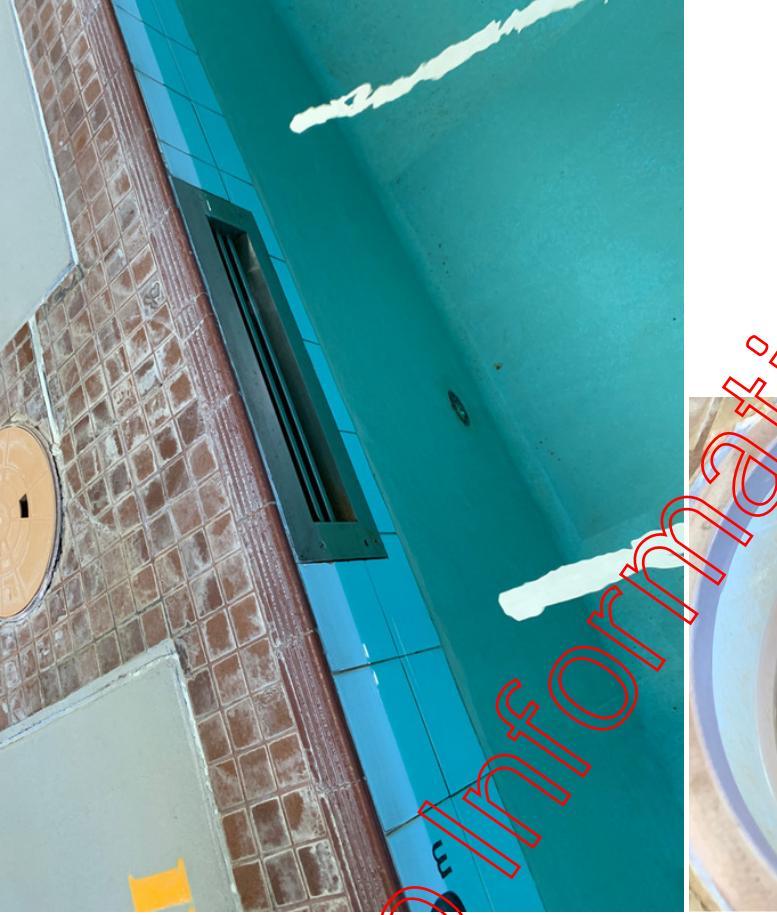
SKIMMER SUCTION FITTINGS

Observation Description	Skimmer Suction Fittings
Observation Details	Each skimmer appears to be connected to a suction fitting in the wall which is not fitted with an AS1923 compliant cover. This creates a suction entrapment strong requires rectification urgently.
Recommendations	Block off fittings or provide compliant fittings.
Critical Item?	Yes
Observation Photos

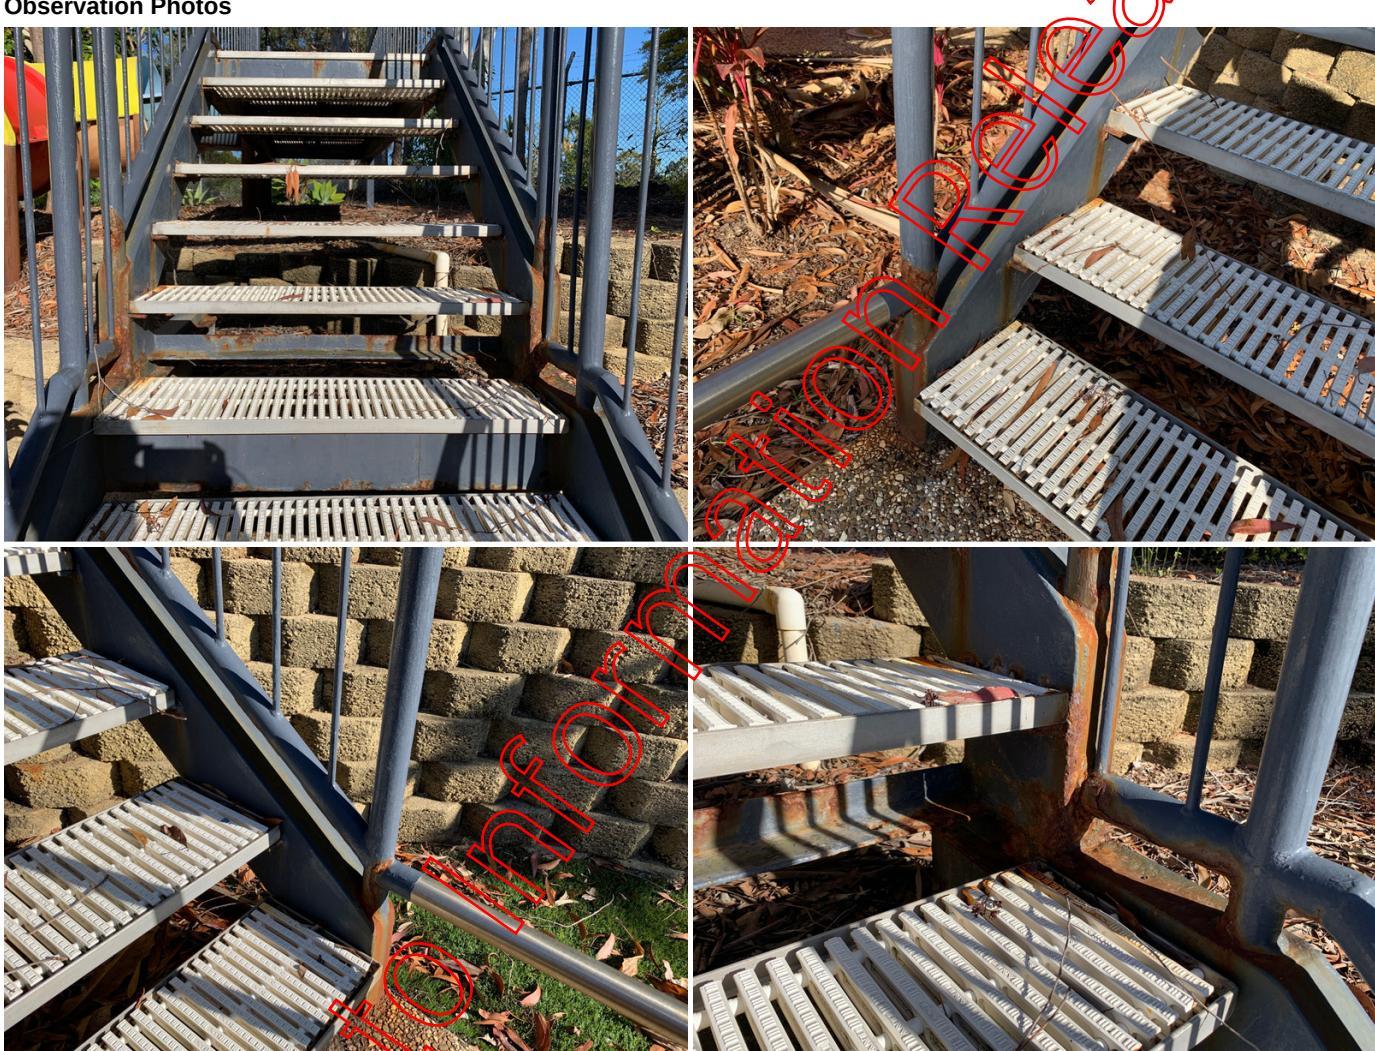
WATERSLIDE START

Observation Description	Waterslide Start	
Observation Details	A significant amount of rust is still present in the rust has increased in magnitude since the previo	stairs leading to the waterslide start. This bus inspection.
Recommendations	Repair the rust as a priority	
Critical Item?	Yes

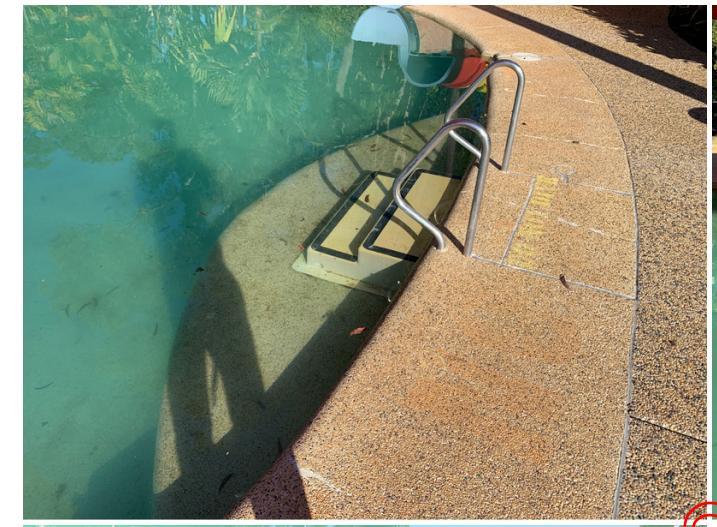
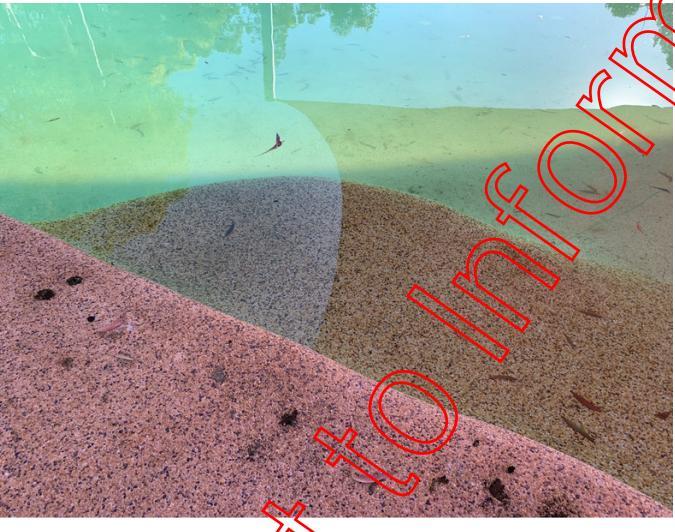
POOL ACCESS

Observation Description	Pool Access	
Observation Details	No compliant access point is provided in the swimout, however access does not continue delineators provided to any steps or swimout	deep end. A fibreglass step is present onto a to the flood of the pool for are edge ts in the pool.
Recommendations	Add compliant ladders. Add edge delineation	markers to all underwater edges.
Critical Item?	Yes
