CLEVELAND AQUATIC CENTRE UPDATED POOL CONDITION ASSESSMENT

AND MAINTENANCE PLANS

(July 2014)

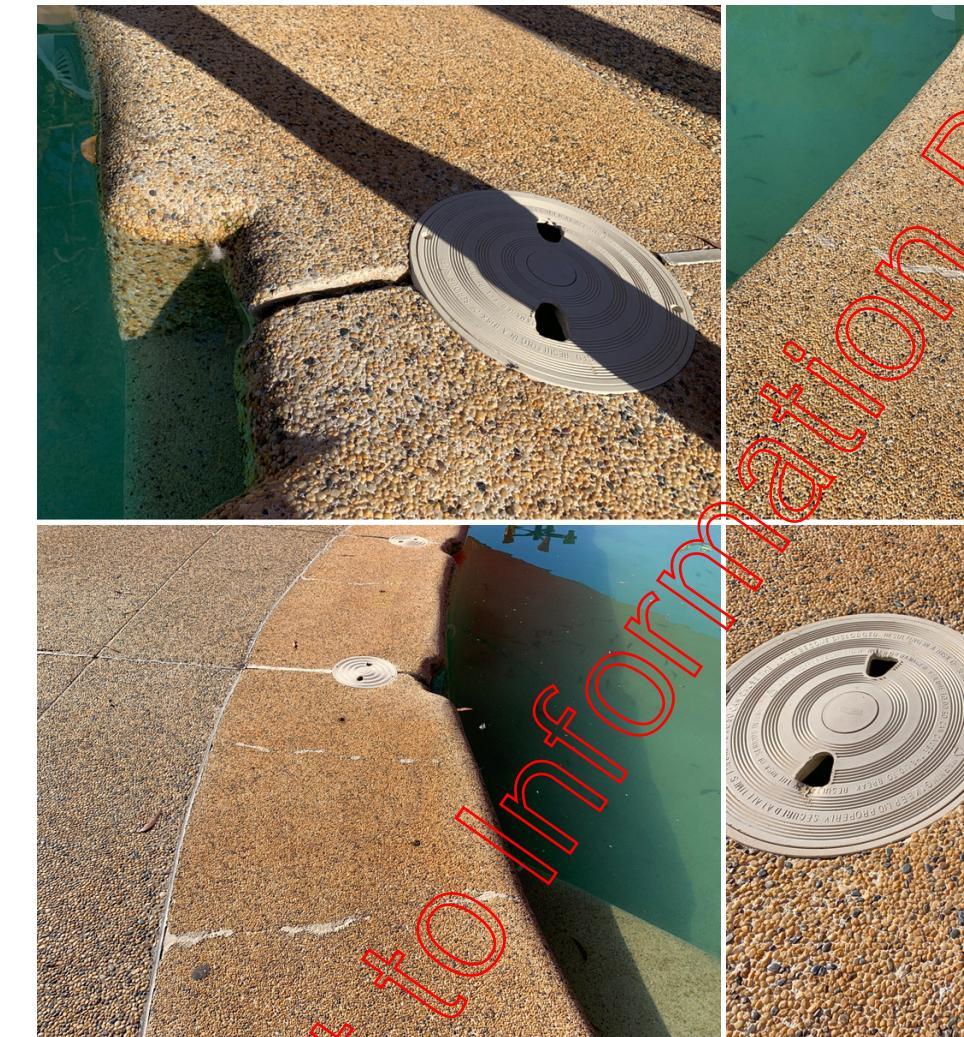
COPING FINISHES CONDITION

Observation Description	Coping Finishes Condition
Observation Details	The coping finishes condition is poor, with notable cracking observed in the finishes. In some areas sections of the finish are missing or delaminated.
Recommendations	Remove all finishes and inspect the sub grade for condition. Provide new finishes. In the interim, remove any loose areas and make good.
Critical Item?	Yes

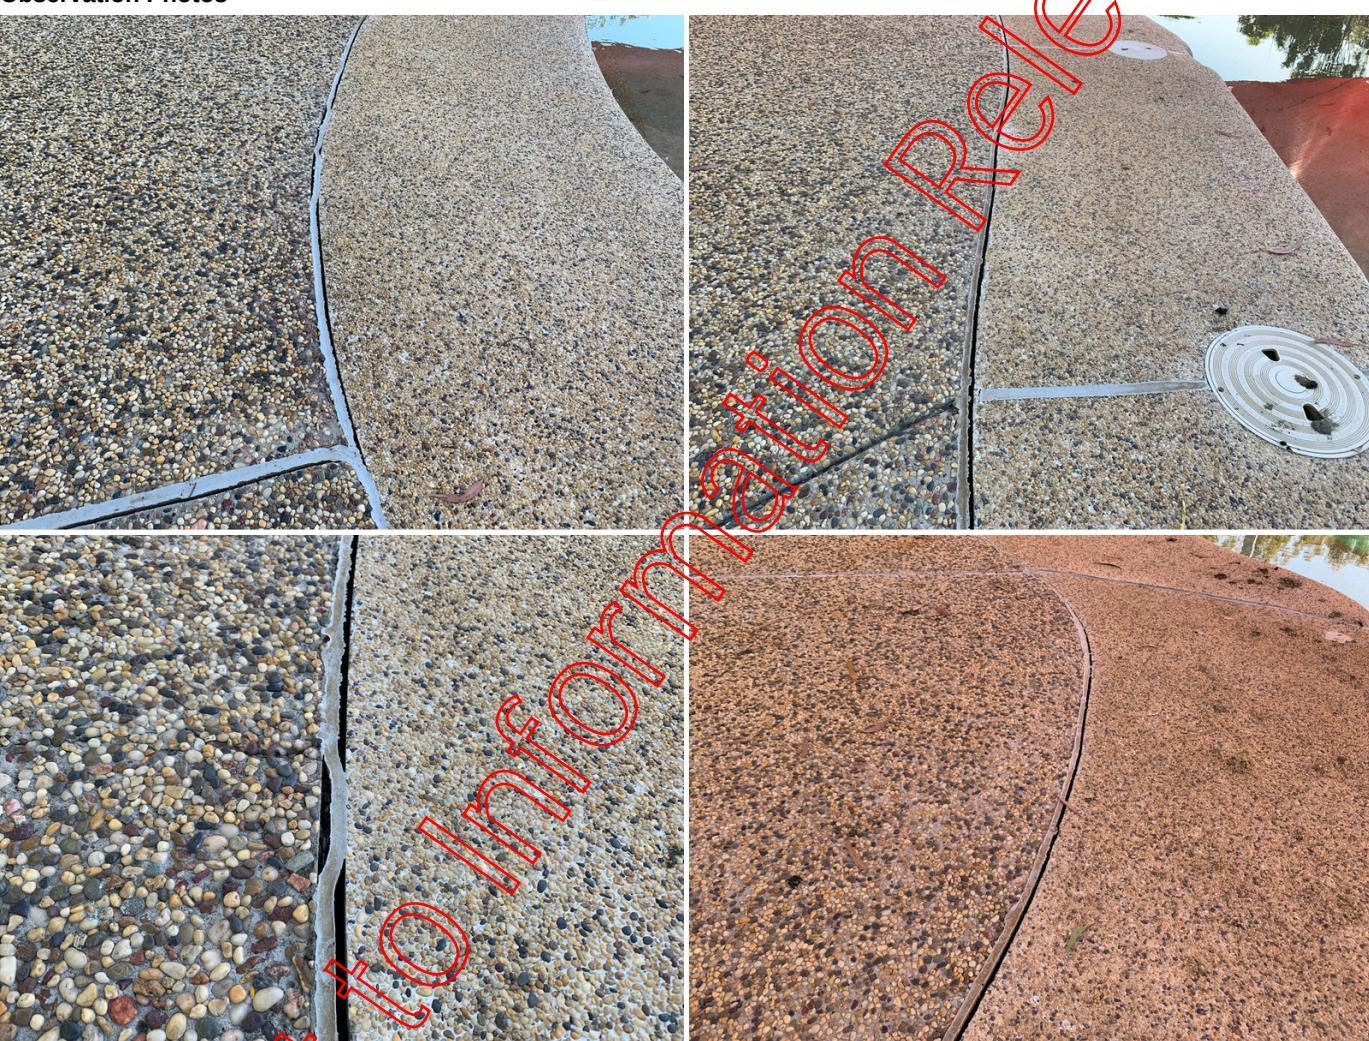
CONCOURSE MOVEMENT

Observation Description	Concourse Movement	
Observation Details	The concourse adjacent the small waterslide appears to have moved away from the poor approximately 10mm, indicating ground subsidence.	I
Recommendations	Reseal the joint and monitor for further movement or structural degradation of the concourse	
Critical Item?	No

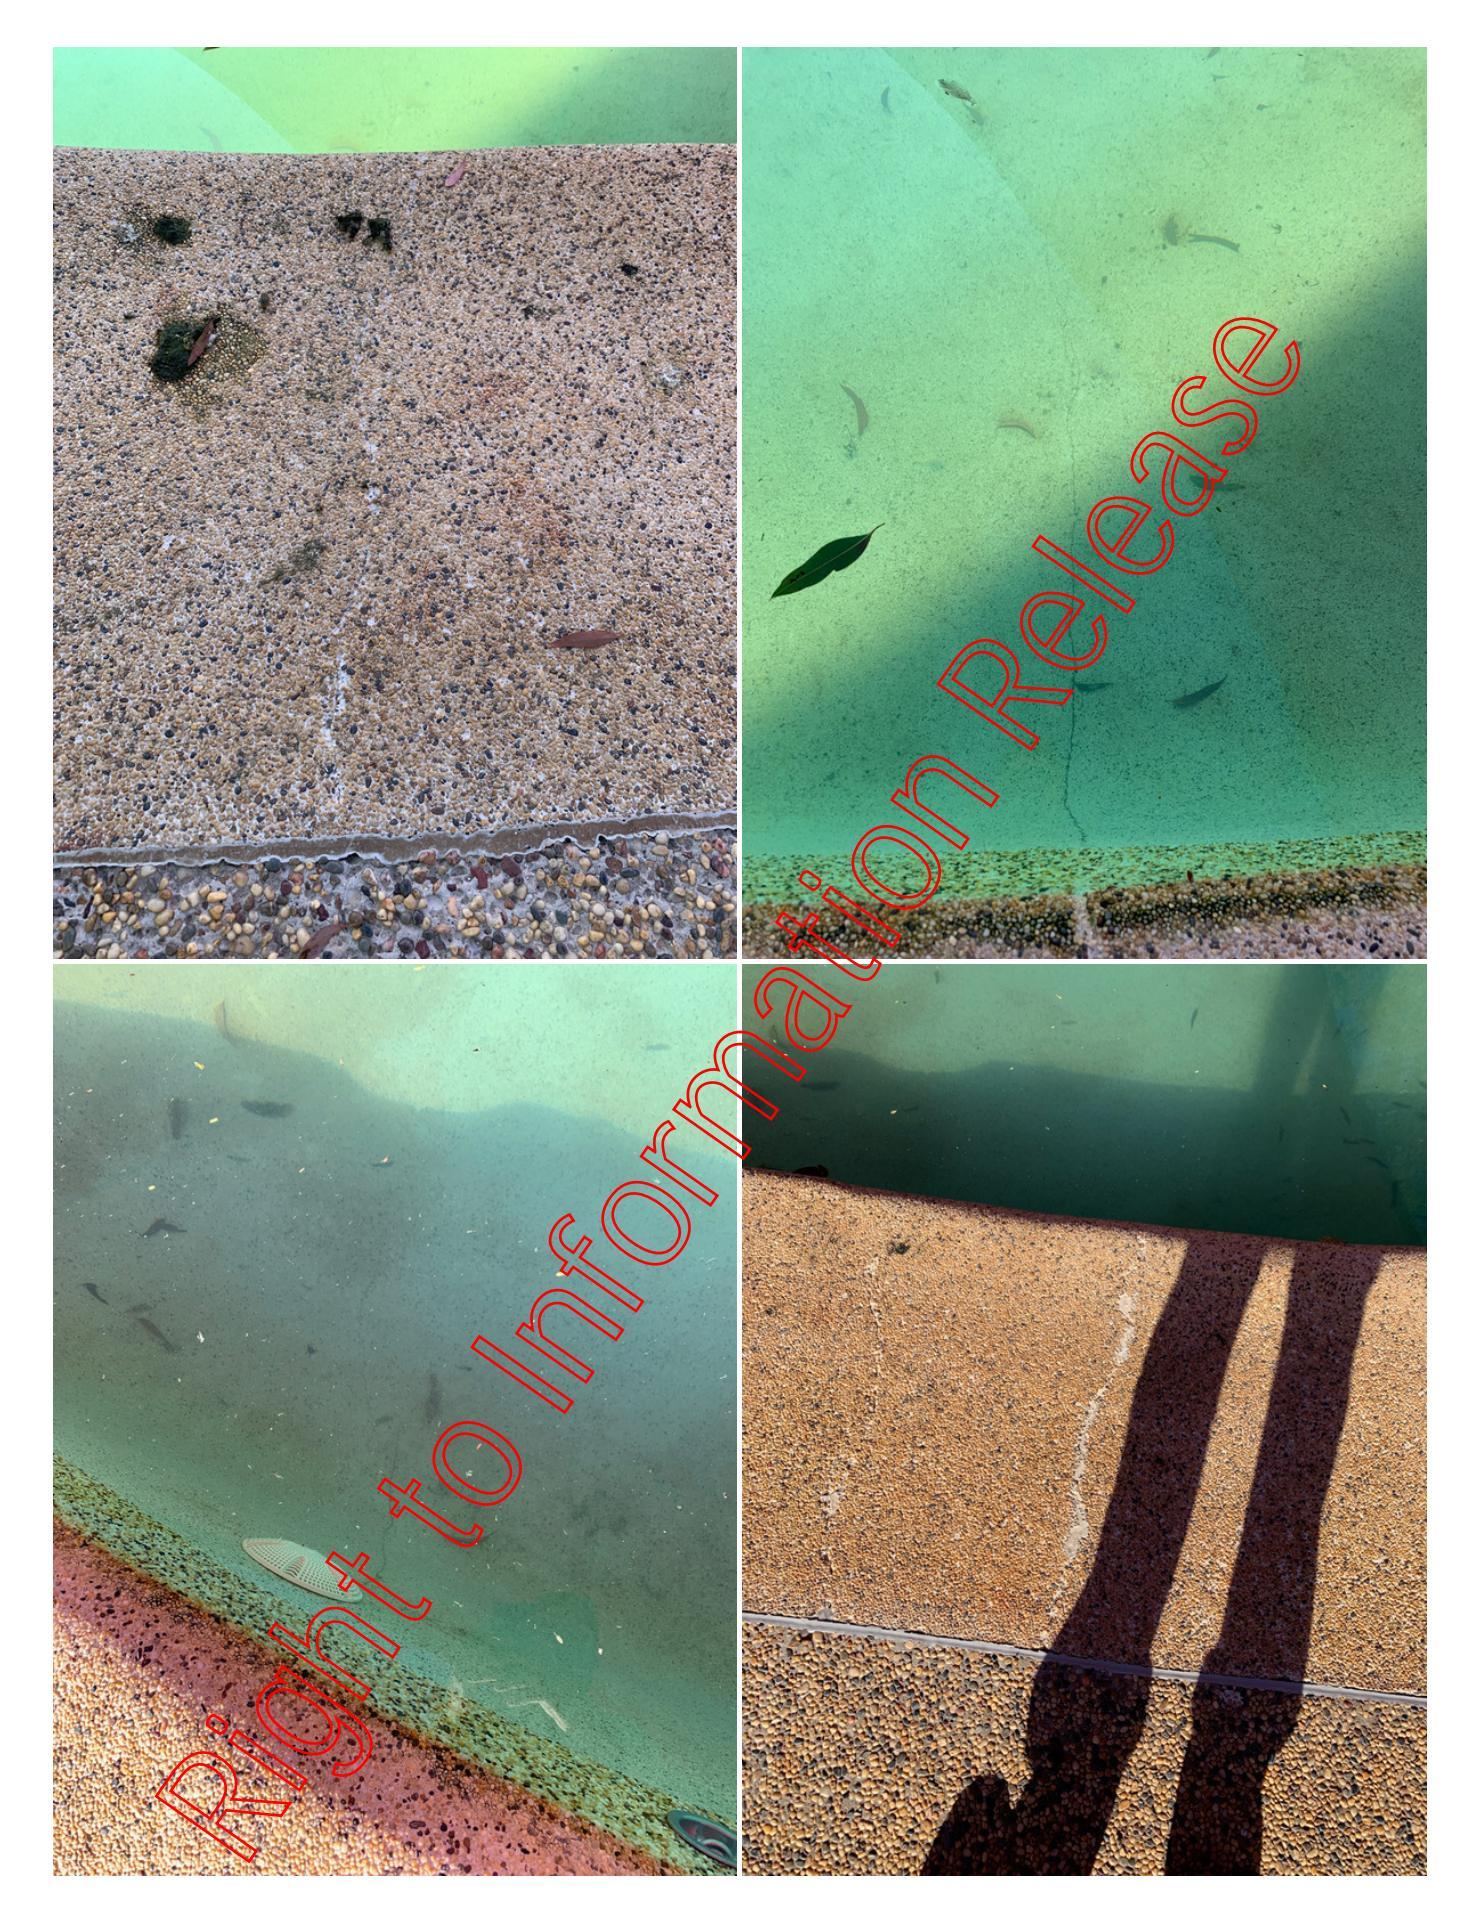
STRUCTURE CRACK

Observation Description	Structure Crack	
Observation Details	A structural crack is observed running across the deep end of the pool	
Recommendations	Inspect the crack for leaks and seal the crack	
Critical Item?	Yes	
Observation Photos

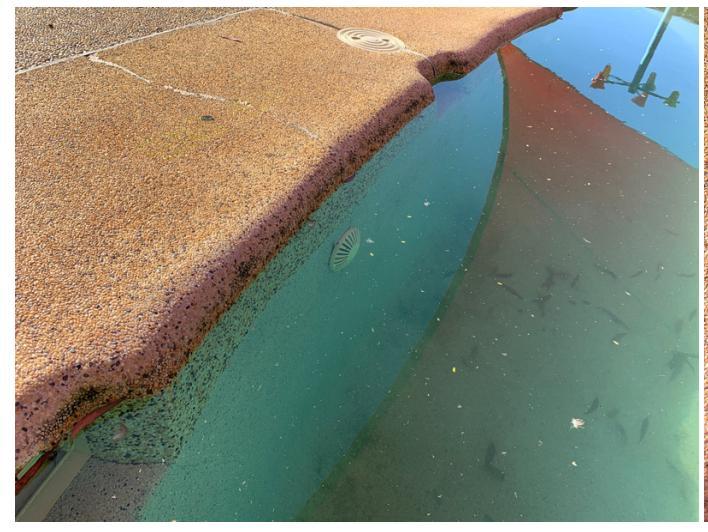
SUCTION FITTINGS

Observation Description	Suction Fittings
Observation Details	Old suction fittings are present in the wall of the pool.
Recommendations	Remove the fittings and replace with new AS1926.3 compliant items
Critical Item?	Yes

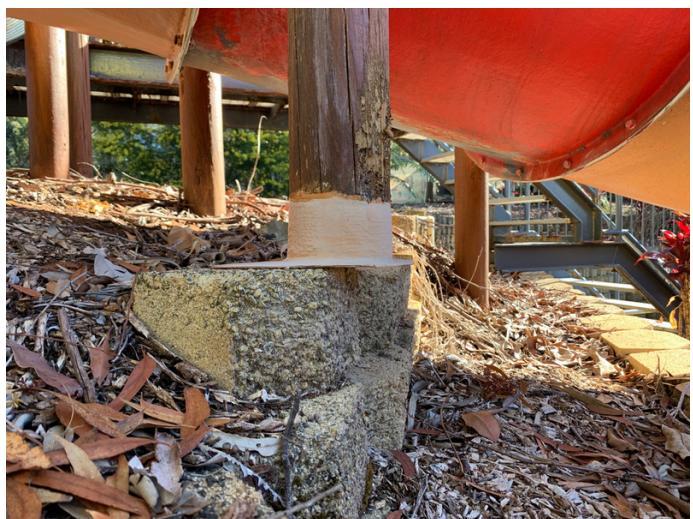
WATERSLIDE SUPPORT

Observation Description	Waterslide Support	
Observation Details	One of the legs of the waterslide is poorly supported half on a brick	
Recommendations	Rectify the support	
Critical Item?	Yes

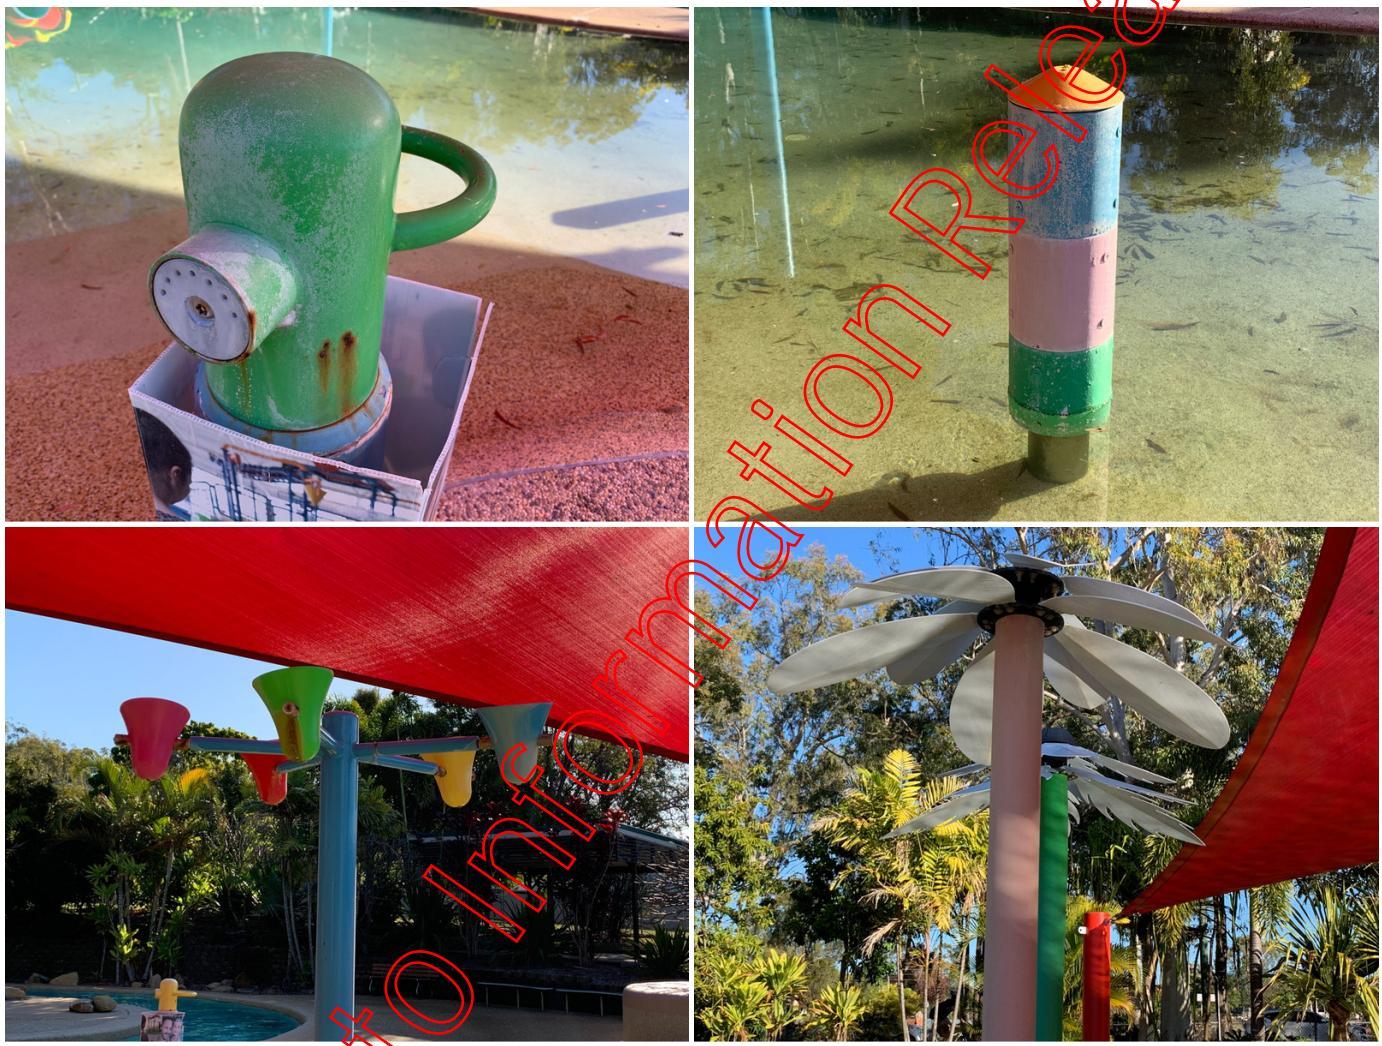
WATER TOY CONDITION

Observation Description	Water Toy Condition	
Observation Details	The water play toys are aging	
Recommendations	Refurbish the Waterplay toys	
Critical Item?	No

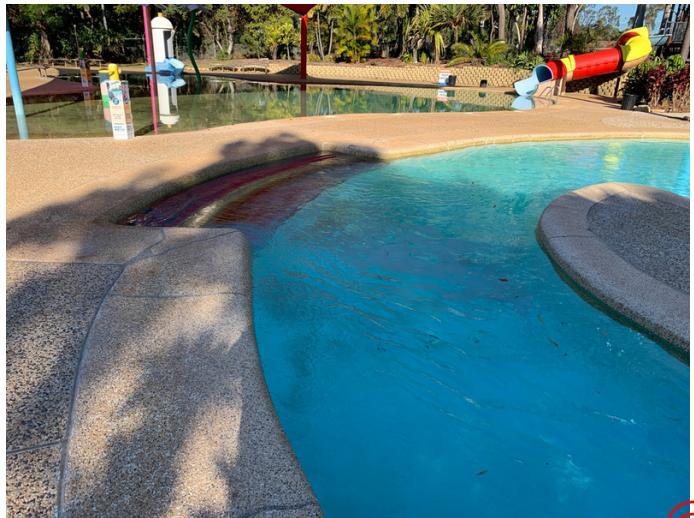
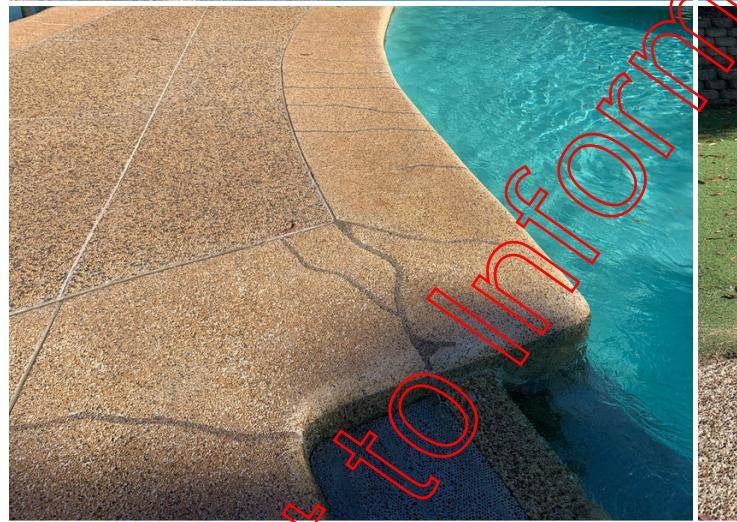
STRUCTURE CRACKS

Observation Description	Structure cracks	
Observation Details	Numerous cracks are present in the structure, with many repairs observed. Whilst the majority of the cracks appear to be in the coping, some of the cracks continue down through the pool structure itself.	
Recommendations	Consider replacement of the pool	
Critical Item?	No

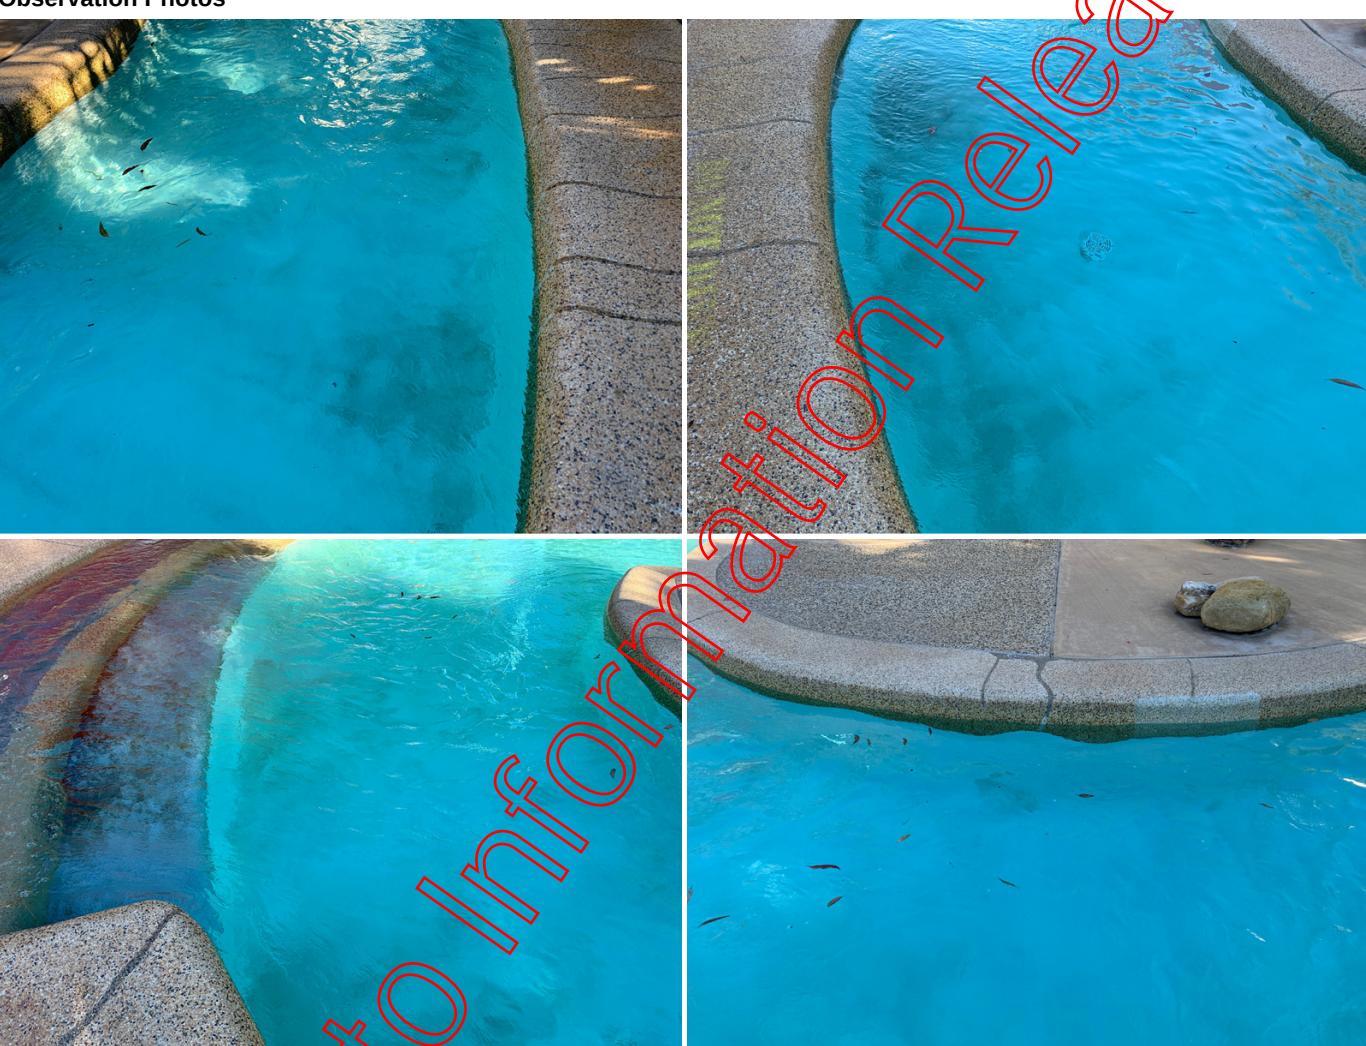
FINISHES CONDITION

Observation Description	Finishes condition	
Observation Details	The painted finish has failed	
Recommendations	Replace the painted finish	
Critical Item?	No

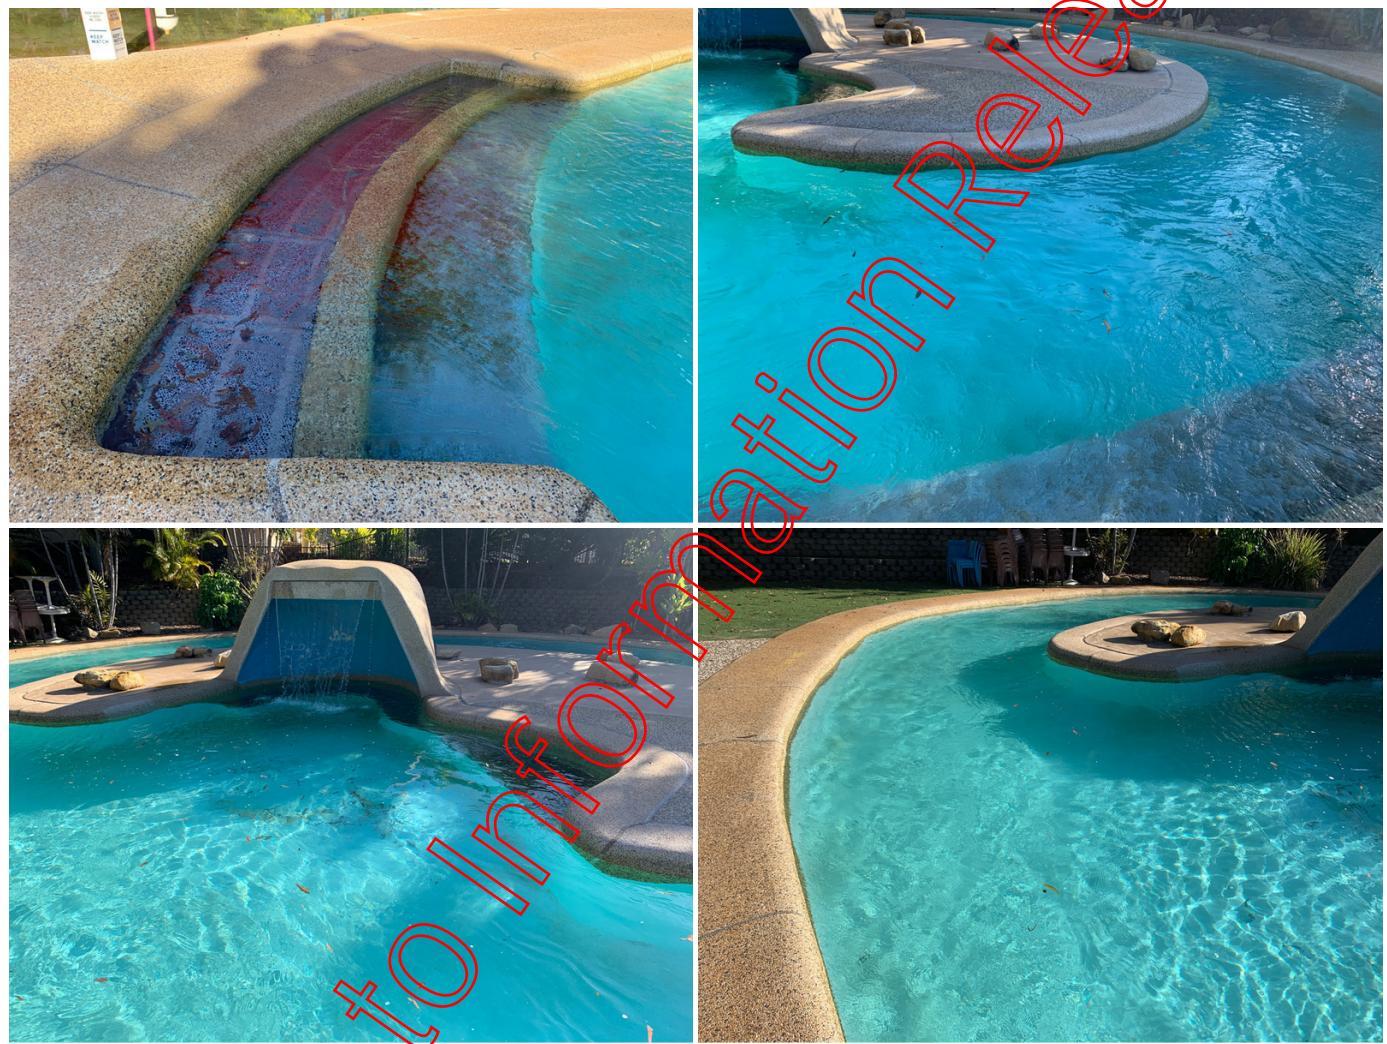
SURFACE SKIMMING

Observation Description	Surface Skimming
Observation Details	The outlet chamber is flooded at the time of the inspection. No surface skimming takes place. A large amount of leaf matter remains suspended in the pool
Recommendations	Consider replacement of the pool
Critical Item?	No

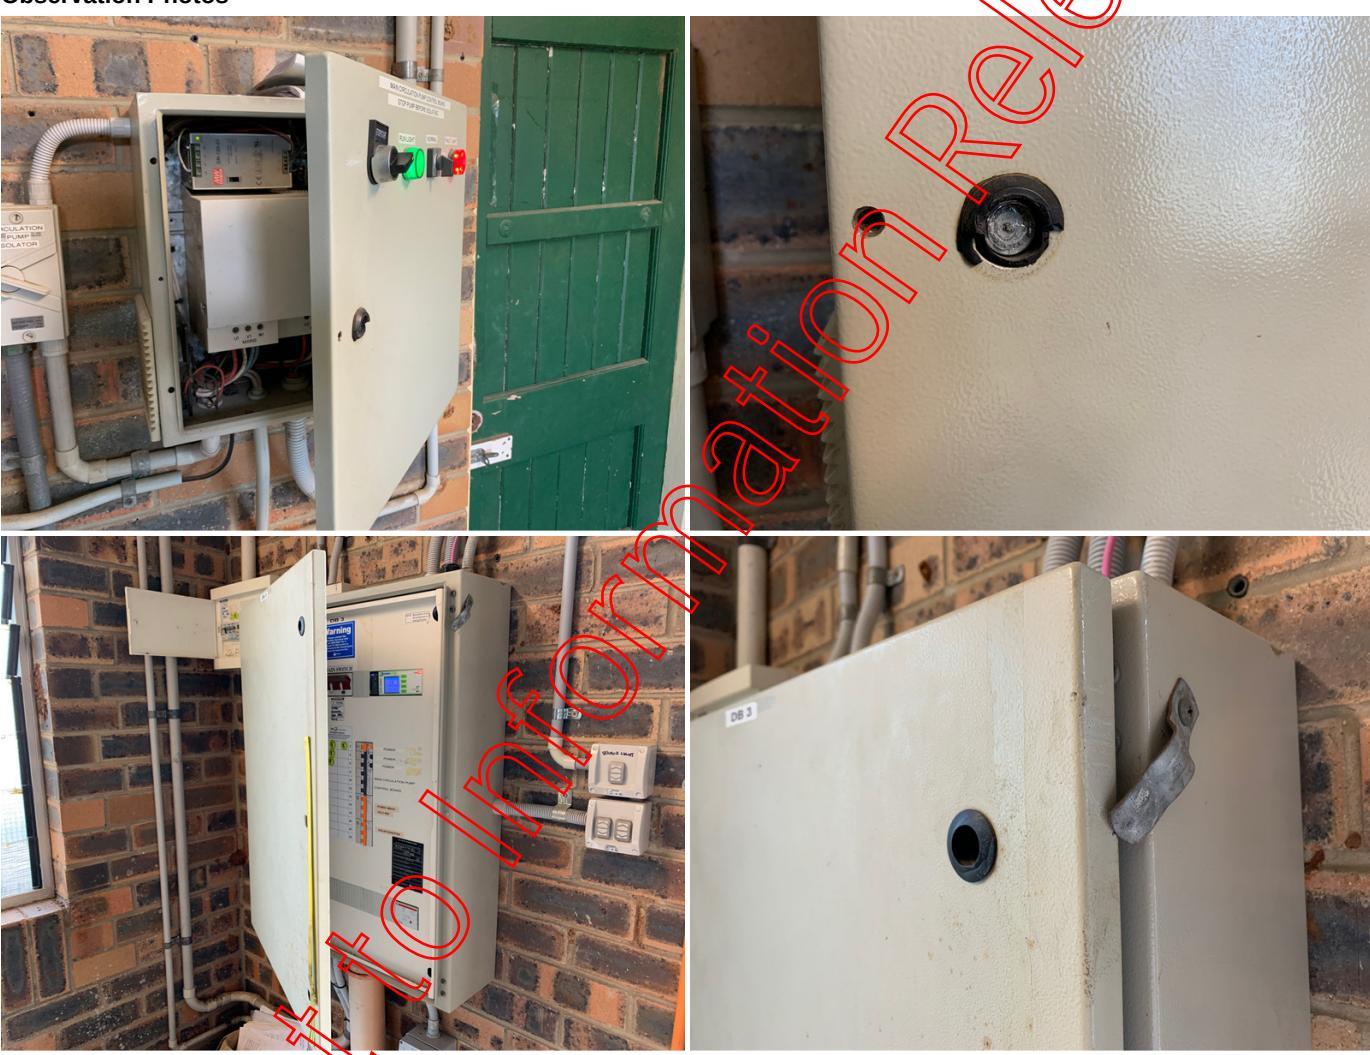
ELECTRICAL INSTALLATION

Observation Description	Electrical Installation
Observation Details	Issues are present with the electrical installation such as boards in poor condition, broken latches etc. This produces a notable safety concern.
Recommendations	Engage an electrician to undertake a condition and compliance agait on the electrical installation as a priority. It is recommended to extend this audit to the entire facility, covering all three plant rooms and any extraneous electrical vertes.
Critical Item?	Yes

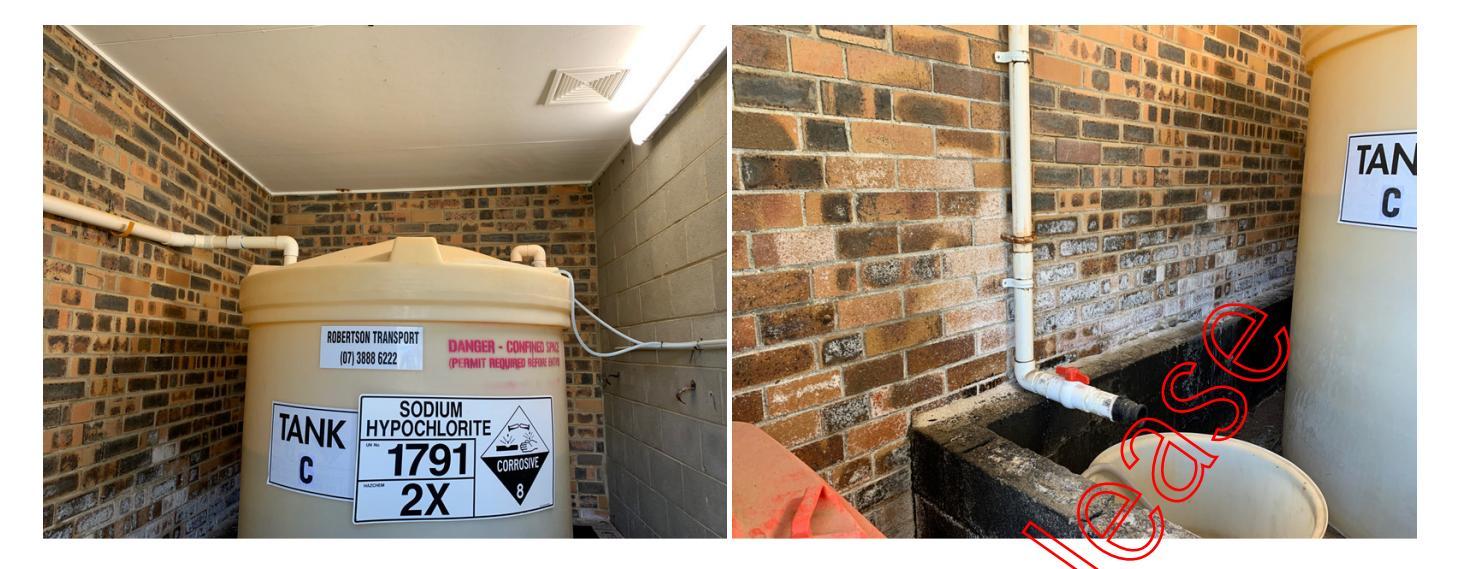
CHLORINE STORAGE

Observation Description	Chlorine Storage
Observation Details	The bulk chlorine storage produces several non-conformances including: o No truck unloading bund o Levels not marked on tank o No tank overflow o Bund in poor condition and unlikely to seal o Tank vents to room o Chlorine pump mounted on degraded shelf
Recommendations	Replace the entire chlorine storage facility
Critical Item?	Yes

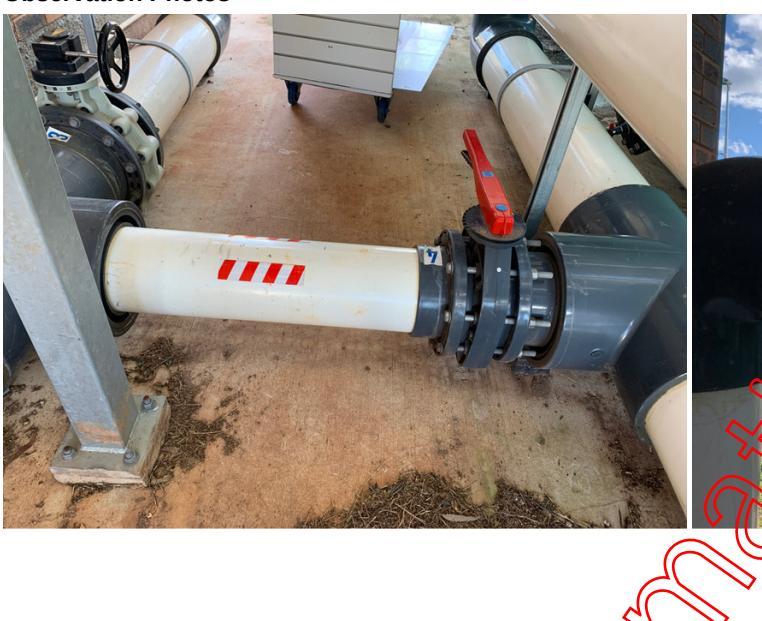
PIPEWORK SIZE

Observation Description	Pipework Size	
Observation Details	The 50m pool pipework reduces in size too soon, increasing the pressure loss as discussed in the audit report.	
Recommendations	Upsize the offending pipework	
Critical Item?	No

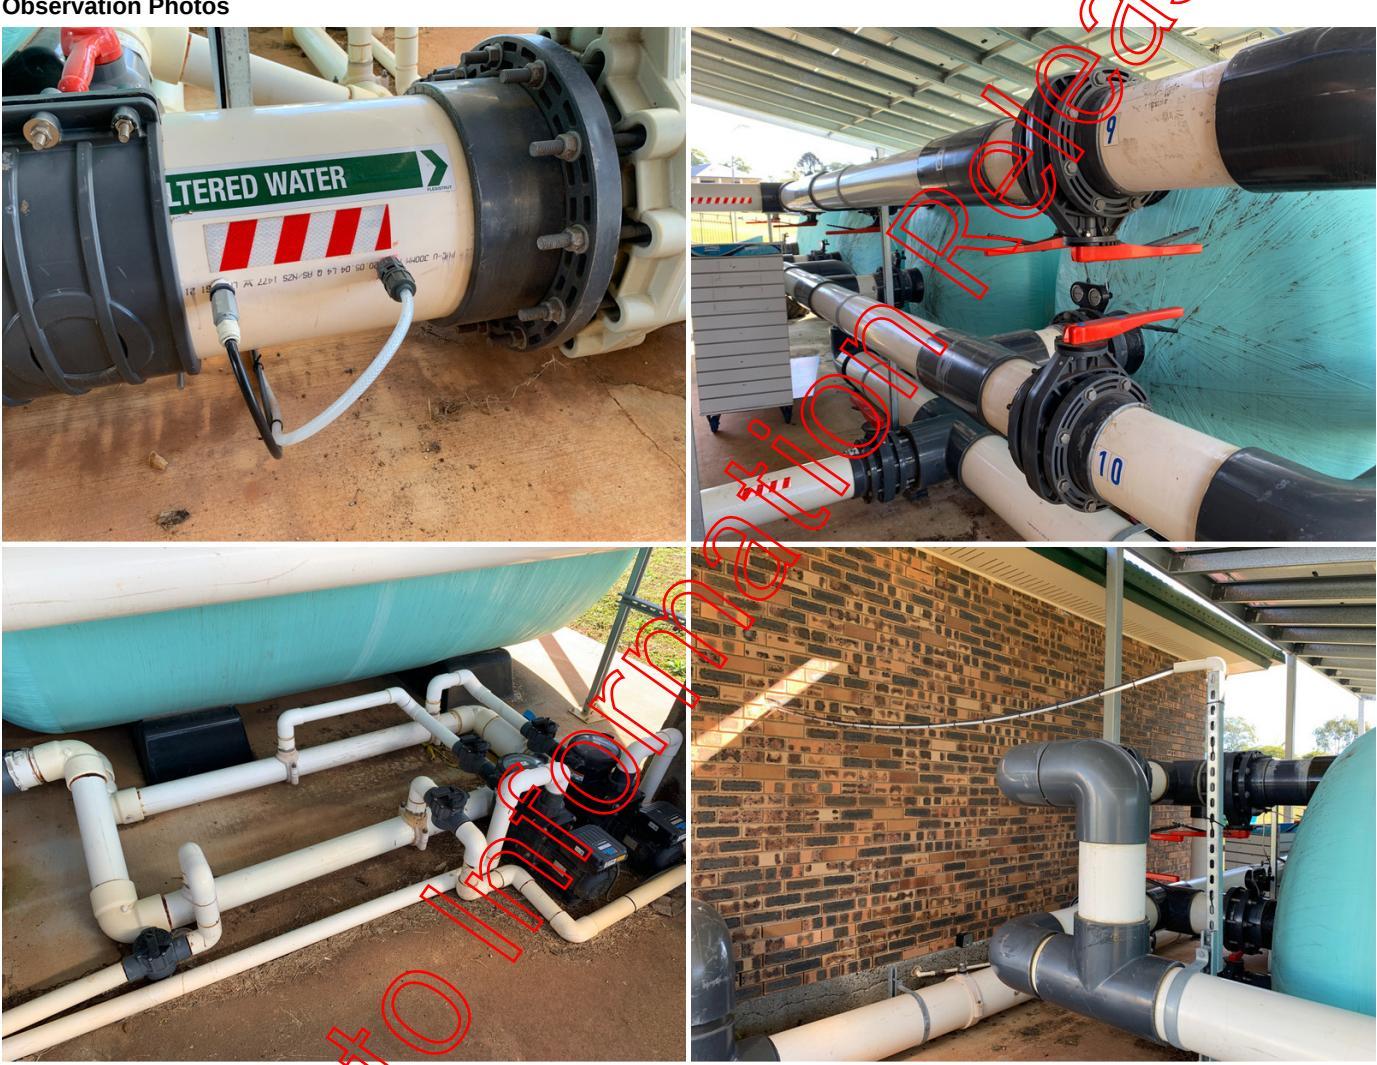
LABELLING

Observation Description	Labelling
Observation Details	Pipework and equipment labelling is generally poor
Recommendations	Label all pipework and chemical injectors, as well as all equipment
Critical Item?	No

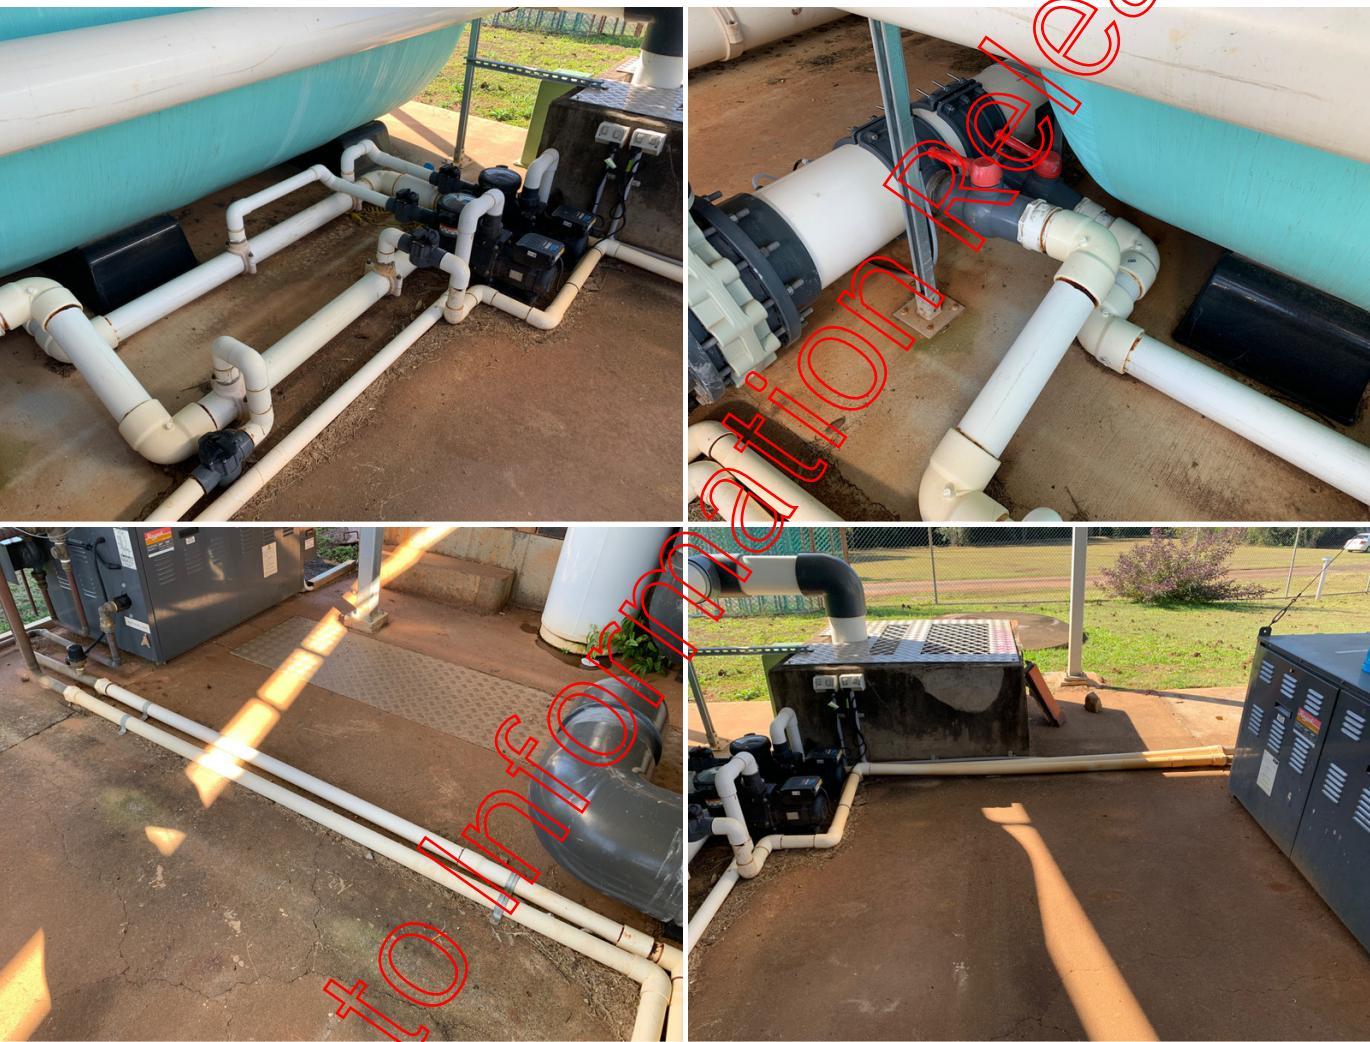
HEATER PIPEWORK

Observation Description	Heater Pipework	
Observation Details	Heater Pipework is poorly installed, with practically no supports and pipe run across the ground instead of overhead creating a trip hazard.	
Recommendations	Rerun all heater pipework and secure properly	
Critical Item?	No

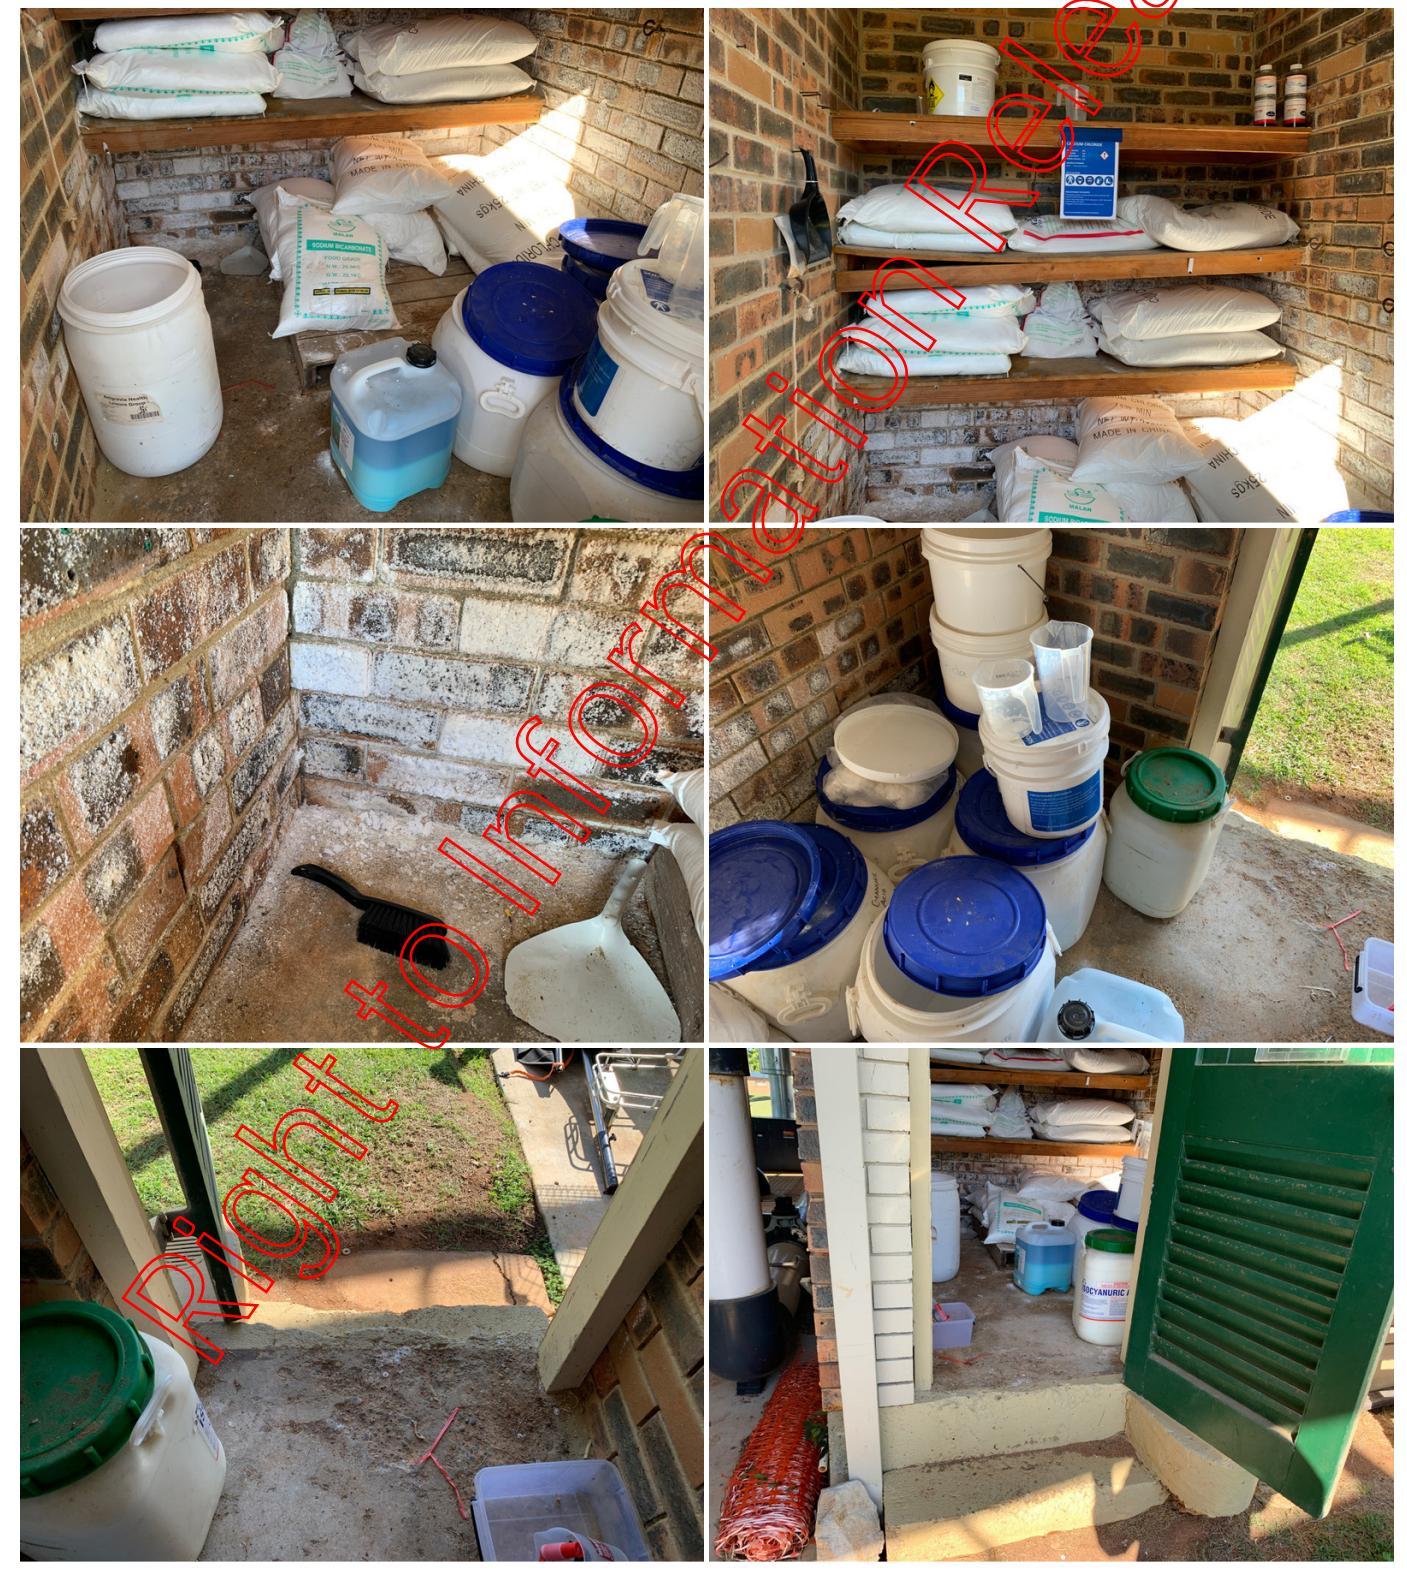
CHEMICAL STORAGE

Observation Description	Chemical Storage
Observation Details	The calcium hypochlorite storage room is not well laid out, with failing shelves, insufficient signage and what appears to be spilled chemicals.
Recommendations	Upgrade chemical storage facilities including shelving, signage, accessive s etc.
Critical Item?	Yes

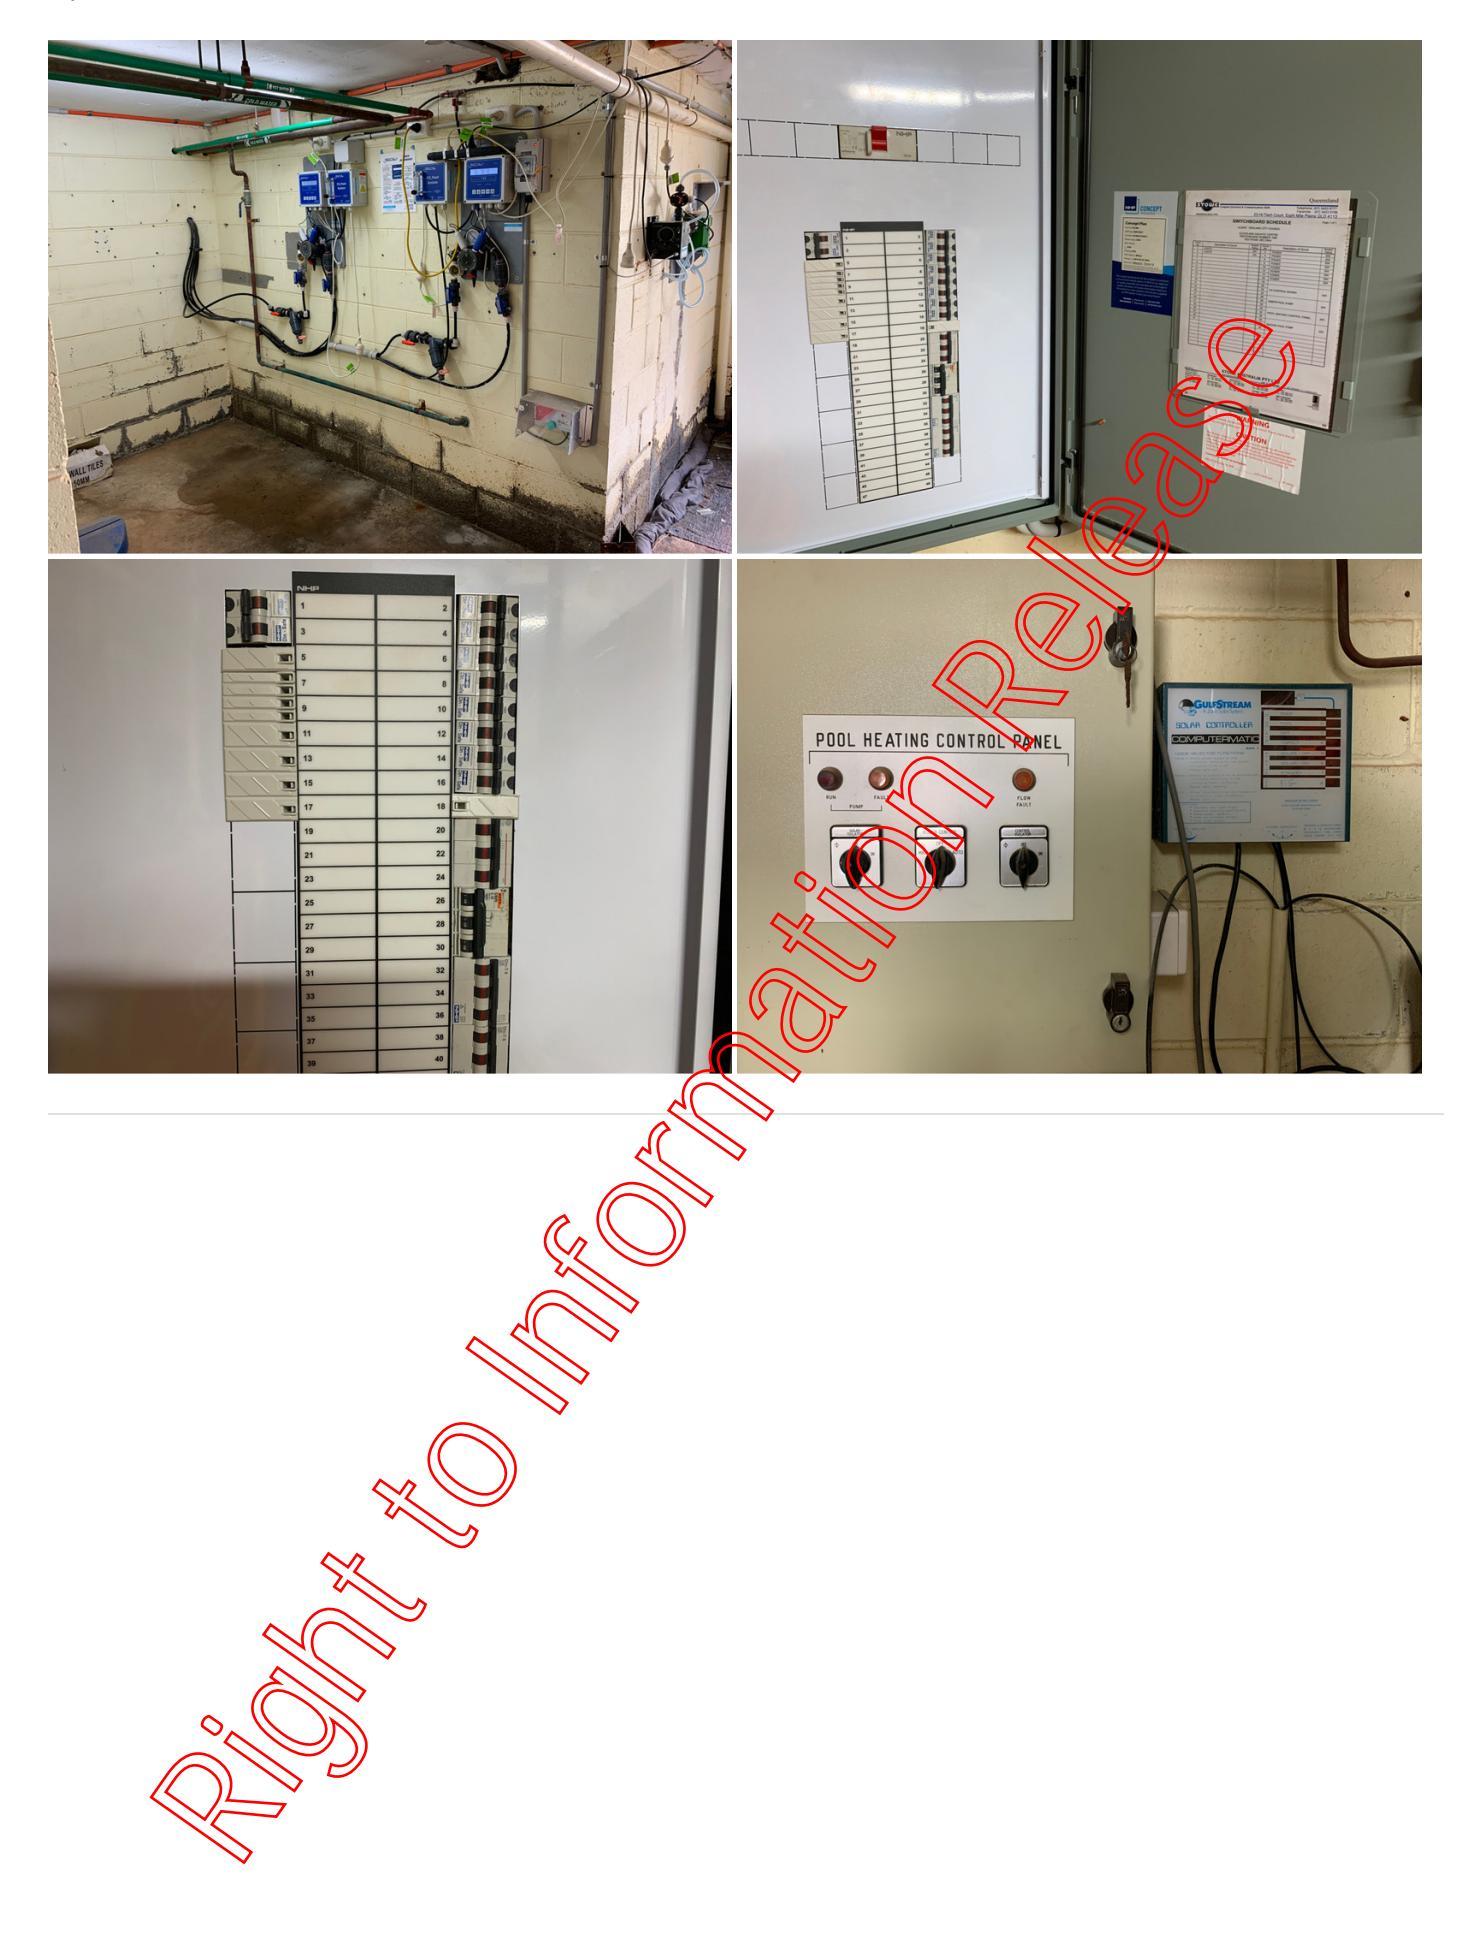
GENERAL ACCESS AND ROOM CONDITION

Observation Description	General Access and Room Condition
Observation Details	General access around the equipment room is poor. External areas require walking on grass and squeezing between areas to reach filter valves whilst internal access is not in compliance with AS1657. Additionally the room is in poor condition with head strike risks from old heater flues, trip hazards on entry, failing door hinges and failing wall panels.
Recommendations	Demolish the existing equipment room and provide a new room that is correctly laid out, with good chemical storage and safe design
Critical Item?	Yes
