CLEVELAND AQUATIC CENTRE UPDATED POOL CONDITION ASSESSMENT

AND MAINTENANCE PLANS

(July 2014)

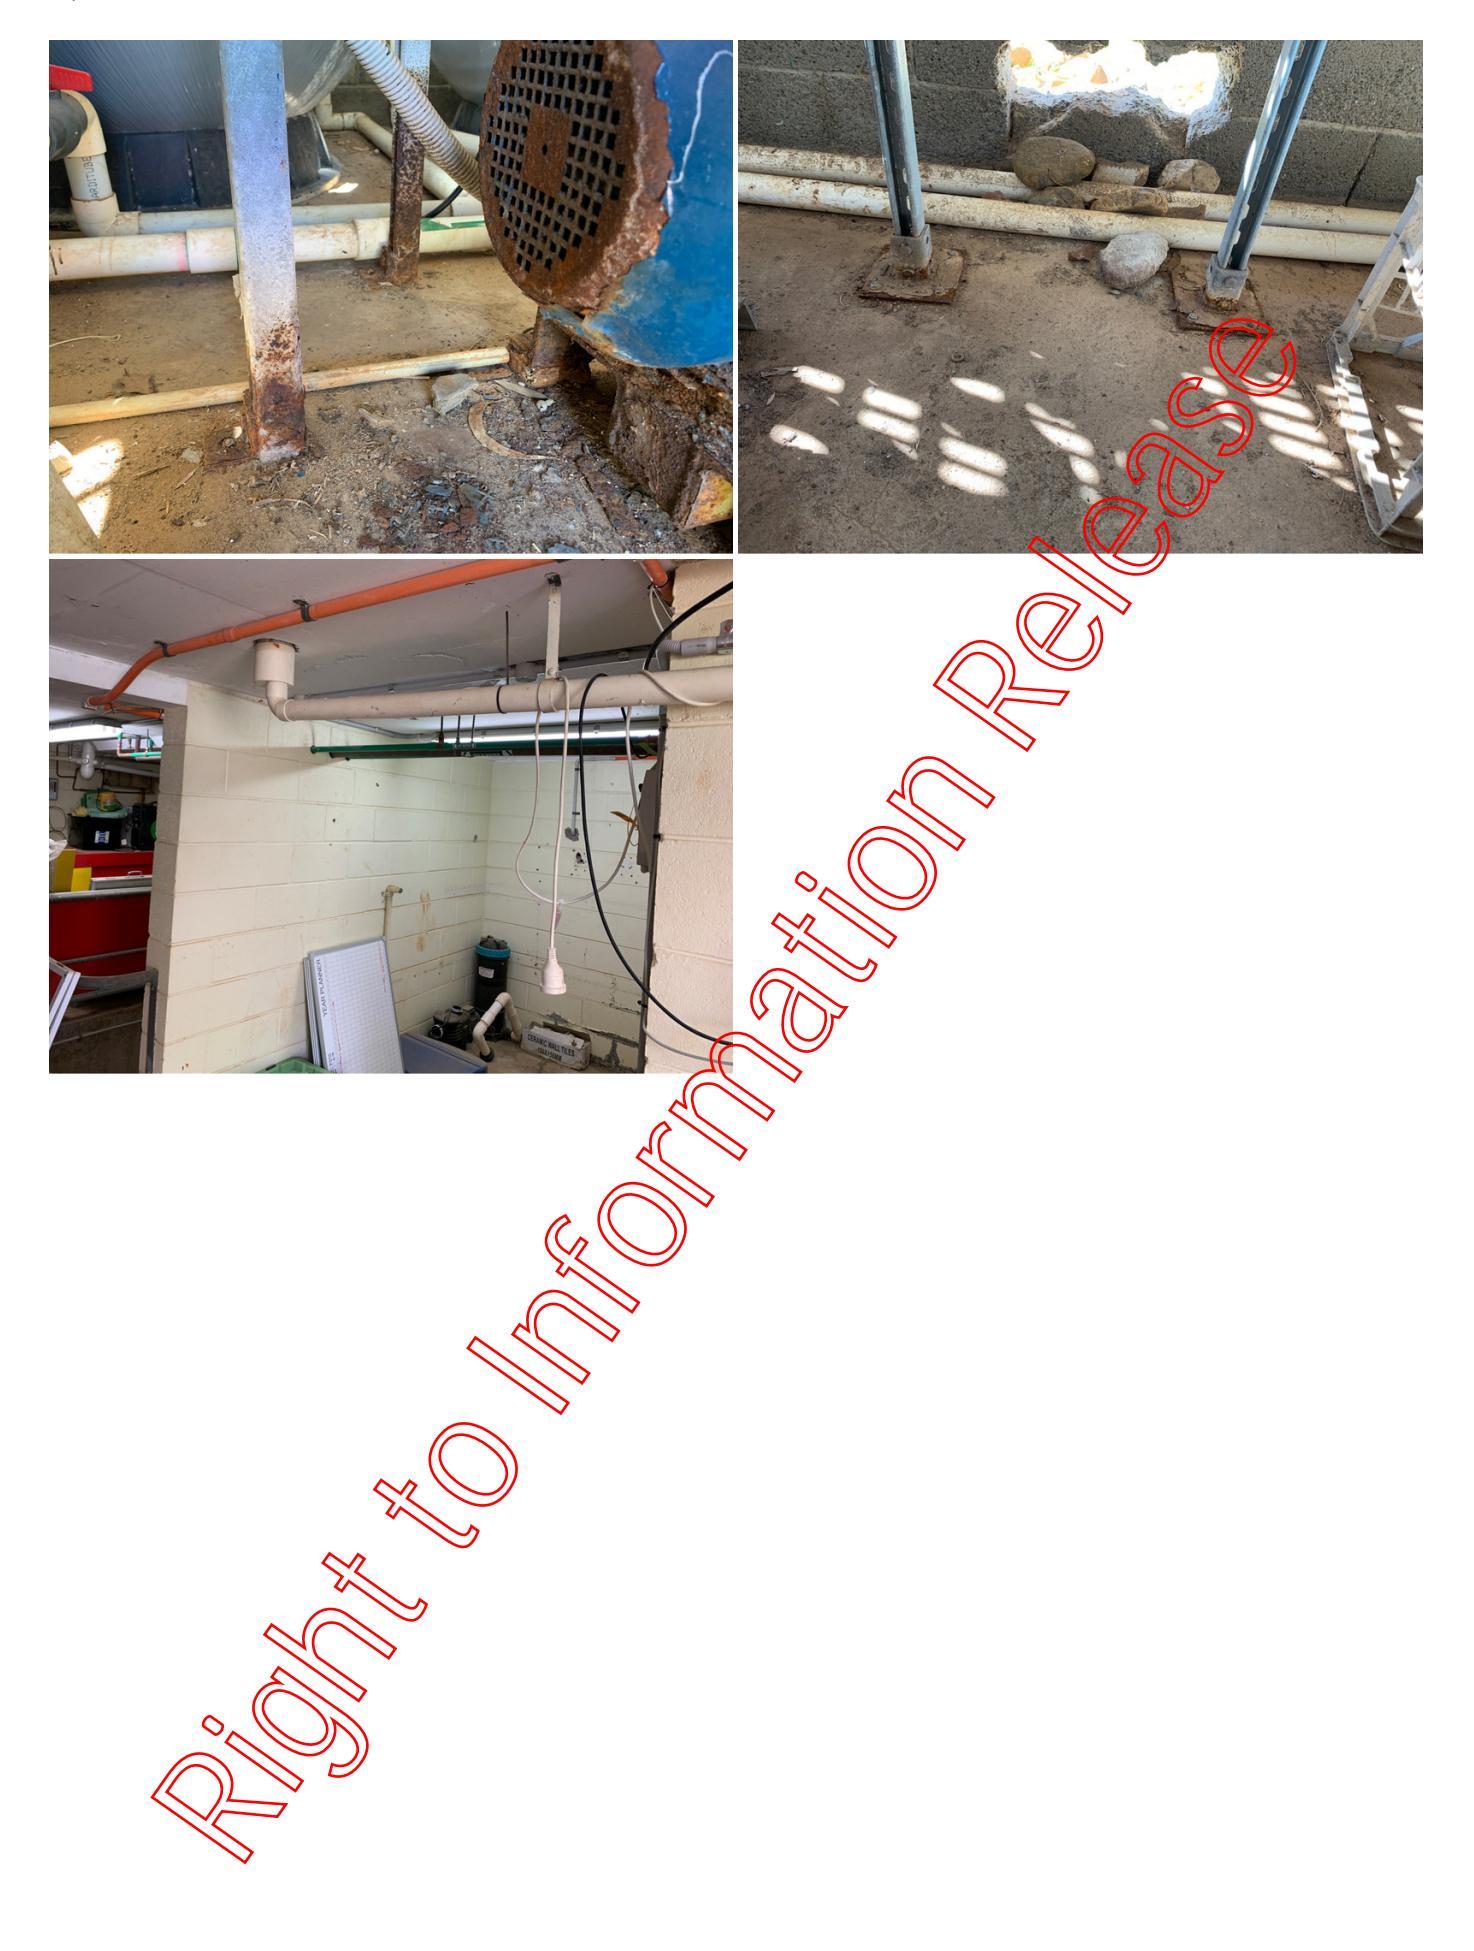
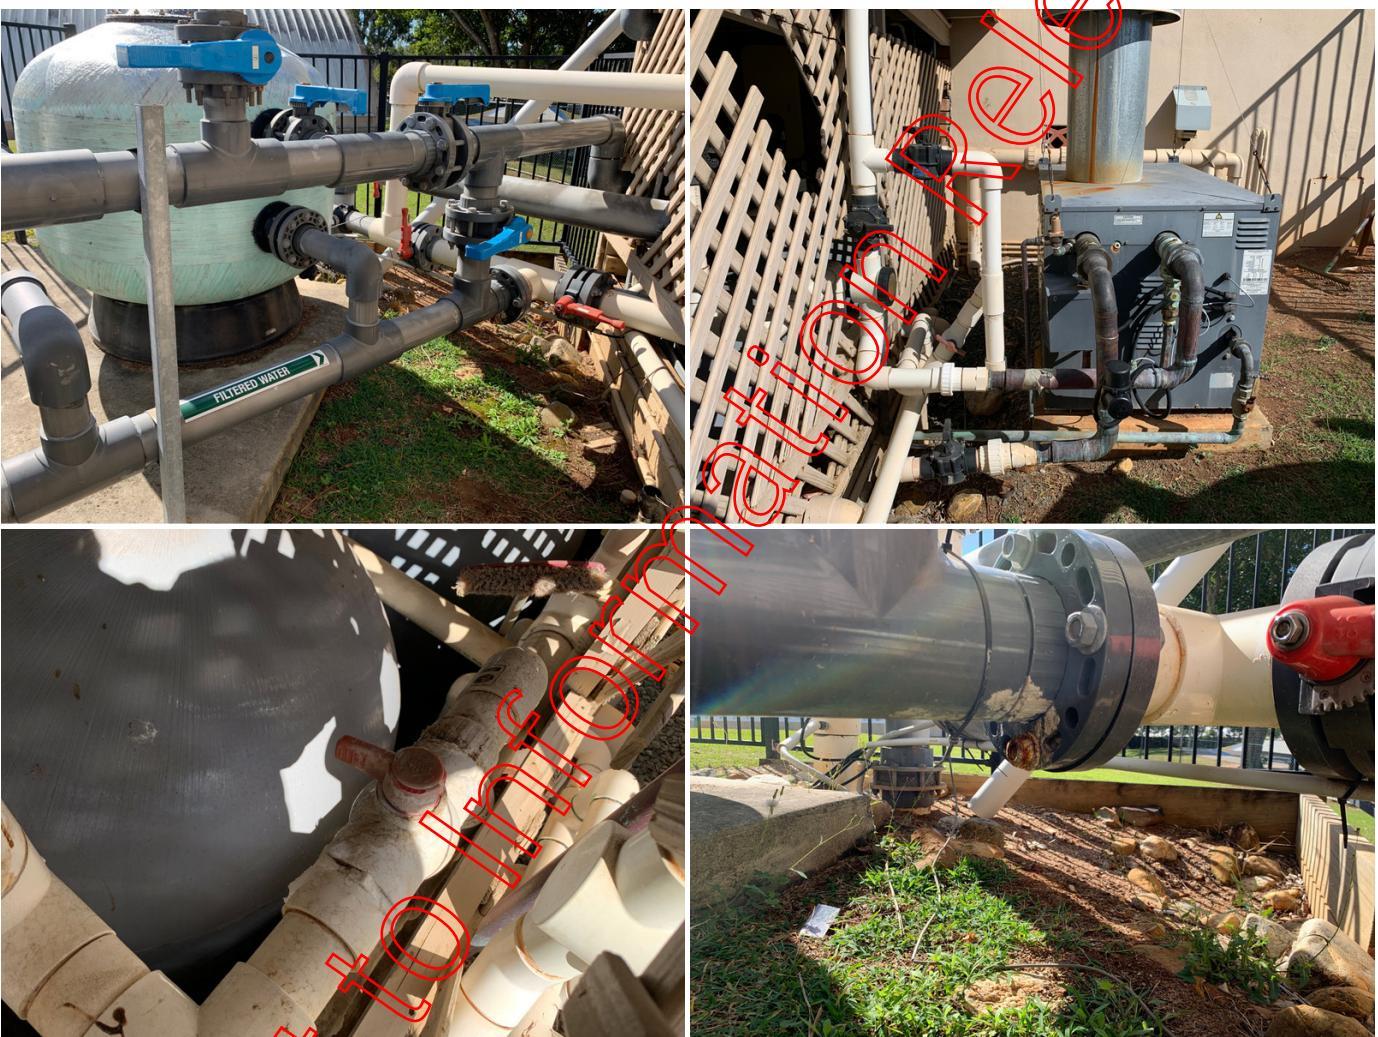
PIPEWORK SUPPORTS

Observation Description	Pipework Supports		
Observation Details	Pipework is poorly run and poorly supported. Leaks are observed in several locations.		
Recommendations	Reroute pipework that is not straight and true, repipe supports to Australian Standards so that no pipework. Seal all leaks	place poor condition varyes and provide item of equipment is supporting	
Critical Item?	No

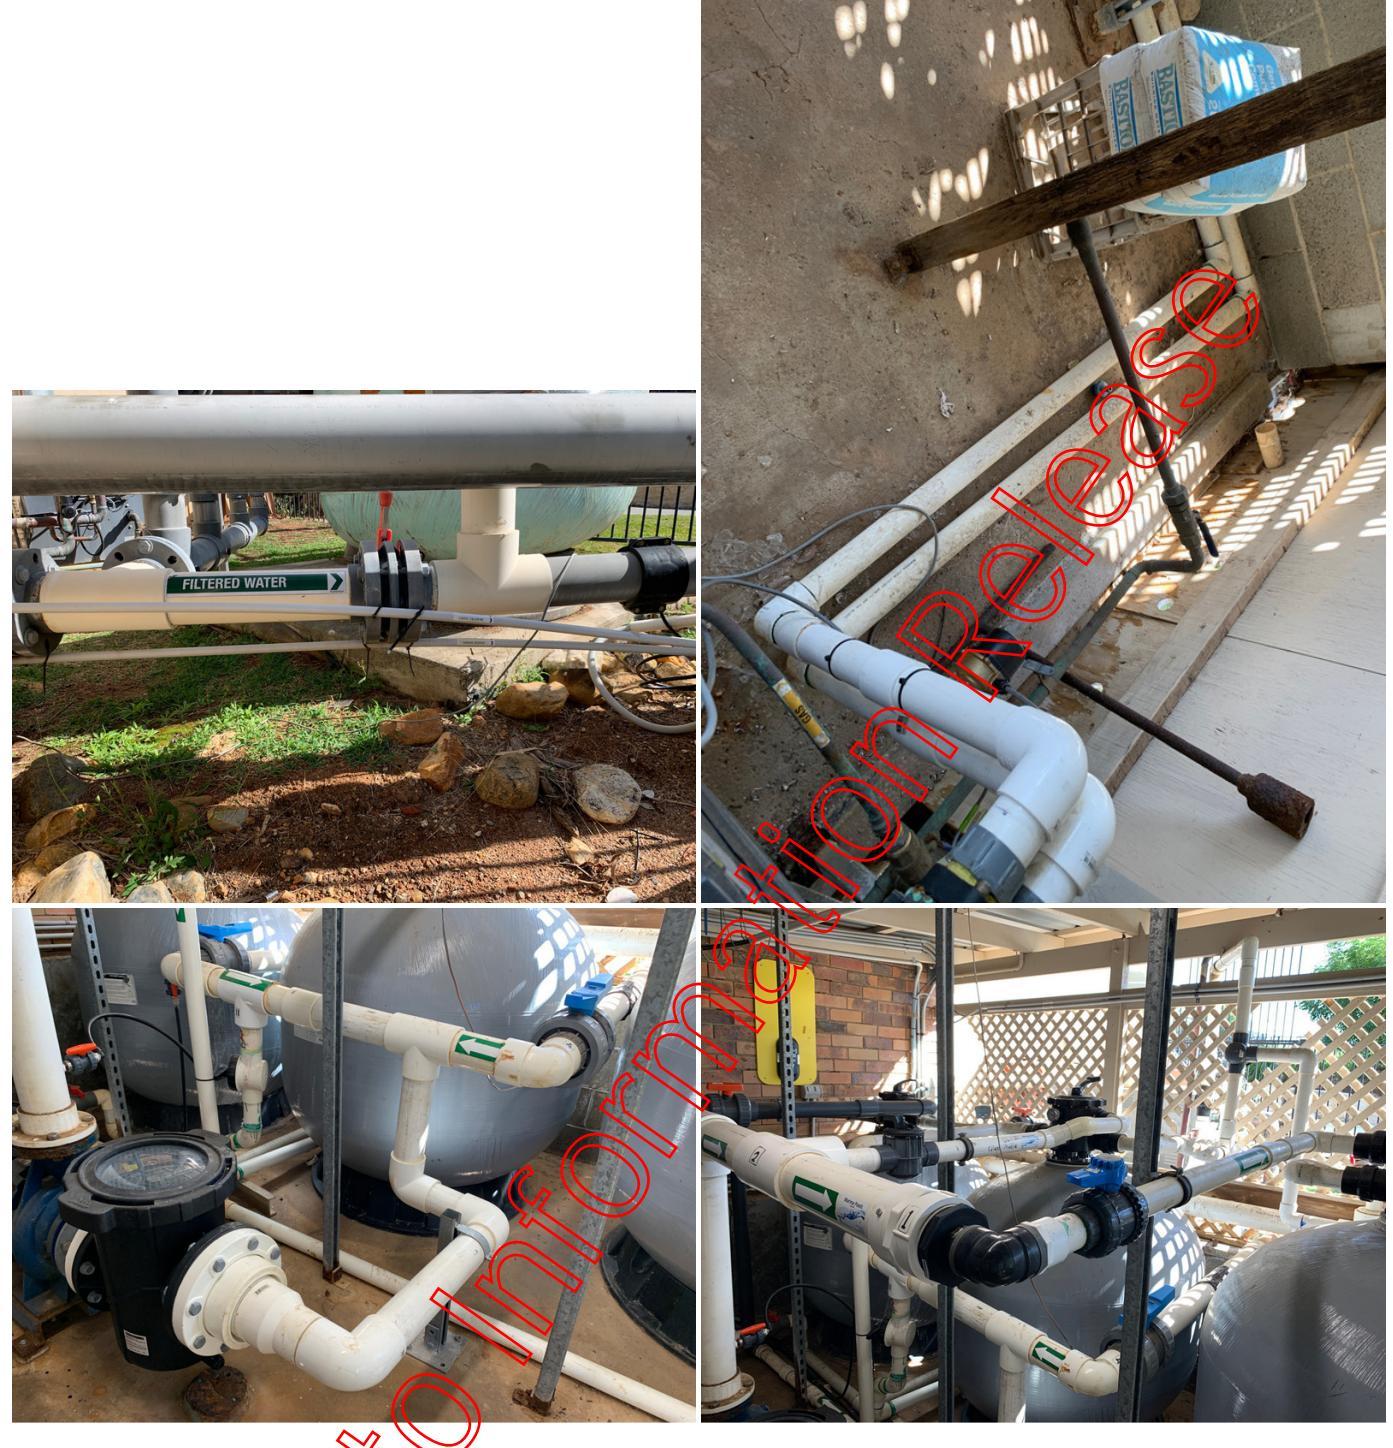
PIPE AND EQUIPMENT LABELLING

Observation Description	Pipe and equipment labelling	
Observation Details	Labelling is generally poor.	
Recommendations	Provide labelling to each item of equipment and each service	
Critical Item?	No

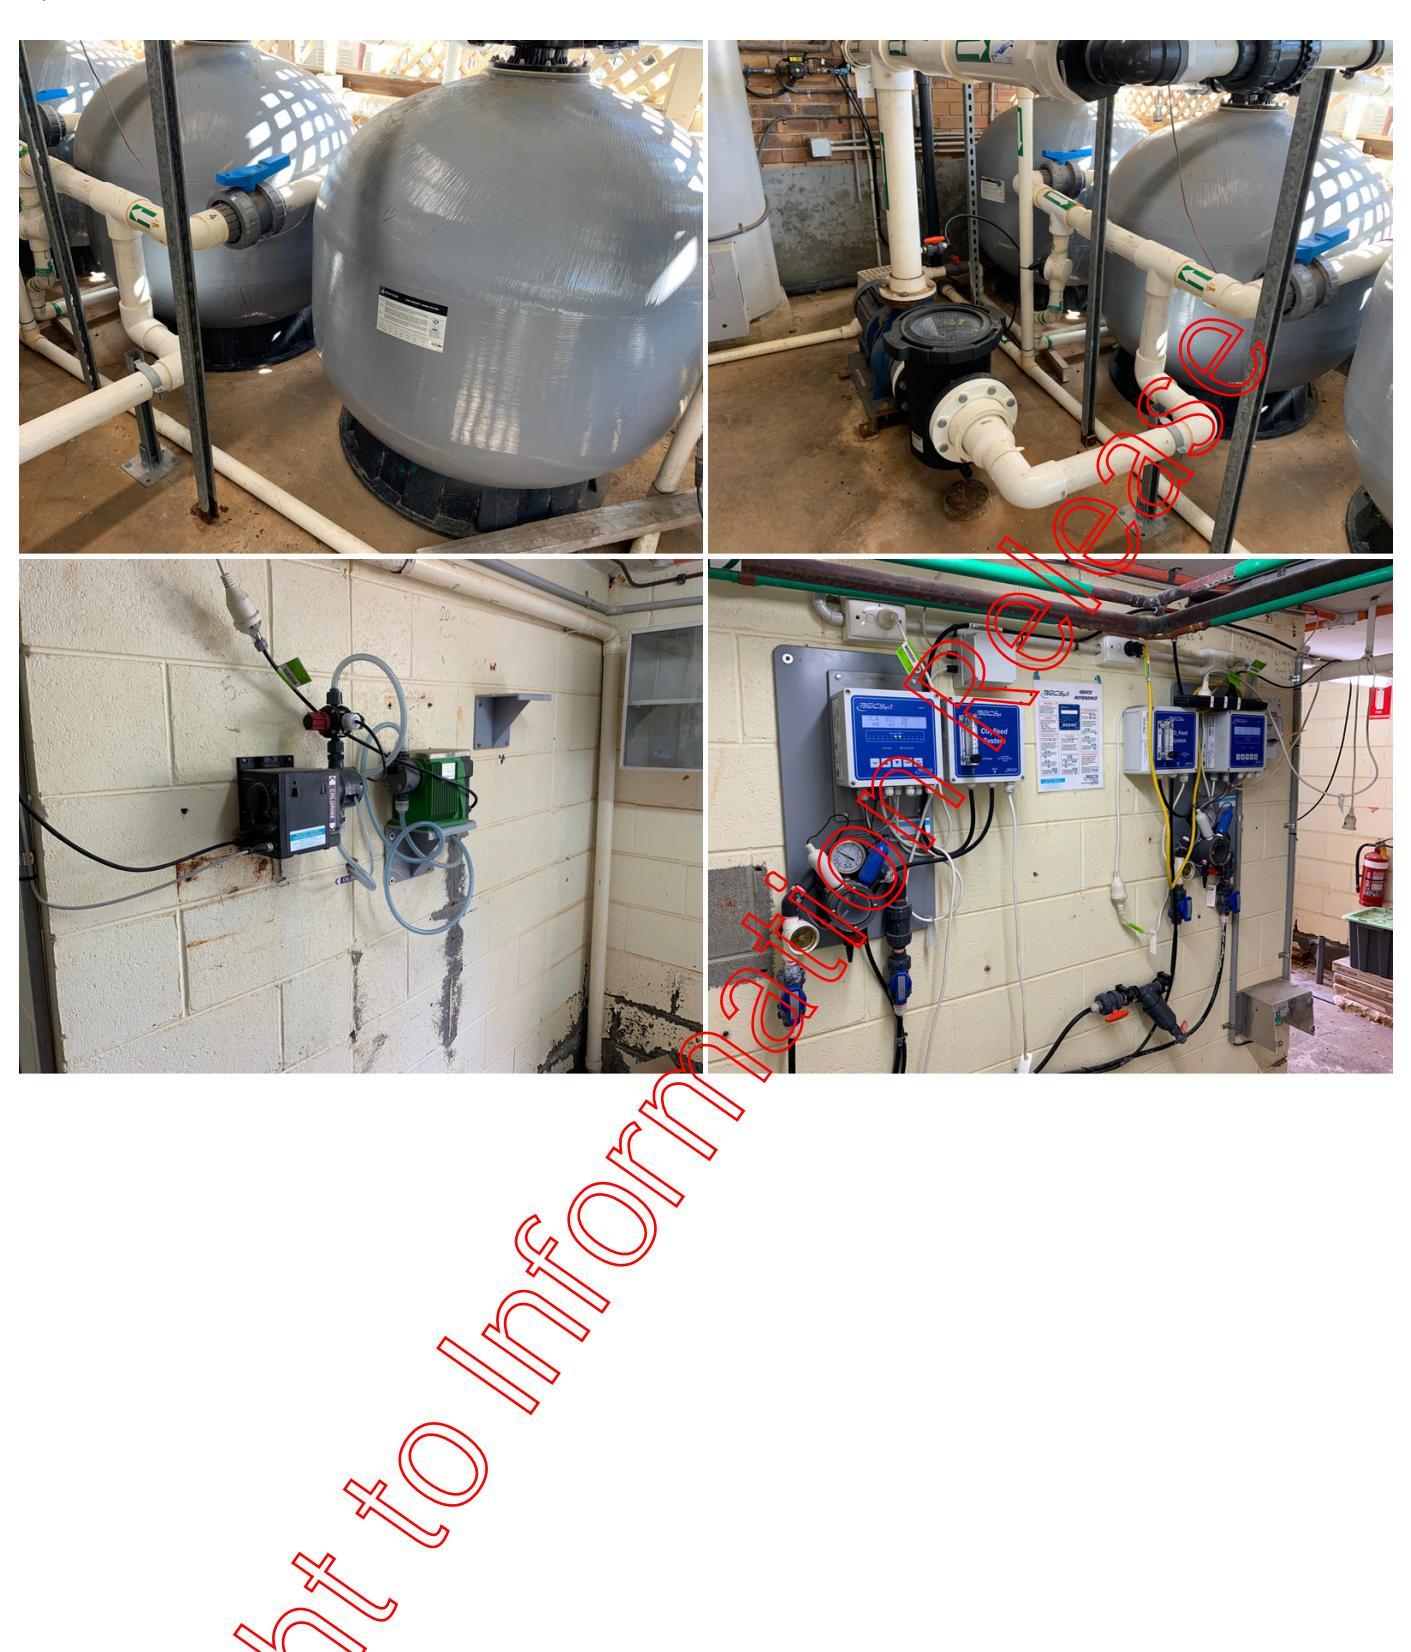
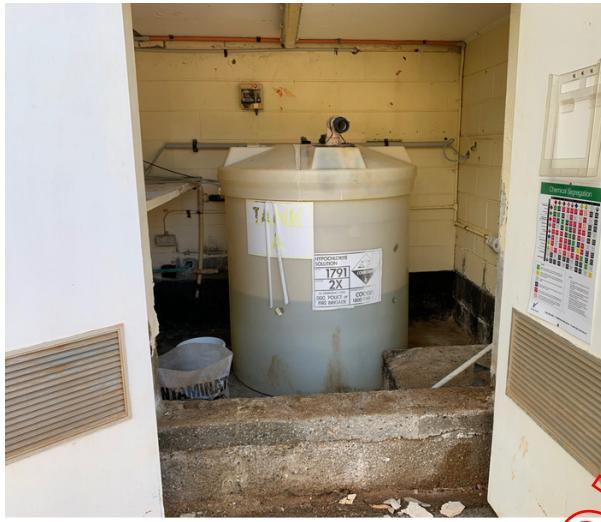
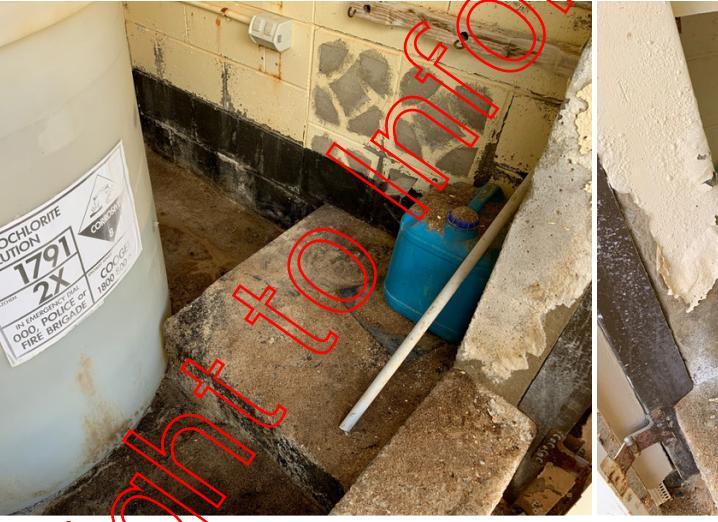
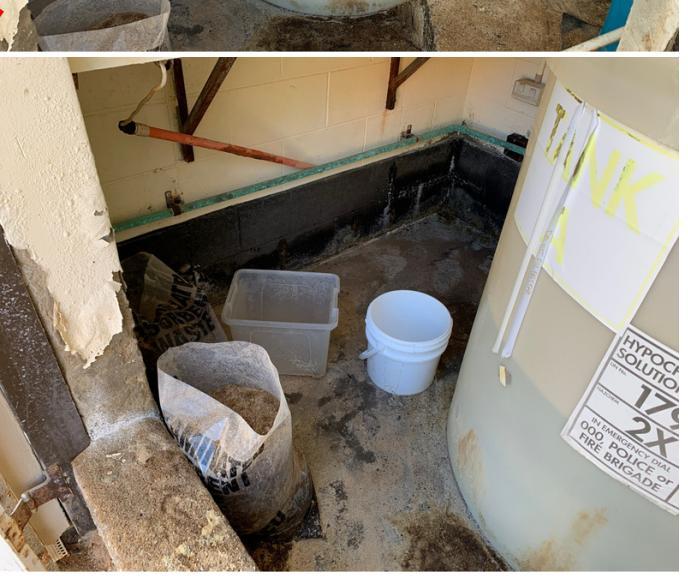
CHLORINE DELIVERY AND STORAGE

Observation Description	Chlorine Delivery and Storage
Observation Details	The chlorine system presents several non-conformances: o No truck bund is provided, with the truck parking in a public space o Trip and slip hazards are present in the filling area o The condition of the bund room is very poor, with the bund unlikely to seal. o The tank vents to the room o No overflow is provided o The tank is in poor condition and at end of life o Levels are not marked on the tank
Recommendations	Replace the entire chlorine storage installation
Critical Item?	Yes

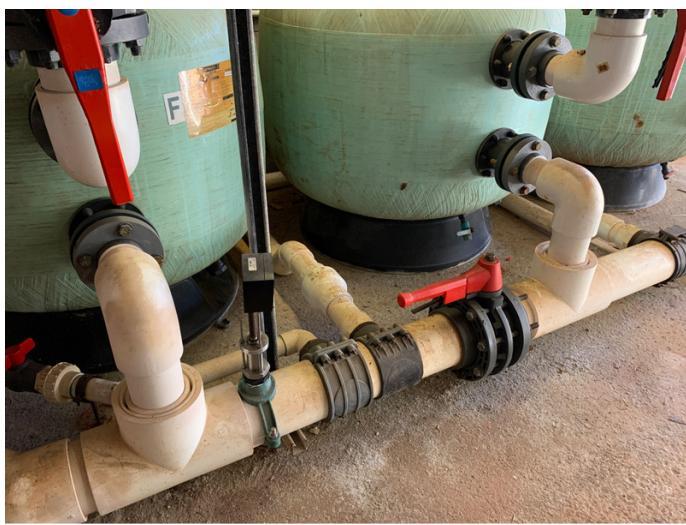
PIPE SUPPORTS

Observation Description	Pipe Supports	
Observation Details	ion Details Pipe supports are generally inadequate, with long lengths of pipe supported on filters of pumps and several supports just being an unsecured shelf under a pre-additionally supports are corroded.	
Recommendations	Replace all pipe supports	\sim
Critical Item?	No

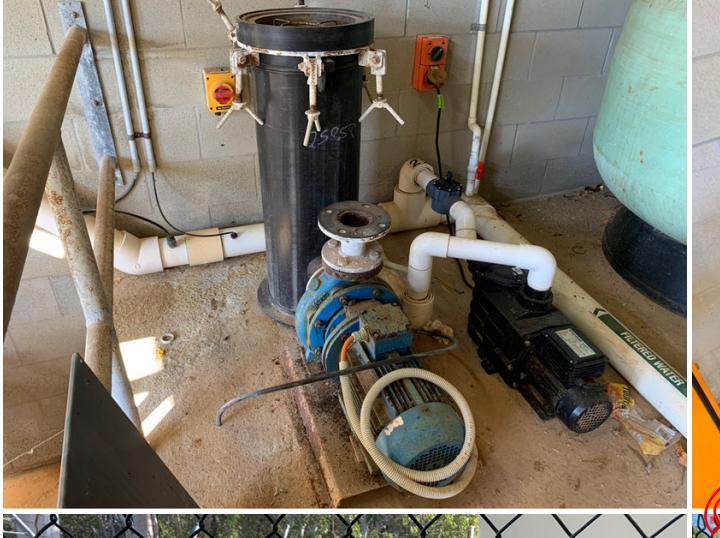
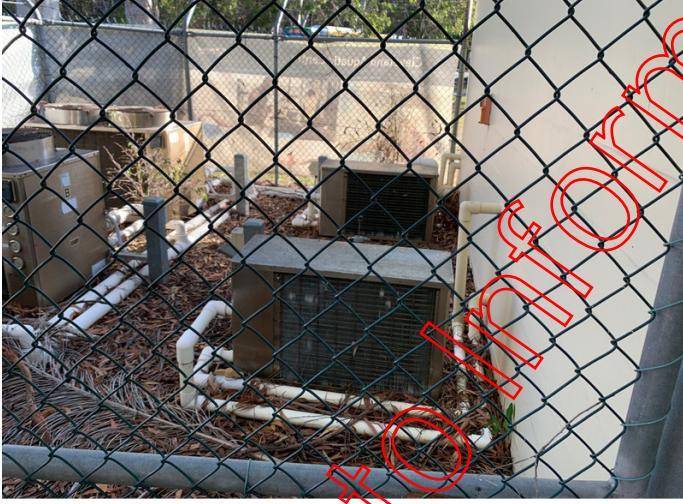
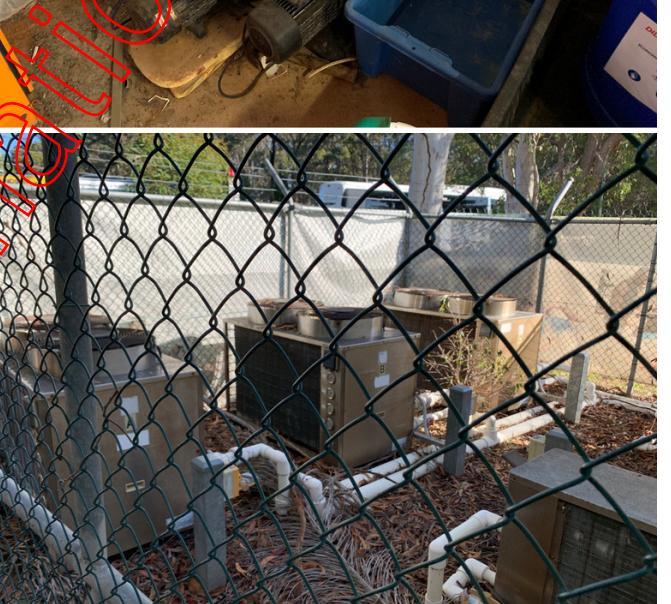
LABELLING

Observation Description	Labelling	
Observation Details	Labelling of pipework, equipment and injectors is poor	
Recommendations	Label all equipment, pipework and injectors	
Critical Item?	Yes

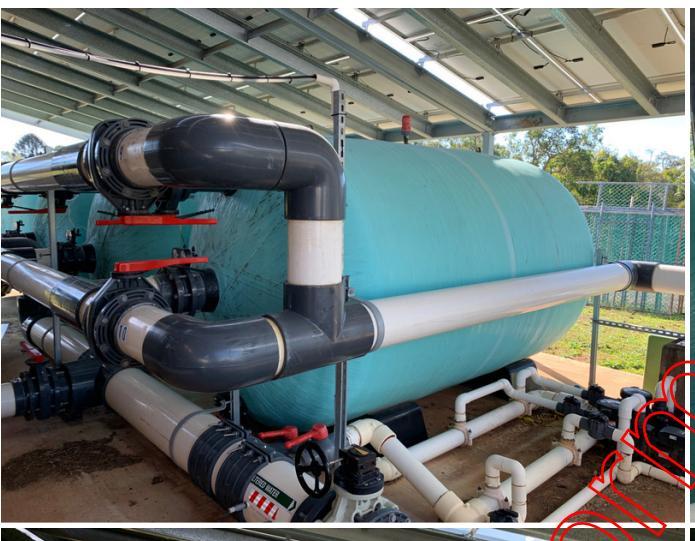
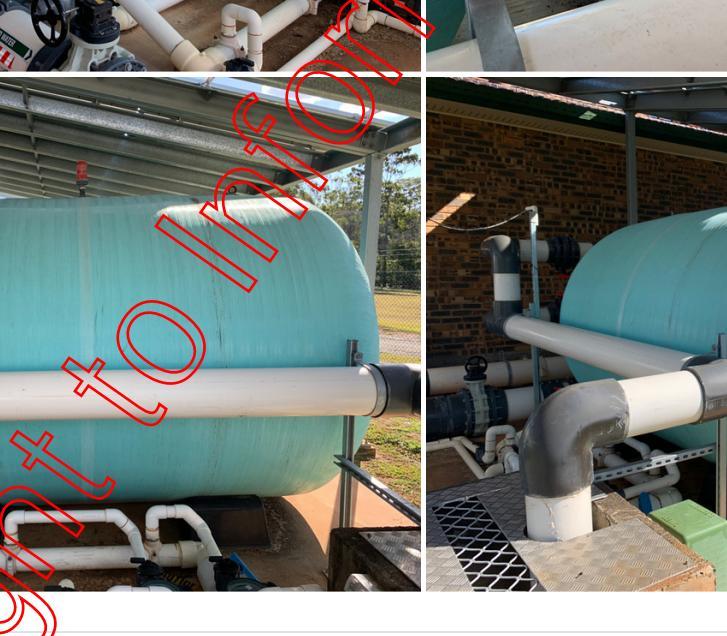
50M SAND FILTER 4

Equipment Type	Filter ► Sand Pressure Filter	
Equipment Identifier	50m Sand Filter 4	
Equipment Make	Poltank	
Equipment Model	05110	
Equipment Serial Number	03P008110	
Equipment Condition	2 - Good	
Remaining Life (Years)	20	
Replacement Cost (\$)	35000

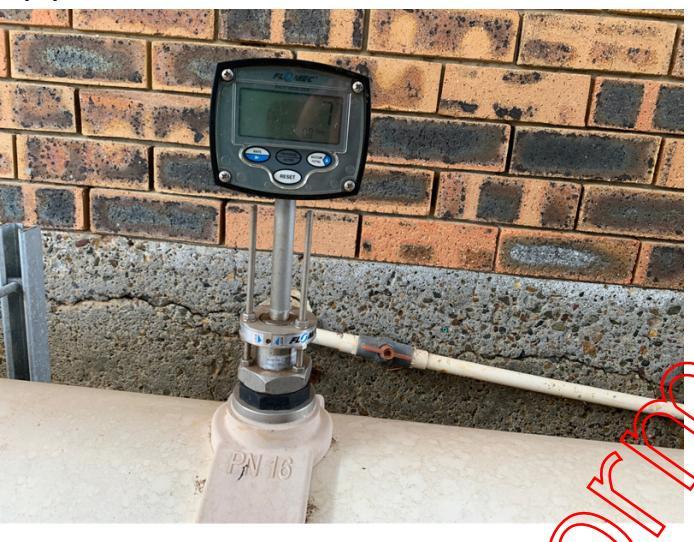
50M FLOW METER

Equipment Type	Ancillary Item ► Sensor	
Equipment Identifier	50m Flow Meter	
Equipment Make	Flomec	
Equipment Model	RT401D0FA	
Equipment Serial Number	2720-4628	
Equipment Condition	4 - Poor	
Remaining Life (Years)	10	
Replacement Cost (\$)	3000

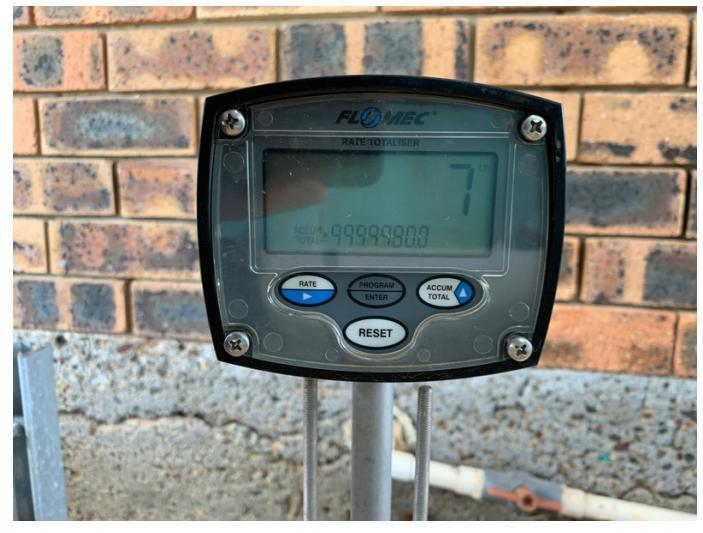
NOT WORKING

Observation Description	Not working	
Observation Details	The flow meter is not working	
Recommendations	Repair the flow meter	
Critical Item?	No

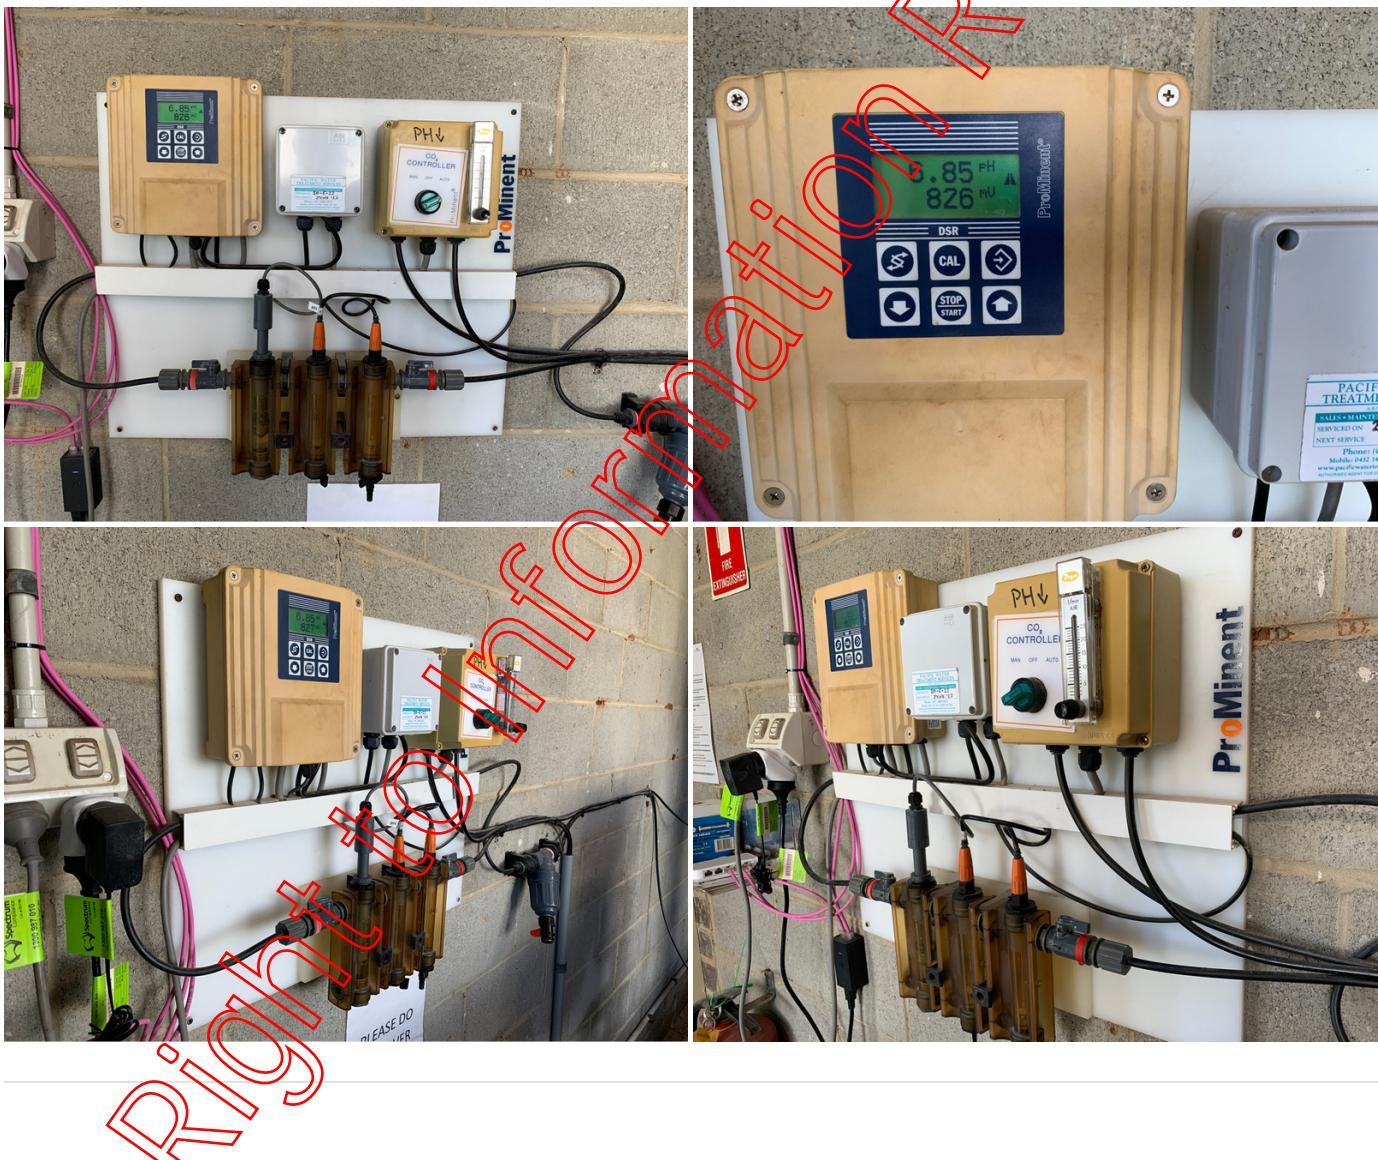
50M CHEMICAL CONTROLLER

Equipment Type	Chemical System ► Chemical Controller	
Equipment Identifier	50m Chemical Controller	
Equipment Make	Prominent	
Equipment Model	DSR	
Equipment Serial Number	N/A	
Equipment Condition	5 - Very Poor	
Remaining Life (Years)	0	
Replacement Cost (\$)	15000

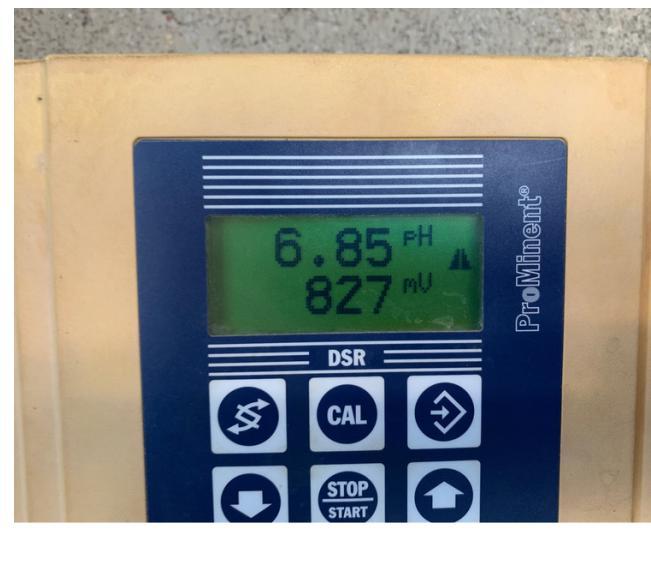
OBSOLETE CONTROLLER

Observation Description	Obsolete controller	
Observation Details	The DSR controller is obsolete and at end of life. The pH probe can no longer be calibrated	
Recommendations	Replace the chemical controller	
Critical Item?	Yes

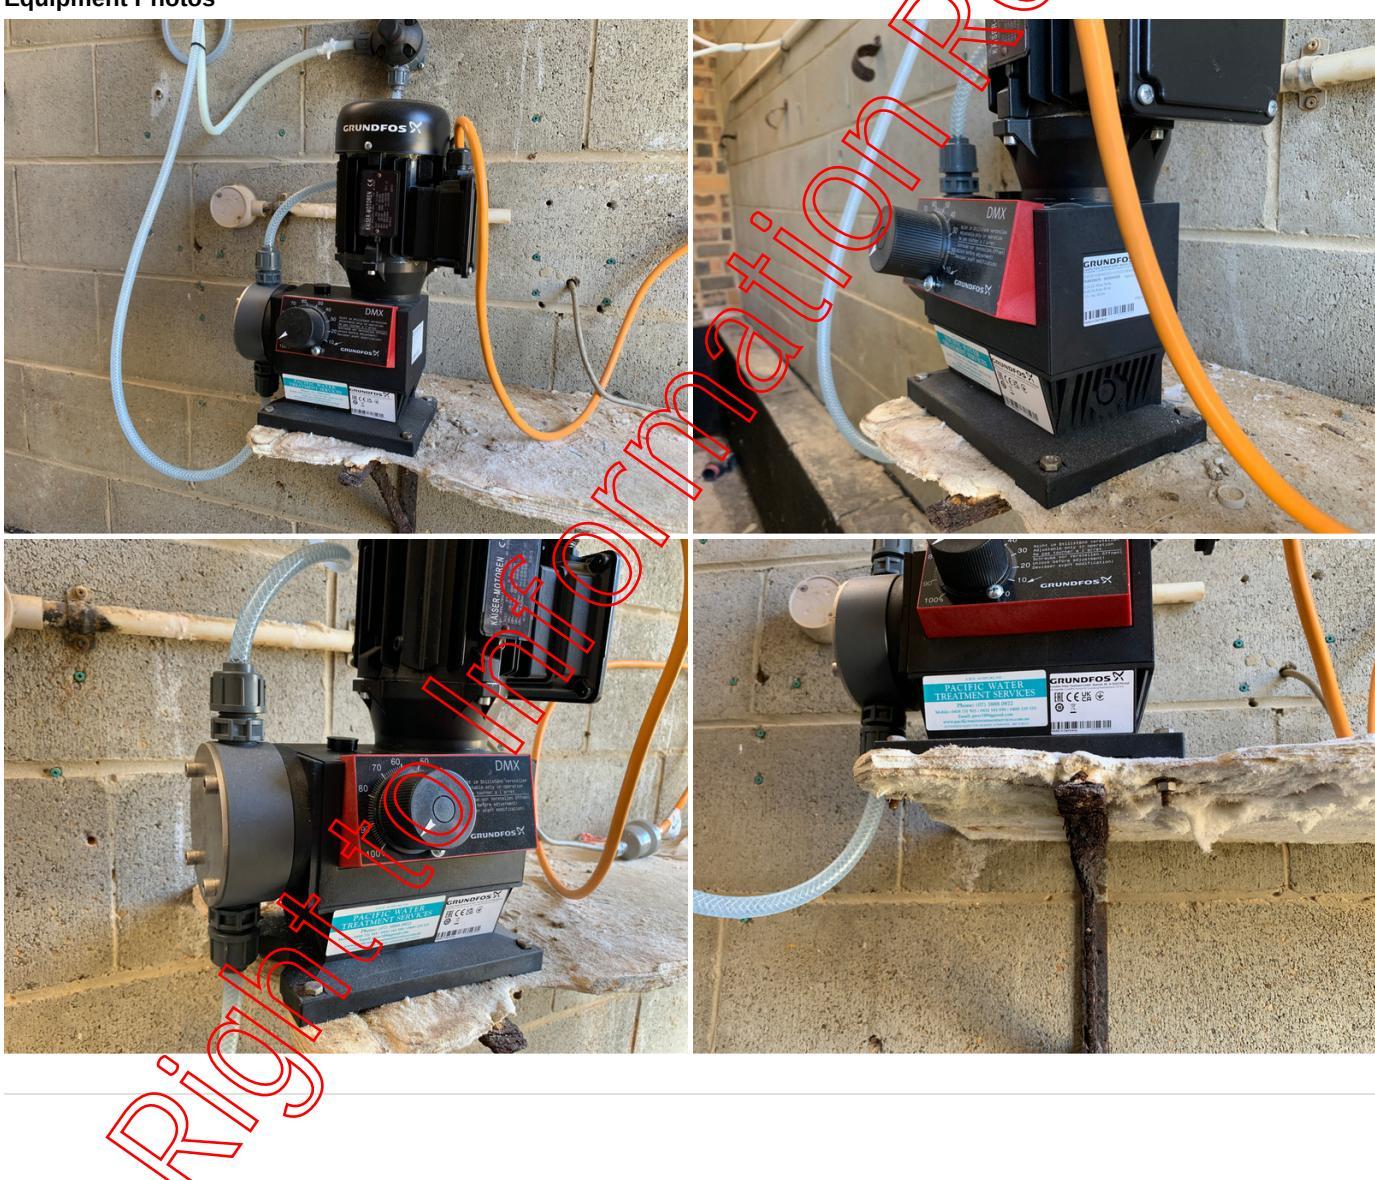
50M CHLORINE DOSING PUMP

Equipment Type	Chemical System ► Chemical Dosing Pump	
Equipment Identifier	50m Chlorine Dosing Pump	
Equipment Make	Grundfos	
Equipment Model	DMX 50-10	
Equipment Serial Number	00000151	
Equipment Condition	2 - Good	
Remaining Life (Years)	6	
Replacement Cost (\$)	3500

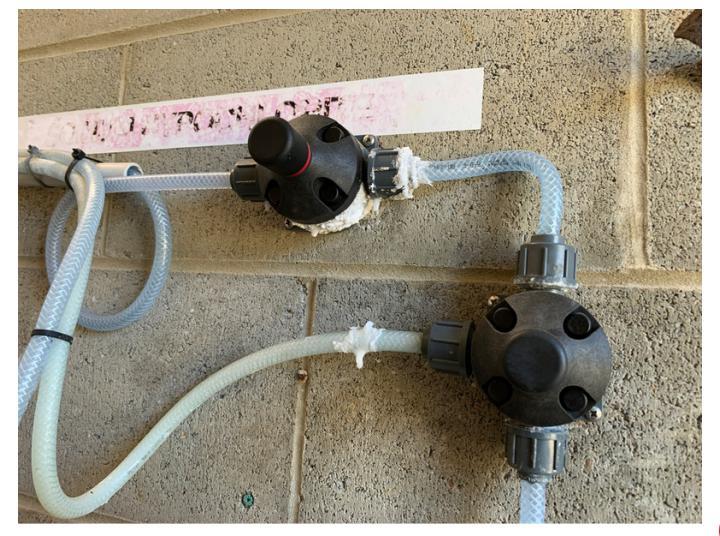
PUMP LEAK

Observation Description	Pump leak	
Observation Details	A valve on the outlet is leaking	
Recommendations	Repair the leak	
Critical Item?	No

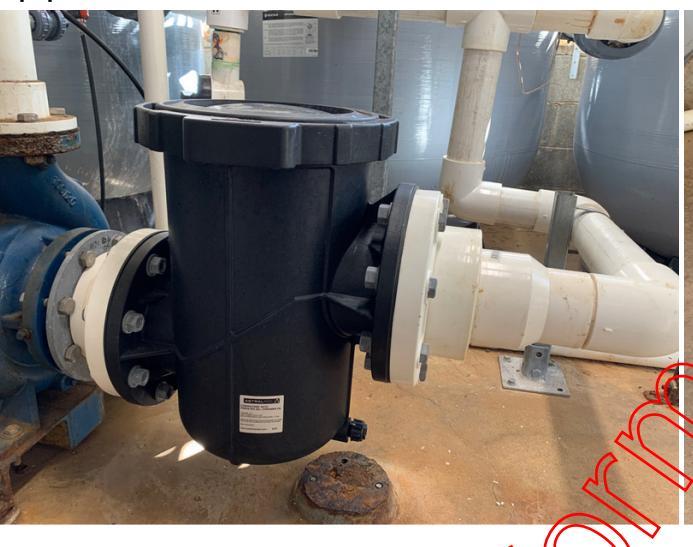
25M FILTRATION STRAINER

Equipment Type	Strainer Plastic Pre-Pump Strainer	
Equipment Identifier	25m Filtration Strainer	
Equipment Make	Astral	
Equipment Model	56733 25L Strainer	
Equipment Serial Number	N/A	
Equipment Condition	2 - Good	
Remaining Life (Years)	8	
Replacement Cost (\$)	1000

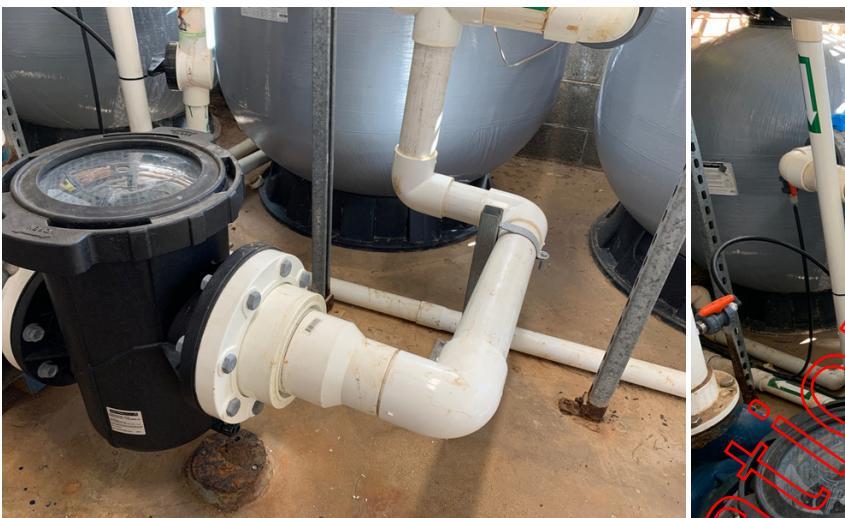
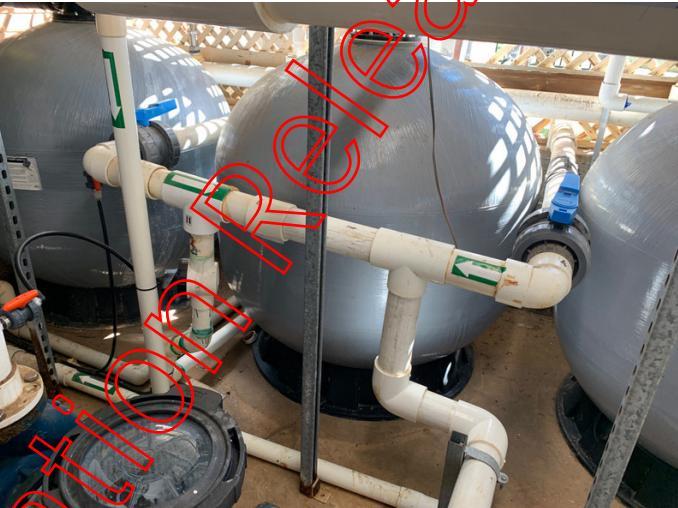
SUCTION PIPEWORK

Observation Description	Suction Pipework	
Observation Details	Suction pipework is undersized and likely restricti	ng flow for the system.
Recommendations	Replumb the suction pipework	
Critical Item?	No

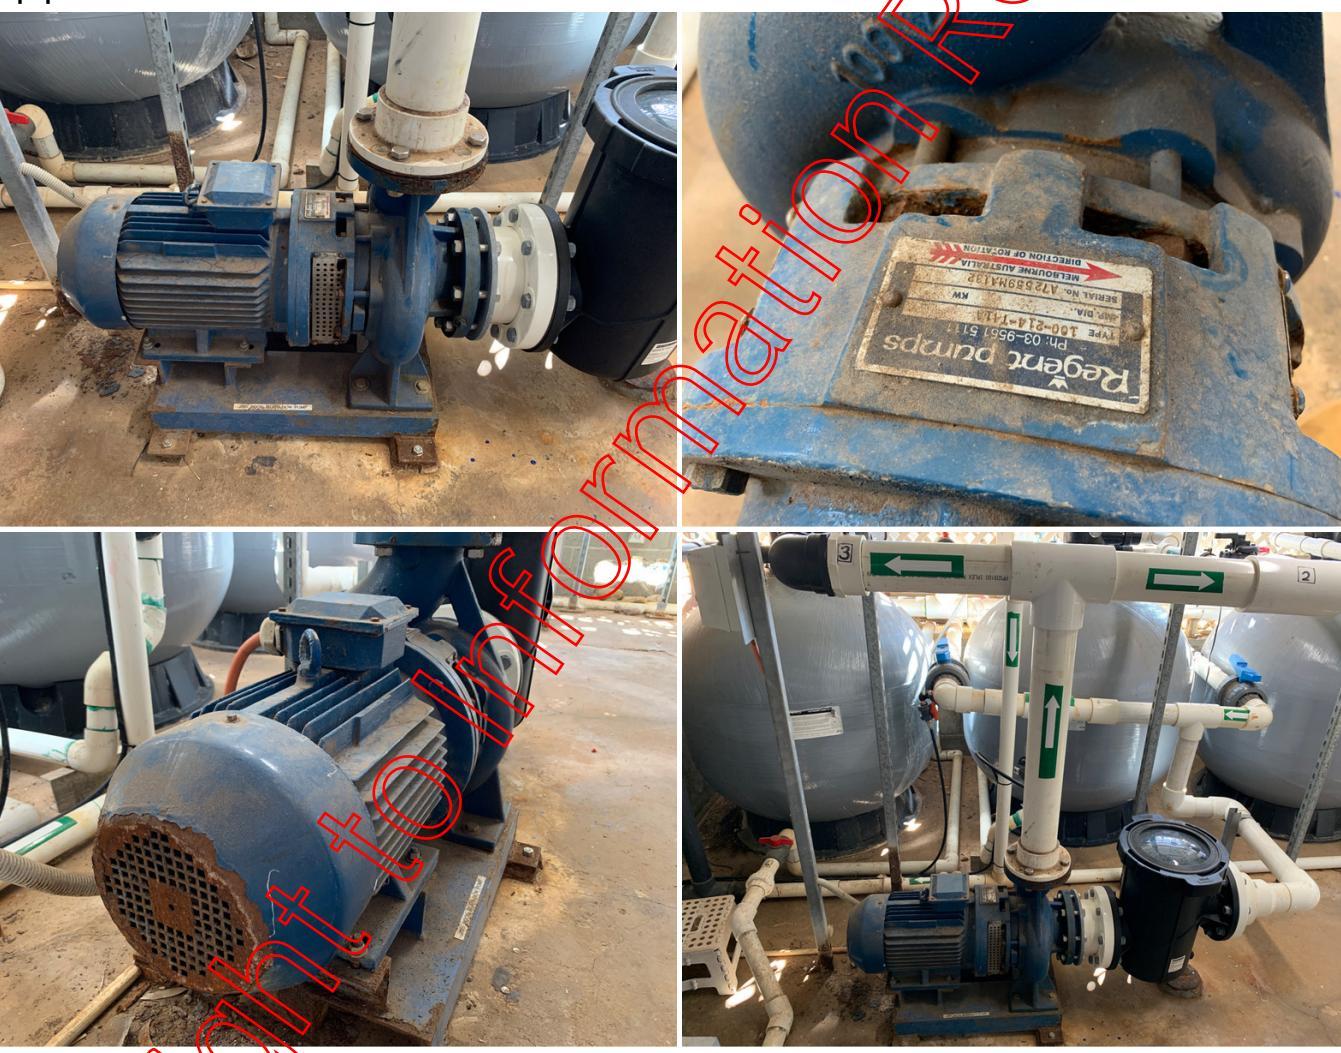
25M FILTRATION PUMP

Equipment Type	Pump ► Filtration Pump	
Equipment Identifier	25m Filtration Pump	
Equipment Make	Regent	
Equipment Model	100-214-T41A 7.5kW	
Equipment Serial Number	A72559MA132	
Equipment Condition	4 - Poor	
Remaining Life (Years)	5	
Replacement Cost (\$)	5000

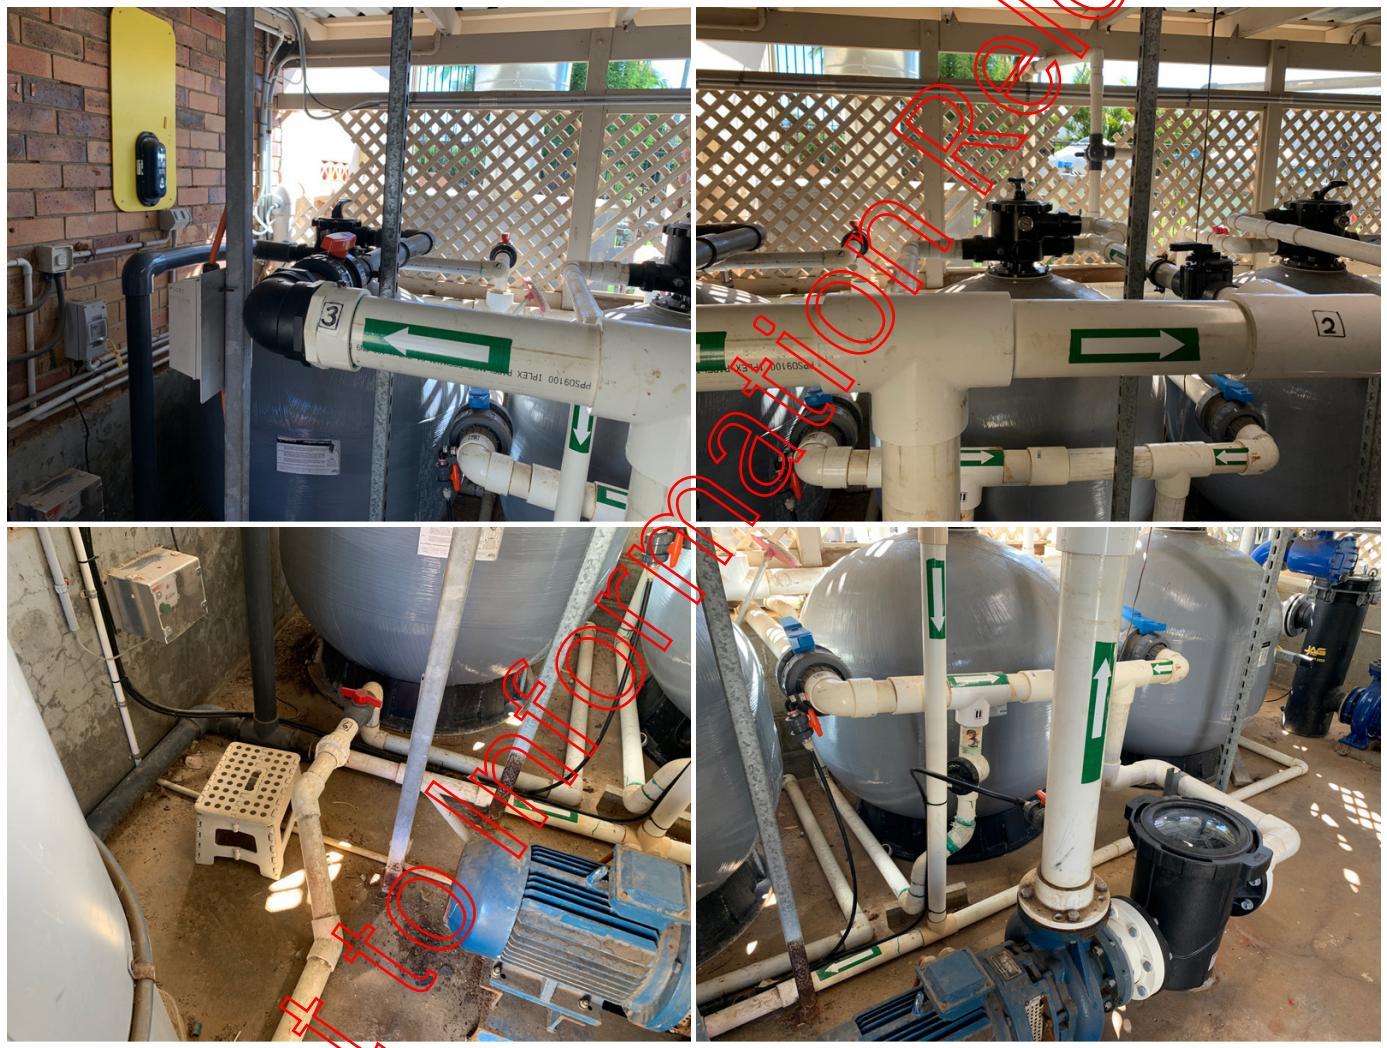
MULTIPORT ACCESS

Observation Description	Multiport Access
Observation Details	Access to the filter multiport valves for 2 and 3 is very poor, requiring operators to step on/near poorly installed pipe. This situation is dangerous and likely to result in injury or pipe breakage.
Recommendations	As noted in the general plant layout, the room requires replacement and to access issues unable to be resolved with simple fixes.
Critical Item?	Yes

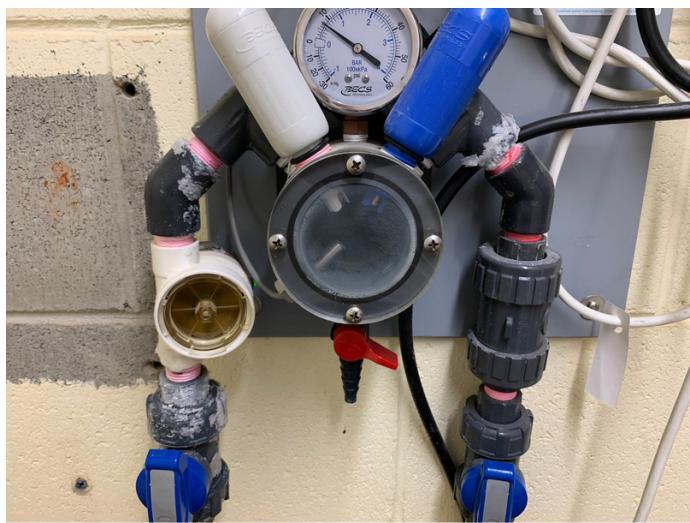
FLOW CELL LEAKS

Observation Description	Flow Cell Leaks	
Observation Details	The flow cell is leaking	
Recommendations	Repair	
Critical Item?	No

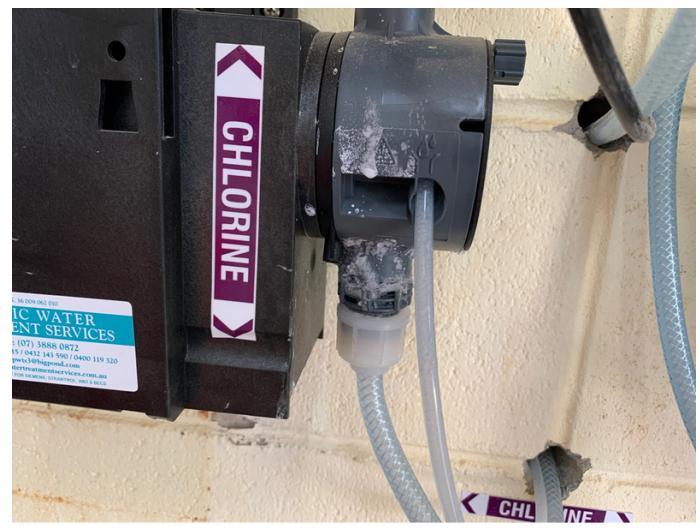
LEAK

Observation Description	Leak	
Observation Details	The pump is leaking	
Recommendations	Repair the pump	
Critical Item?	Yes
