CLEVELAND AQUATIC CENTRE UPDATED POOL CONDITION ASSESSMENT

AND MAINTENANCE PLANS

(July 2014)

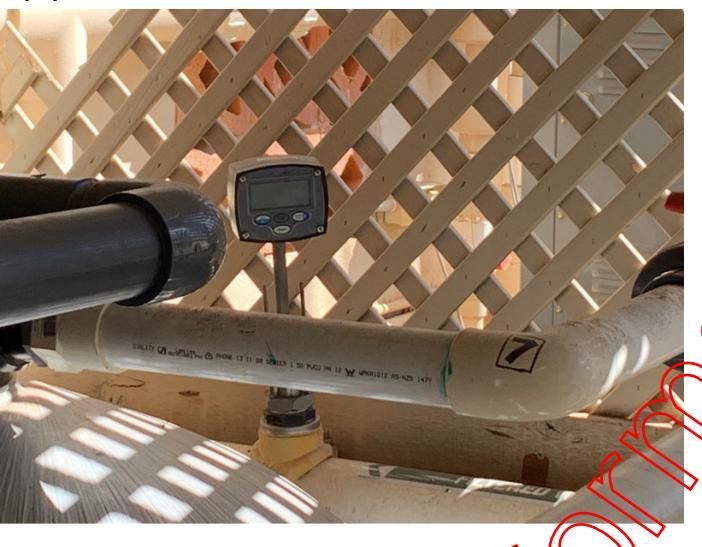
25M FLOW METER

Equipment Type	Ancillary Item ► Sensor	
Equipment Identifier	25m Flow Meter	
Equipment Make	Flomec	
Equipment Model	RT401D0FA	
Equipment Serial Number	2420-4497	
Equipment Condition	4 - Poor	
Remaining Life (Years)	10	
Replacement Cost (\$)	3000

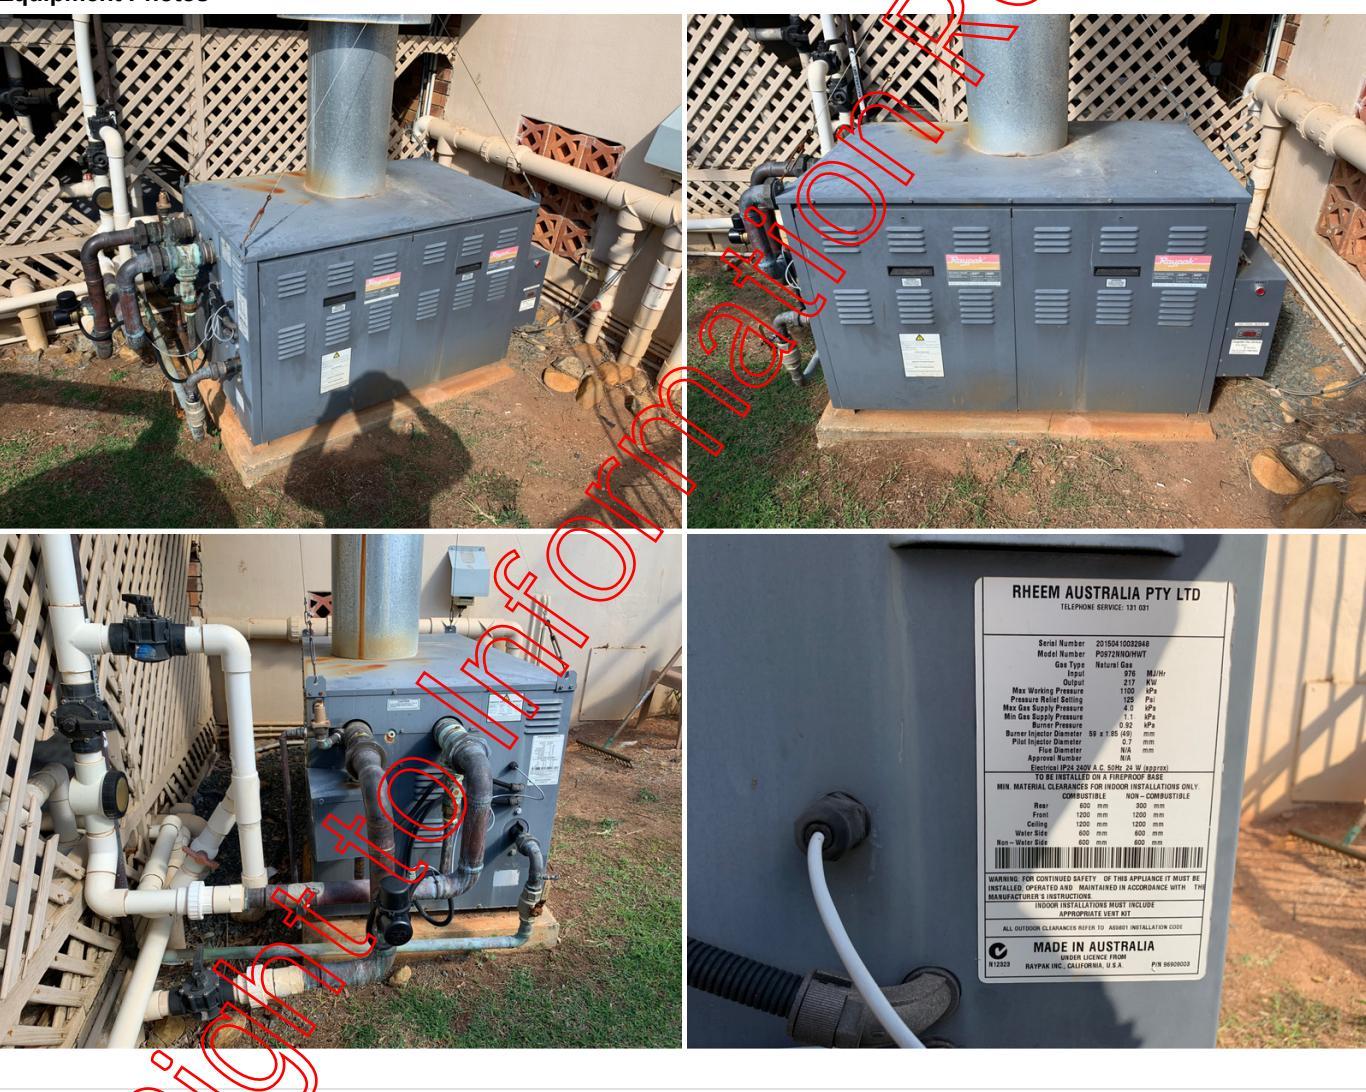
25M GAS HEATER

Equipment Type	Heating System ► Gas Heater - Direct F	ired
Equipment Identifier	25m Gas Heater	
Equipment Make	Raypak	
Equipment Model	P0972NNO/HWT	
Equipment Serial Number	20150410032848	
Equipment Condition	4 - Poor	
Remaining Life (Years)	4	
Replacement Cost (\$)	25000

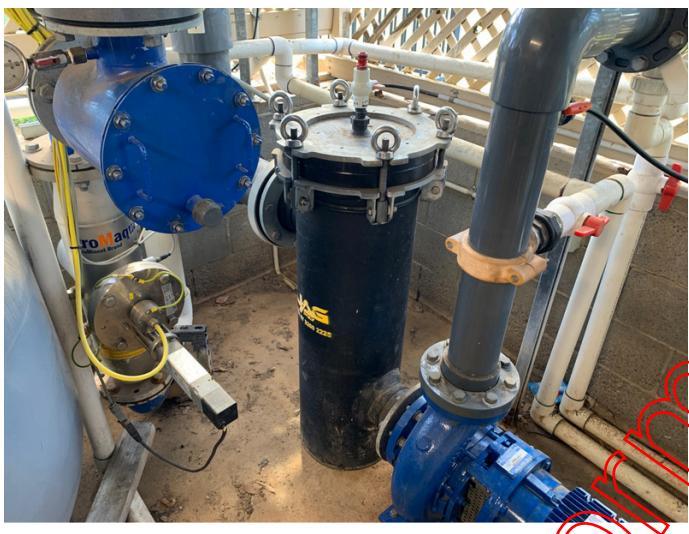
LTS FILTRATION STRAINER

Equipment Type	Strainer ► Poly-Bodied Pre-Pump Strainer	
Equipment Identifier	LTS Filtration Strainer	
Equipment Make	Jag Poly	
Equipment Model	LLP30	
Equipment Serial Number	N/A	
Equipment Condition	3 - Average	
Remaining Life (Years)	12	
Replacement Cost (\$)	4000

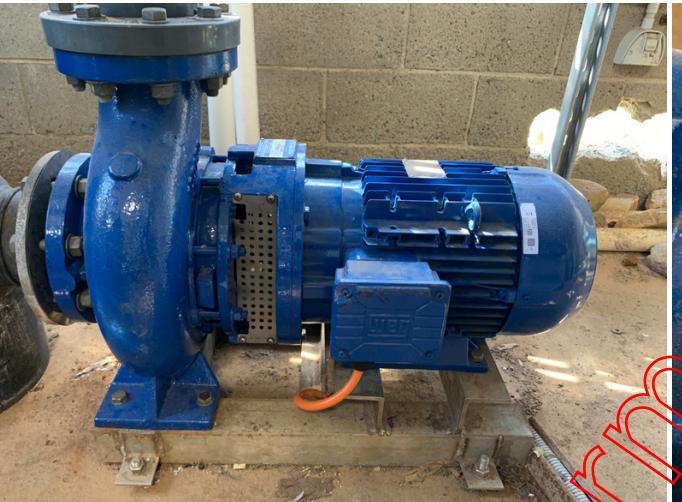
LTS FILTRATION PUMP

Equipment Type	Pump ► Filtration Pump	
Equipment Identifier	LTS Filtration Pump	
Equipment Make	Ajax Elite	
Equipment Model	EB100-20M7.5	
Equipment Serial Number	9972316730	
Equipment Condition	4 - Poor	
Remaining Life (Years)	5	
Replacement Cost (\$)	7000

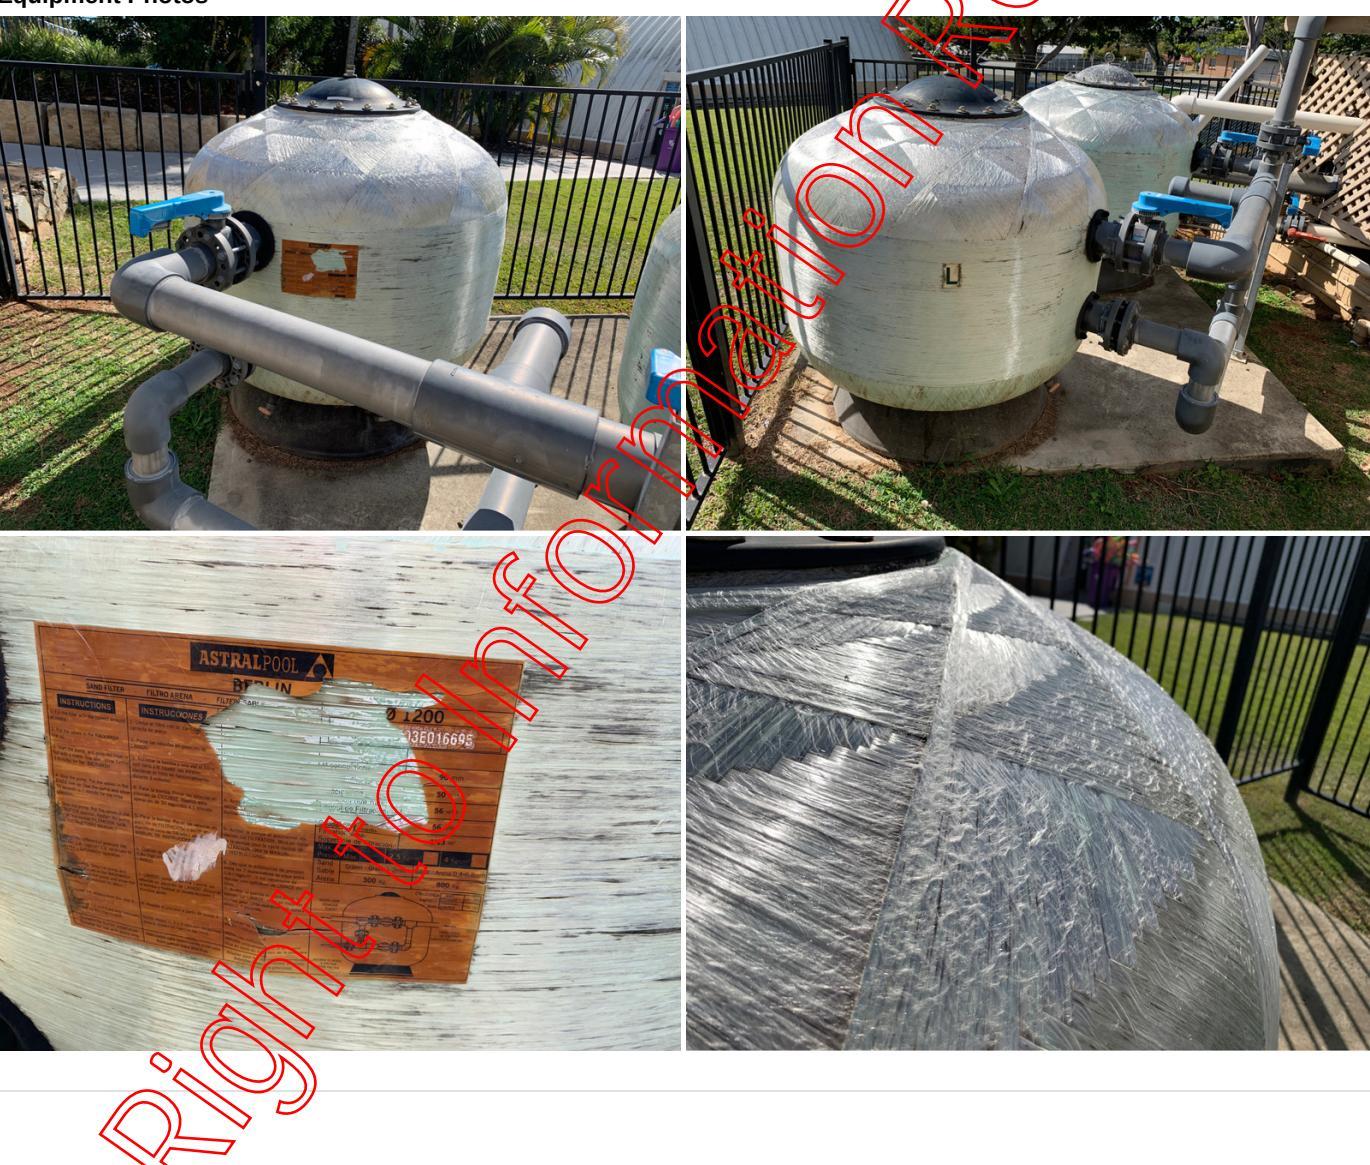
LTS SAND FILTER 1

Equipment Type	Filter ► Sand Pressure Filter	
Equipment Identifier	LTS Sand Filter 1	
Equipment Make	Astral	
Equipment Model	Berlin 1200	
Equipment Serial Number	03E016695	
Equipment Condition	4 - Poor	
Remaining Life (Years)	3	
Replacement Cost (\$)	8500

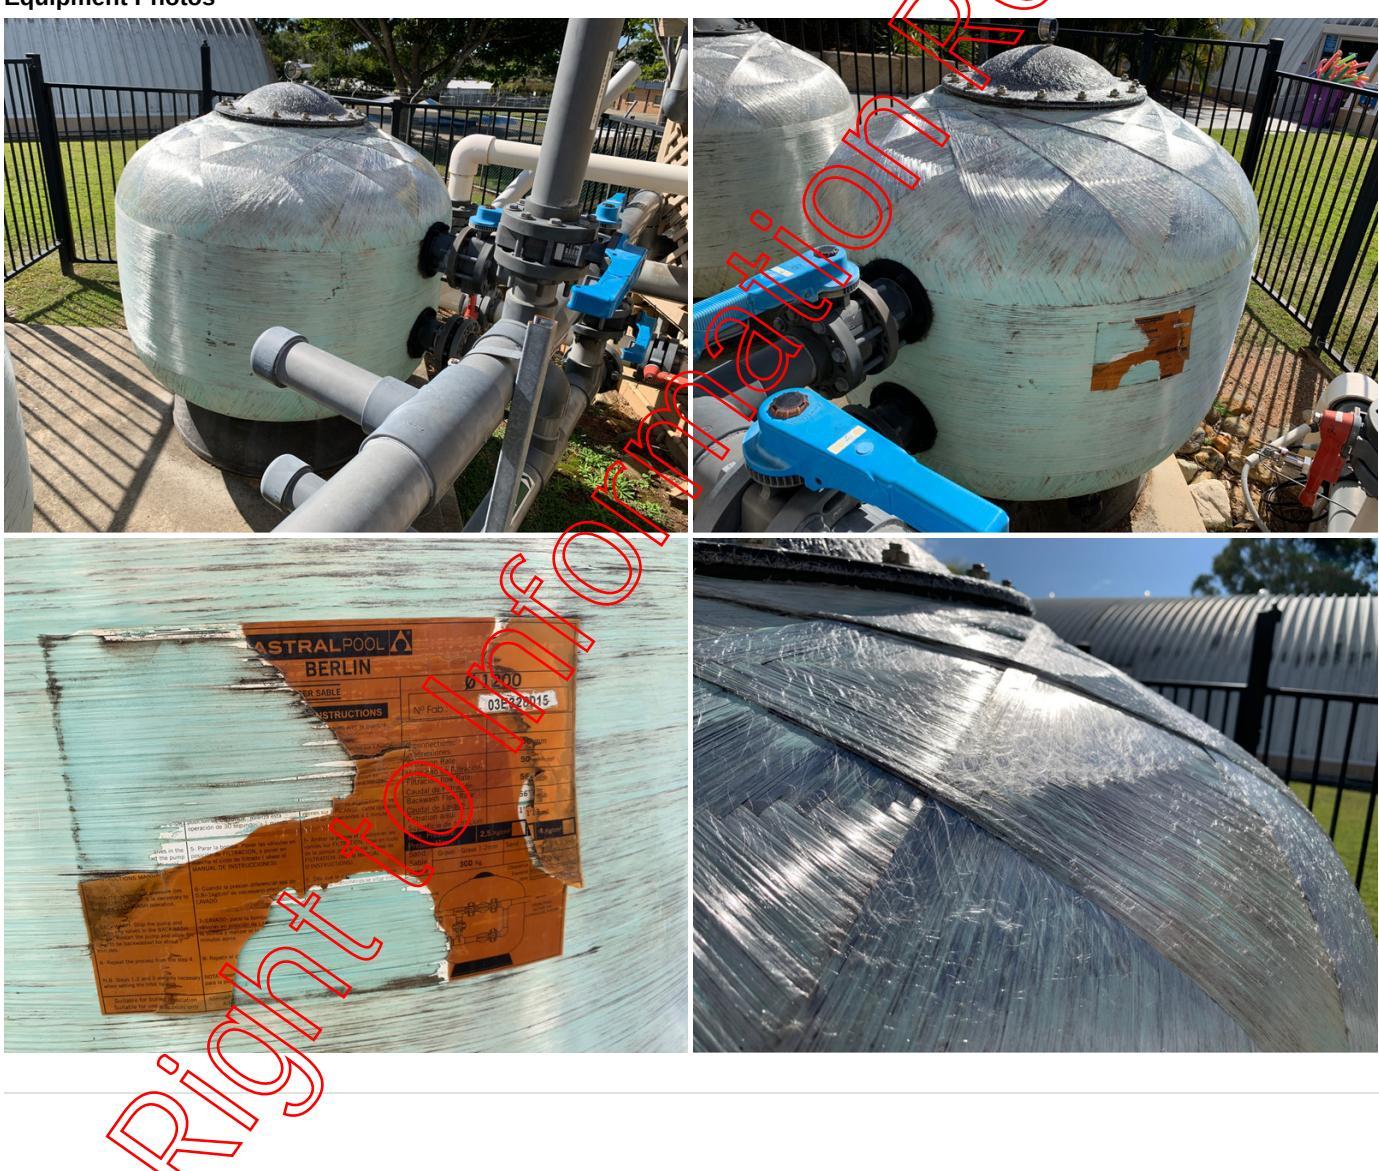
LTS SAND FILTER 2

Equipment Type	Filter ► Sand Pressure Filter	
Equipment Identifier	LTS Sand Filter 2	
Equipment Make	Astral	
Equipment Model	Berlin 1200	
Equipment Serial Number	03E328015	
Equipment Condition	4 - Poor	
Remaining Life (Years)	3	
Replacement Cost (\$)	8500

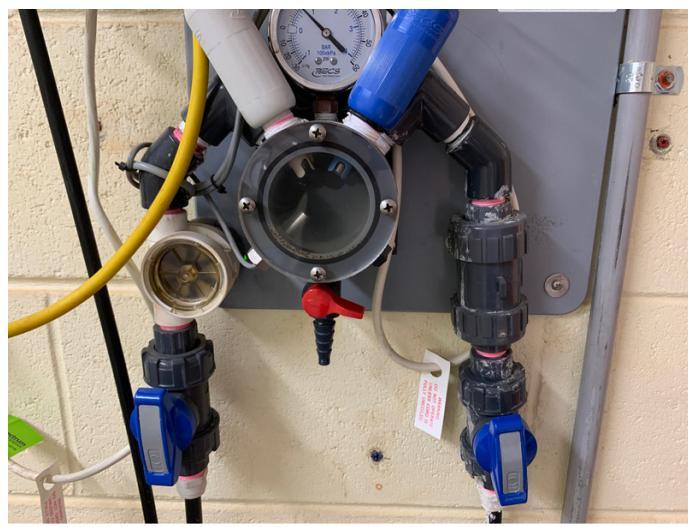
FLOW CELL LEAK

Observation Description	Flow Cell Leak	
Observation Details	The flow cell is leaking	
Recommendations	Repair	
Critical Item?	No

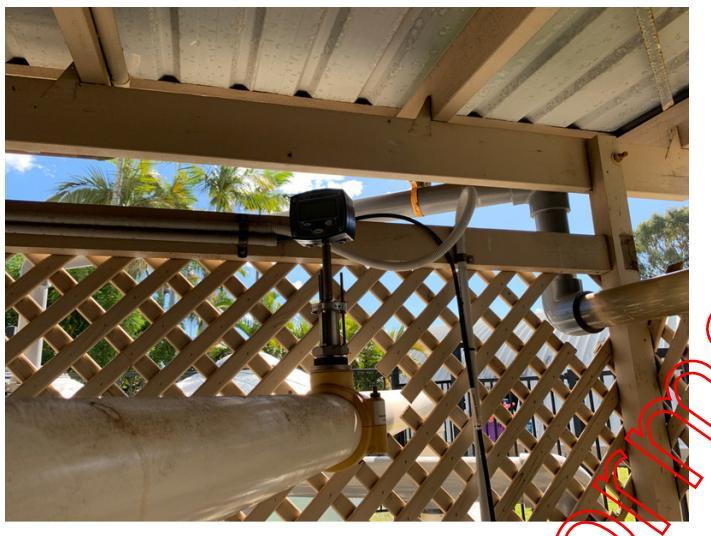
LTS FLOW METER

Equipment Type	Ancillary Item ► Sensor	
Equipment Identifier	LTS Flow Meter	
Equipment Make	Flomec	
Equipment Model	RT401D0FA	
Equipment Serial Number	N/A	
Equipment Condition	3 - Average	
Remaining Life (Years)	10	
Replacement Cost (\$)	3000

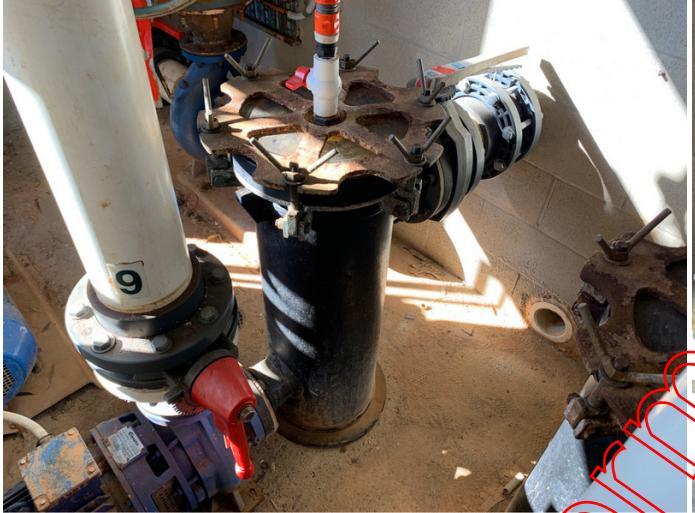
PLAY POOL FILTRATION STRAINER

Equipment Type	Strainer ► Poly-Bodied Pre-Pump Strainer	
Equipment Identifier	Play Pool Filtration Strainer	
Equipment Make	Unknown	
Equipment Model	Unknown	
Equipment Serial Number	N/A	
Equipment Condition	4 - Poor	
Remaining Life (Years)	3	
Replacement Cost (\$)	3500

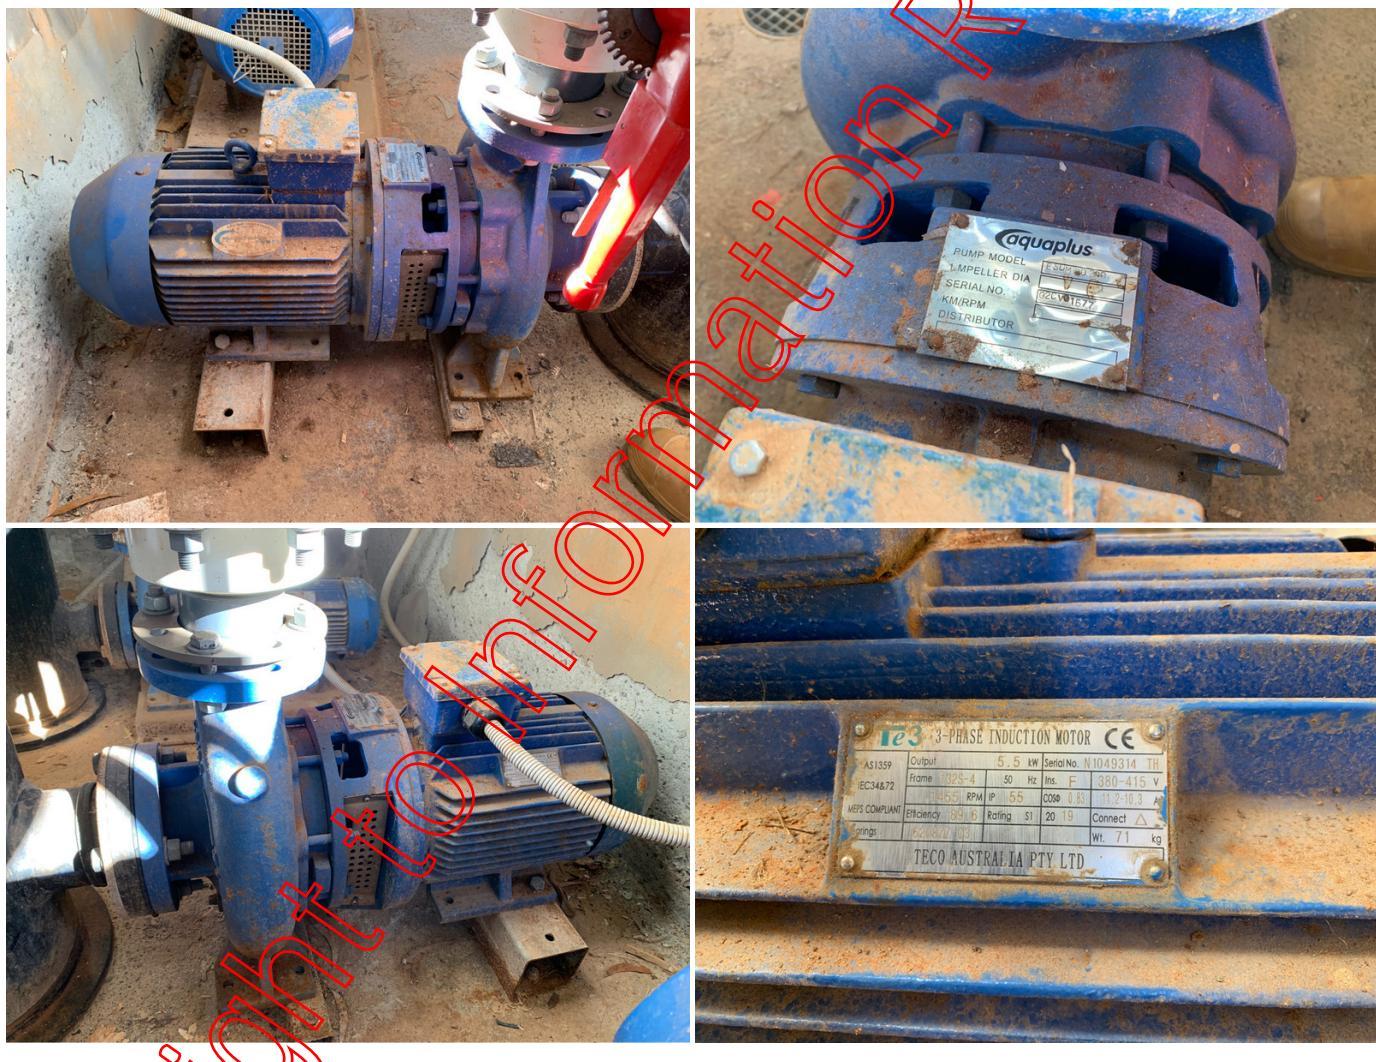
PLAY POOL FILTRATION PUMP

Equipment Type	Pump ► Filtration Pump	
Equipment Identifier	Play Pool Filtration Pump	
Equipment Make	Aquaplus	
Equipment Model	ESDM 80-200 5.5kW	
Equipment Serial Number	020V01677	
Equipment Condition	5 - Very Poor	
Remaining Life (Years)	0	
Replacement Cost (\$)	5000

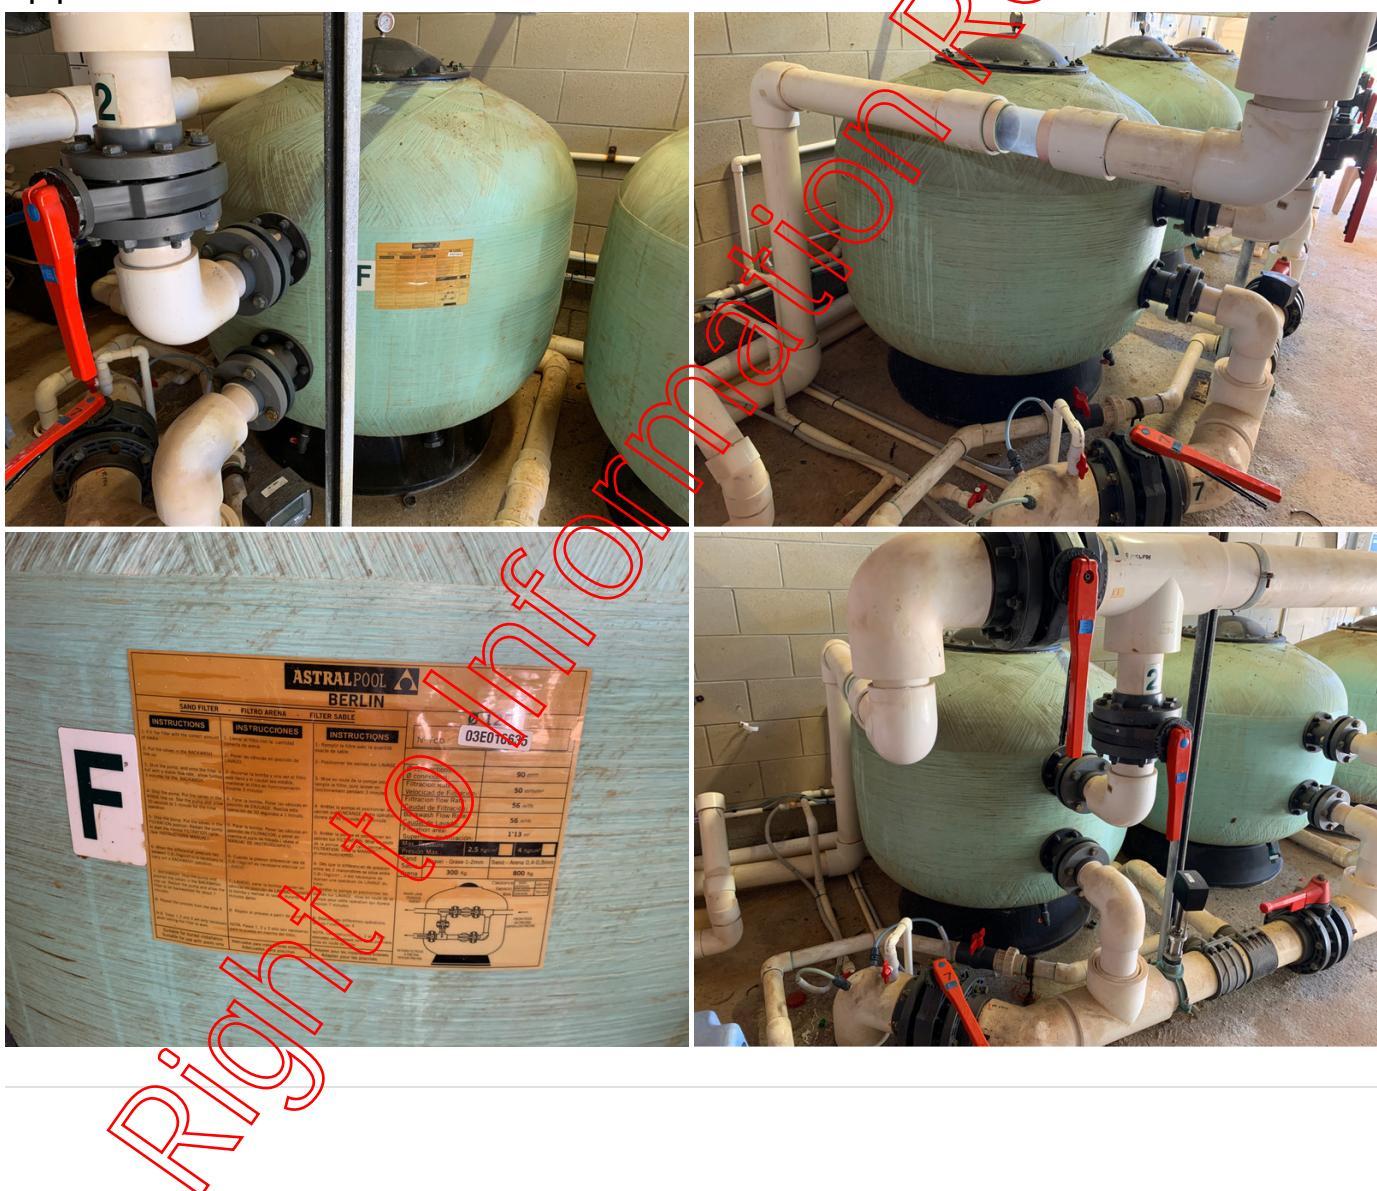
PLAY POOL SAND FILTER 1

Equipment Type	Filter ► Sand Pressure Filter	
Equipment Identifier	Play Pool Sand Filter 1	
Equipment Make	Astral	
Equipment Model	Berlin 1200	
Equipment Serial Number	03E017313	
Equipment Condition	3 - Average	
Remaining Life (Years)	8	
Replacement Cost (\$)	8500

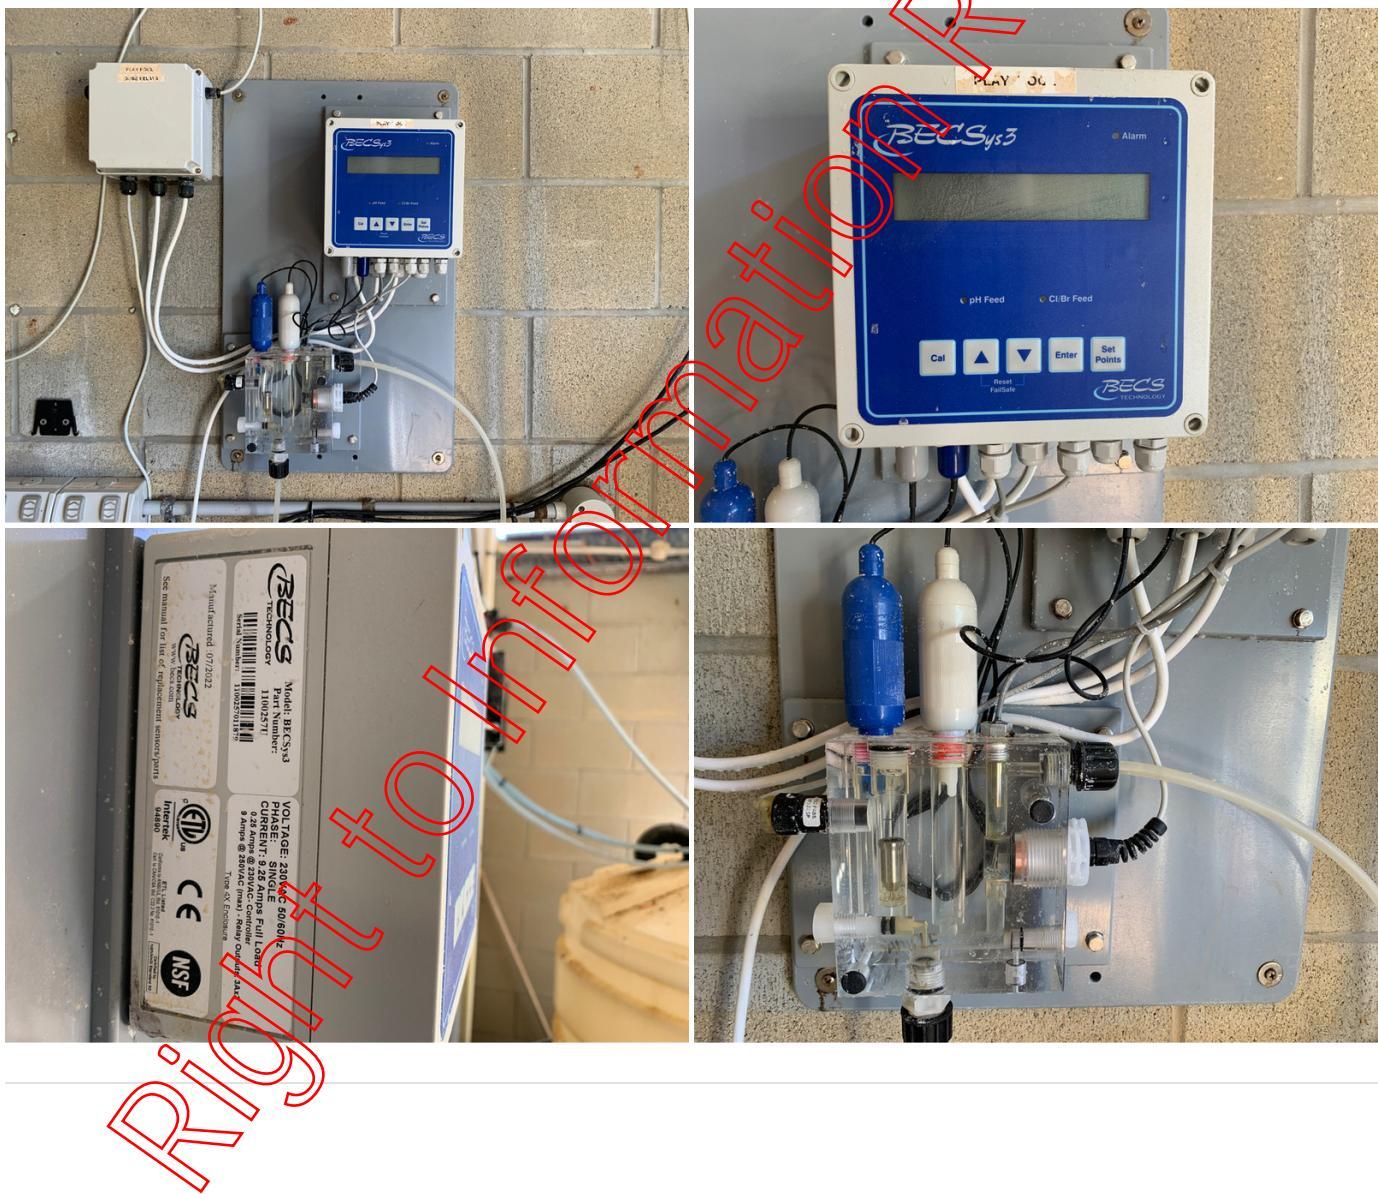
PLAY POOL CHEMICAL CONTROLLER

Equipment Type	Chemical System ► Chemical Controller	
Equipment Identifier	Play Pool Chemical Controller	
Equipment Make	BecSYS	
Equipment Model	System 3	
Equipment Serial Number	1100257011879	
Equipment Condition	2 - Good	
Remaining Life (Years)	12	
Replacement Cost (\$)	12500

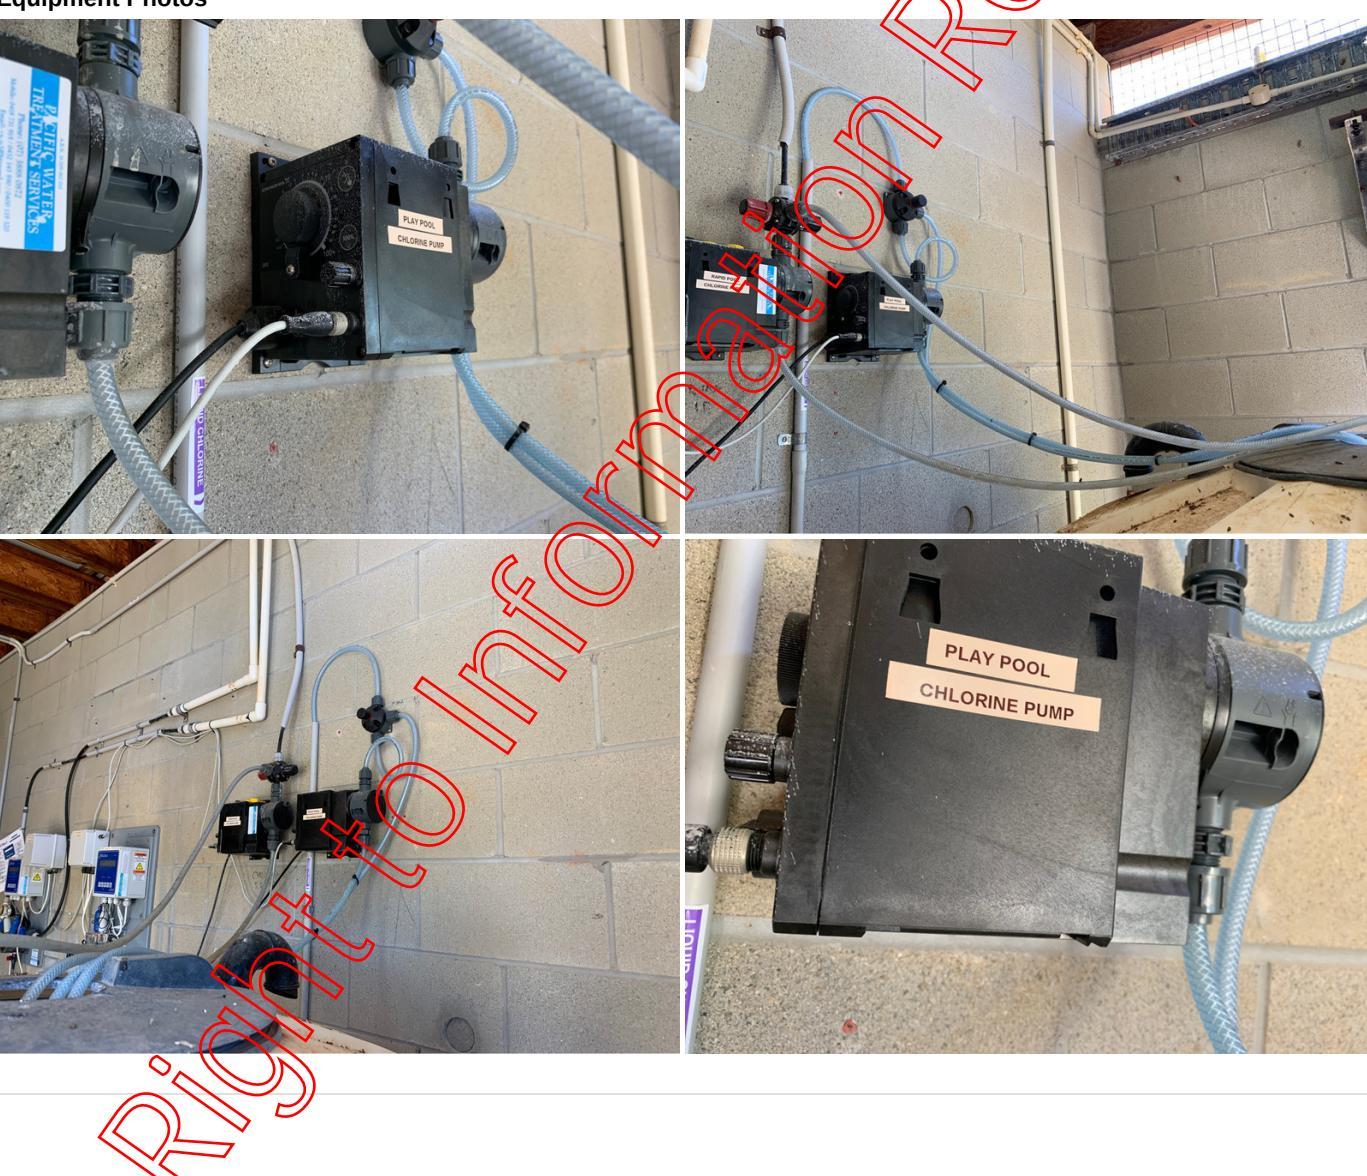
PLAY POOL CHLORINE DOSING PUMP

Equipment Type	Chemical System ► Chemical Dosing Pump	
Equipment Identifier	Play Pool Chlorine Dosing Pump	
Equipment Make	Grundfos	
Equipment Model	DDE	
Equipment Serial Number	N/A	
Equipment Condition	2 - Good	
Remaining Life (Years)	8	
Replacement Cost (\$)	1500

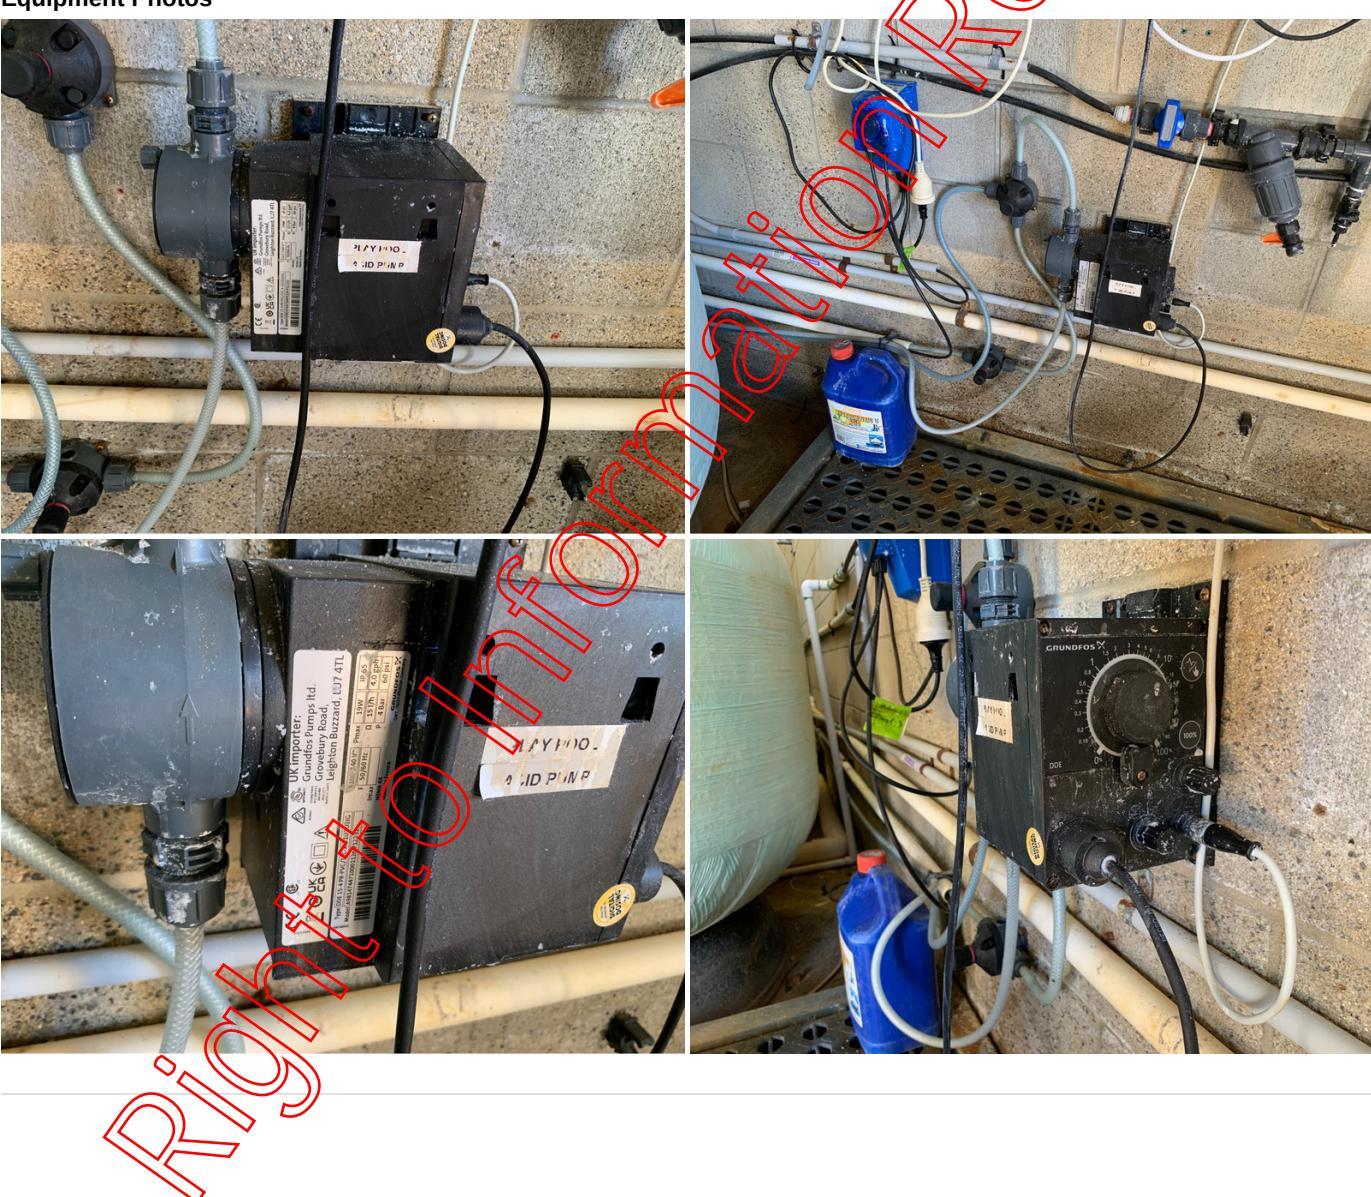
PLAY POOL ACID DOSING PUMP

Equipment Type	Chemical System ► Chemical Dosing Pump	
Equipment Identifier	Play Pool Acid Dosing Pump	
Equipment Make	Grundfos	
Equipment Model	DDE 15-4	
Equipment Serial Number	N/A	
Equipment Condition	2 - Good	
Remaining Life (Years)	8	
Replacement Cost (\$)	1500

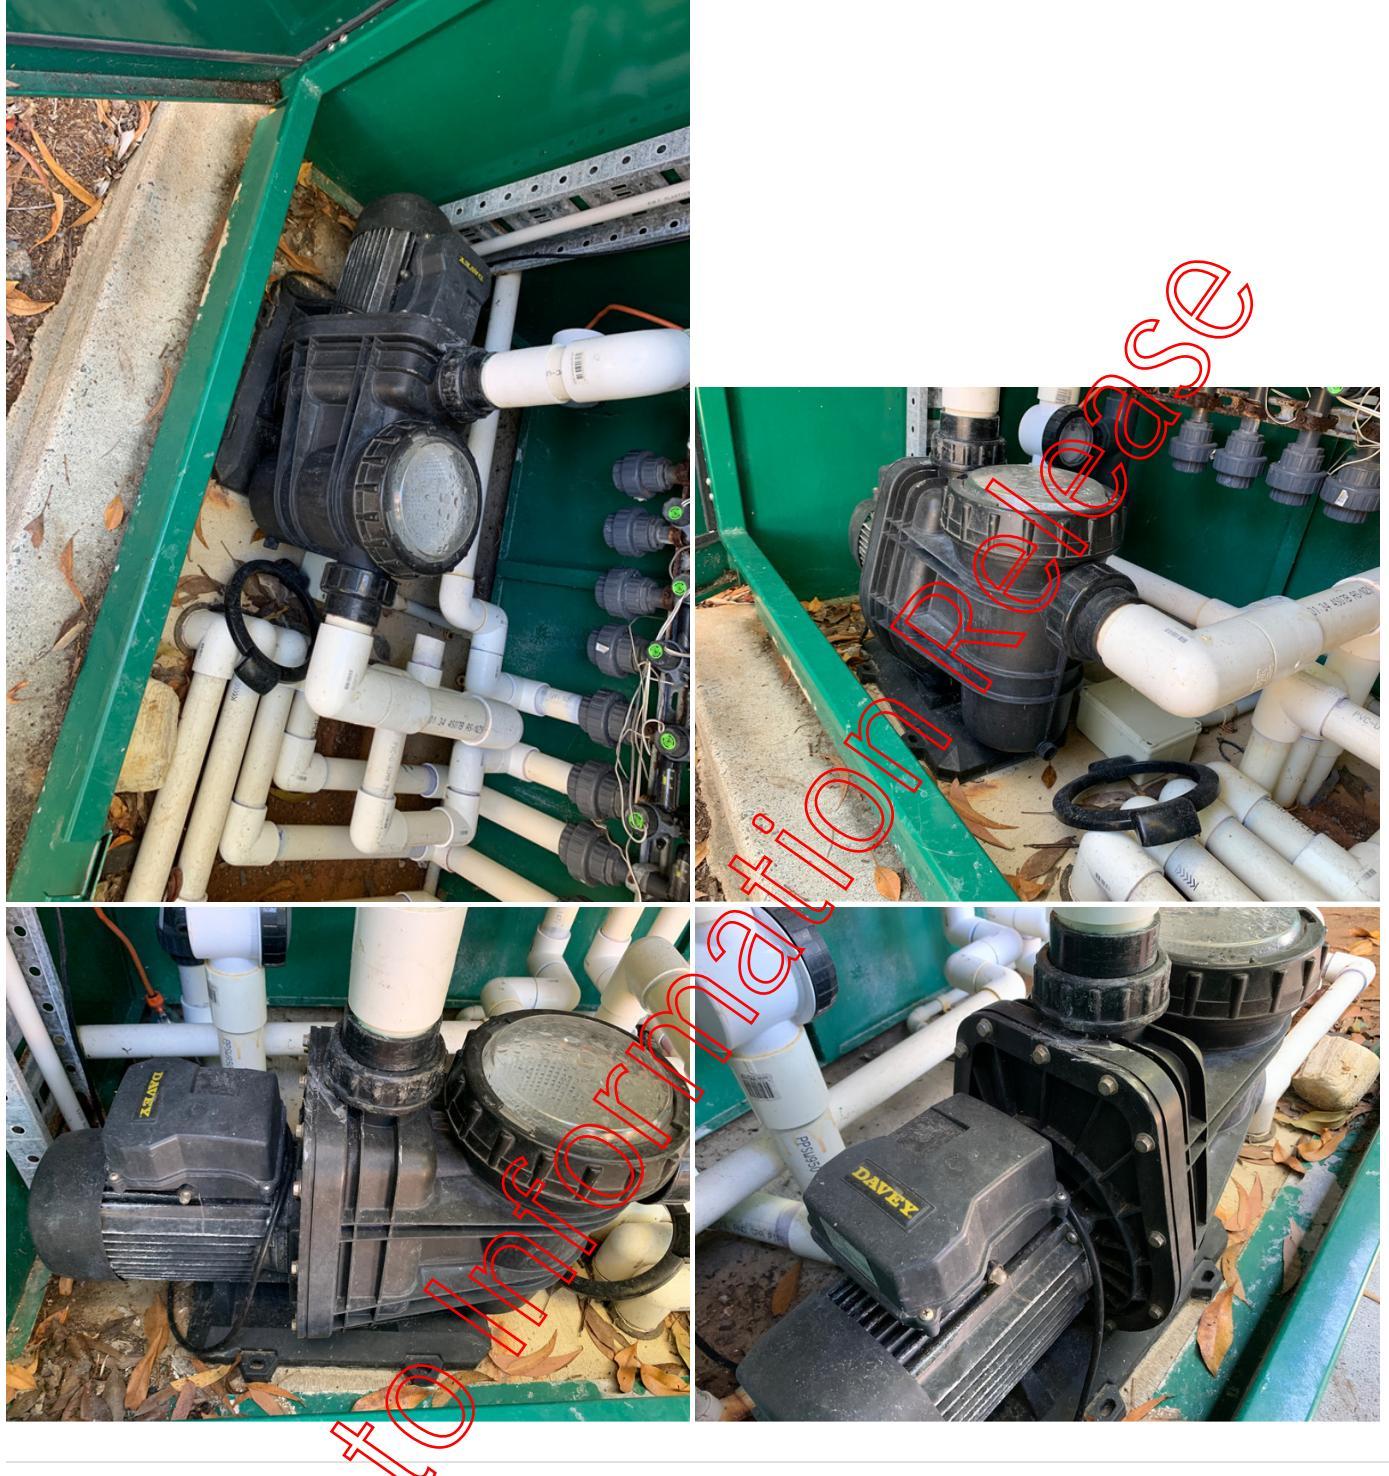
PLAY POOL FEATURE PUMP

Equipment Type	Pump ► Water Feature Pump
Equipment Identifier	Play Pool Feature Pump
Equipment Make	Davey
Equipment Model	N/A
Equipment Serial Number	N/A
Equipment Condition	3 - Average
Remaining Life (Years)	3
Replacement Cost (\$)	1500

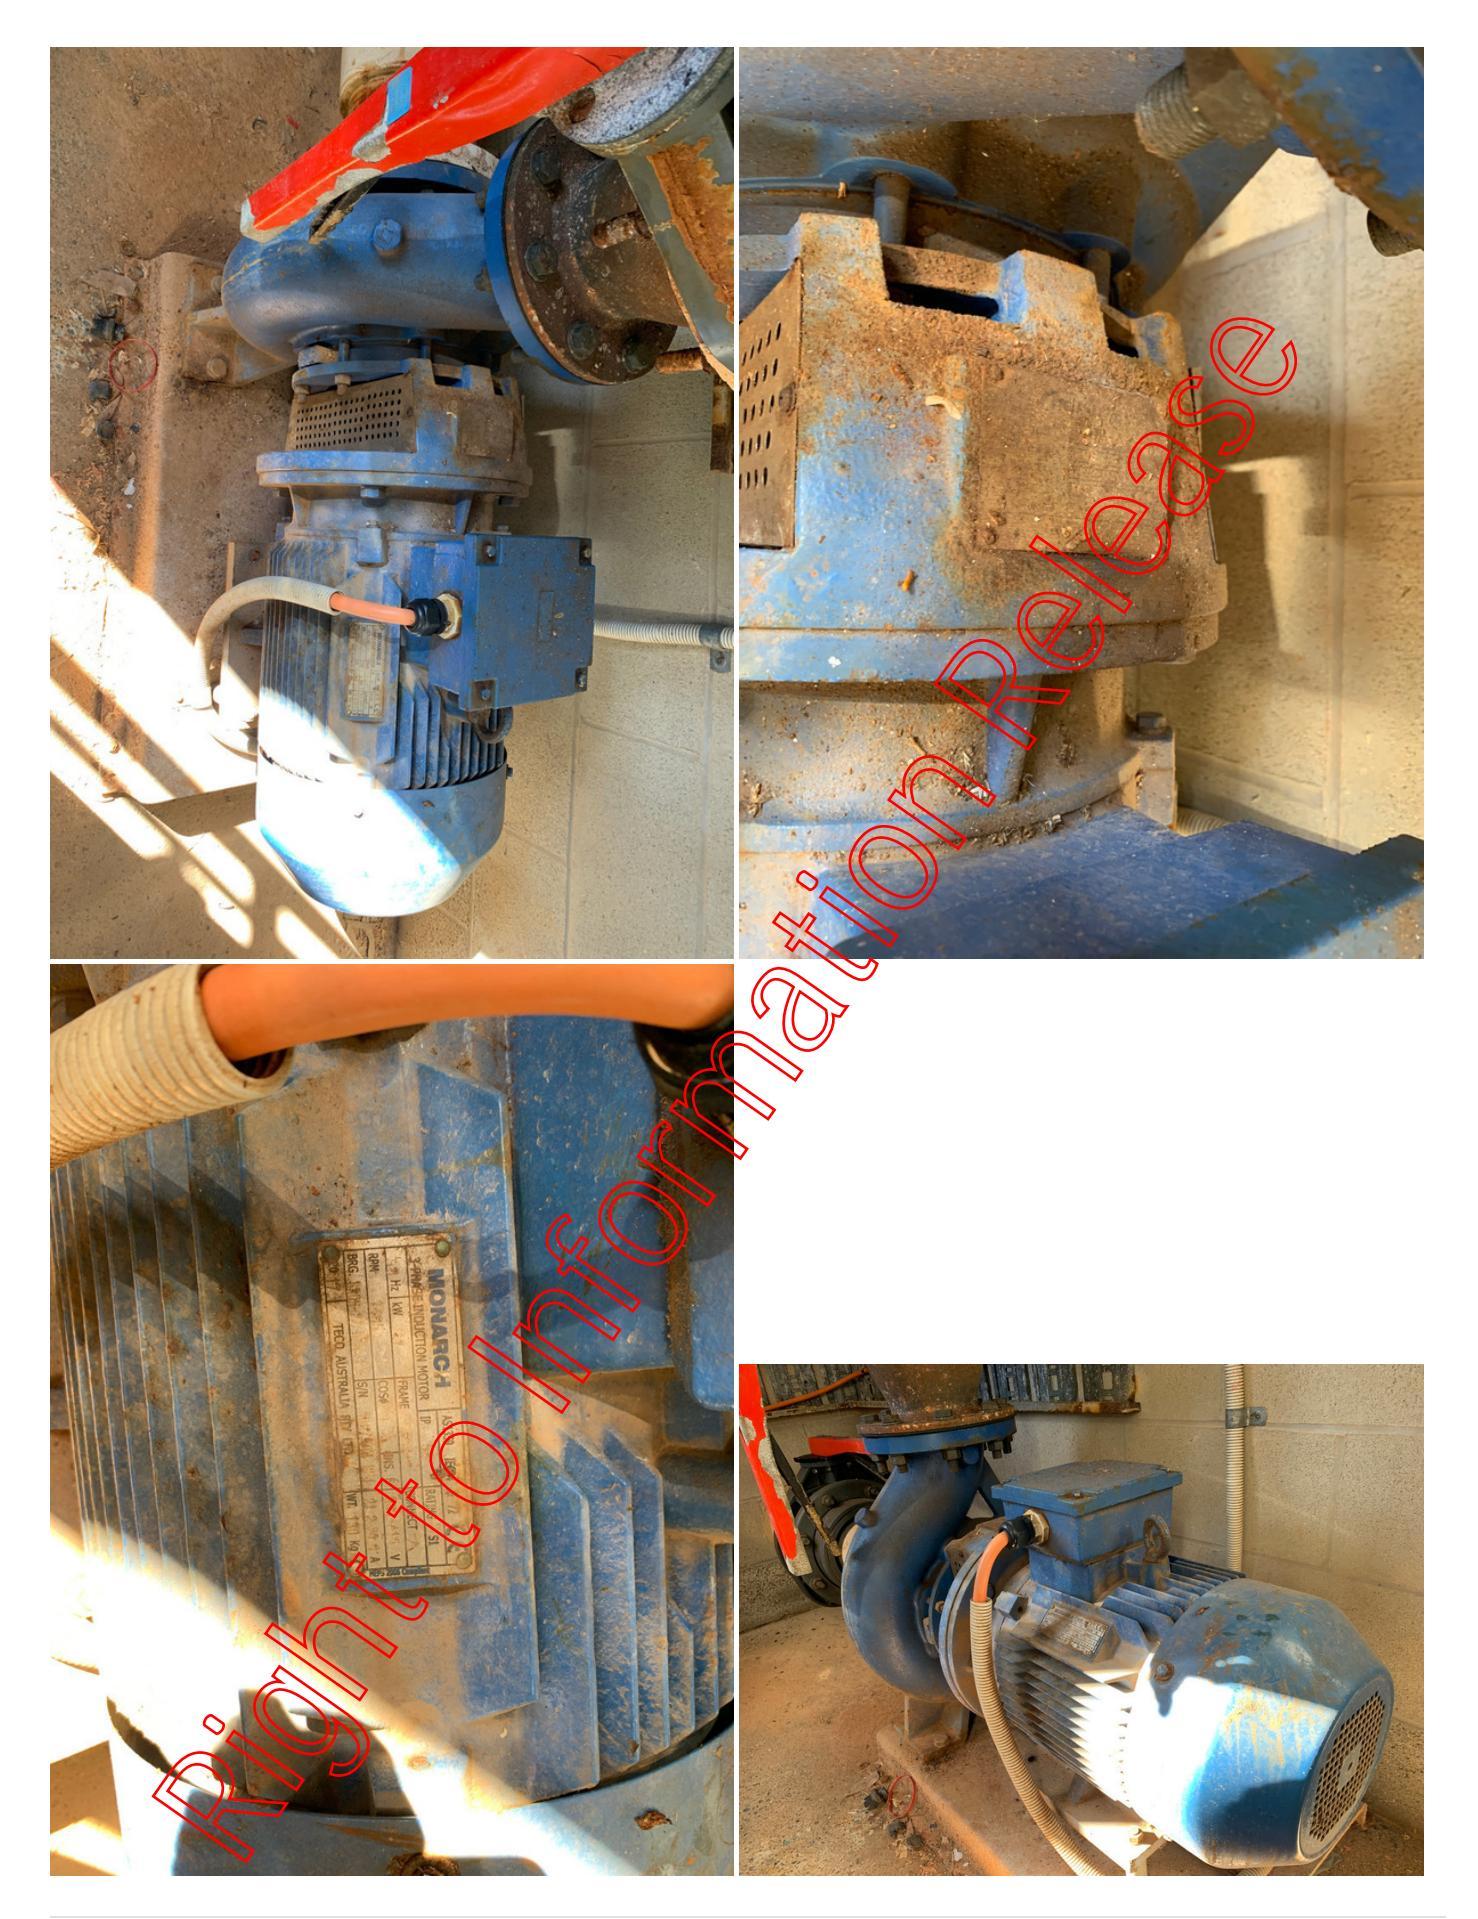
RIVER PUMP 2

Equipment Type	Pump ► Water Feature Pump
Equipment Identifier	River Pump 2
Equipment Make	Aquaplus
Equipment Model	ESDM 125 200 11kW
Equipment Serial Number	020V00769
Equipment Condition	4 - Poor
Remaining Life (Years)	2
Replacement Cost (\$)	10000
Remaining Life (rears) 2 Replacement Cost (\$) Equipment Photos

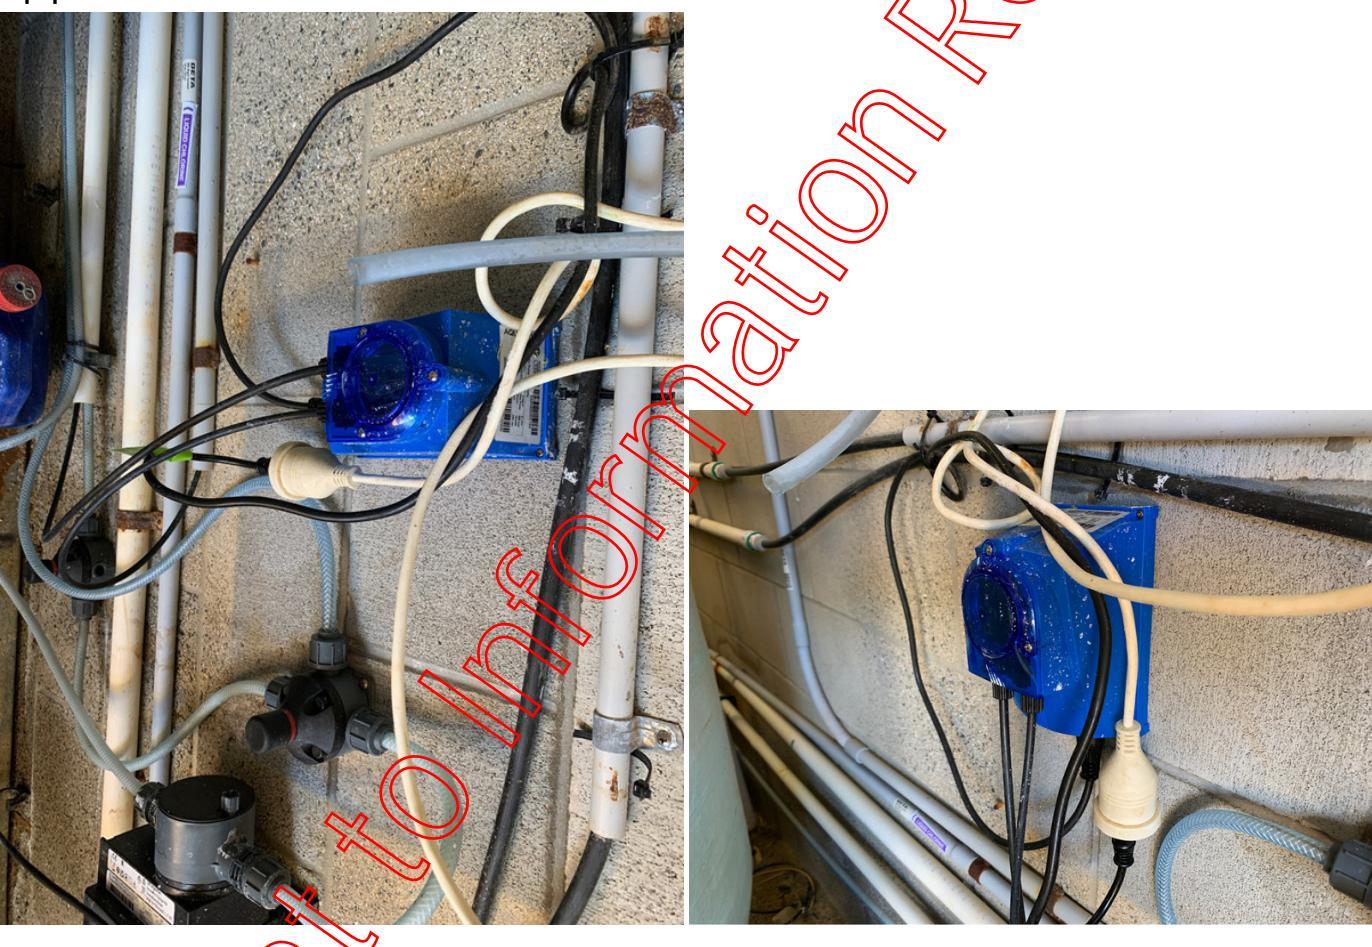
RIVER POOL ACID DOSING PUMP

Equipment Type	Chemical System ► Chemical Dosing Pump	Chemical System ► Chemical Dosing Pump	
Equipment Identifier	River Pool Acid Dosing Pump		
Equipment Make	Aquarius		
Equipment Model	AP_Peri3		
Equipment Serial Number	1509AP3021783		
Equipment Condition	4 - Poor		
Remaining Life (Years)	1		
Replacement Cost (\$)	900
