CLEVELAND AQUATIC CENTRE UPDATED POOL CONDITION ASSESSMENT

AND MAINTENANCE PLANS

(July 2014)

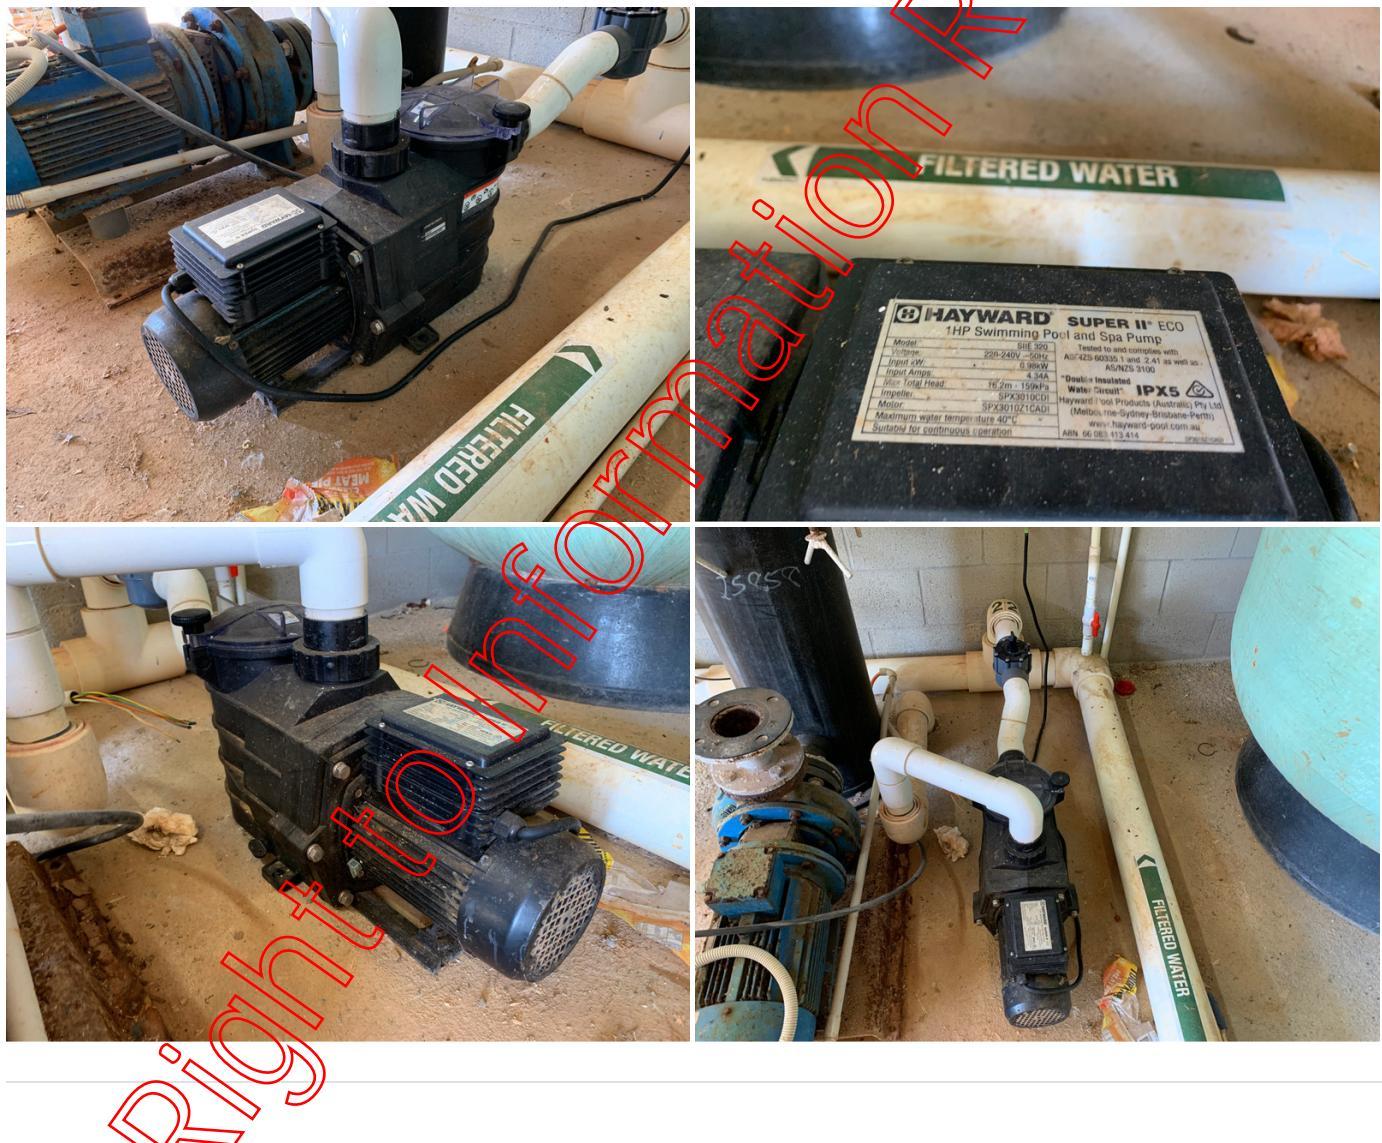
RIVER POOL WATERFALL PUMP

Equipment Type	Pump ► Water Feature Pump	
Equipment Identifier	River Pool Waterfall Pump	
Equipment Make	Hayward	
Equipment Model	Super II Eco	
Equipment Serial Number	SPC3010CDI	
Equipment Condition	2 - Good	
Remaining Life (Years)	3	
Replacement Cost (\$)	1500
