onsite meeting at 2 Sanctuary Dr, Mt Cotton

Re, the Ficus Trees at 2 Sanctury Drive, Mount Cotton.

Assetic chronology and notes of WR88126 and following WO226299

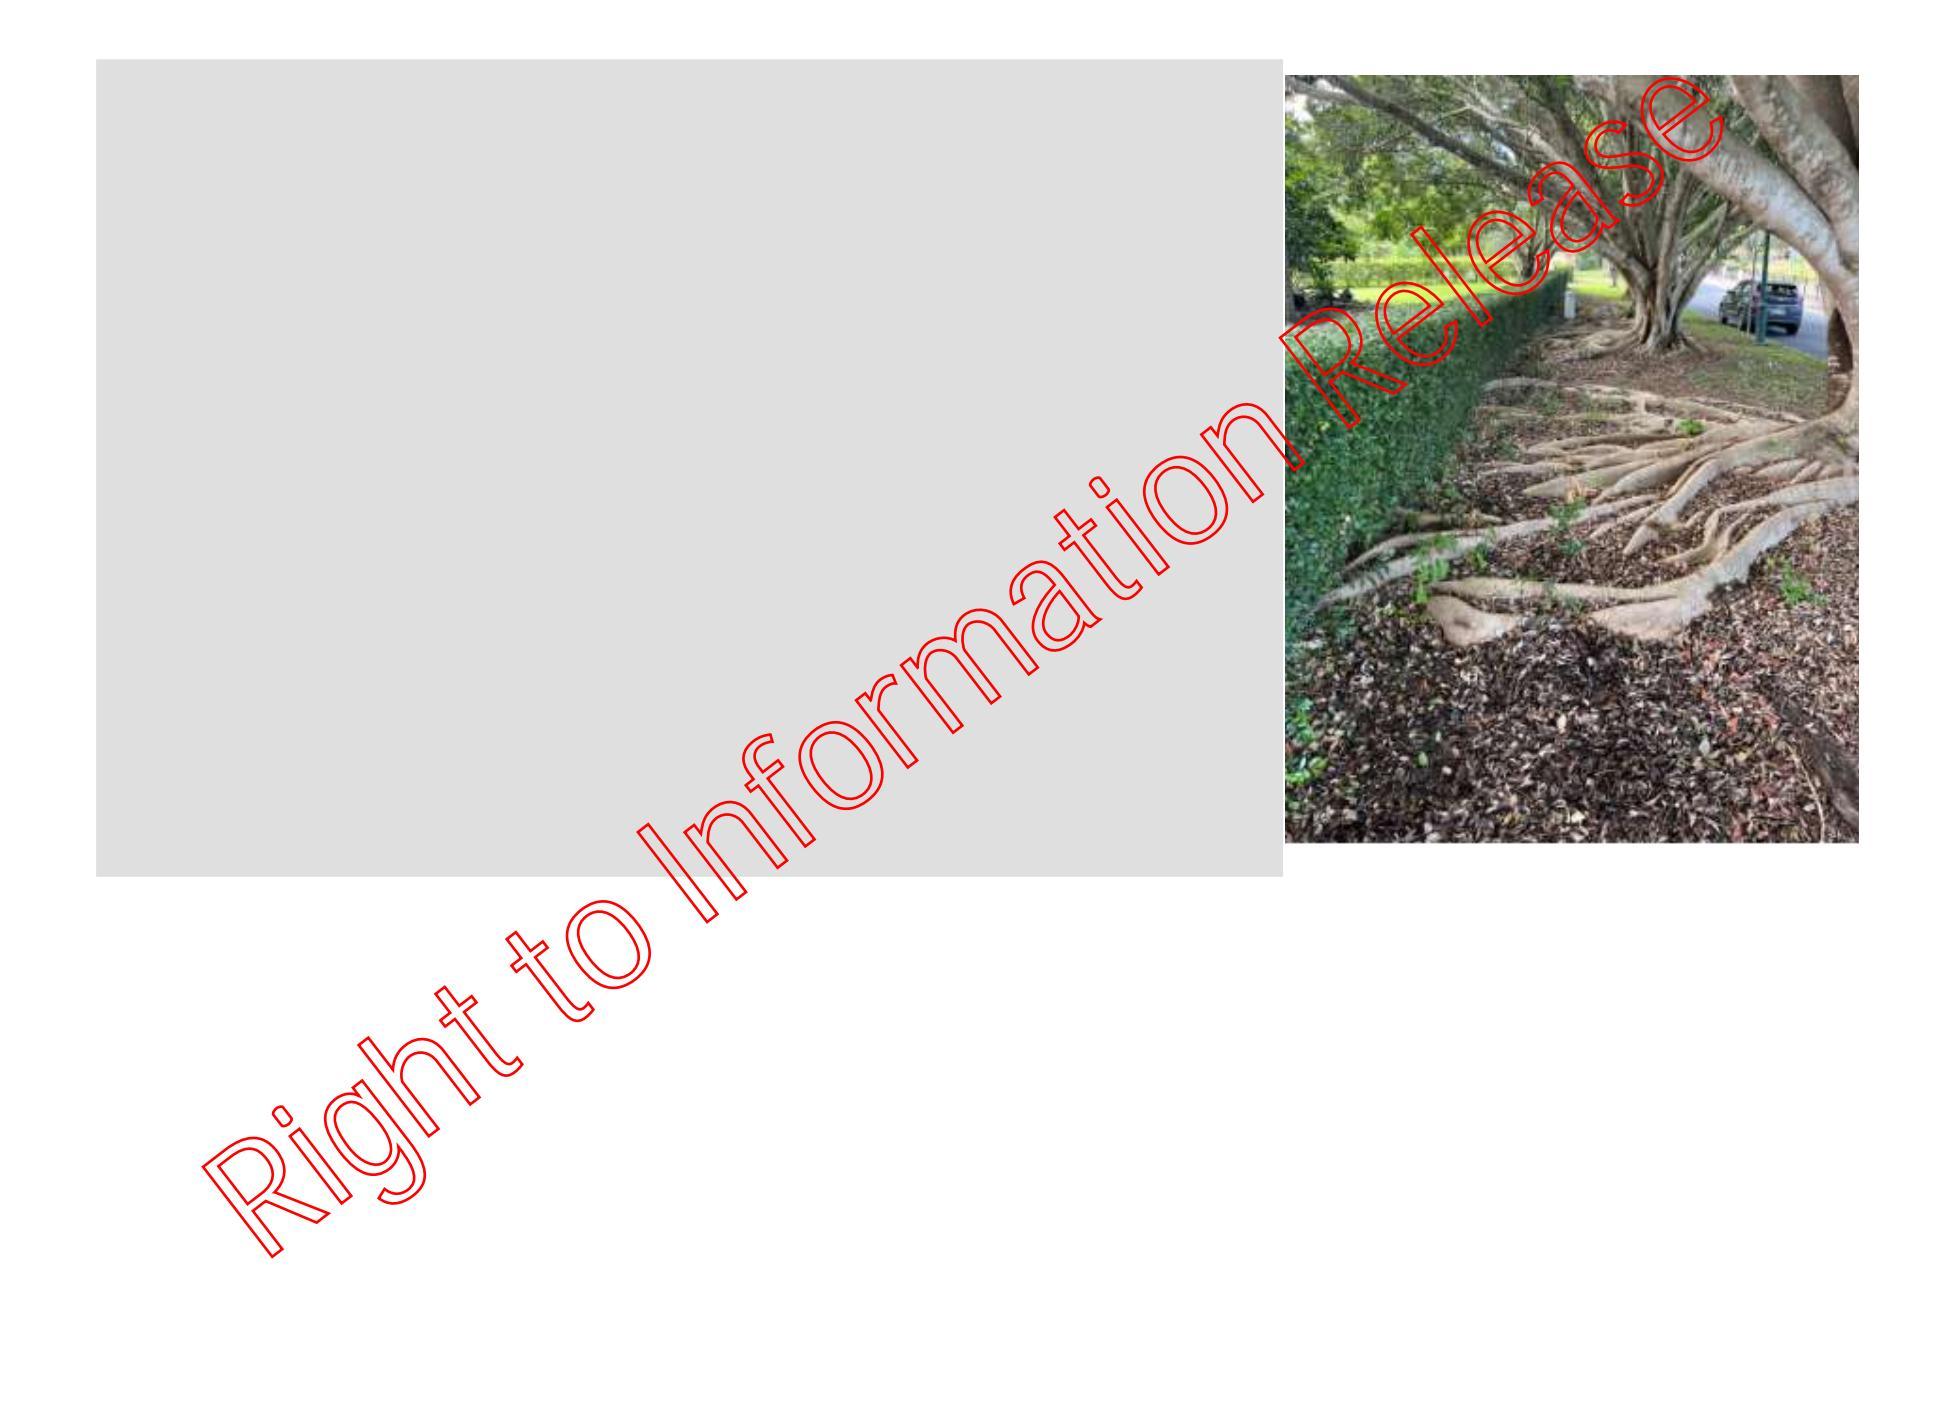
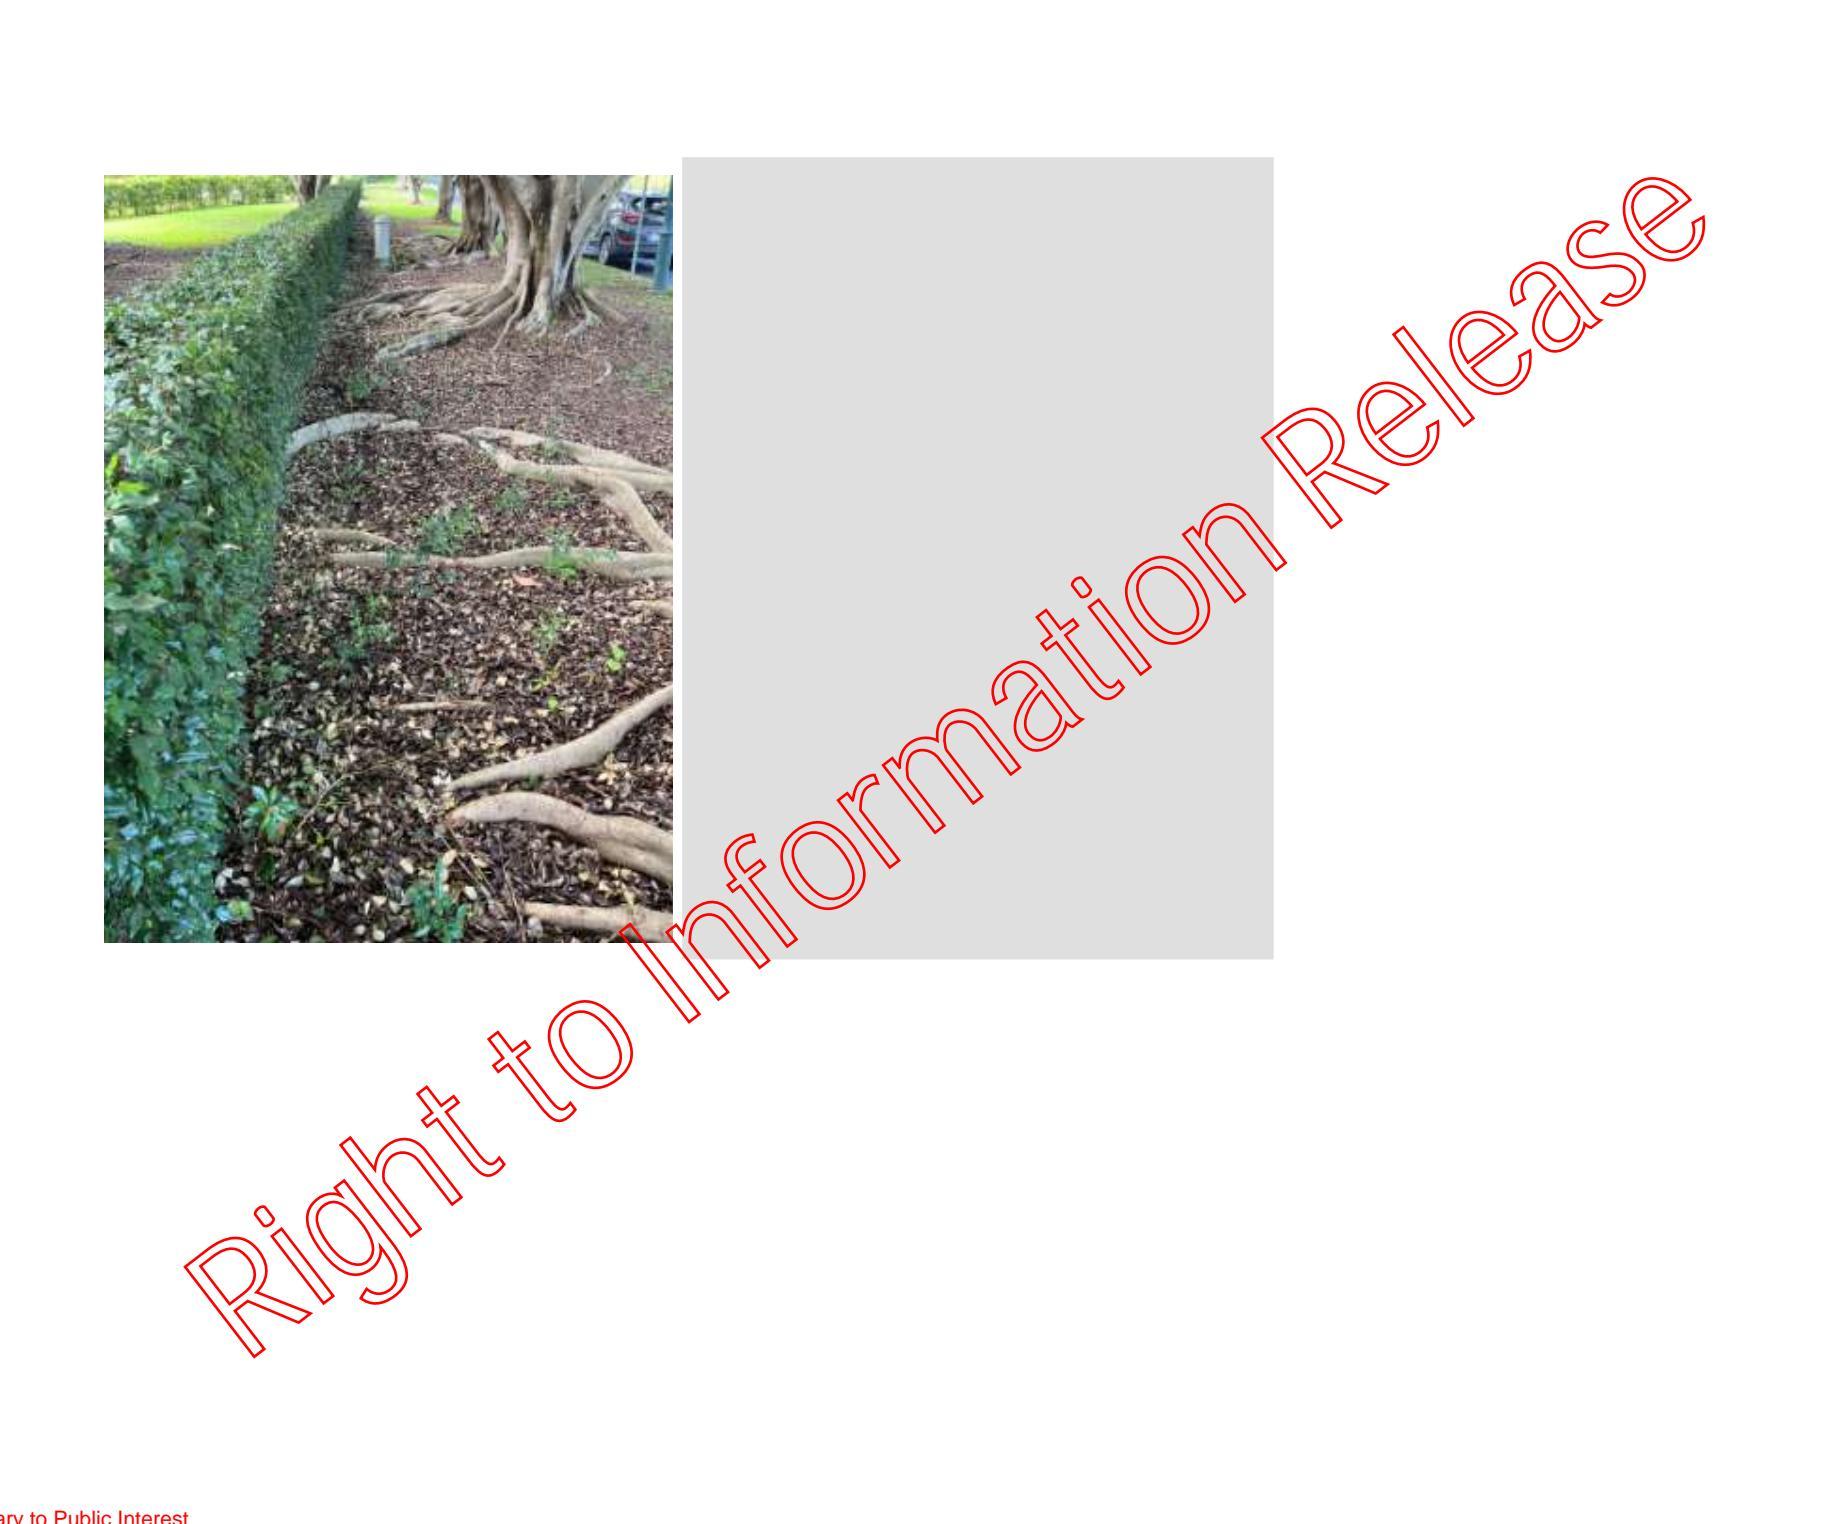
expected when planted in reserve adjacent a hard surfaced road. The root systems have been hindered in developing southwards under the road due to the non viable growth environment under a road with compacted, dry and nutrient deficient soil. Therefore as would be expected the trees roots systems have predominantly grown northwards and down the slope

The buttress roots also made parts of the road reserve surface unsafe for pedestrian movement. The potential option of root severance being performed could

not be performed within arboricultural best practice and Australian Standards AS4970. AS4970 provides the required unaffected distances for root growth without causing tree health or stability issues. In the case of these Ficus as the root systems of these trees was asymmetrical due to the roads proximity, root severance would cause in excess of 30% root loss. AS4970 provides that

would create large wounds allowing for pathogen attack on the retained tree and would destabilise the tree given the huge reduction in the root system torsional force within the soil profile. Additionally the issues related to the unsafe road reserve surface and risk to telecommunications infrastructure would not be resolved.

Tree removal required of 4 x Ficus trees as marked in attached photo. Removal required of 4 x Ficus trees and stump grinding required on council to RCC specifications. Community Consultation required to arrange quotation. - 24/05/2024 14:54:35 Correction 4 x 'Ficus species' are being removed. WR88126 -- 24/05/2024 14:50:14 3 x Ficus trees located at marked location on attached map have met removal criteria. Trees require removal due to having an Arborieulturally responsible way of preventing future damage without resulting in structural damage to the tree. Trees will require removal as approved by Senior supervisor Trees / service/manager following meeting with Risk and Liability. WR88126 -- 24/05/2024 14:40,4 Arranged onsite meeting with R&L for 4 April 2024 @ 11am - 22x03x2024 09:31:53 WR88126 -FIR - Request inspected and further investigation required prior to outcome decision Discuss with 🔨 Exposed roots through hedge into yard - 18/03/2024 10:11:18 WR881262-10 Sanctuary Drive Mount Cotton Qld 4165 urgent inspection and remedial action for root ingress from
