Expert Report in Response to Revocation of Confirmed Order VPO3

Protected Vegetation: ***Araucaria columnaris* (Cook Island Pine)**

Located at: **62-64 Beachcrest Road, Wellington Point, Qld 4160**

25 November 2013

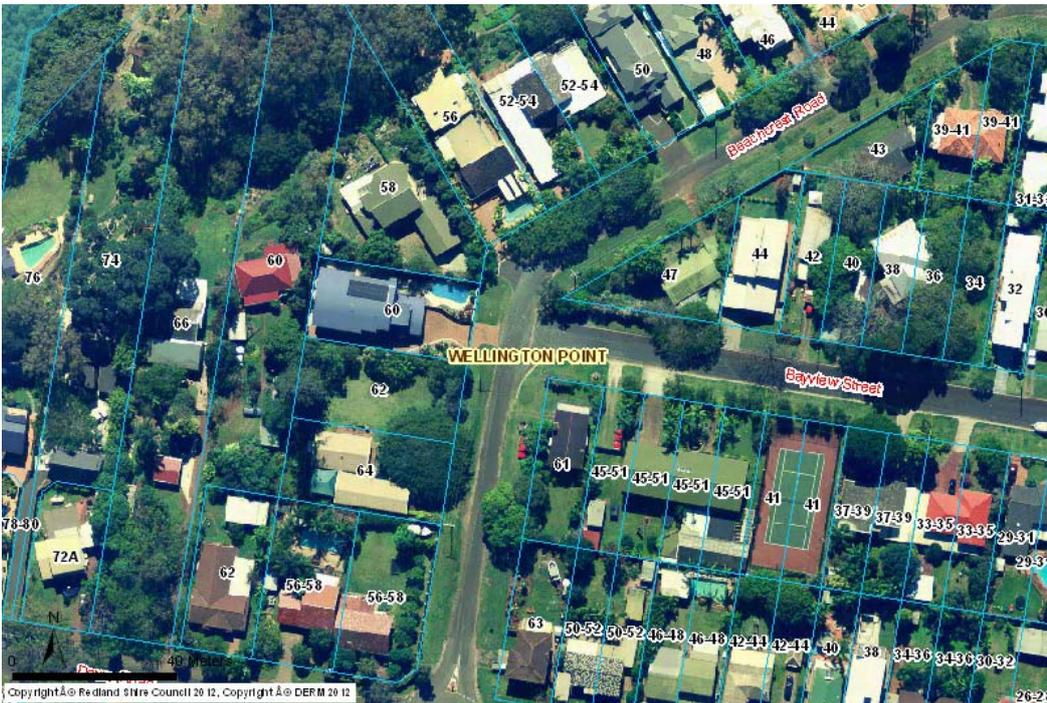
The contribution and relationship of the Cook Island Pine to its immediate area and link to neighbouring urban forest is illustrated in Figures 1 and 2 in the Appendix.

Prior to construction commencing, the tree had a large, fertile growing space with no interference from abiotic or biotic influences. Rainfall and sub-surface water was directed naturally to the trees root zone (refer to figure 1).

Figure 1: Aerial photo dated 2008 of Beachcrest Rd and the surrounding urban forest. It is these large and mature trees that provide the landscape amenity, ambience and balance. Each veteran tree is an identity to the area and each can have significant meaning to local residents and as well as to visitors to the area.

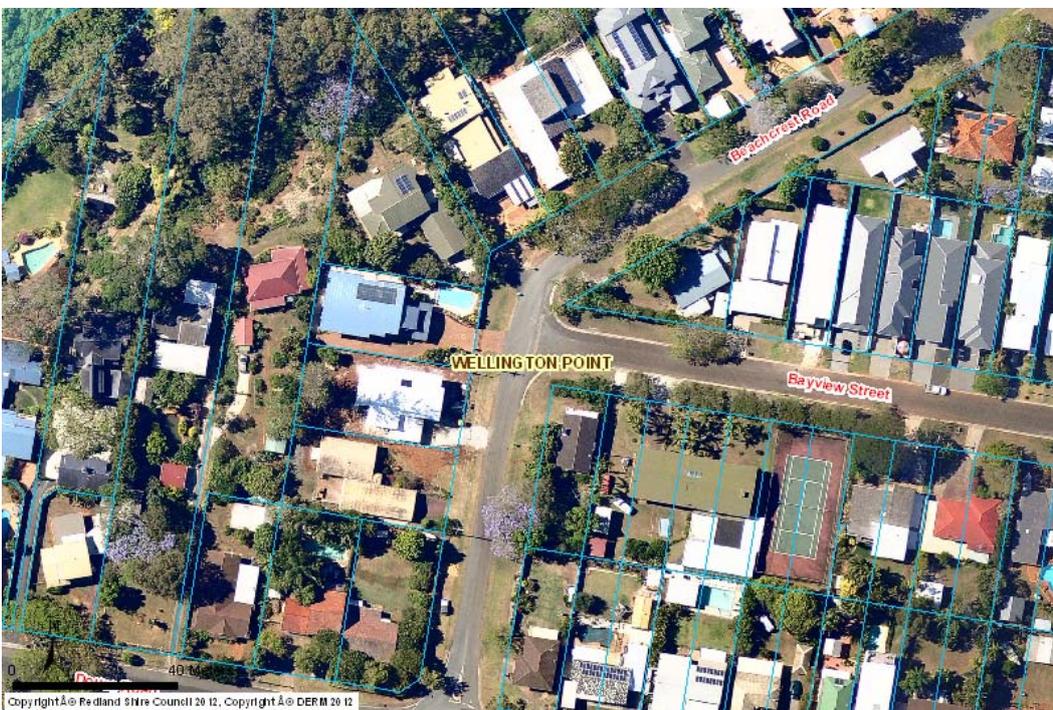
Figure 2: Aerial dated 2013. Due to urban development, shrinking property sizes, and the application of Local Law 6 permissible exemptions, the large and dominating trees within the urban forest are fast disappearing, as can be seen in this 2013 photo as compared to the 2008 photo above.

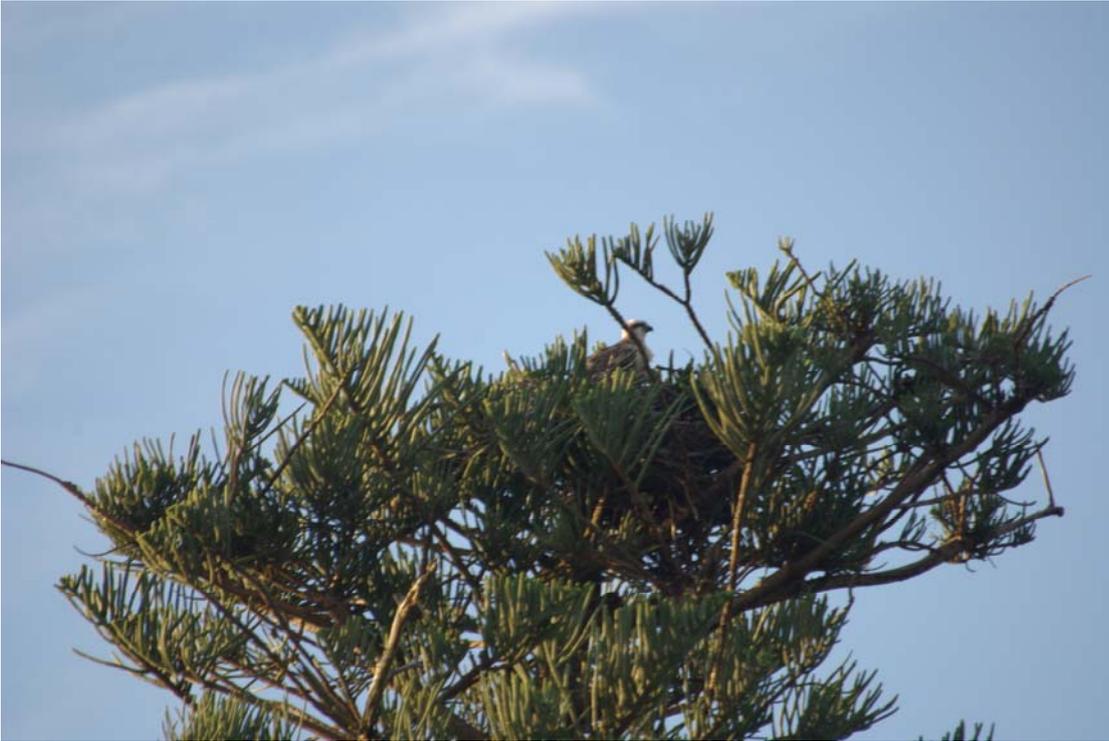
The tree's height and proximity to Moreton Bay, provides a unique nesting site for the Eastern Osprey (*Pandion cristatus*) (refer to figure 4). The tree has an important ecological value by providing a habitat for arboreal birds. The Eastern Osprey requires high roosting sites with an uninterrupted view to the water for food-gathering and observation. The Eastern Osprey is territorial with a territorial forage-range of around 30 square kilometres. The tree currently has an Eastern Osprey stick nest located in the apex of the tree. It is reported by locals as being occupied annually by breeding Eastern Osprey. This year, the nest was occupied by a breeding pair of Eastern Osprey, and the parents and chicks have only just recently vacated the nest. The closest Raptor neighbour is a Brahminy Kite (*Haliastur indus*), which has a stick nest high in the canopy of a veteran blue gum located on the foreshore at number 26 Beachcrest Road, approximately 200 metres away. The Raptor will normally return to the same nest during annual breeding cycles. This particular tree has been reported by locals as being used each year for over 30 years by Osprey including this year (2013) (refer to photograph 3). The Brahminy Kite is a Raptor that lives symbiotically within an Eastern Osprey's territory on a symbiotic relationship, often stealing the Osprey's fish in mid-air.

Figure 3: Photograph of Eastern Osprey in its nest in the apex of the Cook Island Pine

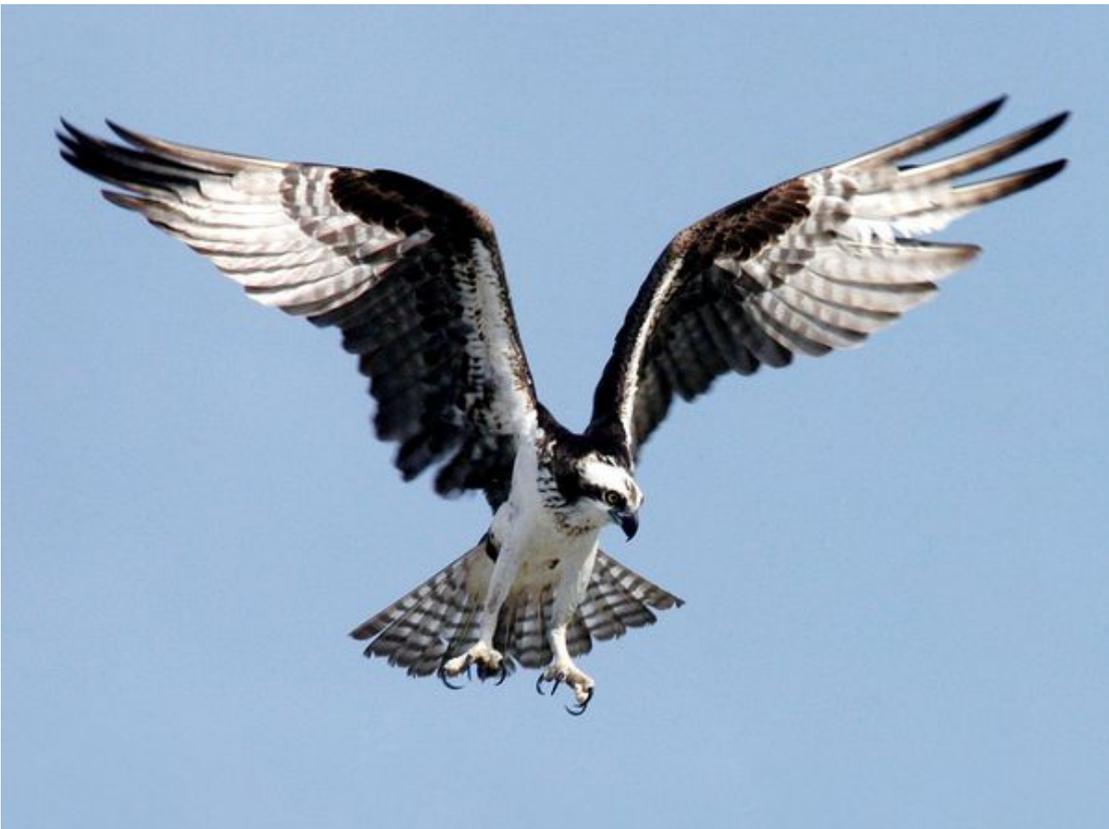
Figure 4: Photograph of Eastern Osprey in flight
