PRIORITY DEVELOPMENT AREAS SP1 TOONDAH HARBOUR, CLEVELAND SP2 WEINAM CREEK, REDLAND BAY

DRILLING & TESTING

SITE INVESTIGATION REPORT

PROJECT: Drilling & Testing - Priority Development Areas

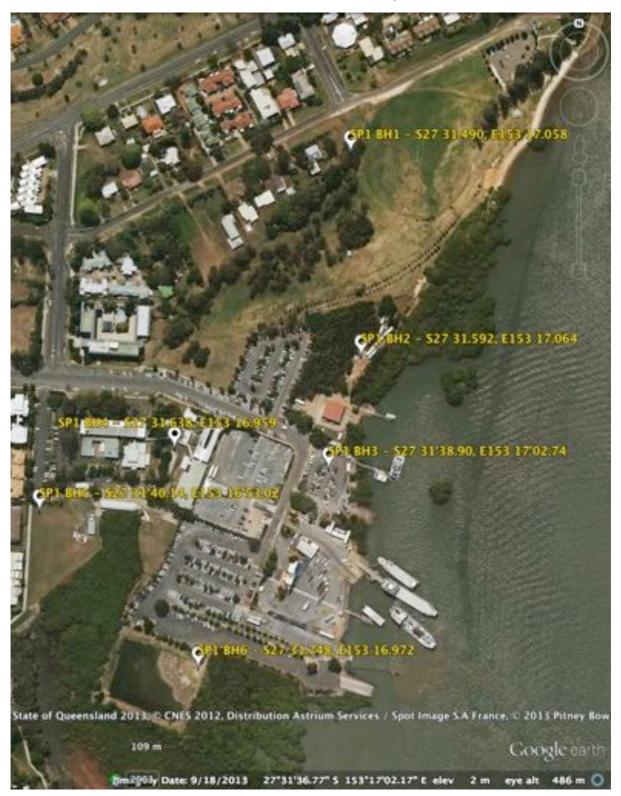
BOREHOLE LOCATIONS

SP1 - Toondah Harbour, Cleveland

SP1 Toondah Harbour, Cleveland

Lot 66/SP115554	240 Middle Street, Cleveland
Lot 58/SP115554	248 Middle Street, Cleveland
Lot 79/SL7088	13-21 Emmett Drive, Cleveland
Lot 1/RP145396	233 Middle Street, Cleveland
Lot 19/SP115544	233 Middle Street, Cleveland
Lot 21/SP125288	2-10 Emmett Drive, Cleveland
	Lot 66/SP115554 Lot 58/SP115554 Lot 79/SL7088 Lot 1/RP145396 Lot 19/SP115544 Lot 21/SP125288

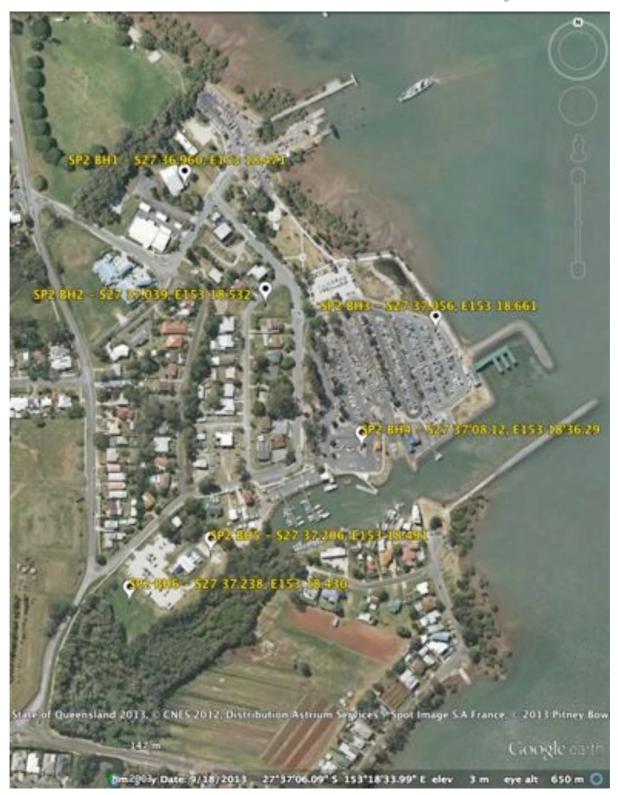
BOREHOLE LOCATIONS

SP2 - Weinam Creek, Redland Bay

SP2 Weinam Creek, Redland Bay

BH1- Lot 9	902/SP223465	5-9 Weinam Street, Redland Bay
BH2- Lot	167/CP884275	46-72 Banana Street, Redland Bay
BH3- Lot	197/SP123870	9 Meissner Street, Redland Bay
BH4- Lot	197/SP123870	9 Meissner Street, Redland Bay
BH5- Lot	1/RP90590	22 Meissner Street, Redland Bay
BH6- Lot	143/SL843	2-26 Meissner Street, Redland Bay
