# Safety Management Plan

## Amity Point Flow Slide Barrier

Redland City Council

February 2019

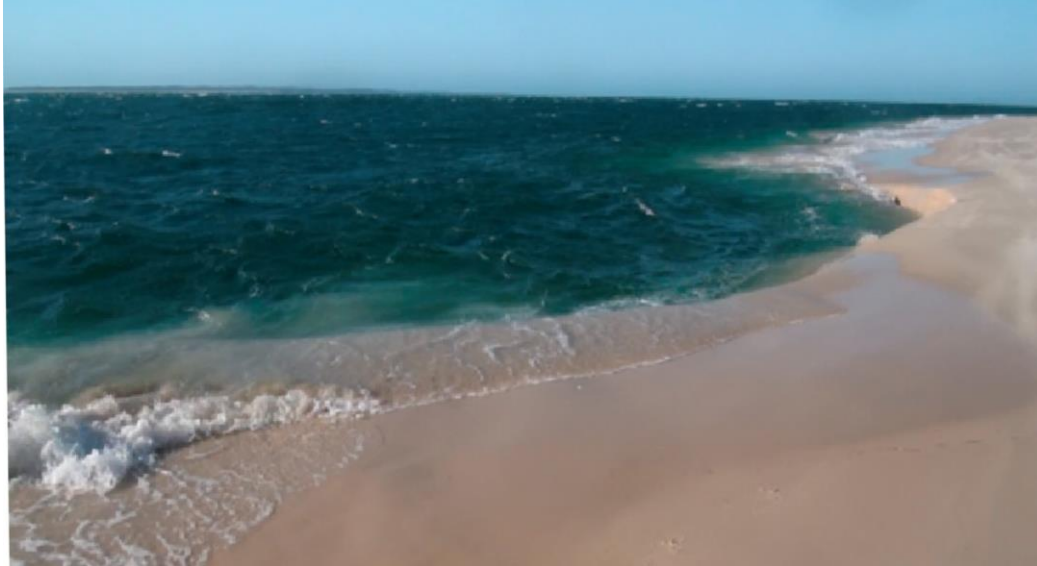
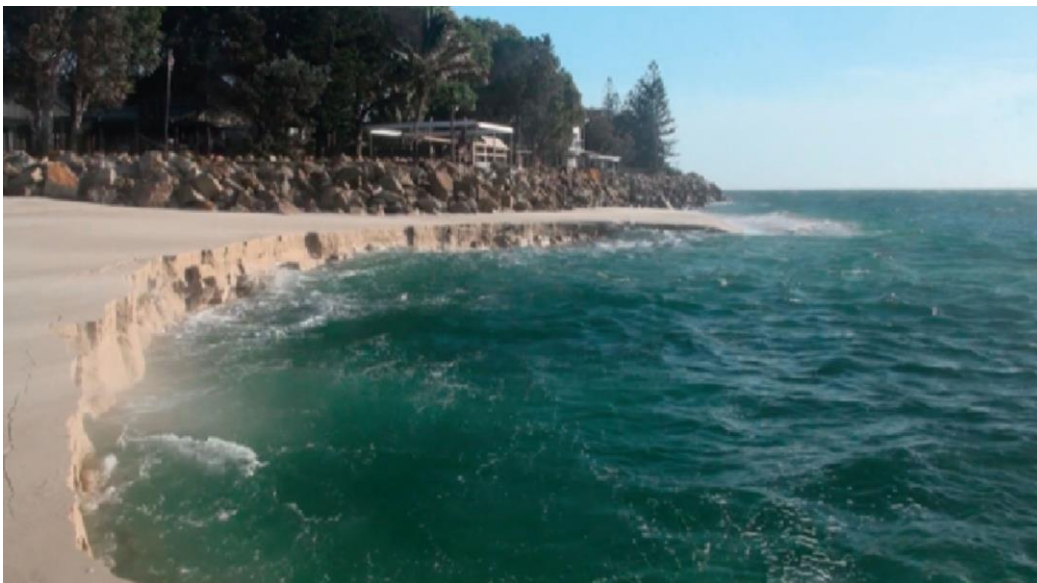
**Figure 2-1 A Retrogressive Flow Slide Underway at Amity Point**

Figure 2-1 shows images of a retrogressive flow slide underway at Amity Point<sup>1</sup>.

- In other words, the mechanism of flow slide development is driven by short-lived density currents that entrain sand off the near-vertical wall of a shoreward moving failure plane, causing sand grains to continually cascade off this advancing face. This process is classed as retrogressive breaching failure.

- As the advancing sand wall grows in height, wedges of sand can also collapse off the vertical face - breaking up as they fall and mix with water, thereby enhancing the density current. Dilation in the sand face immediately behind the collapsing wedge temporarily stabilises the wall until retrogressive breaching restarts.
- Retrogression continues, creating a deep bowl-shaped scour feature in the submerged side slope of the tidal channel or river bank (as seen in Figure 2-1 above). Typically, as the event grows, this then becomes more of an amphitheatre-shaped characteristic with a narrower throat at its deeper offshore end.
- The base of the retrogressing sand wall propagates into the sand slope slightly upwards on an approximate angle of 1 vertical : 15 horizontal.

- A triggering mechanism develops a localised scour somewhere on the submerged slope, which can then progress to a shear failure should the disturbed area exceed the stable angle of repose for the sand.

- The sand grains remaining on the sheared face of the slope are unsupported, and will consequently move apart - increasing the void ratio (this is called *dilation*) which temporarily decreases pore pressures within the face of the slope. The lower pore pressures (compared to the surrounding hydrostatic water pressures) cause individual sand grains near the face to be “sucked” together for a short time. This enables the sand body to resist further collapse and for a near-vertical face to develop.

- The lower pore pressures at the near-vertical sand face are quickly dissipated - by the surrounding water infiltrating the voids. The unconfined grains at the face then detach and fall from the wall, generating a density current of entrained sand which carries the falling sand away into deeper water. The process continues on the newly exposed sand grains in the near-vertical face - increasing the momentum of the event.

- The density currents carry the removed sand away from the failure zone and beyond the immediate toe of the near-vertical face, allowing it to remain steep and high. This dispersion of sand away from the base of the breach can be further assisted by tidal currents flowing in the channel itself.

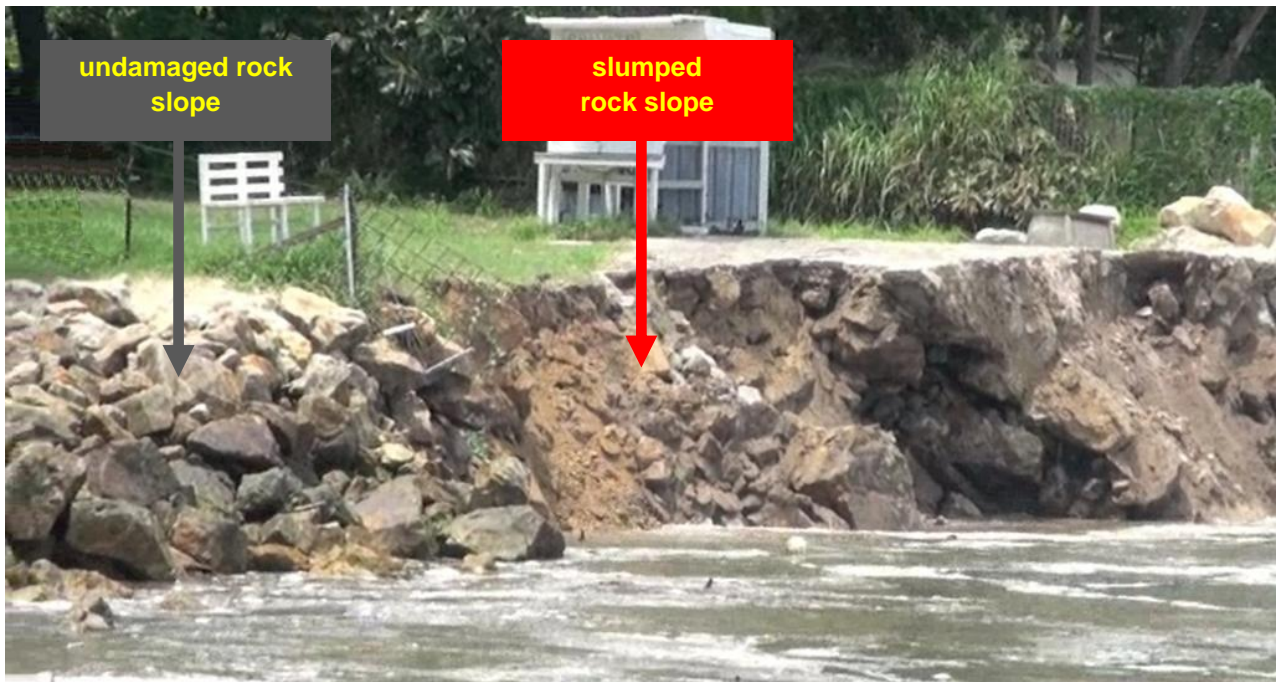
**Figure 3-1 Emergency Tidal Works Trigger Event – Excessive Rock Slumping**

- Excessive rock slumping : All visible rocks in the flow slide barrier above the prevailing tide level have slumped down below the waterline; or
- Excessive rock erosion : The extent of rock settlement during a single retrogressive flow slide event is such that the upper seaward-most corner of the barrier’s front slope is eroded inland by 5 metres.

These two fundamental trigger actions are illustrated respectively in Figure 3-1 and Figure 3-2.
