# 28 - POINT LOOKOUT: Point Lookout Lighthouse

Street Address	40 Lucinda Crescent, Point Lookout
GPS/RPD	Lot 6 on SL1335
Place Type	Built

Condition	Good	Integrity	Good
Statutory Listings	Local Heritage Place		
Non-Statutory Listings	No current listing		
Inspection Date	17/01/2017

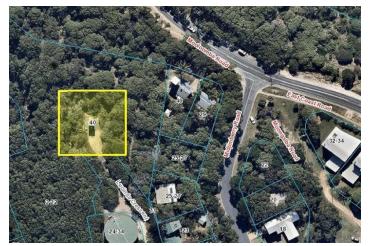
Point Lookout Lighthouse, Point Lookout (AHS, 2017).

The Point Lookout Lighthouse is a square concrete structure with a modern electrical light on top. The site is located on the highest point of the ridge off Midjimberry Road in a clearing surrounded by low native and introduced vegetation. Evidence of the former acetylene cylinder store is visible in the concrete slab adjacent to the lighthouse structure. Interpretive signage exists at the entrance.
